# Construction and Stormwater Inspection

September 7, 2017

Operator: BURLINGTON RESOURCES OIL & GAS LP- #26580

Location ID: 451622

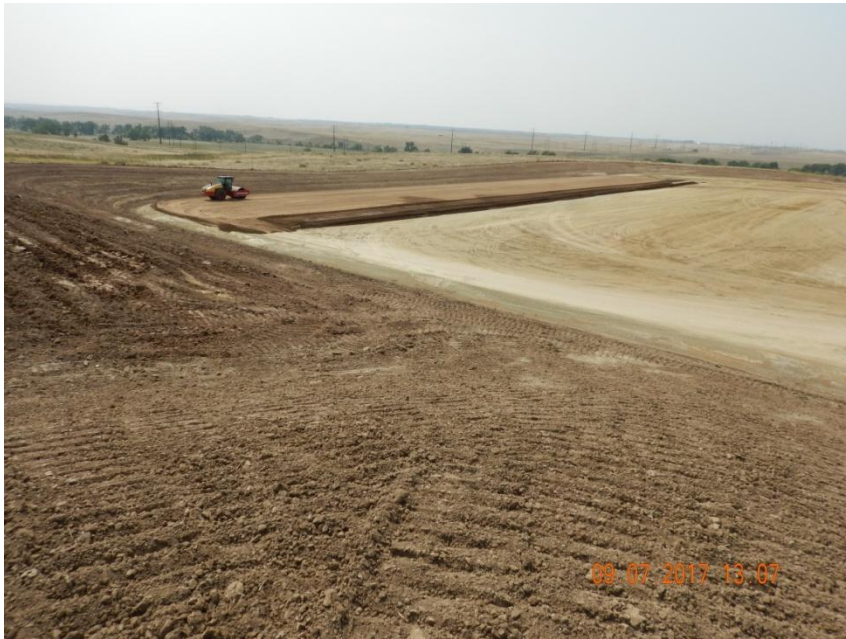
**Photo 1.** Photo taken from the eastern location, facing Southwest. Construction operations are still underway. Disturbance areas outside of the well pad have been temporarily stabilized with equipment.

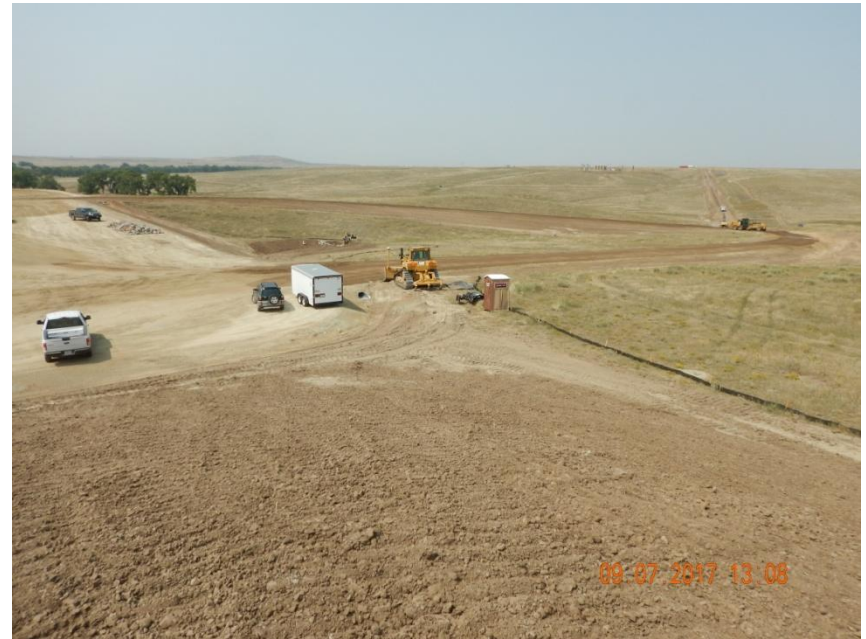
**Photo 2.** . Photo taken from the eastern location, facing Northwest. Construction operations are still underway. Disturbance areas outside of the well pad have been temporarily stabilized with equipment.

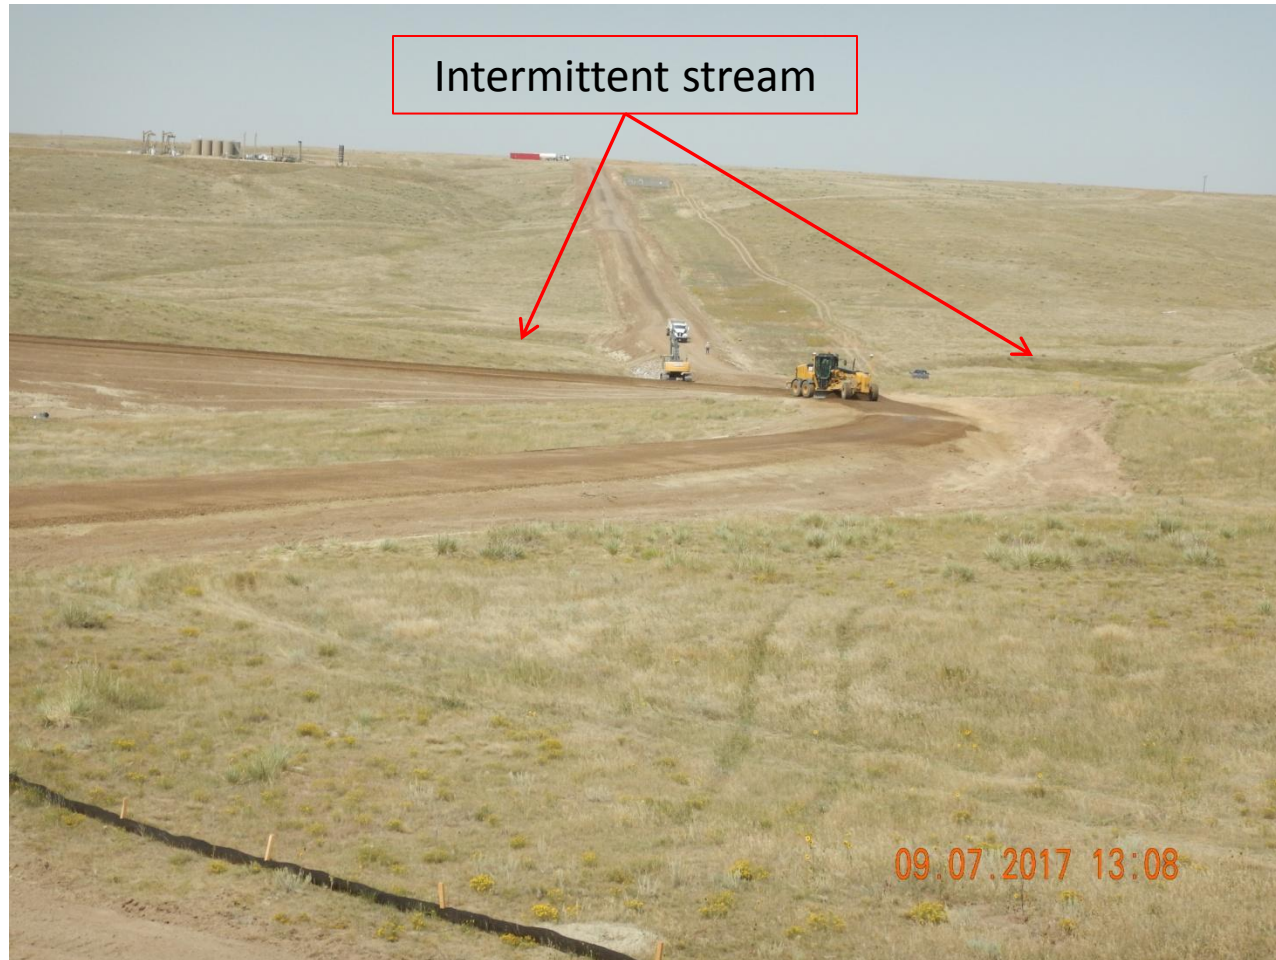
**Photo 3.** Photo taken from the eastern location, facing North. Photo taken of the access road coming into the location.

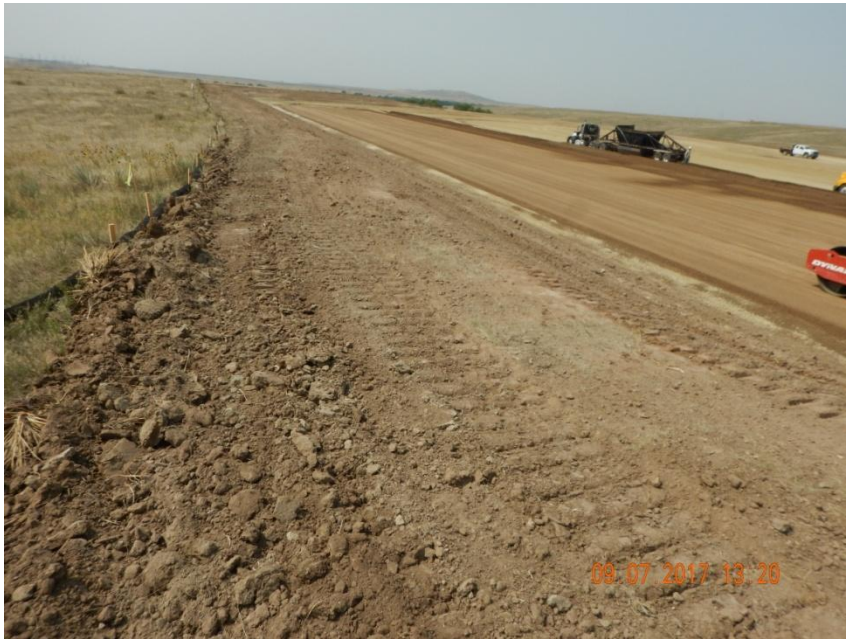
**Photo 4.** Photo taken from the southern location, facing West. Temporary Filtrexx BMP installed around the southern location. Cut slopes have been temporarily stabilized. It should be noted that equipment did not correctly track some cut slopes such that the grooves run perpendicular to the cut slopes. Operator will mulch and seed all disturbance area outside of the well pad. Perimeter ditch around well pad.

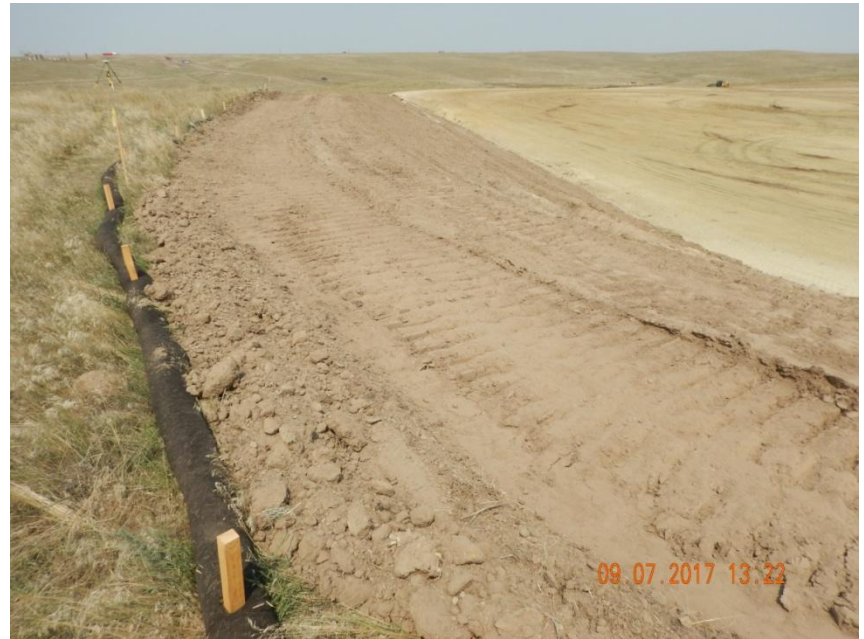
**Photo 5.** Photo taken from the western location, facing North. Temporary Filtrexx BMP installed around portions of the western location. Perimeter ditch around well pad.

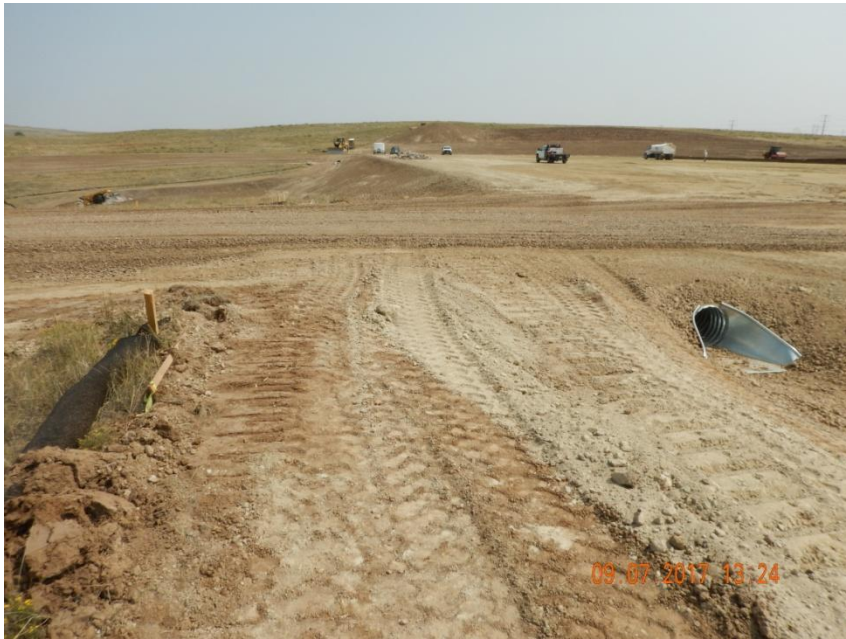
**Photo 6.** Photo taken from the northern well pad, west access entrance to location, facing East. Culvert installed with a stabilized outlet area. Culvert installed in conjunction with the well pad perimeter ditch. Stormwater runoff is being directed to a sediment trap-see photo 7.

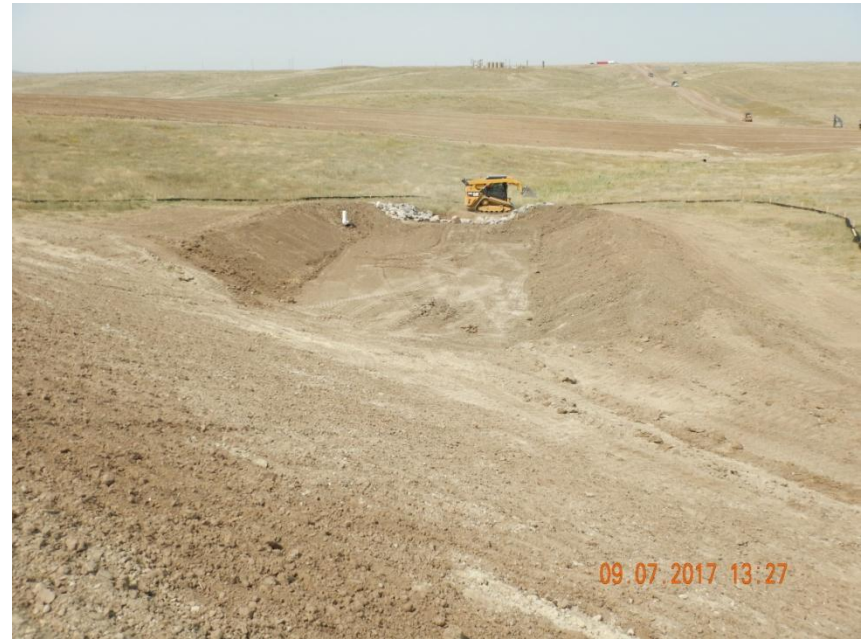
**Photo 7.** Photo taken from the northern location, facing North. Sediment trap construction underway.

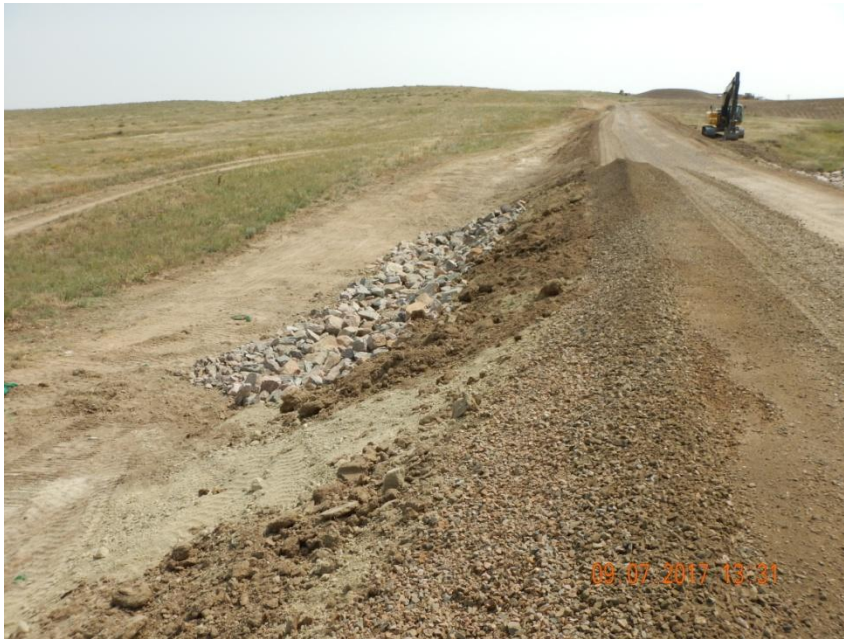
**Photo 8.** Photo taken from the east culvert area of the intermittent stream crossing, facing South. Operator In-Process of stabilizing culvert area. Operator shall ensure erosion and sediment controls are installed along access road portions to control and manage for sediment discharge.

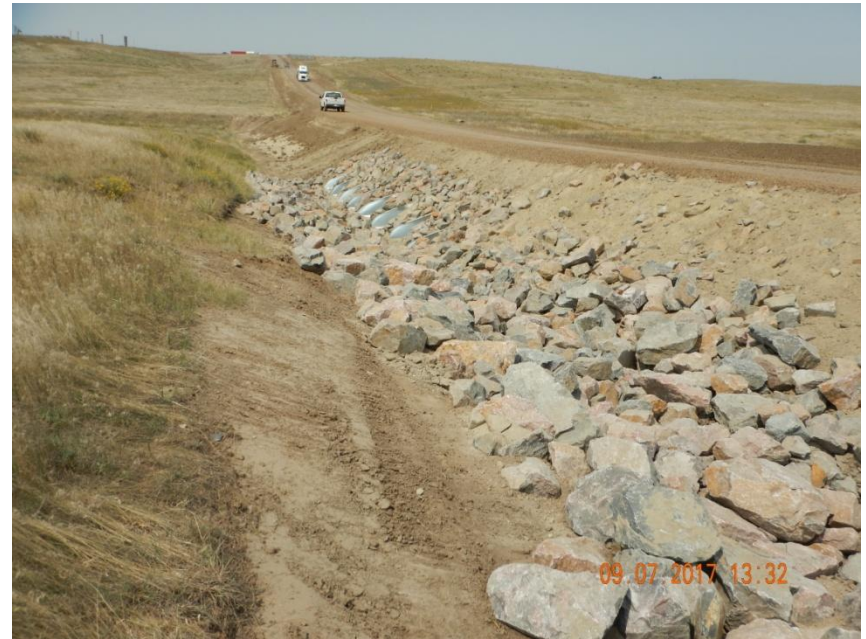
**Photo 9.** Photo taken from the west culvert area of the intermittent stream crossing, facing North. Operator In-Process of stabilizing culvert area. Operator shall ensure erosion and sediment controls are installed along access road portions to control and manage for sediment discharge.
