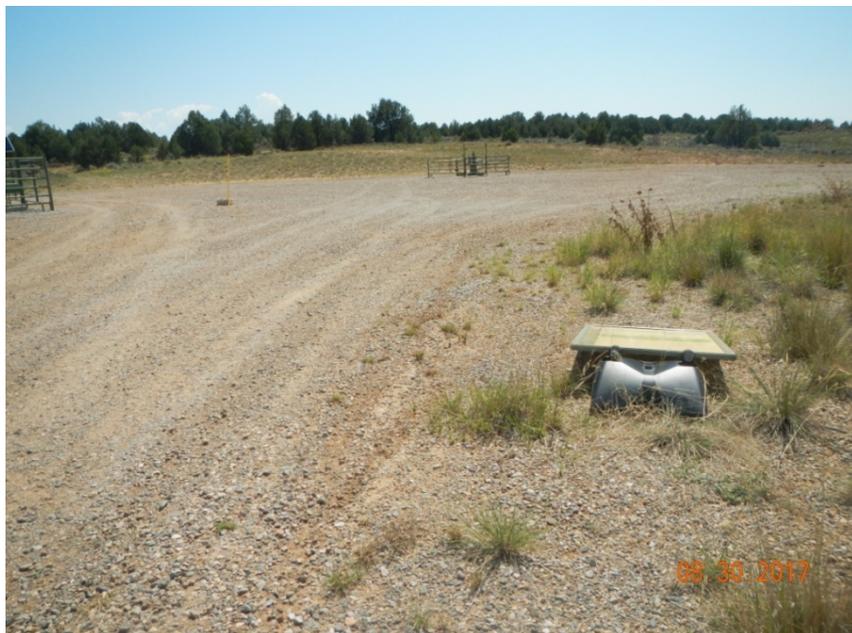
Photo 1: View of the project area from the northwestern corner facing center. Sign is tipped over.

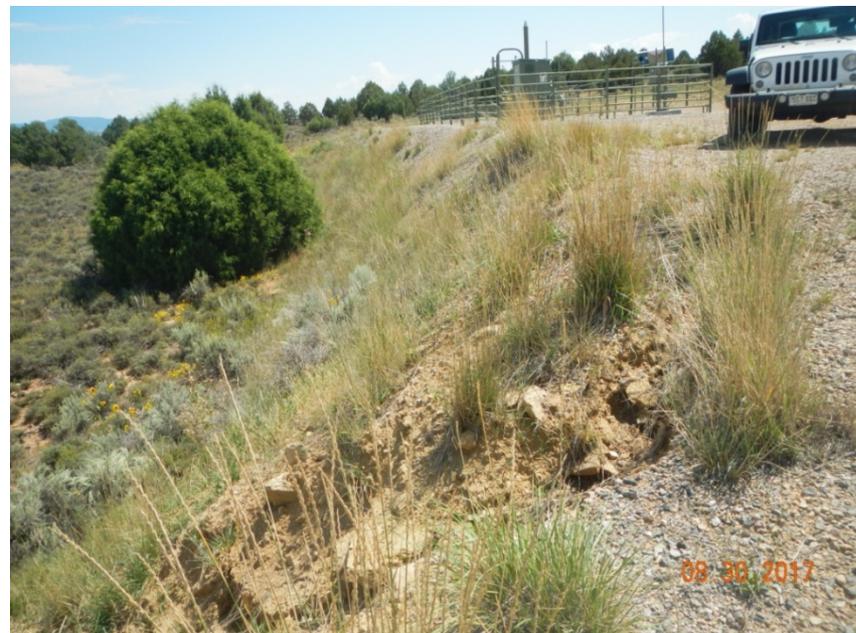
Photo 2: View of the northern portion of the project area from the northwestern corner facing eastward. Revegetation is progressing within the interim reclamation areas such as western wheatgrass (*Pascopyrum smithii*), crested wheatgrass (*Agropyron cristatum*), and intermediate wheatgrass (*Thinopyron intermedium*).

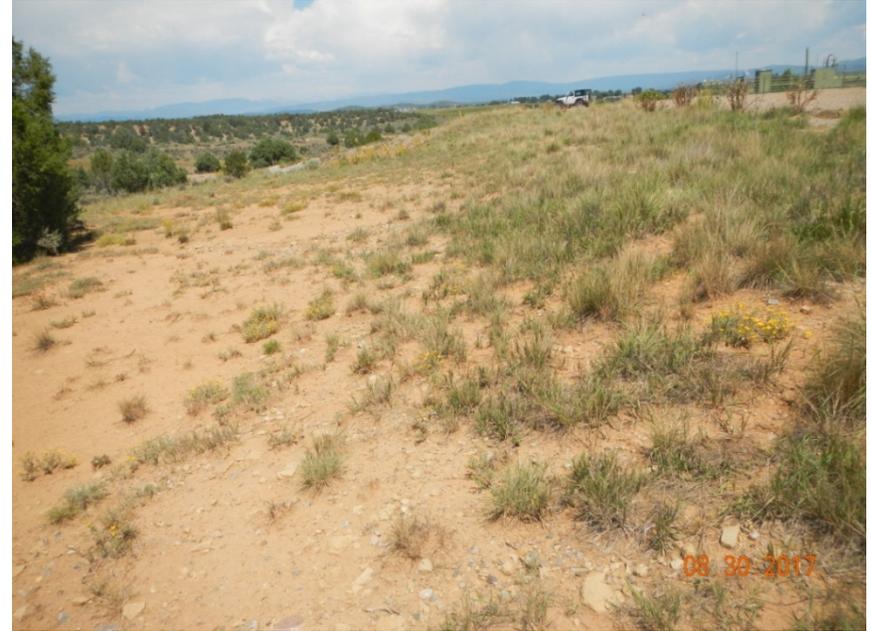
Photo 4: View of the western portion of the project area from the southwestern corner facing northward. Vegetation below fill slope is degraded and sparse.

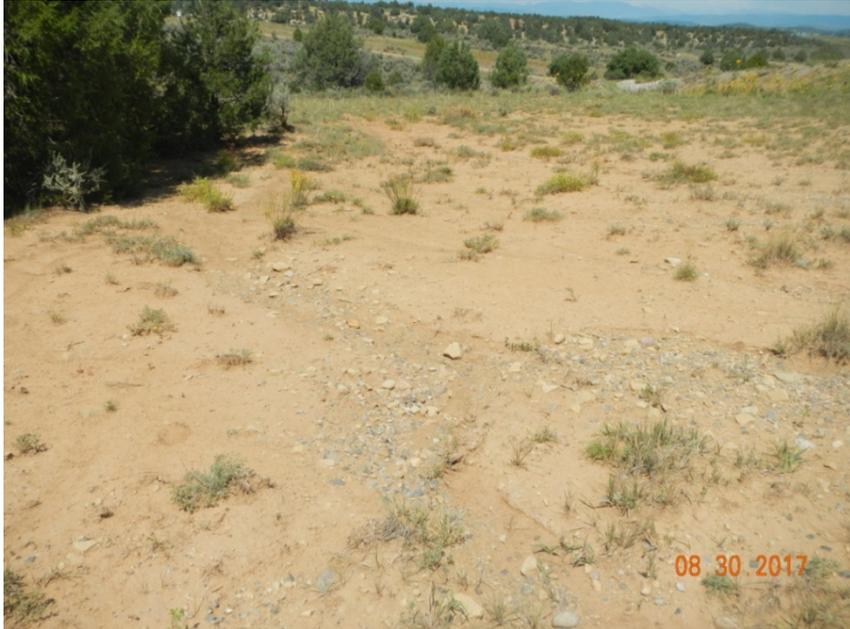
Photo 5: View of area in the western portion of the project area where concentrated stormwater flow is eroding a channel here.

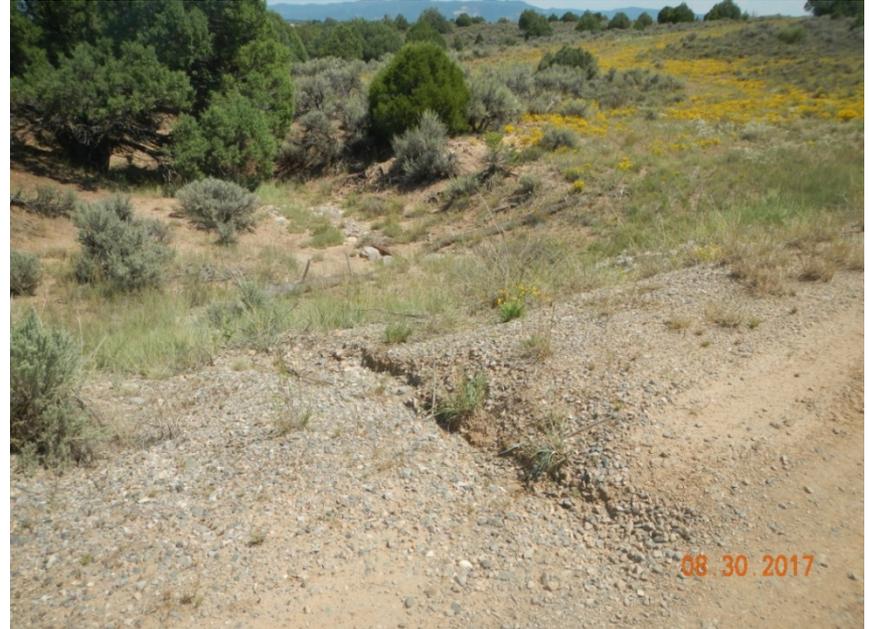
Photo 6: View of erosion occurring along the access road into a drainage. This area needs to be stabilized.

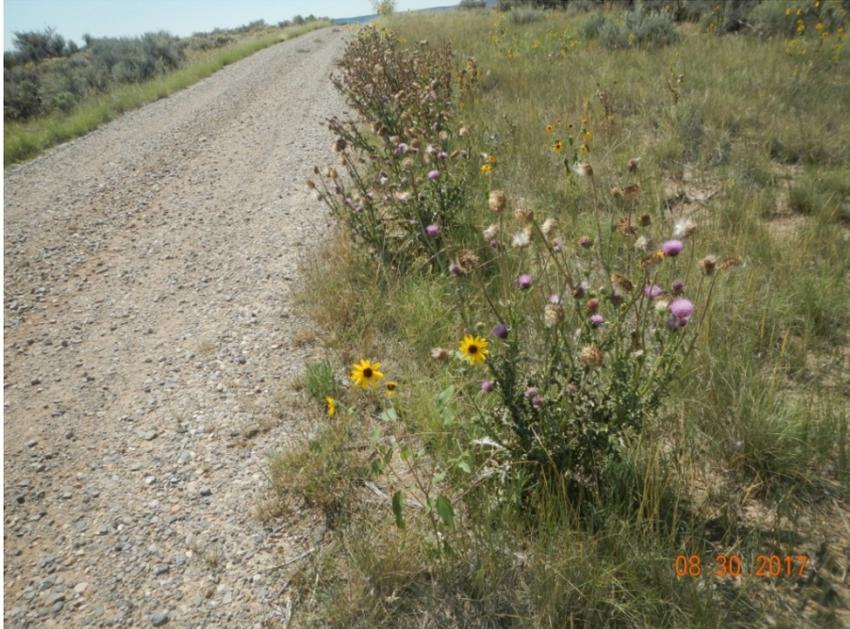
Photo 7: View of flowering and seeding musk thistles (*Carduus nutans*) within the project area.
