Interim Reclamation and Stormwater Inspection

September 8, 2017

Operator: NOBLE ENERGY INC- #100322

Location ID: 445237

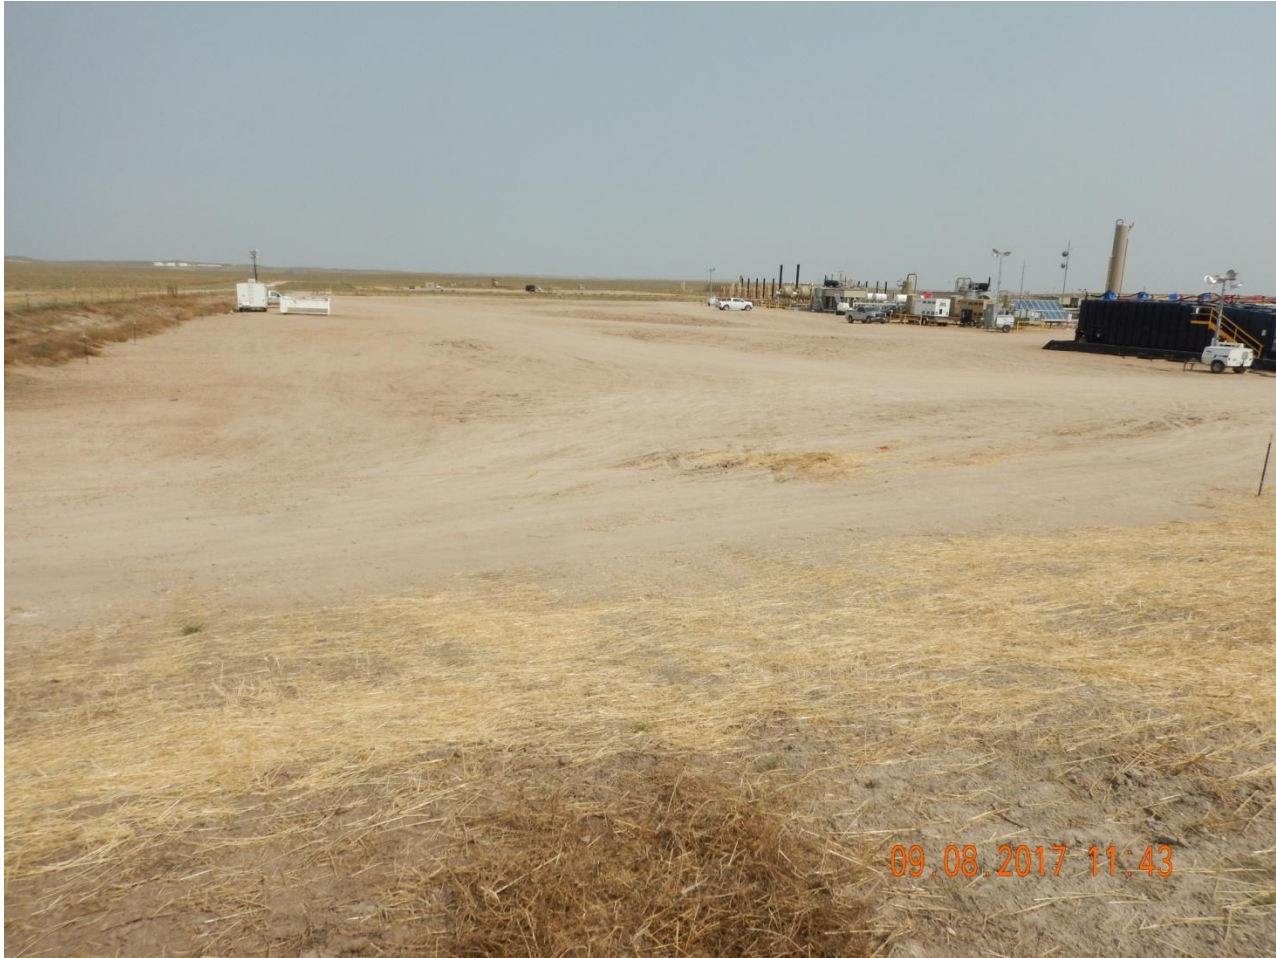
Photo 1. Photo taken from the southwestern location, facing North. Operator shall comply with Rule 1003 to reclaim all areas not reasonably needed for production operations. Appears to be a significant portion of the western location that is not needed for production operations.

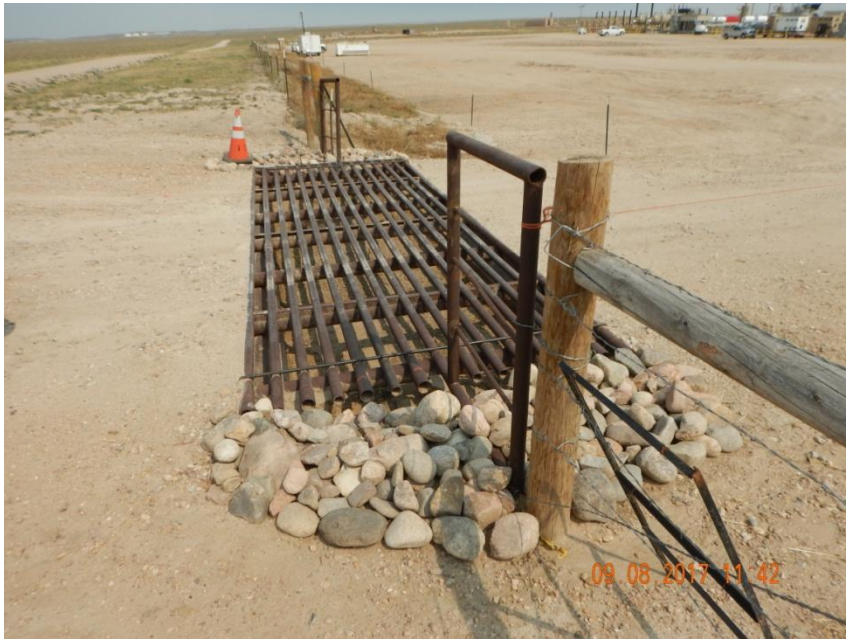
Photo 2. Photo taken from the south entrance of location, facing North. Appears the Operator has installed rip-rap material on both sides of the cattle guard to capture potential runoff.

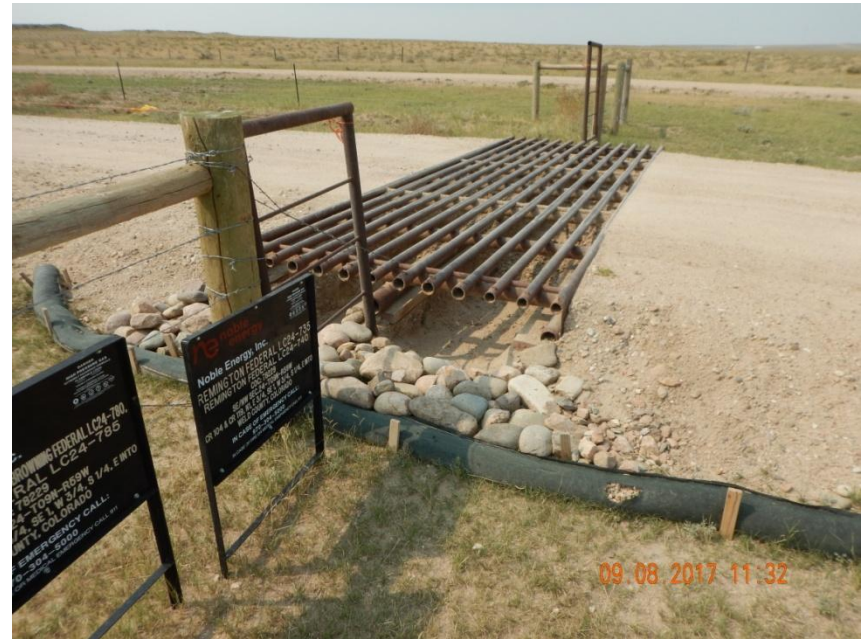
Photo 3. Photo taken from the north entrance of location, facing West. Appears the Operator has installed rip-rap material on both sides of the cattle guard to capture potential runoff.

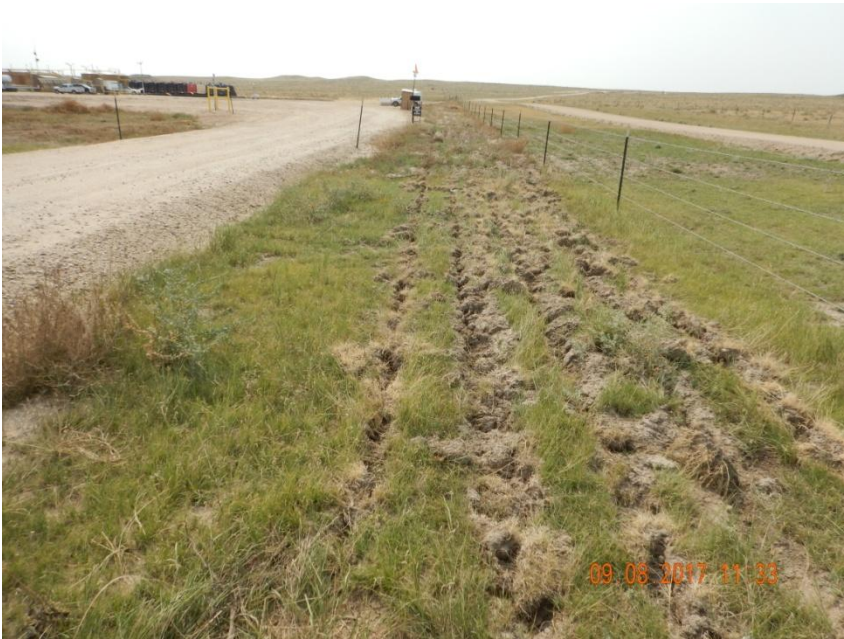
Photo 4. Photo taken from the north entrance of location, facing South. Appears the Operator has surface roughening along the portions of the western perimeter.

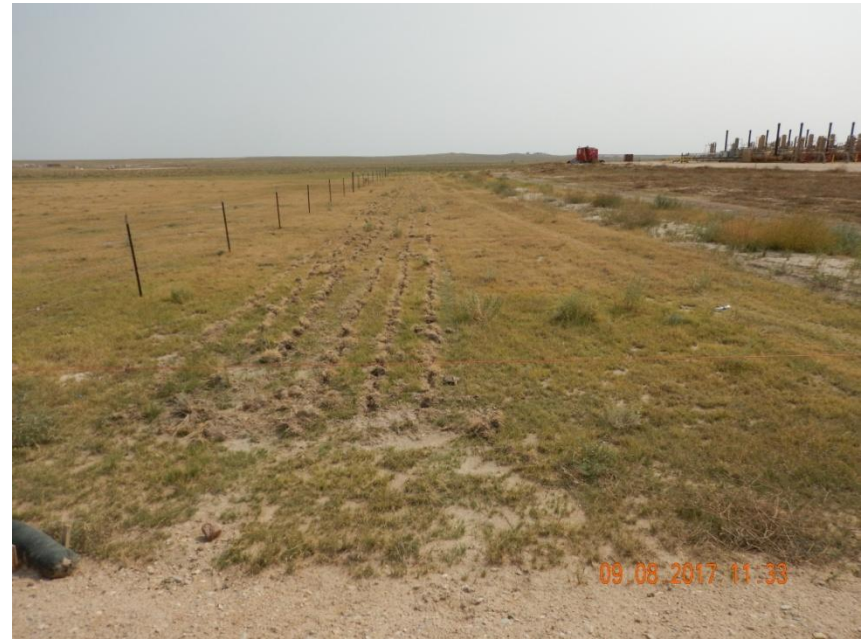
Photo 5. Photo taken from the north entrance of location, facing East. Appears the Operator has surface roughening along the portions of the northern perimeter.

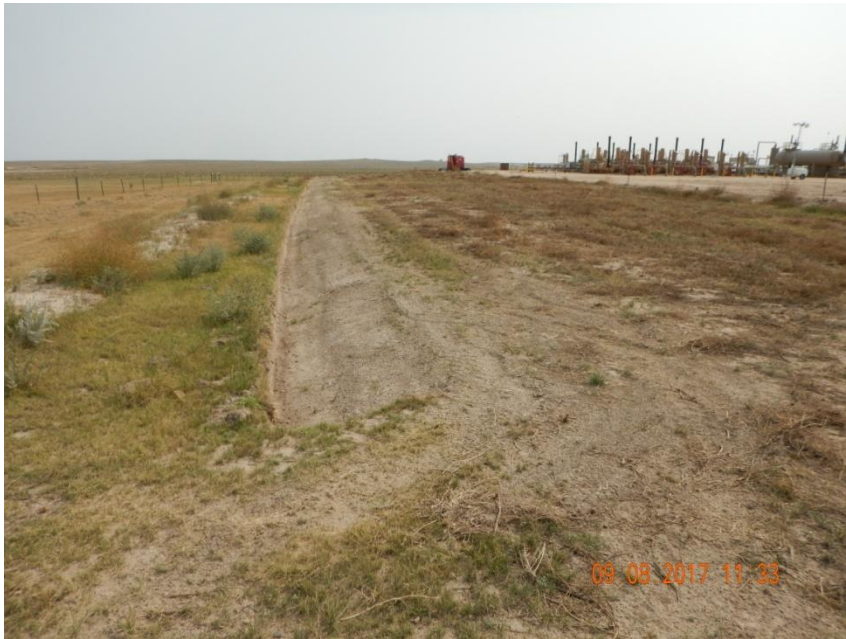
Photo 6. Photo taken from the northwestern location, facing East. Operator has installed a ditch BMP to the inside (south) of the surface roughening BMP. Vegetative growth south of the ditch BMP and the pad consists mainly of weedy, annual vegetation. Appears the Operator has recently mowed the area. This area was previously thought to be topsoil storage.

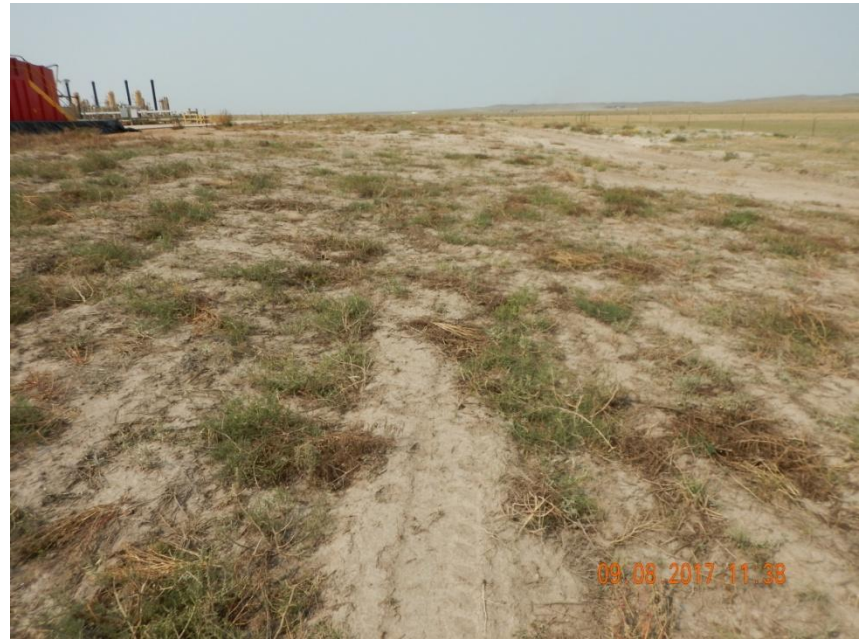
Photo 7. Photo taken from the northeastern location, facing West. Vegetative growth south of the ditch BMP and the pad consists mainly of weedy, annual vegetation. Appears the Operator has recently mowed the area. This area was previously thought to be topsoil storage.

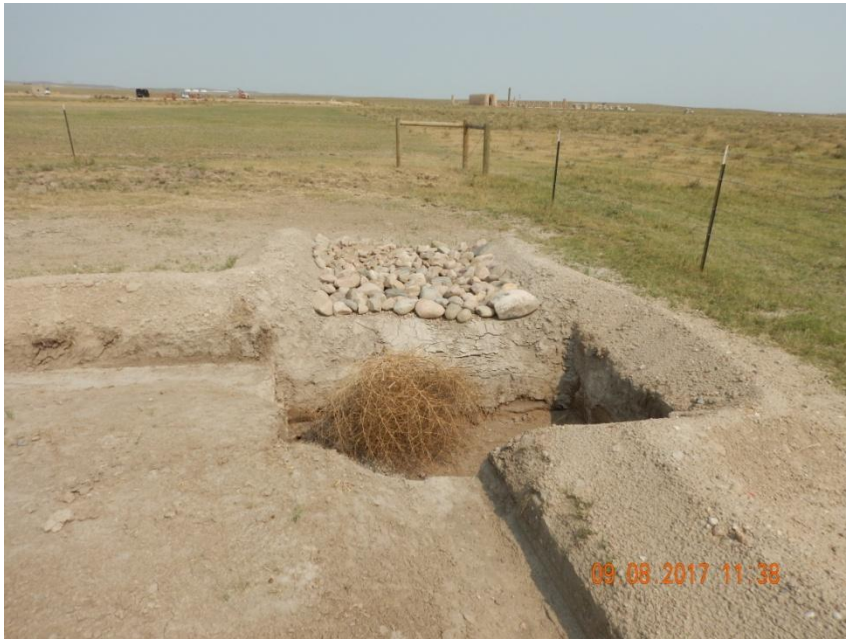
Photo 8. Photo taken from the northeastern location, facing North. Appears the Operator has enlarged the depth of the sediment trap, installed an outlet device, and constructed embankment berm material.

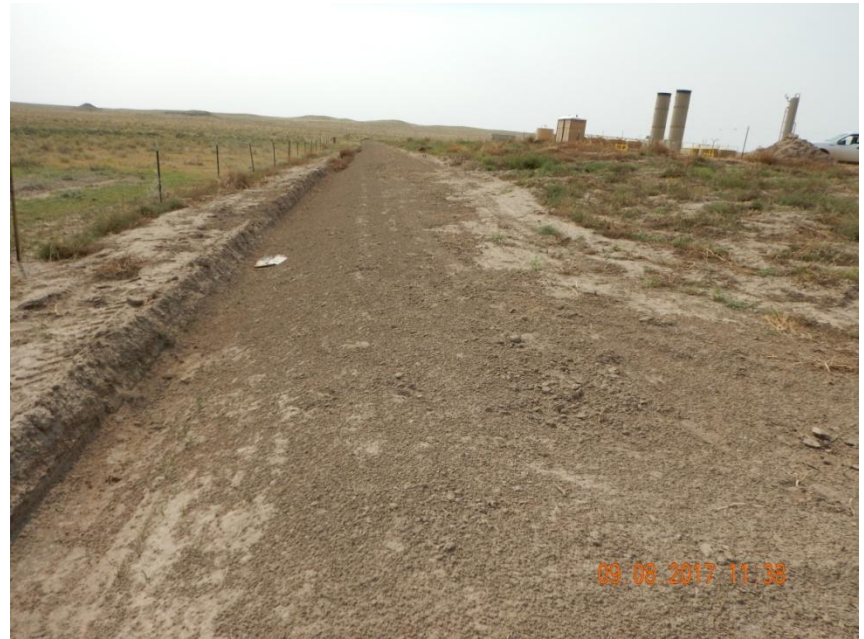
Photo 9. Photo taken from the northeastern location, facing South. Appears to be a significant portion of bare soil that is not stabilized.

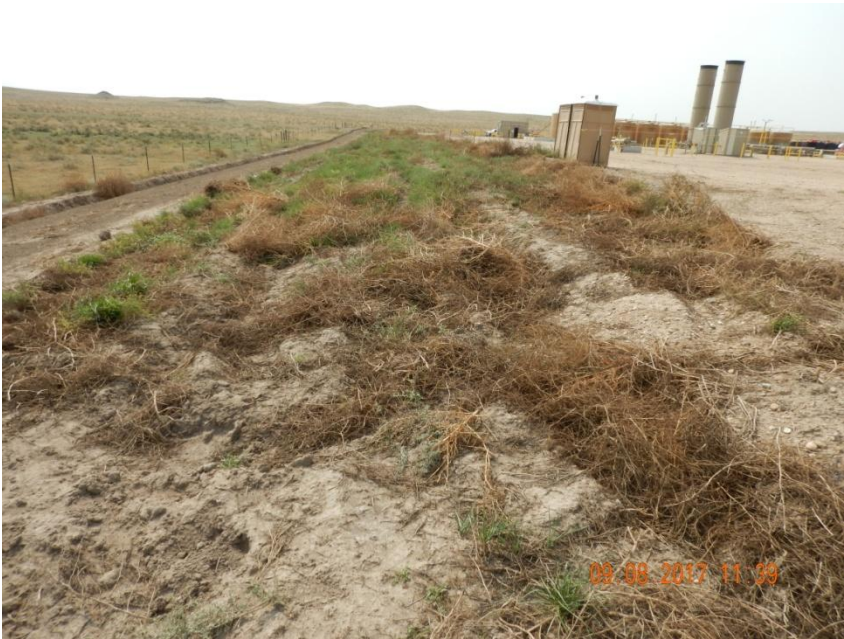
Photo 10. Photo taken from the eastern location, facing South. Vegetative growth west of the ditch BMP and the pad consists mainly of weedy, annual vegetation. Appears the Operator has recently mowed the area. This area was previously thought to be topsoil storage.

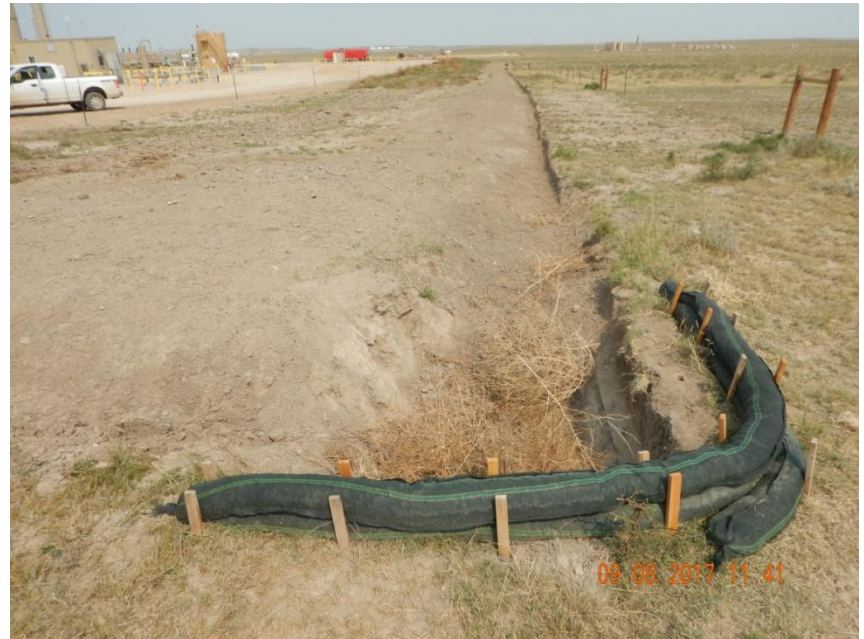
Photo 11. Photo taken from the southeast location, facing North. Does not appear that the sediment trap has been improved since the previous inspection and would still be considered insufficiently built.

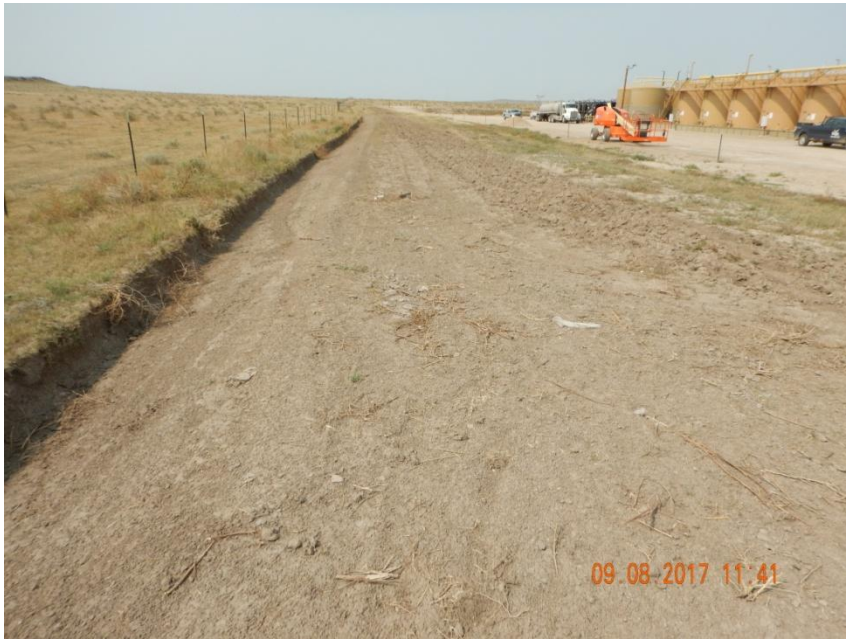
Photo 12. Photo taken from the southeast location, facing West. Appears to be a significant portion of bare soil that is not stabilized.

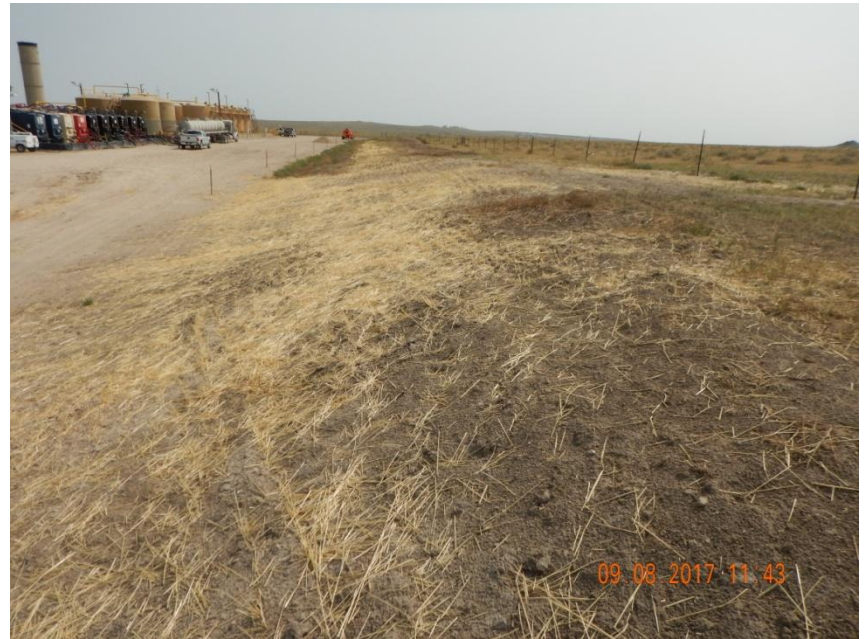
Photo 13. Photo taken from the south entrance of location, facing East. Appears the Operator has stabilized portions of the southwest disturbance area by crimping straw mulch.
