Inspection Photos
Location Name: Wells Ranch USX AA23-65-1HN Pad
API: 05-123-35337

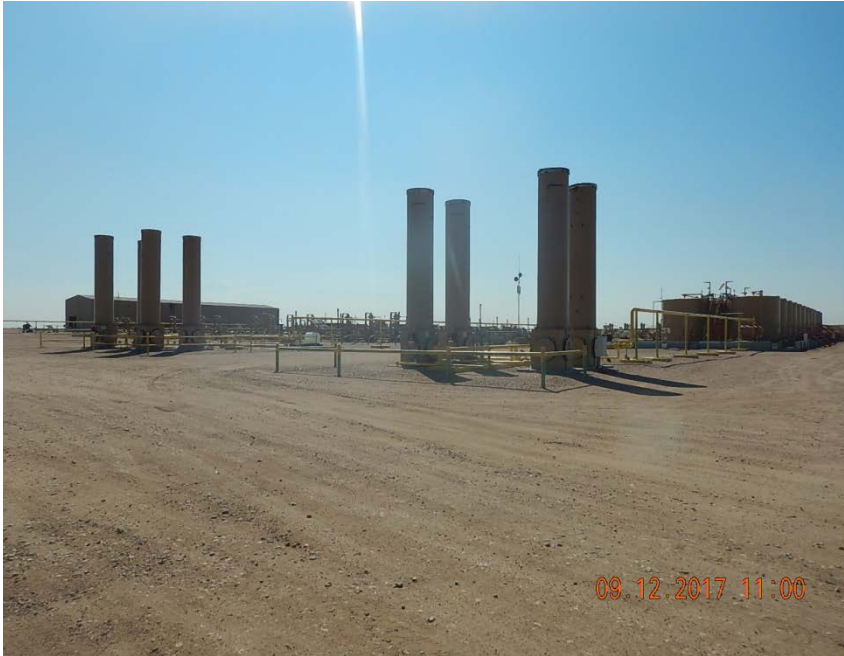
Photo 1: Location, looking SE

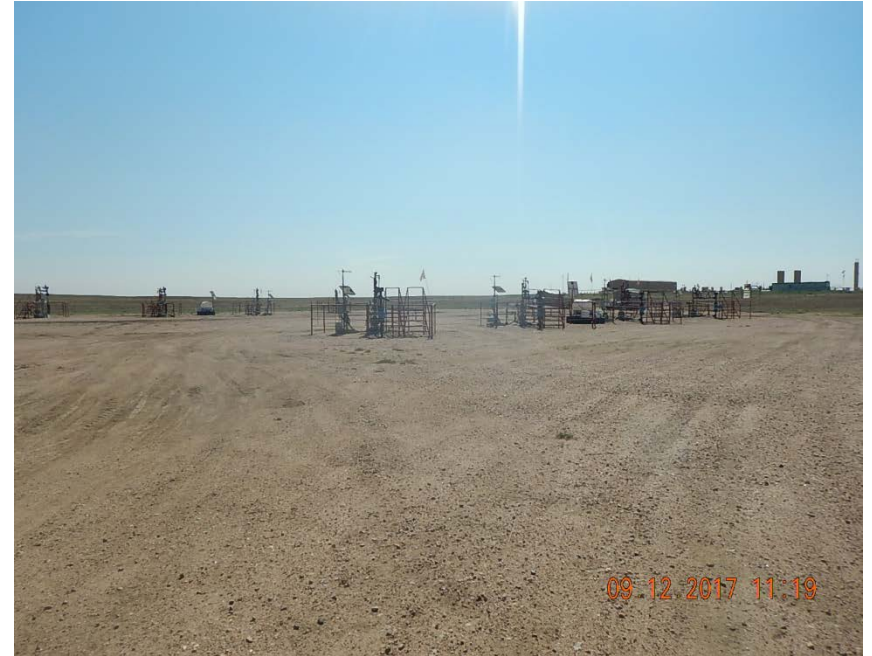
Photo 2: Wellheads, looking SE

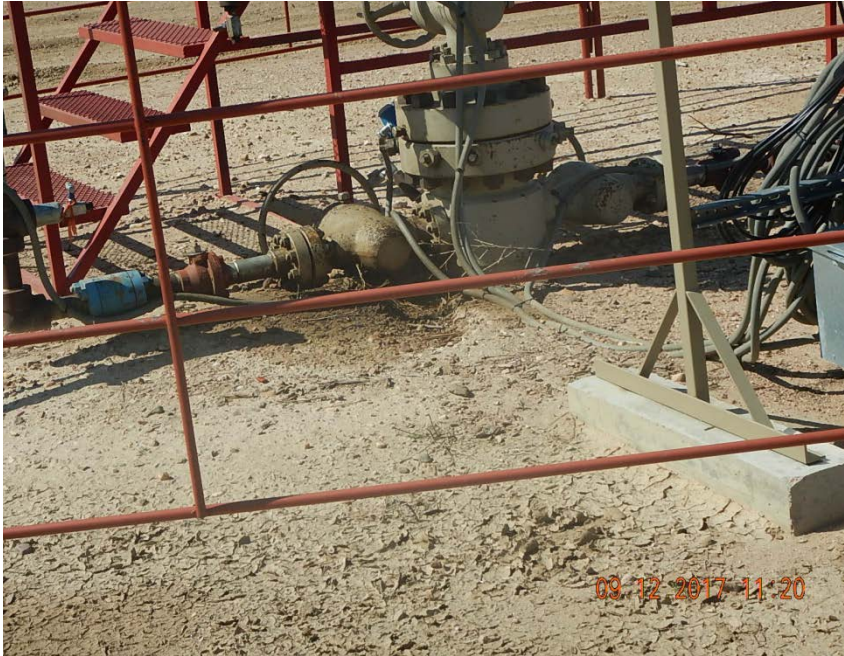
Photo 3: Stained soil at wellhead

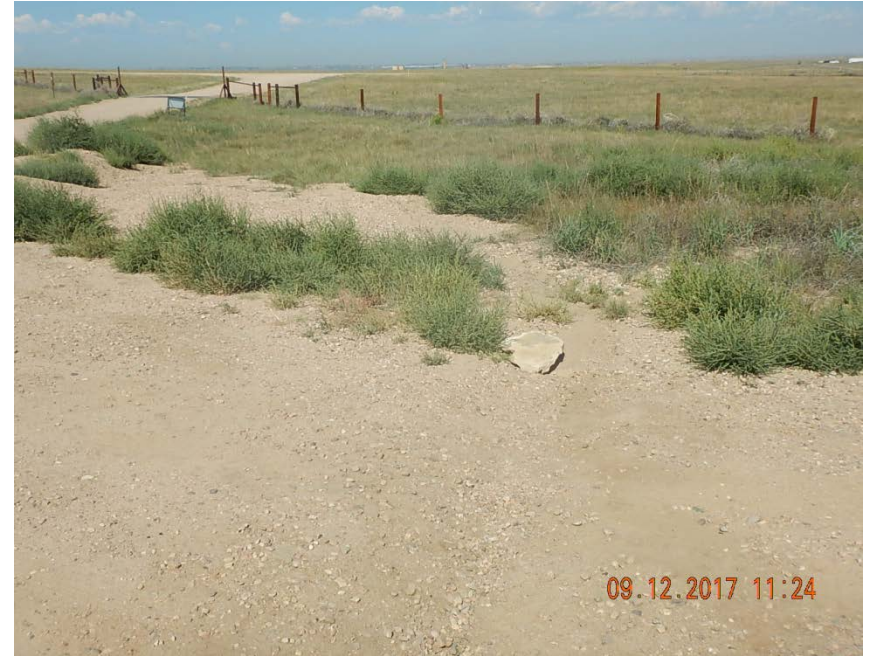
Photo 4: Stormwater erosion on NW side of location

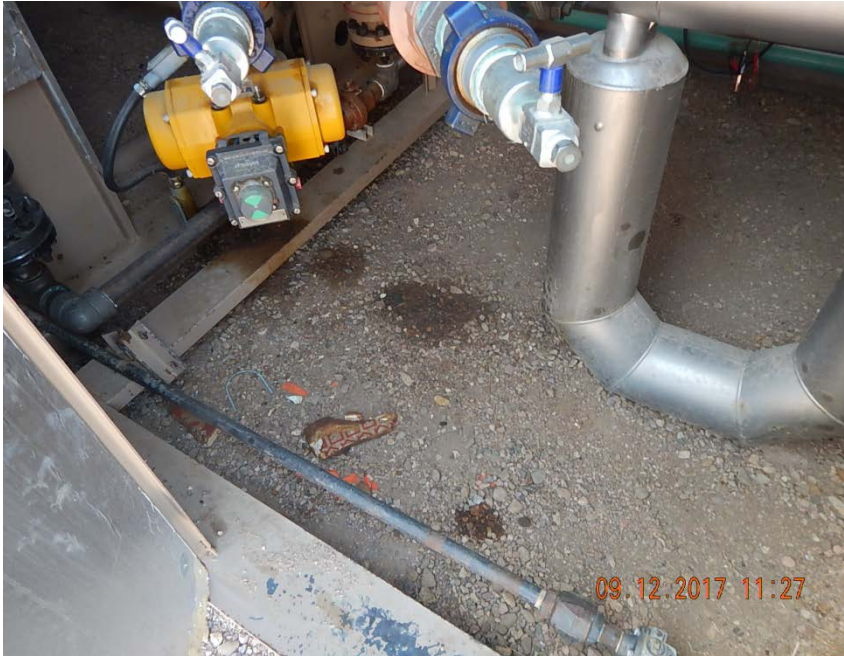
Photo 5: Stained soil in separator housing
