Inspection Photos
Location Name: K Diamond Ranch 32-10
API: 05-081-07692

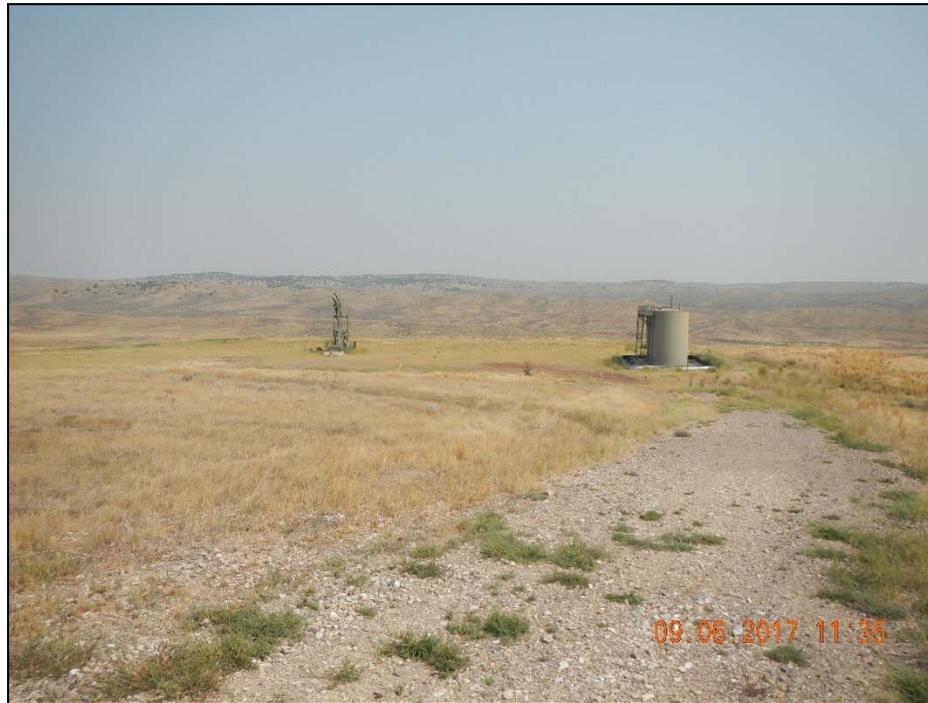
Photo 1. Overview of location taken at entrance facing north.

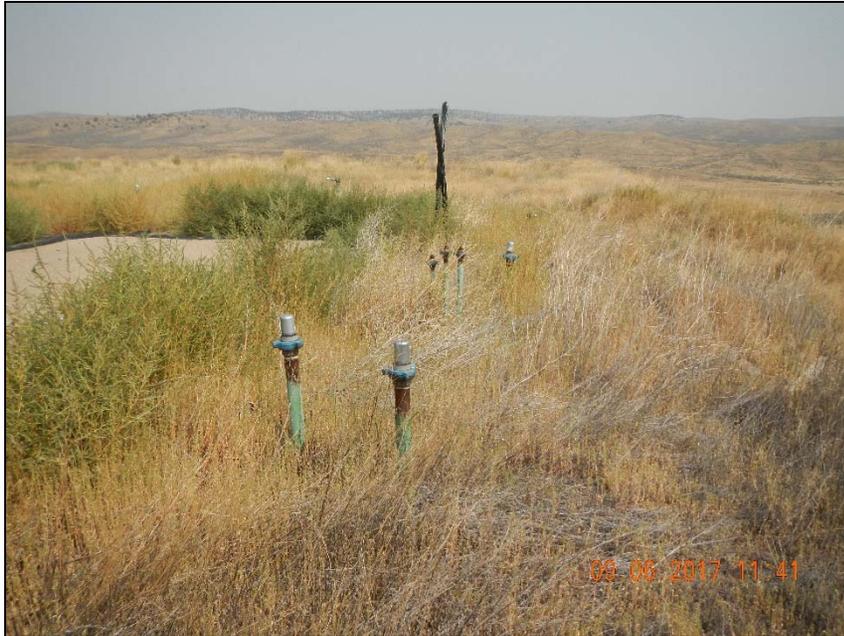
Photo 2. 3 – 2” and 3 – 1” steel risers at 40.48653, -107.81559

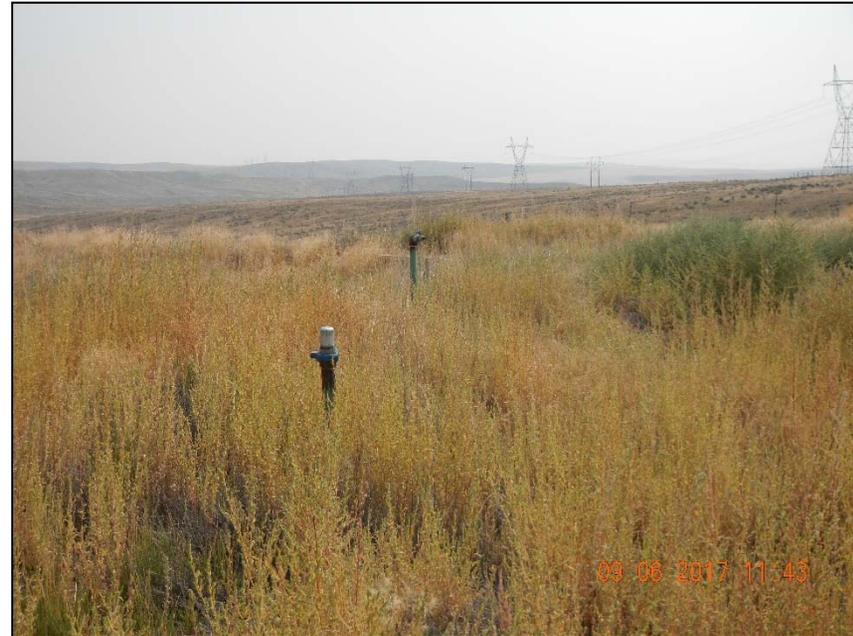
Photo 3. 3 – 2” steel risers at 40.48669, -107.81572

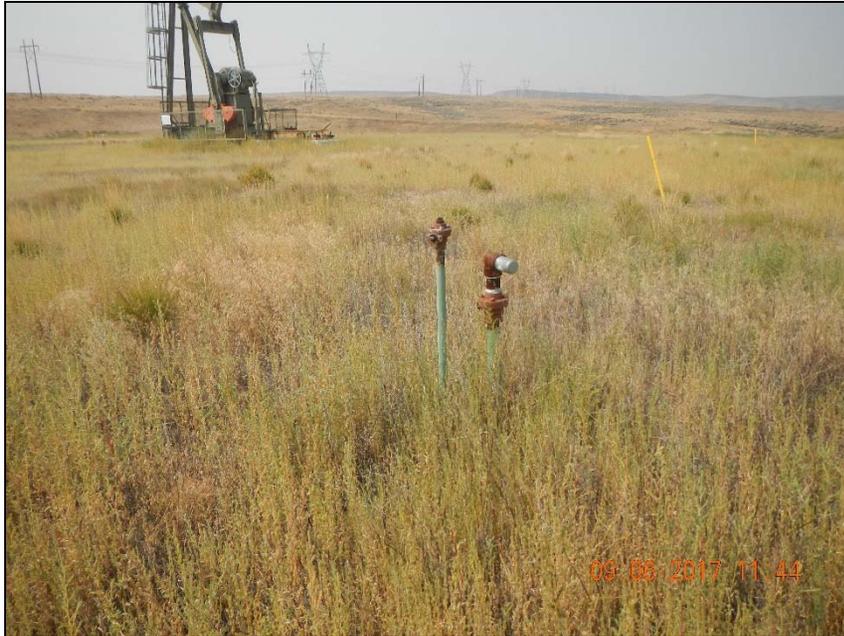
Photo 4. 1 -1" and 1 - 2" steel riser at 40.48676, -
107.81588

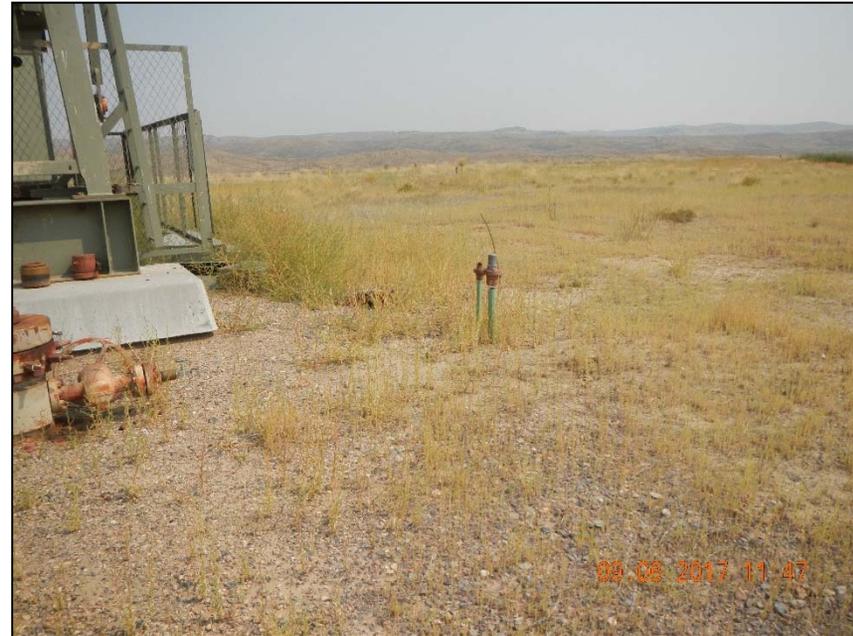
Photo 5. 1 -1" steel riser and 1 - 2" steel riser at
wellhead
