Inspection Photos
Location Name: Schmidt #1-B
API: 05-001-08205
Inspection Date: September 14, 2017

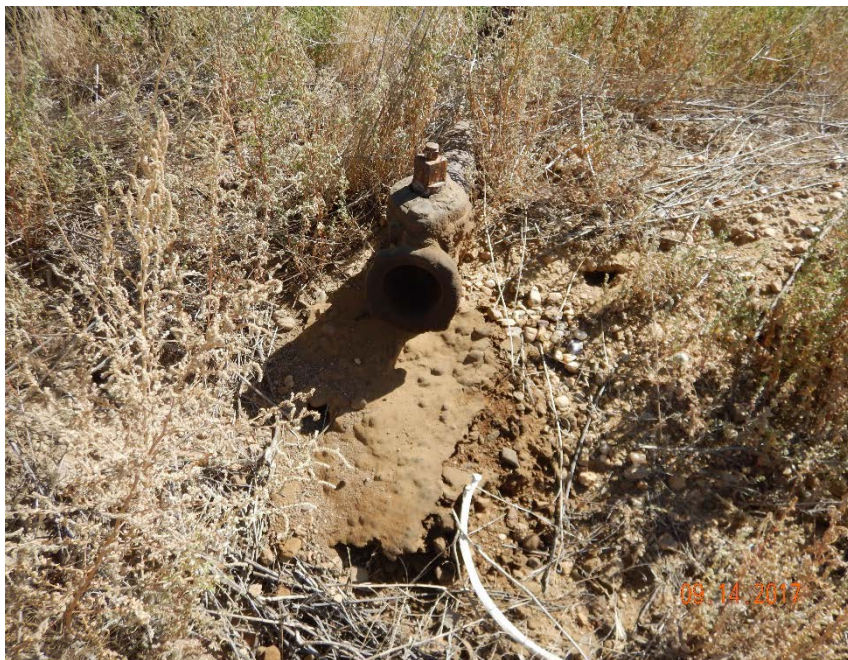
Photo #1 – Historical accumulation of oily waste at crude oil tank loadout. Note: loadout lacks secondary containment device.

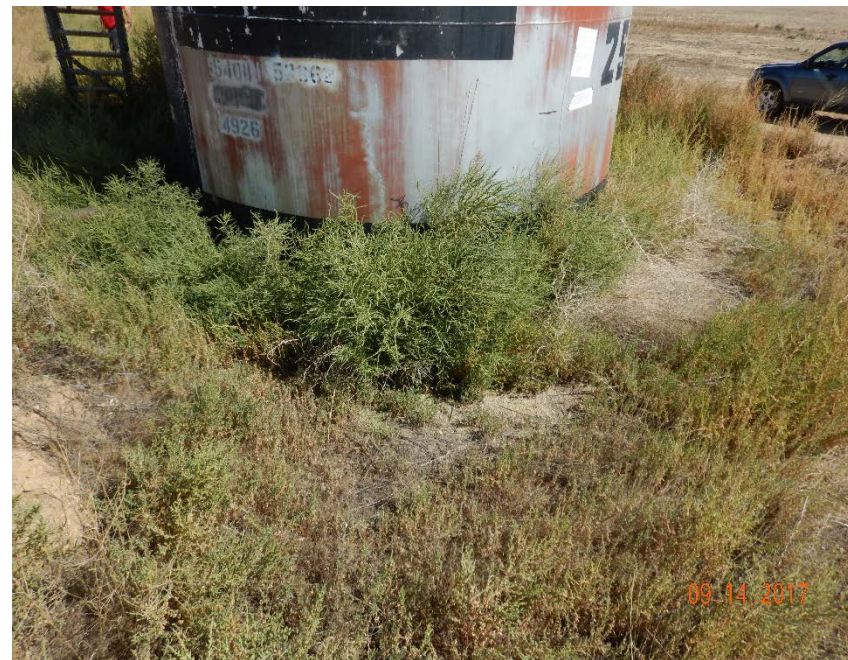
Photo #2 – Uncontrolled weeds inside of tank berm.

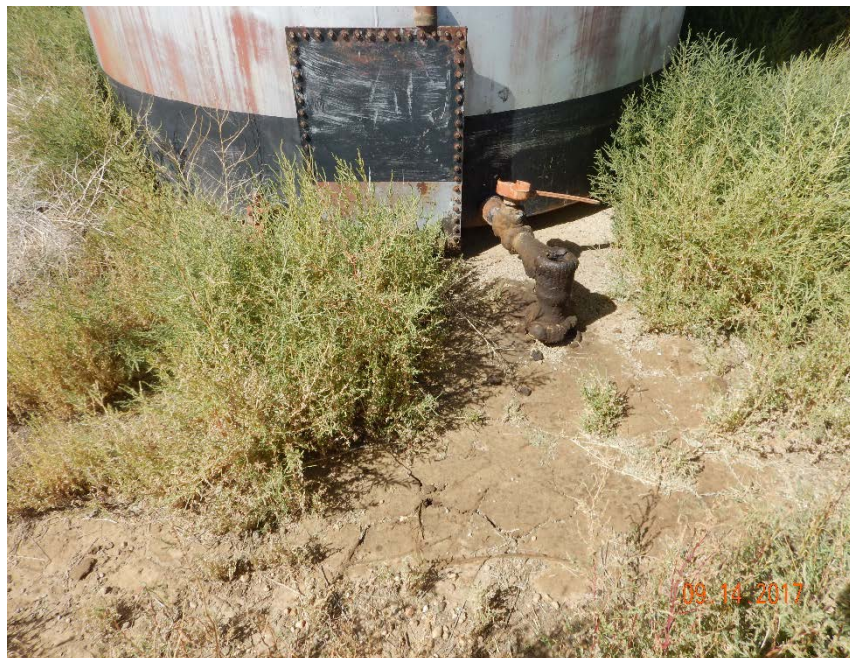
Photo #3 – Historical accumulation of oily waste beneath crude oil AST valve.

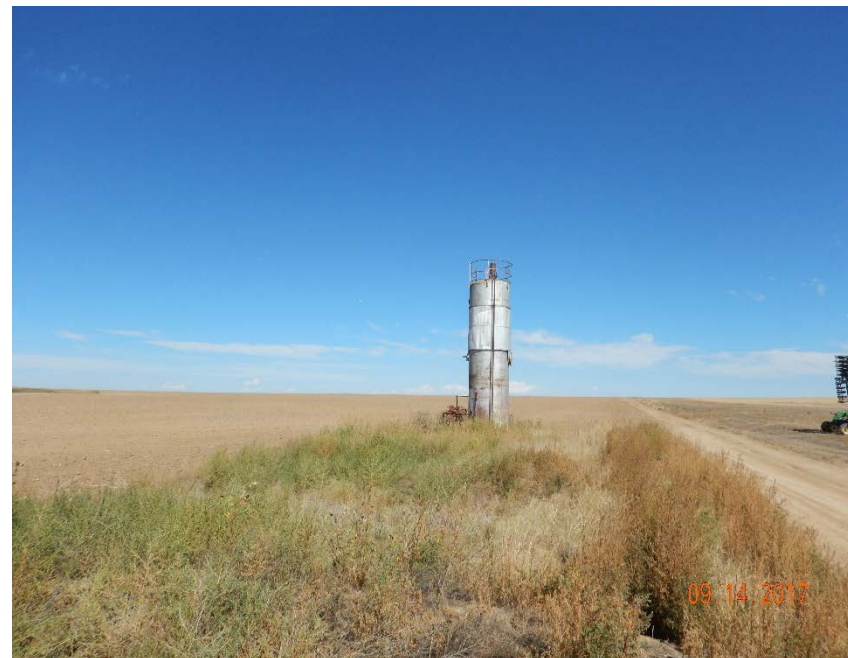
Photo #4 – Uncontrolled weeds overgrowing earthen berms and associated equipment between crude oil tank and VHT.

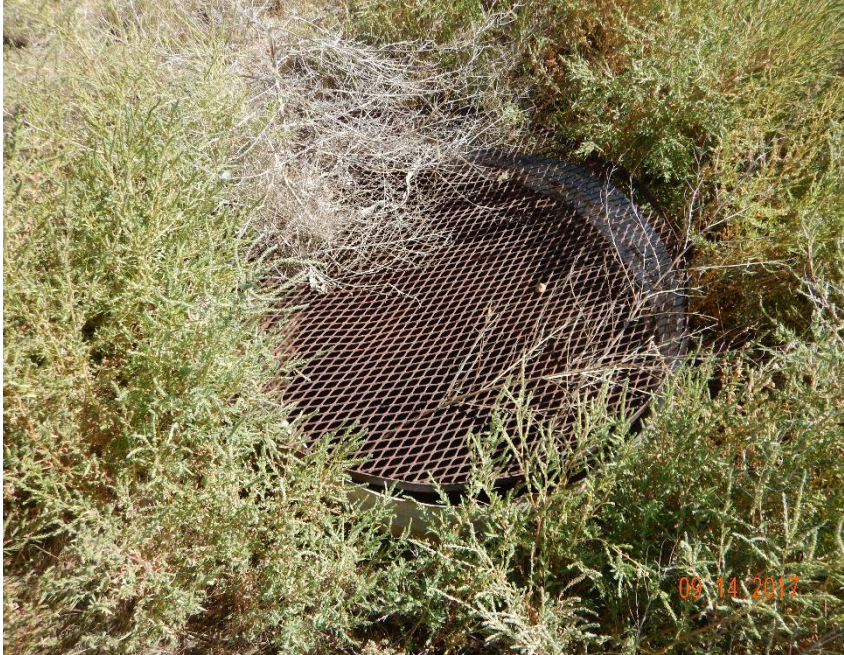
Photo #5 – Tinhorn pit, Facility ID #114389, located north of crude oil AST.

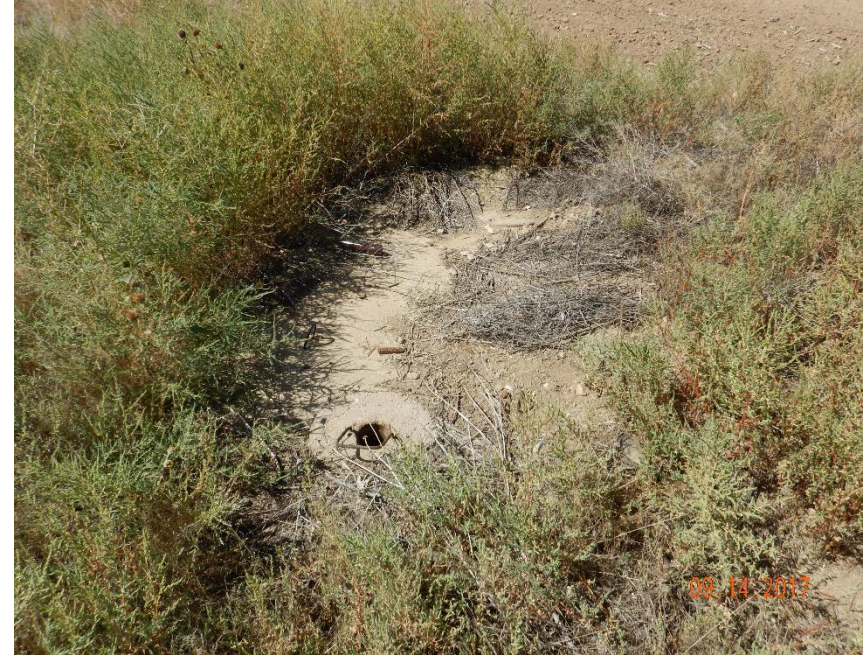
Photo #6 – Buried concrete vault north of tinhorn.

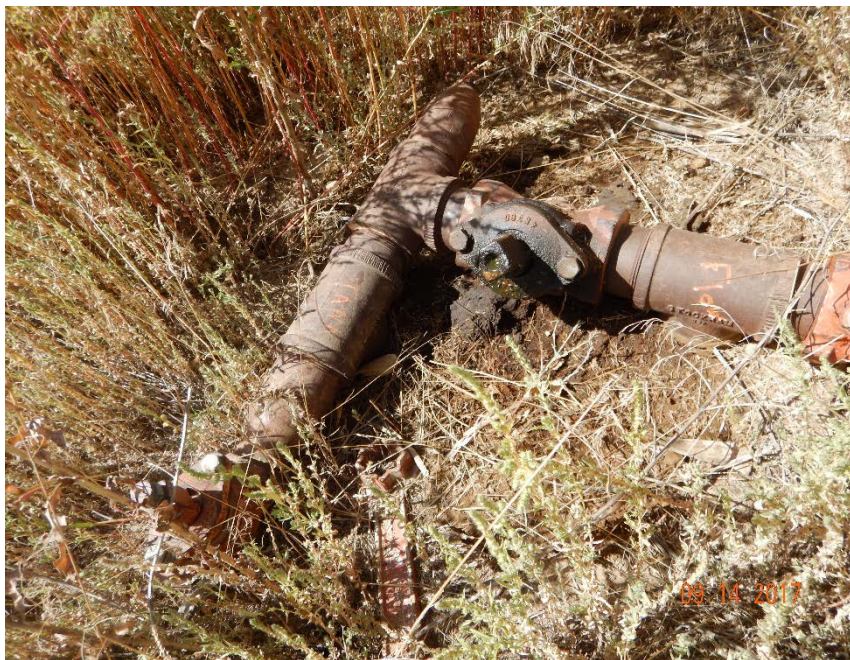
Photo #7 – Exposed flowline manifold north of buried concrete vault has localized accumulations of oily waste.

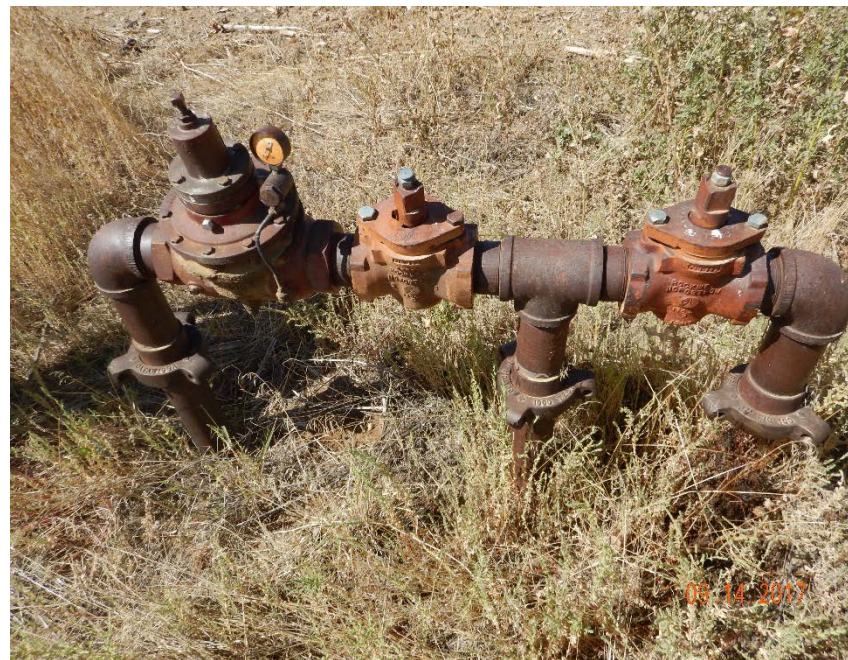
Photo #8 – Second exposed flowline riser manifold located north of equipment in previous photo. Note: 3" pipe on the right is uncapped and facing downward.

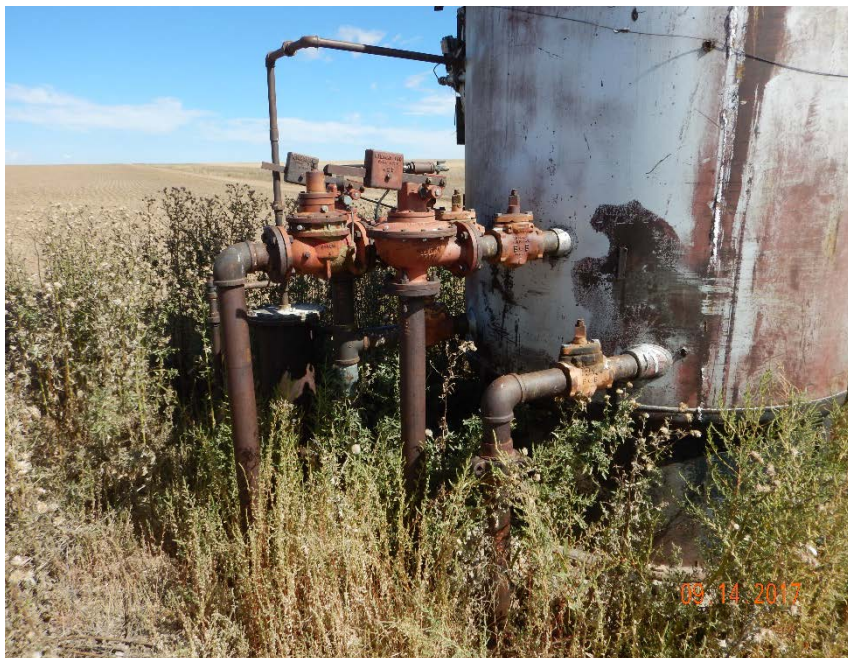
Photo #9 – Unused flowline risers plumbed to VHT on north side of production facility.

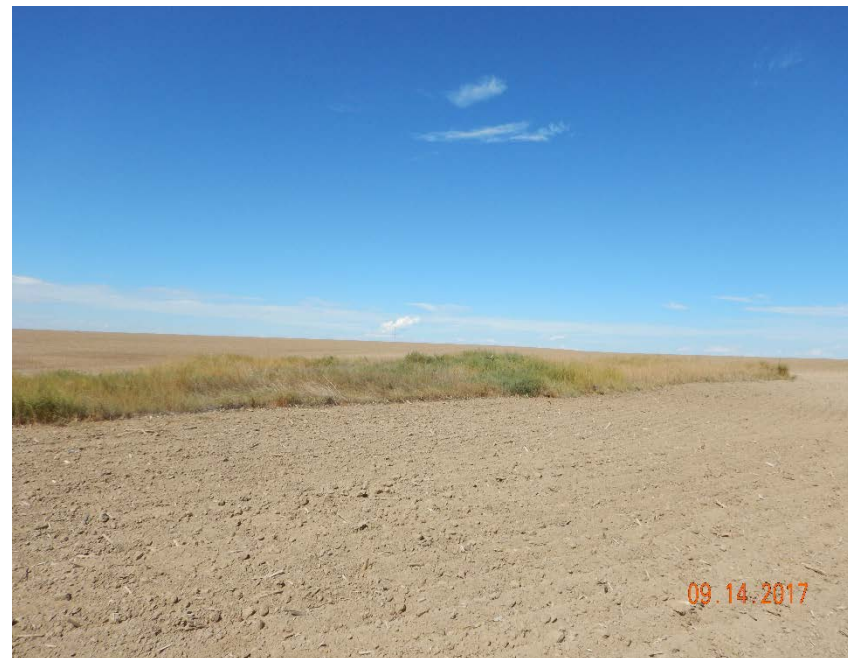
Photo #10 – Uncontrolled weeds in cultivated area surround unmarked Schmidt #1-B wellhead (which is located ~780' NW of crude oil AST).

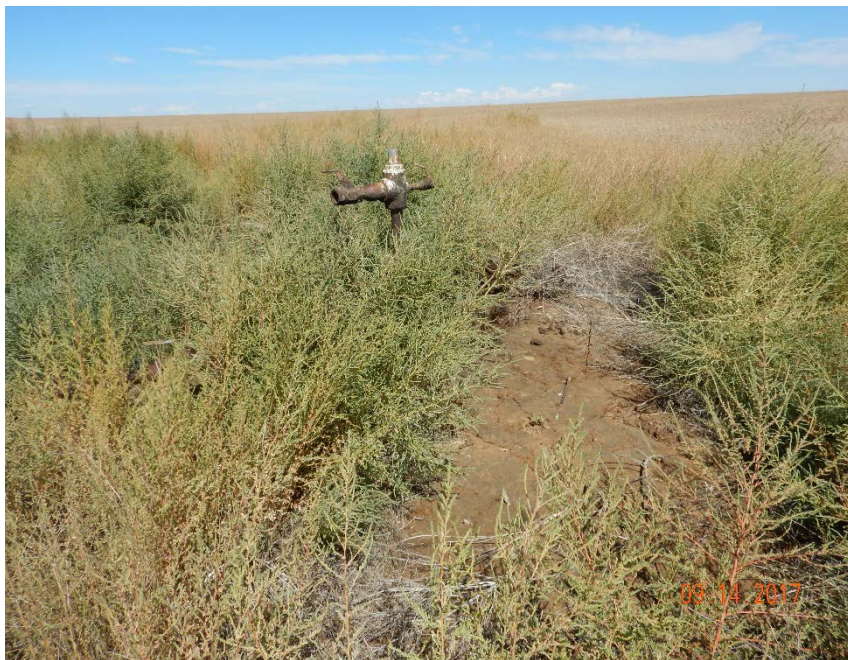
Photo #11 – Schmidt #1-B wellhead with localized accumulation of oily waste and uncontrolled weeds.

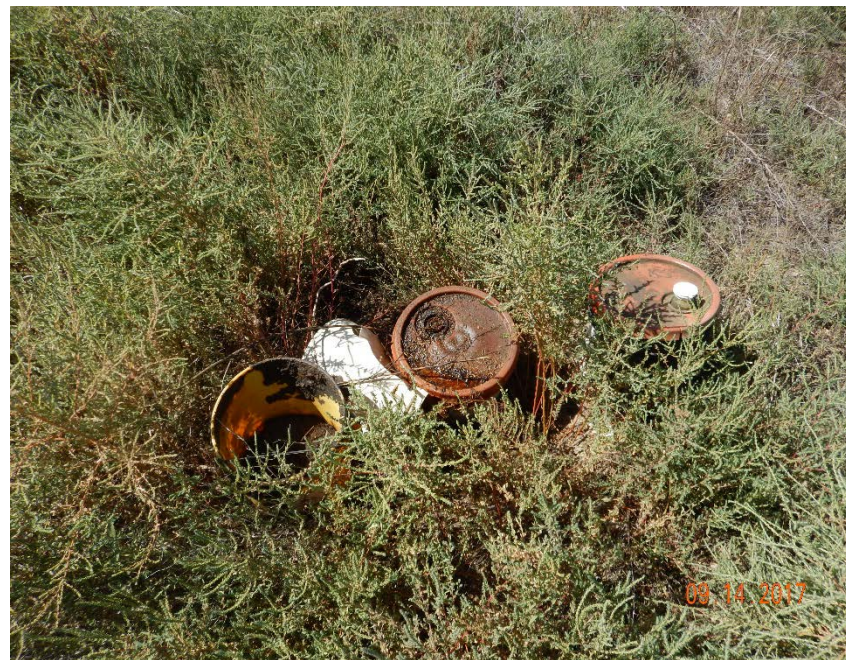
Photo #12 – Unidentified chemical storage at wellhead location.

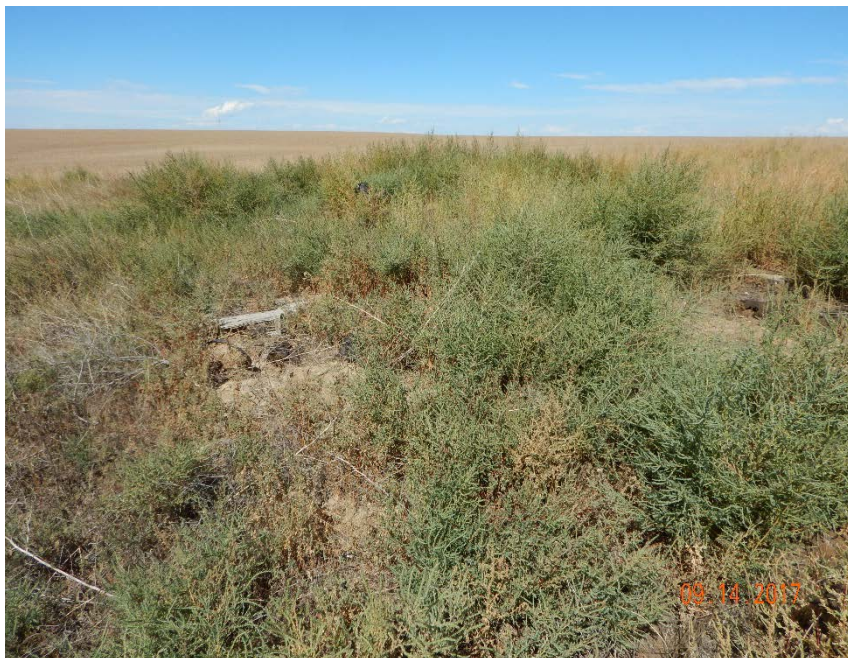
Photo #13 – Junk, weeds, and unused equipment in area surrounding wellhead.

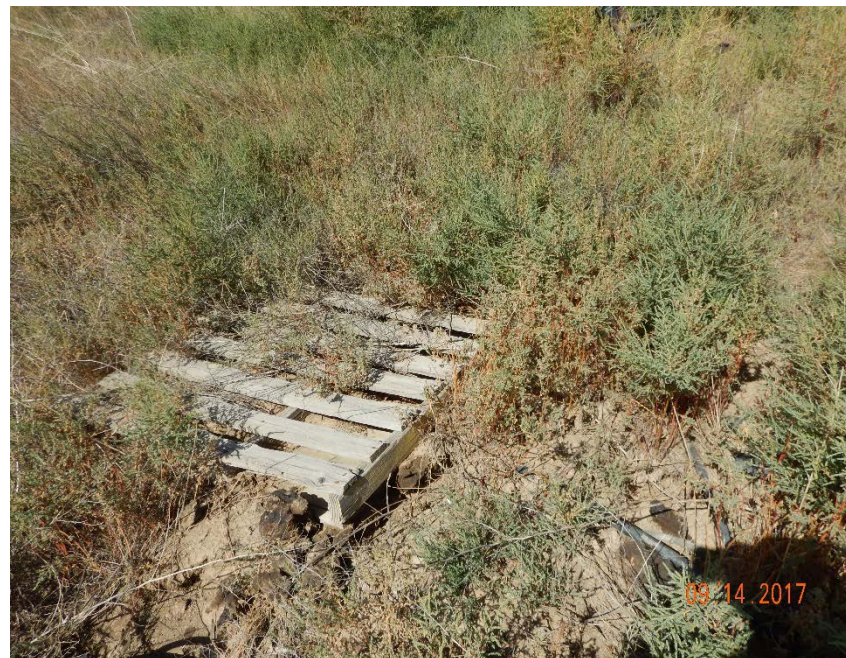
Photo #14 – Pallet and weeds at wellhead location.

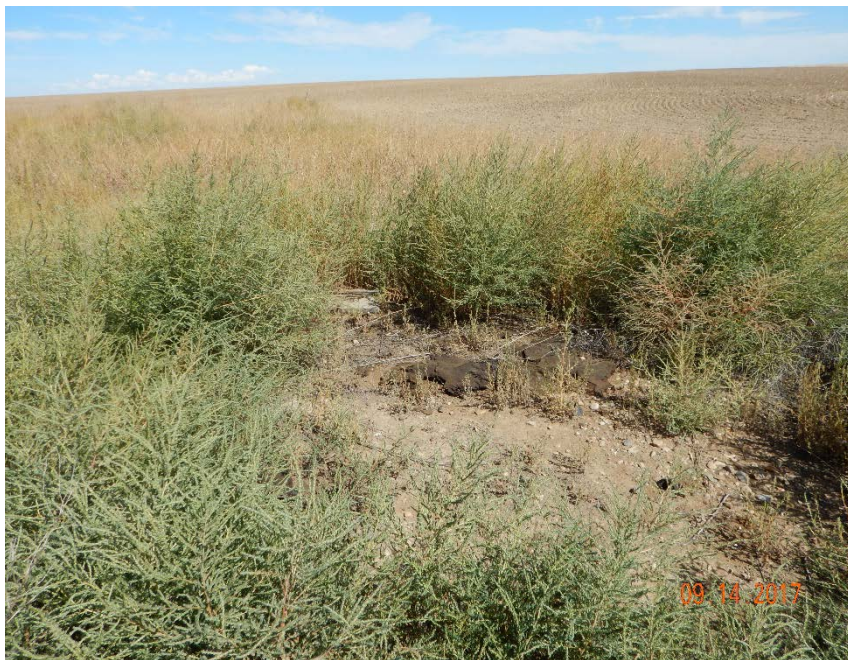
Photo #15 - Localized accumulation of oily waste in area surrounding wellhead.

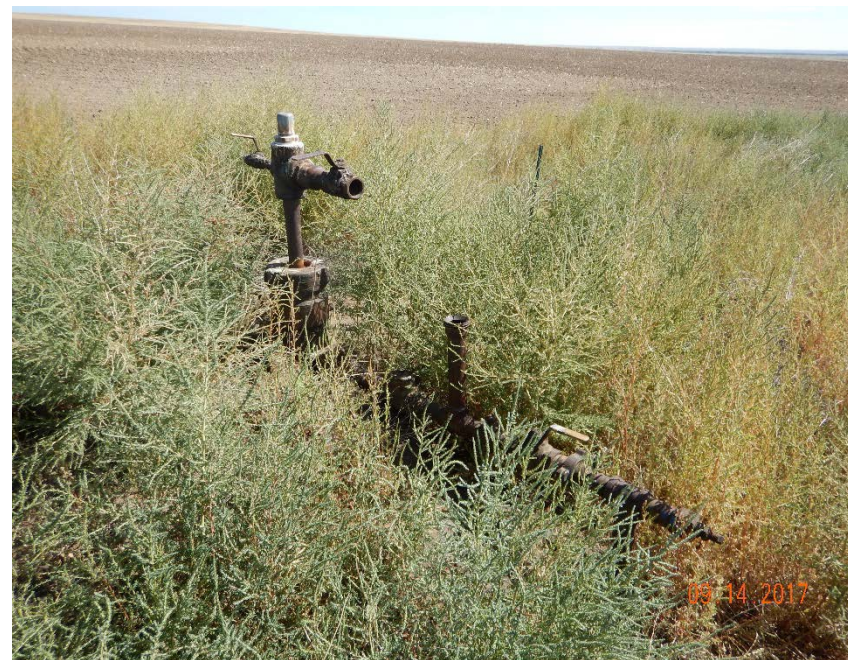
Photo #16 – Uncapped and unplugged valves plumbed to wellhead.

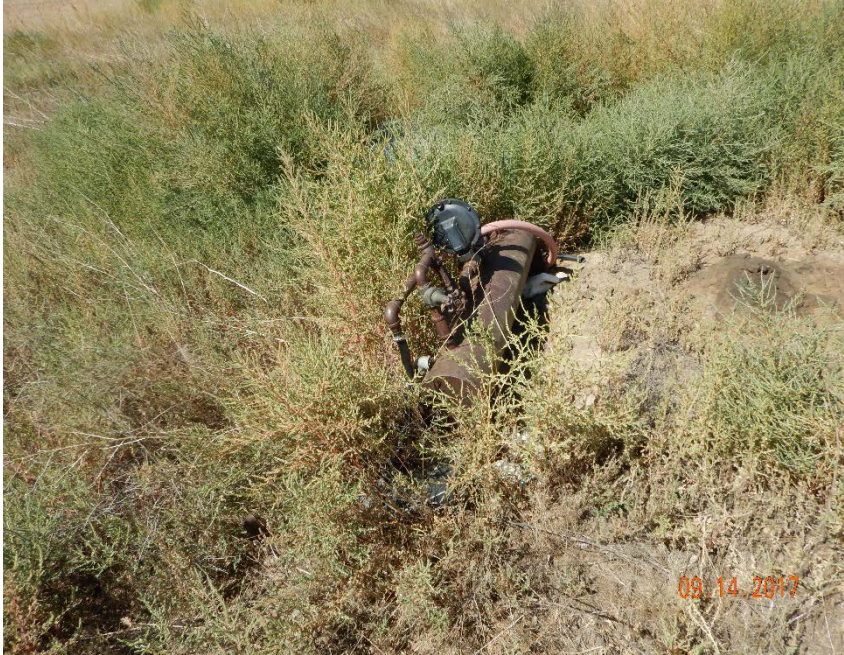
Photo #17 – Unused equipment at wellhead.

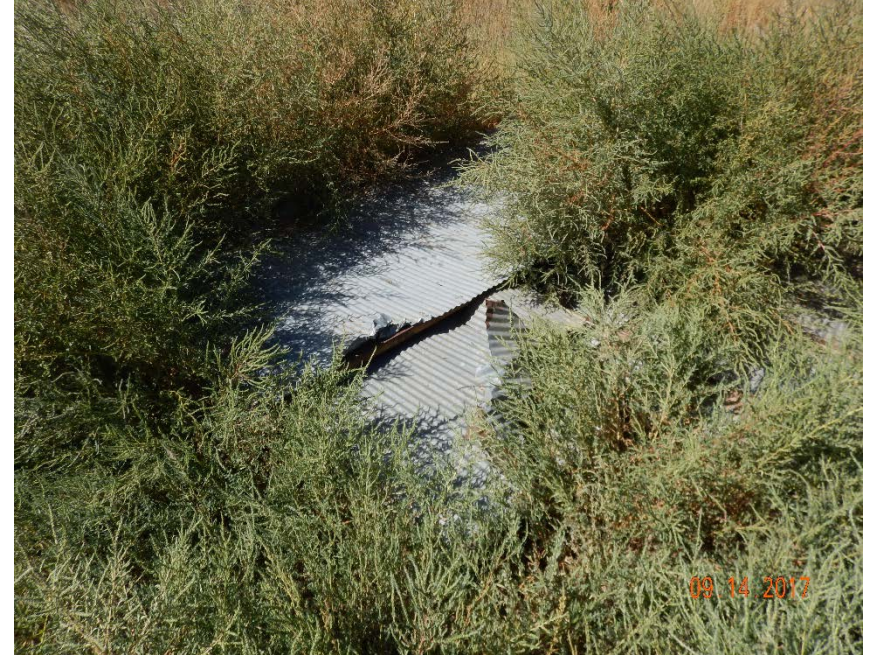
Photo #18 – Metal debris at wellhead.
