**Inspection Photos**  
**Location Name: USX AE #21-99HZ**  
**API: 05-123-31033**

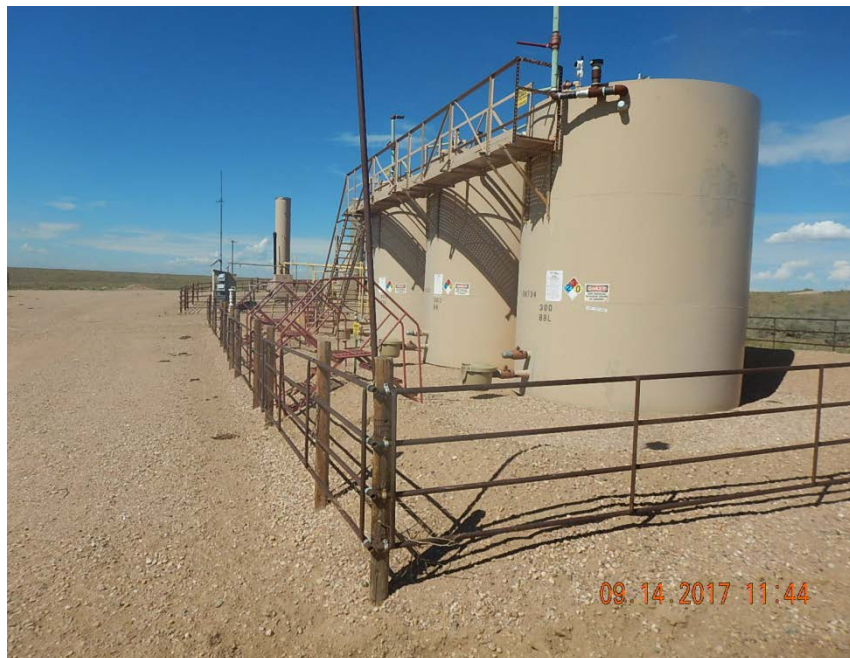
**Photo 1: Location, looking NE**

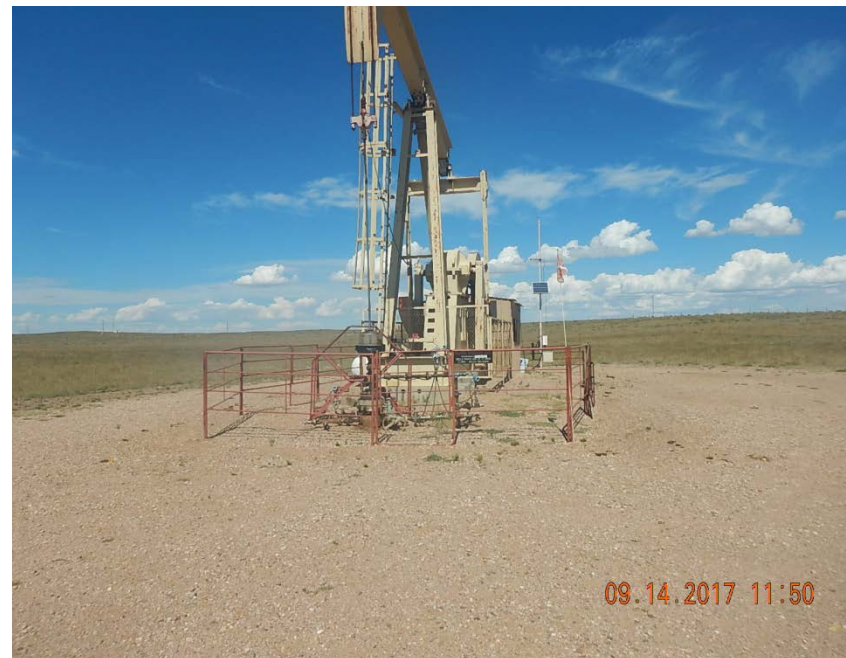
**Photo 2: Wellhead, looking NE**

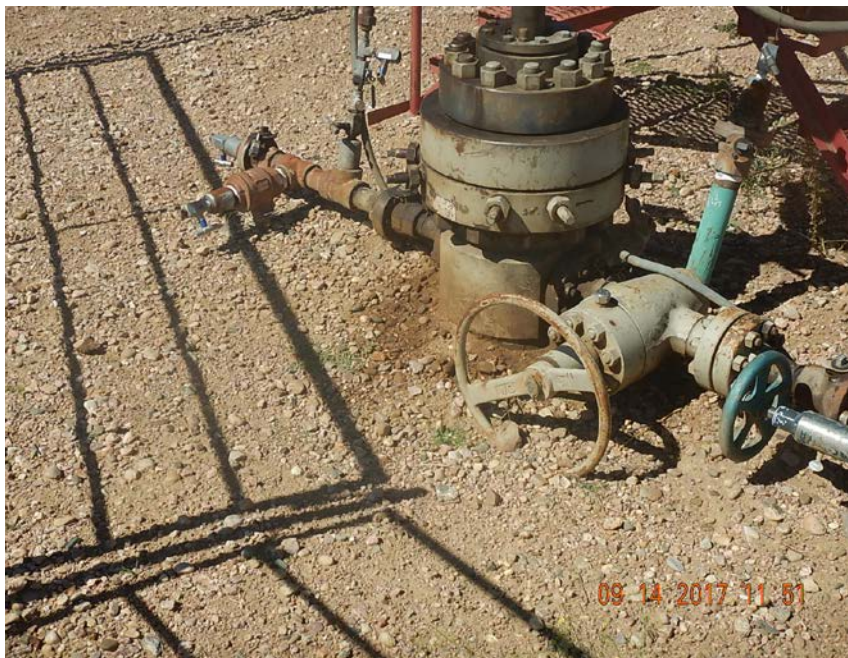
**Photo 3: Stained soil at wellhead**

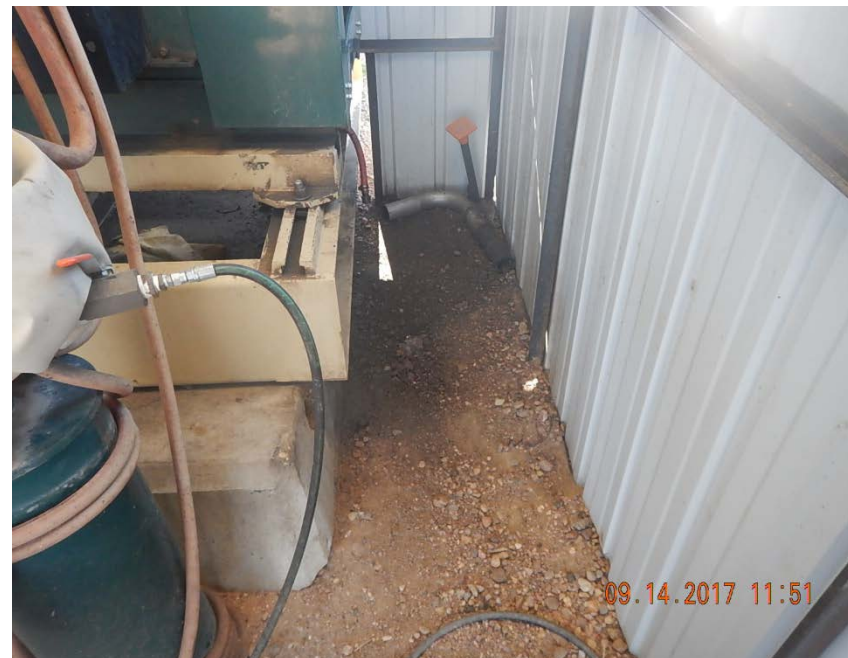
**Photo 4: Stained soil at engine**
