Inspection Photos
Location Name: USX AE #21-12
API: 05-123-26704

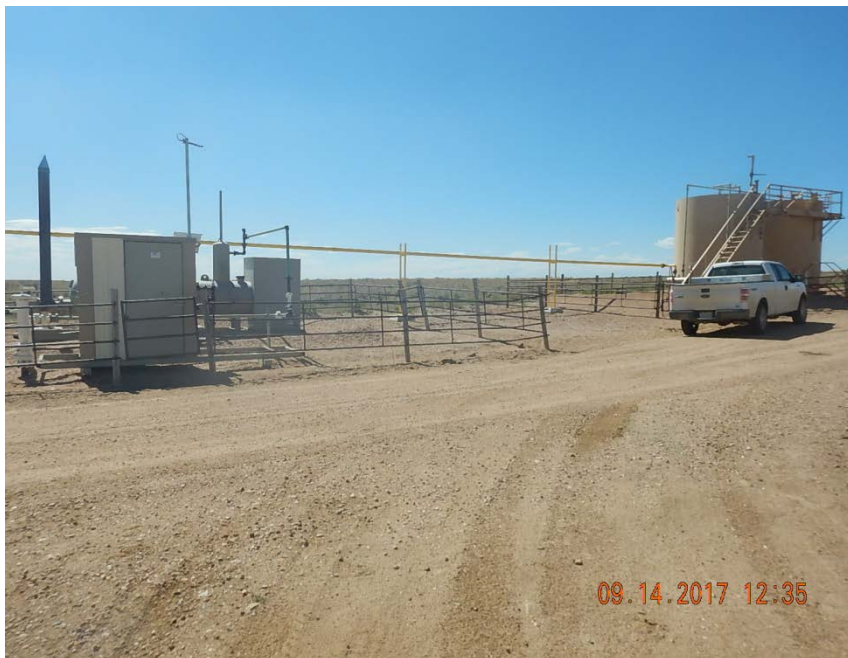
Photo 1: Location, looking SW

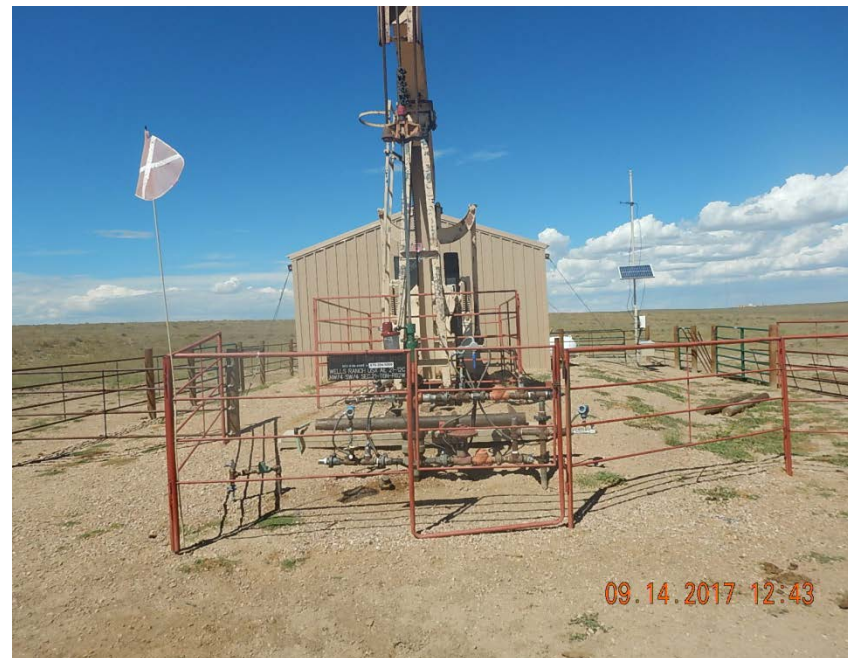
Photo 2: Wellhead, looking NW

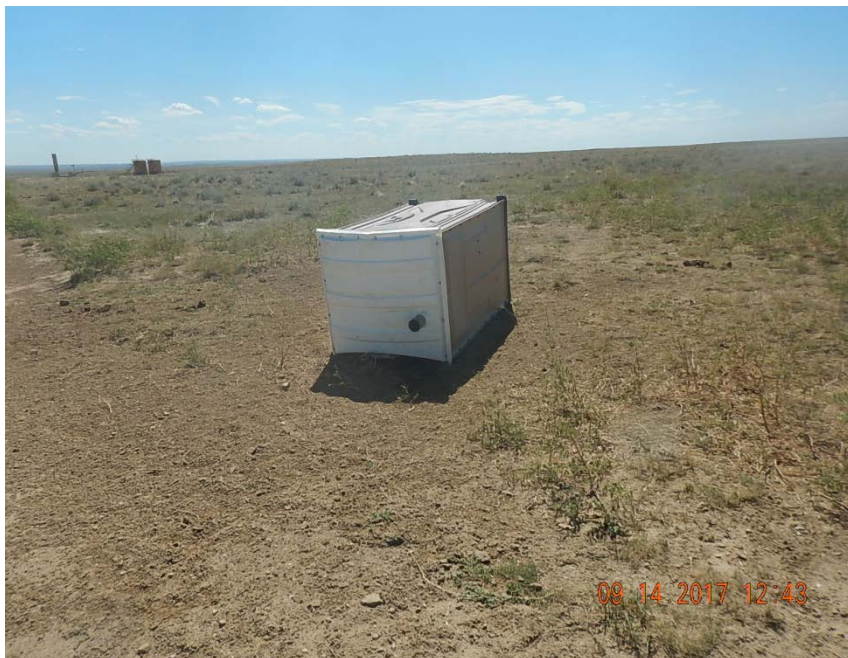
Photo 3: Unused equipment at wellhead

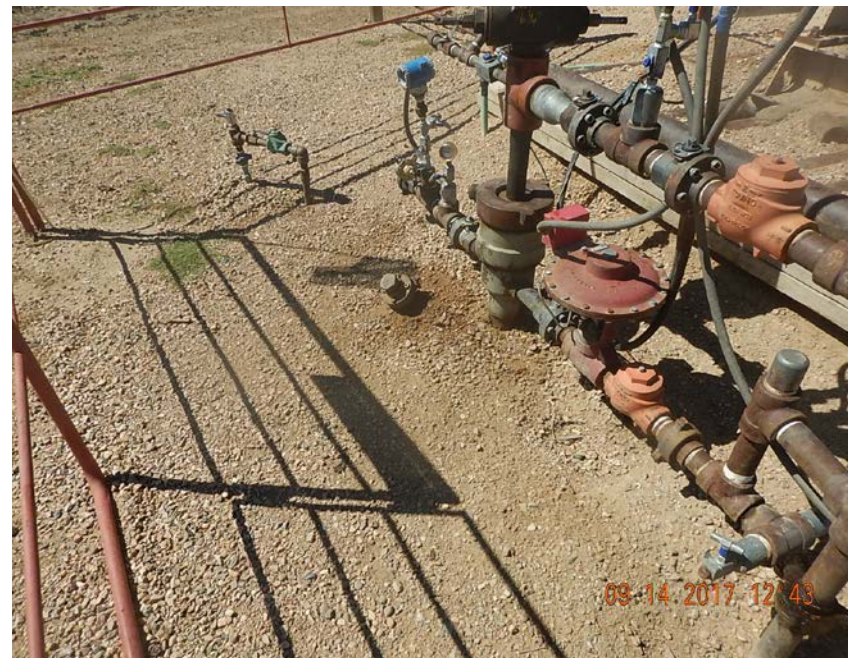
Photo 4: Stained soil at wellhead.
