On September 12, 2017, COGCC staff, Kris Neidel inspected the spill on the DAKA flowline (spill 401395060). The release point was observable as the excavation was still open. Some (lite) salt staining was observable in the excavation, it appeared to be recent and not indicative of an older or historic release. There was no other indication in the excavation that this spill had occurred previous to the reported date. Surface area that was impacted by release has been tilled; it is approximately 300' by 100' area. Some observable hydrocarbon stained soil has been tilled into the spill area. Required Action: remove any detected oil stained soil and haul to Landfarm. Visually stained soils should not be treated in place.

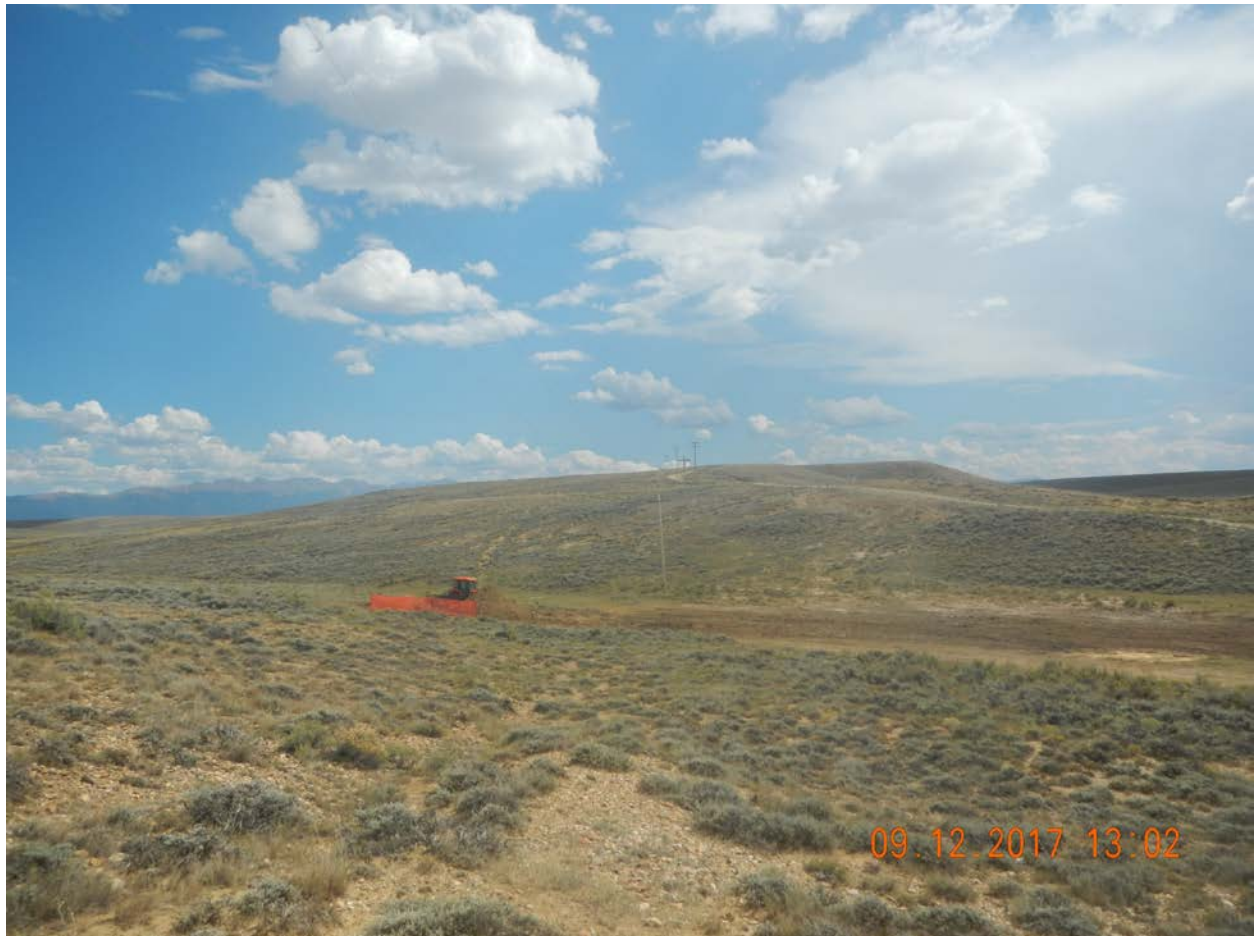
Spill area from upgrade

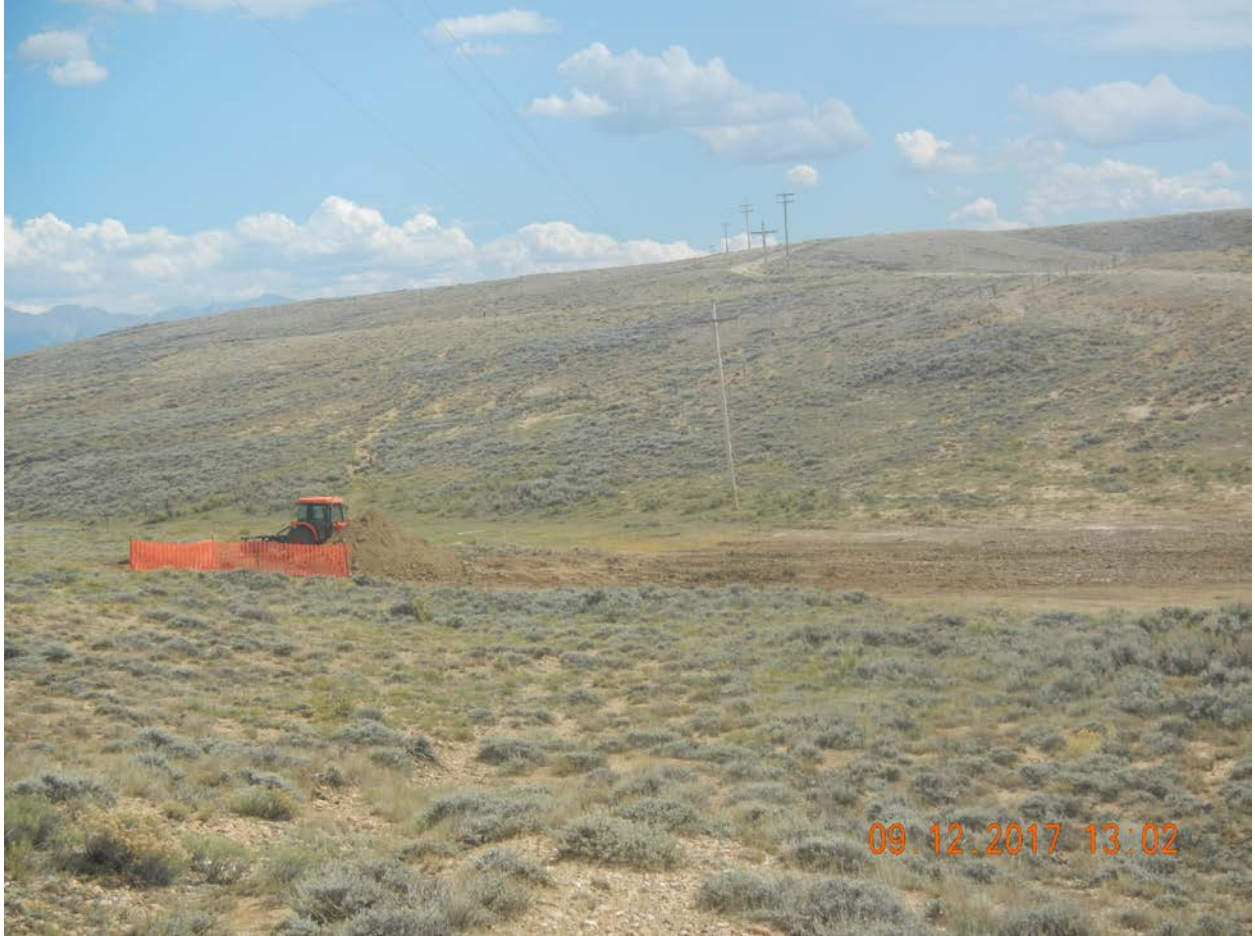
Spill area from upgrade

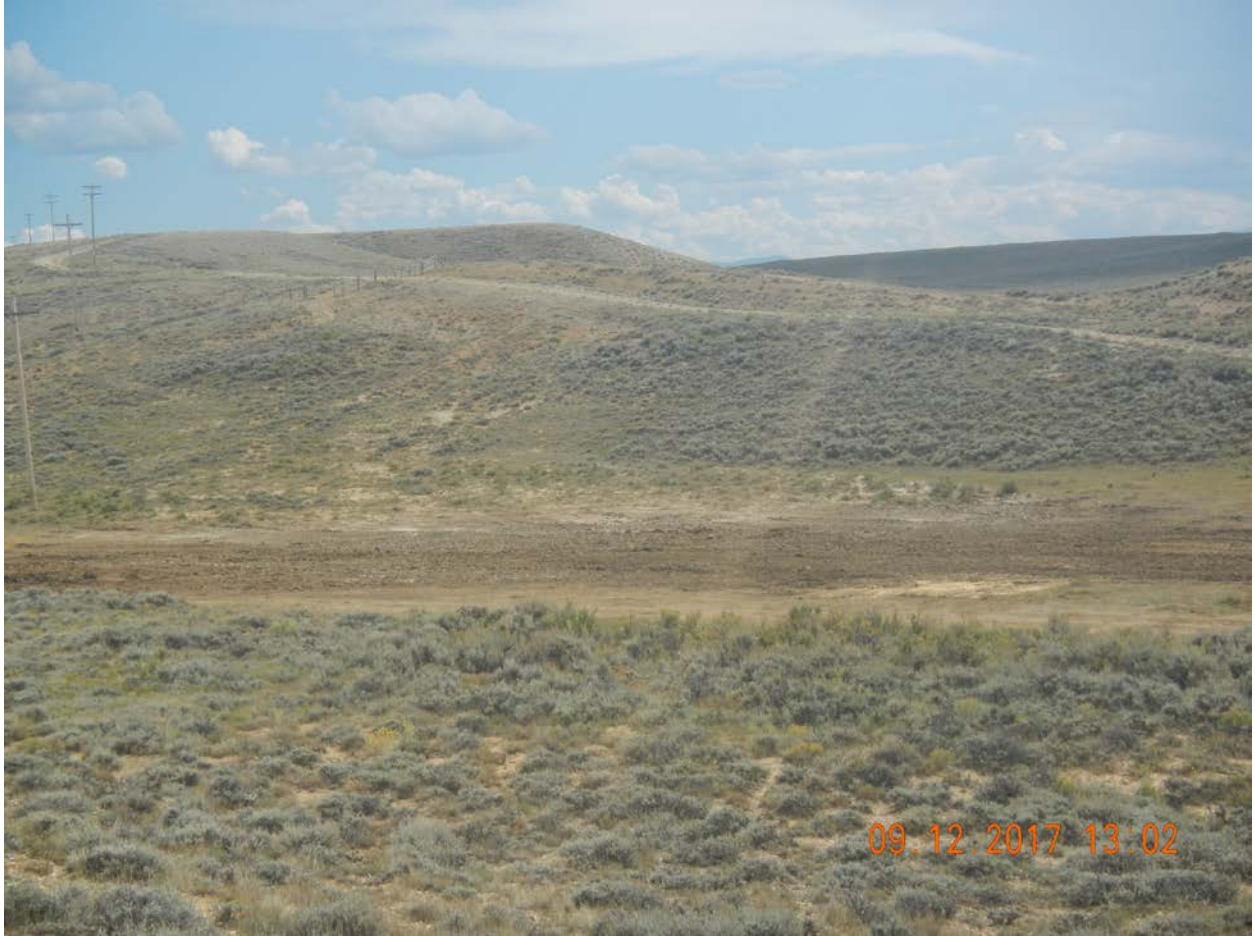
Spill area from upgrade

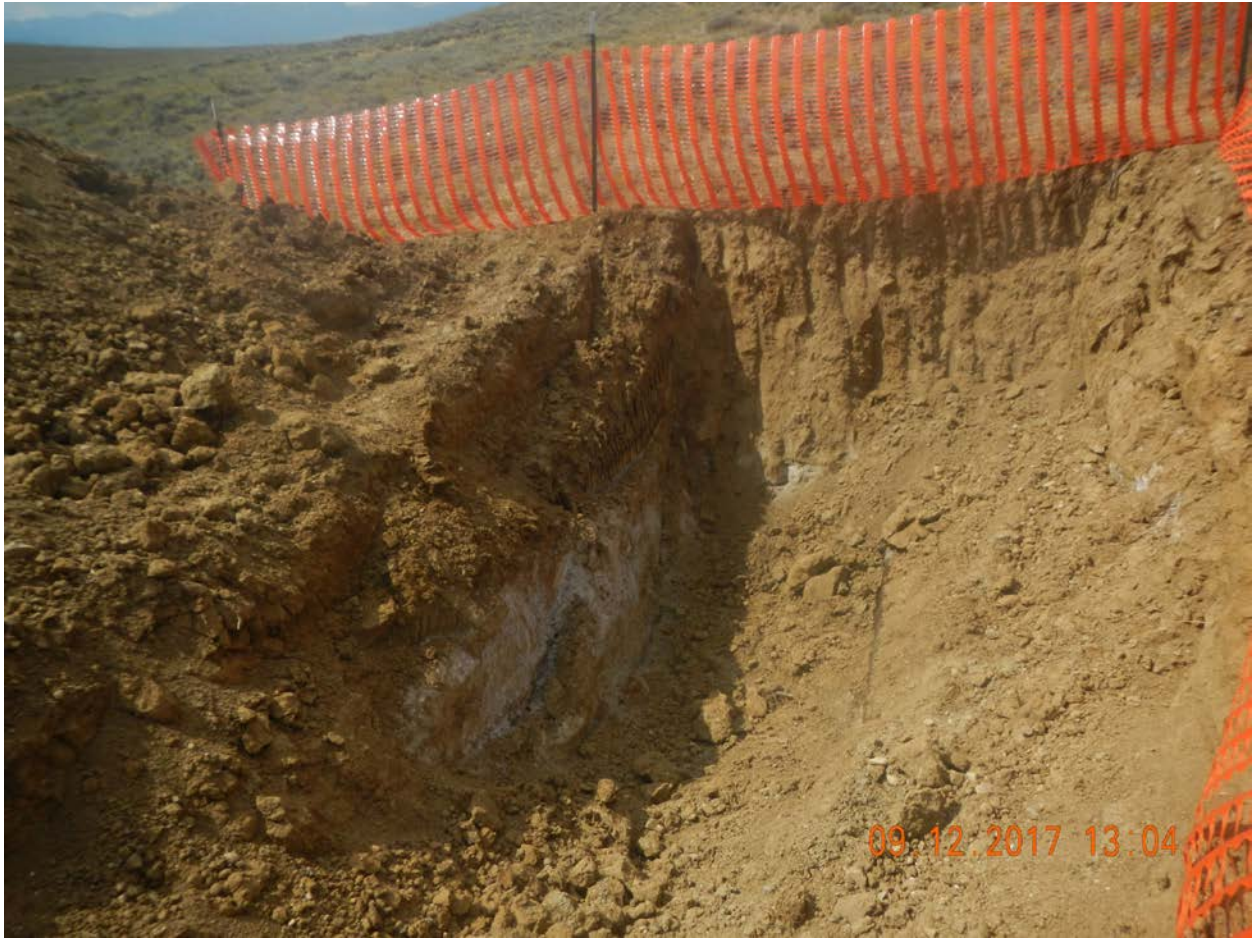
Flowline, repair is observable
