- Cross Canyon Unit 1
- 05-033-06012

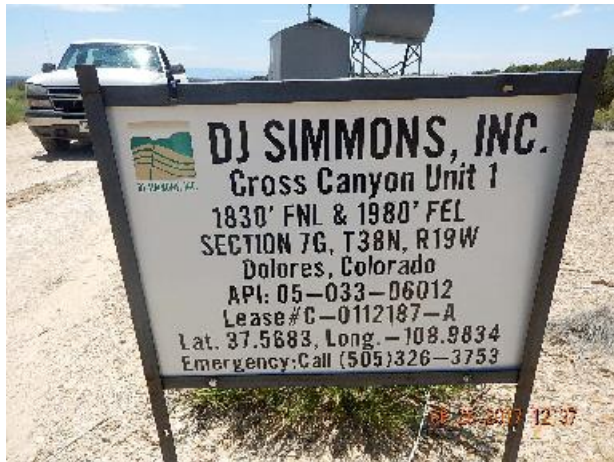
Photo 1: Wellhead sign. Previous inspection.

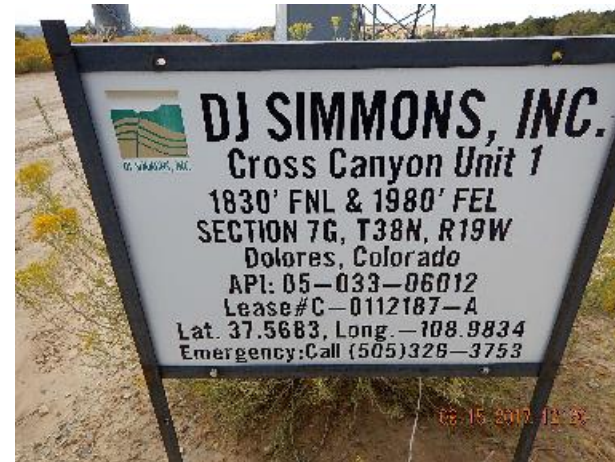
Photo 2: Wellhead sign.

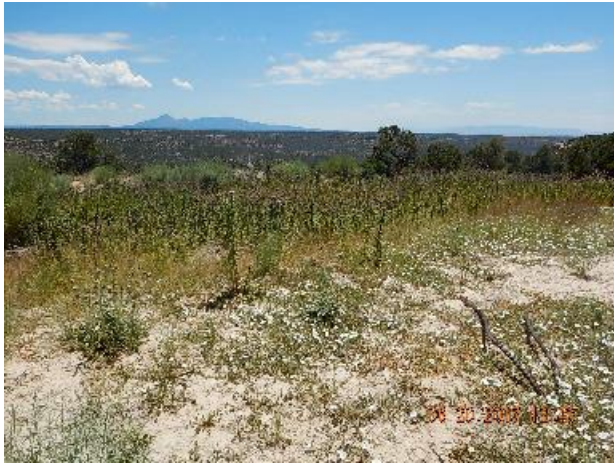
**Photo 3: 1 of 3 pieces of cable, thistle, and vine weed.
Previous inspection.**

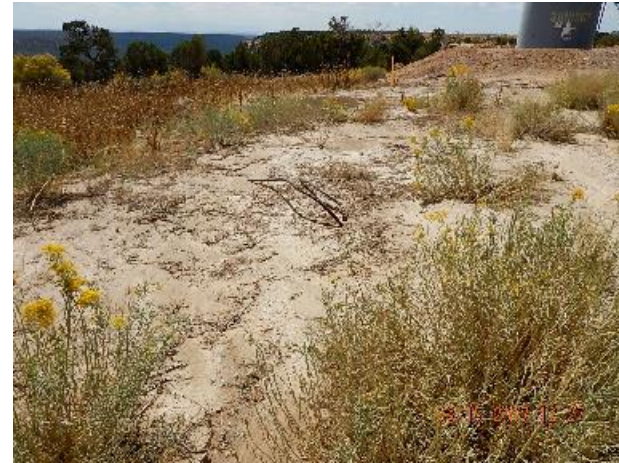
Photo 4: 1 of 3 pieces of cable, thistle, and vine weed.

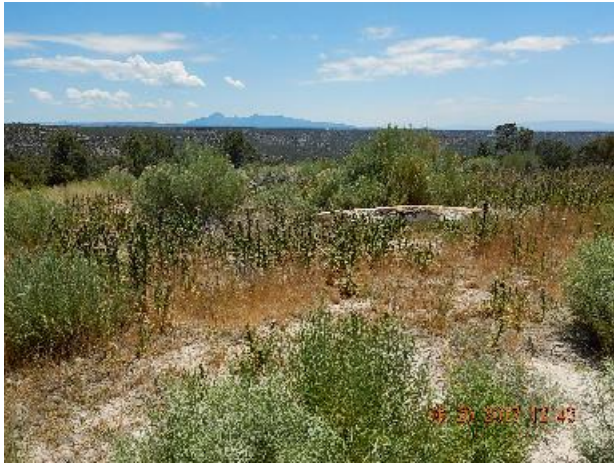
Photo 5: Thistle. Previous inspection.

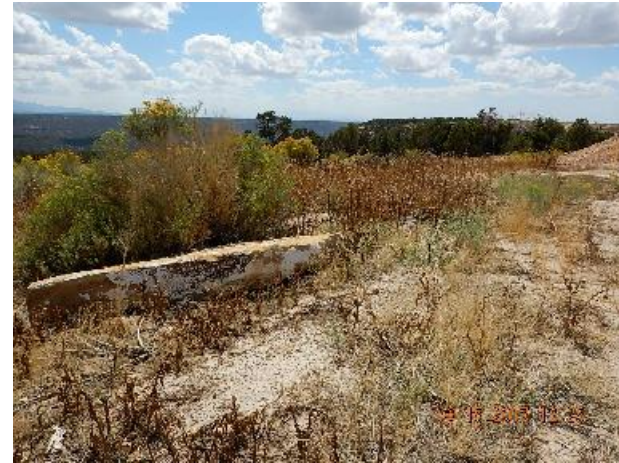
Photo 6: Thistle.

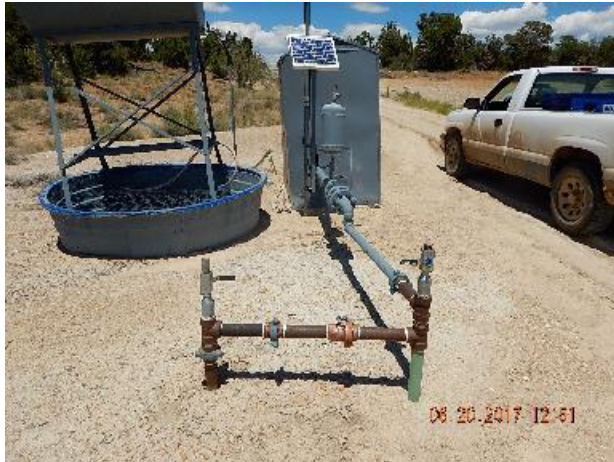
**Photo 7: Line into meter and low point stub up and valve.
Previous inspection**

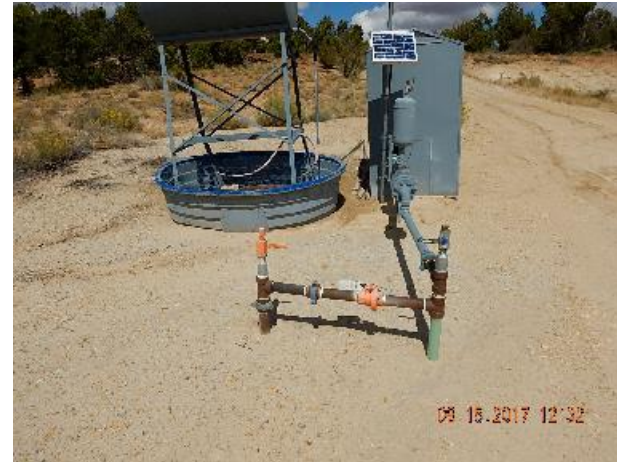
Photo 8: Line into meter and low point stub up and valve.

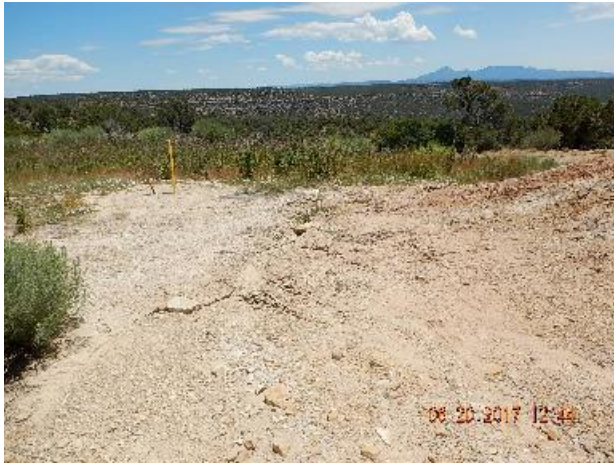
Photo 9: Storm water erosion channel off front of production tank berm. Previous inspection.

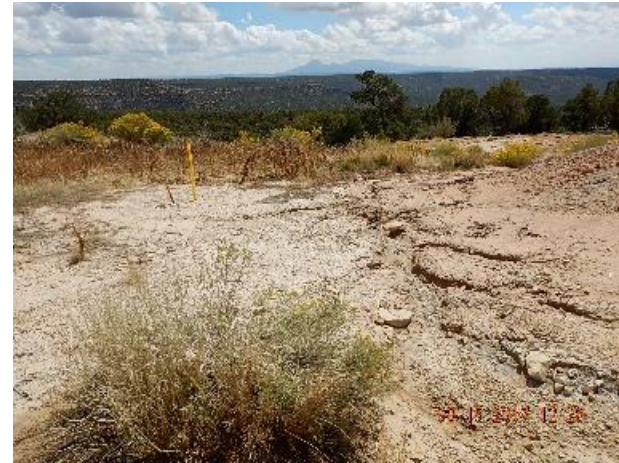
Photo 10: Storm water erosion channel off front of production tank berm.

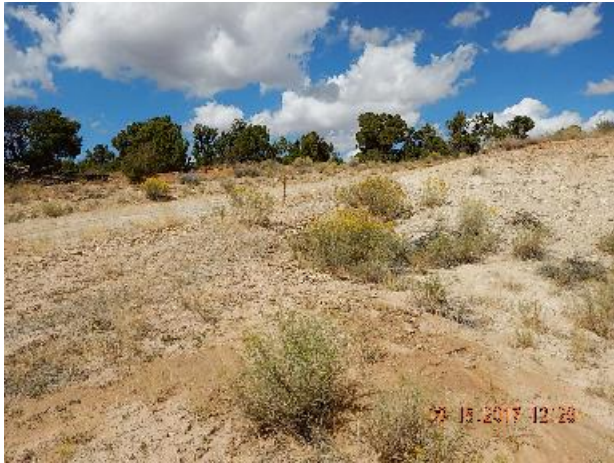
Photo 11: Stormwater flow coming down access road grade at entrance. Current inspection.

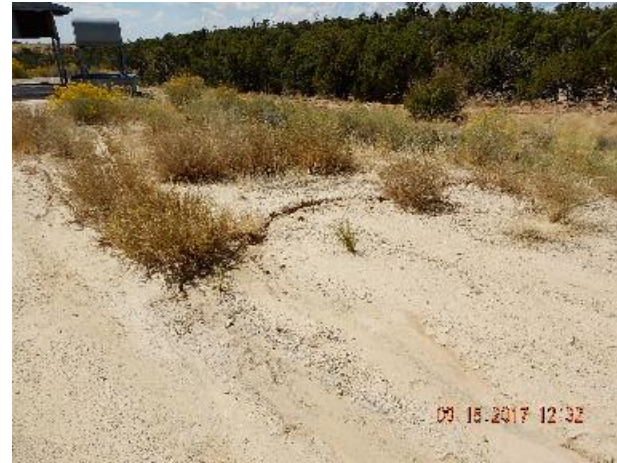
Photo 12: Erosion channel off west side of location. Current inspection.

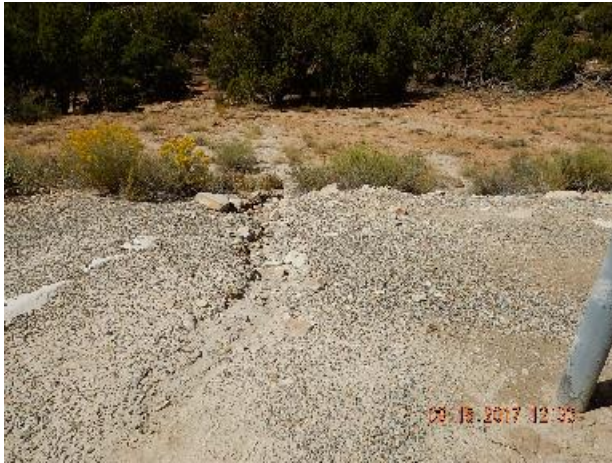
Photo 13: Erosion channel on SW corner beside carport shelter. Current inspection.

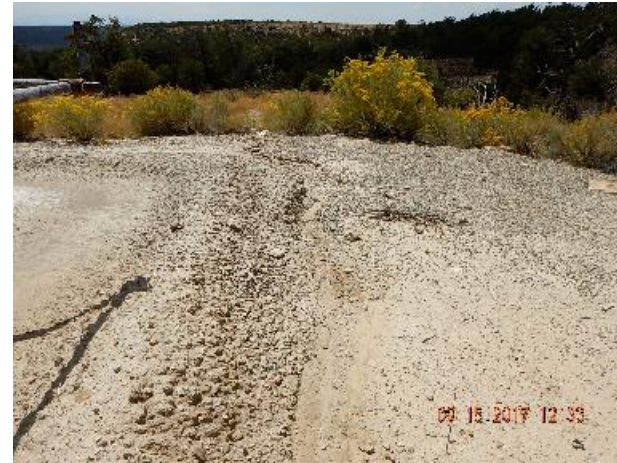
Photo 14: Erosion channel on SW corner along separator berms. Current inspection.
