Construction and Stormwater Inspection

September 19, 2017

Operator: GREAT WESTERN OPERATING COMPANY LLC- #10110

Location ID: 427917

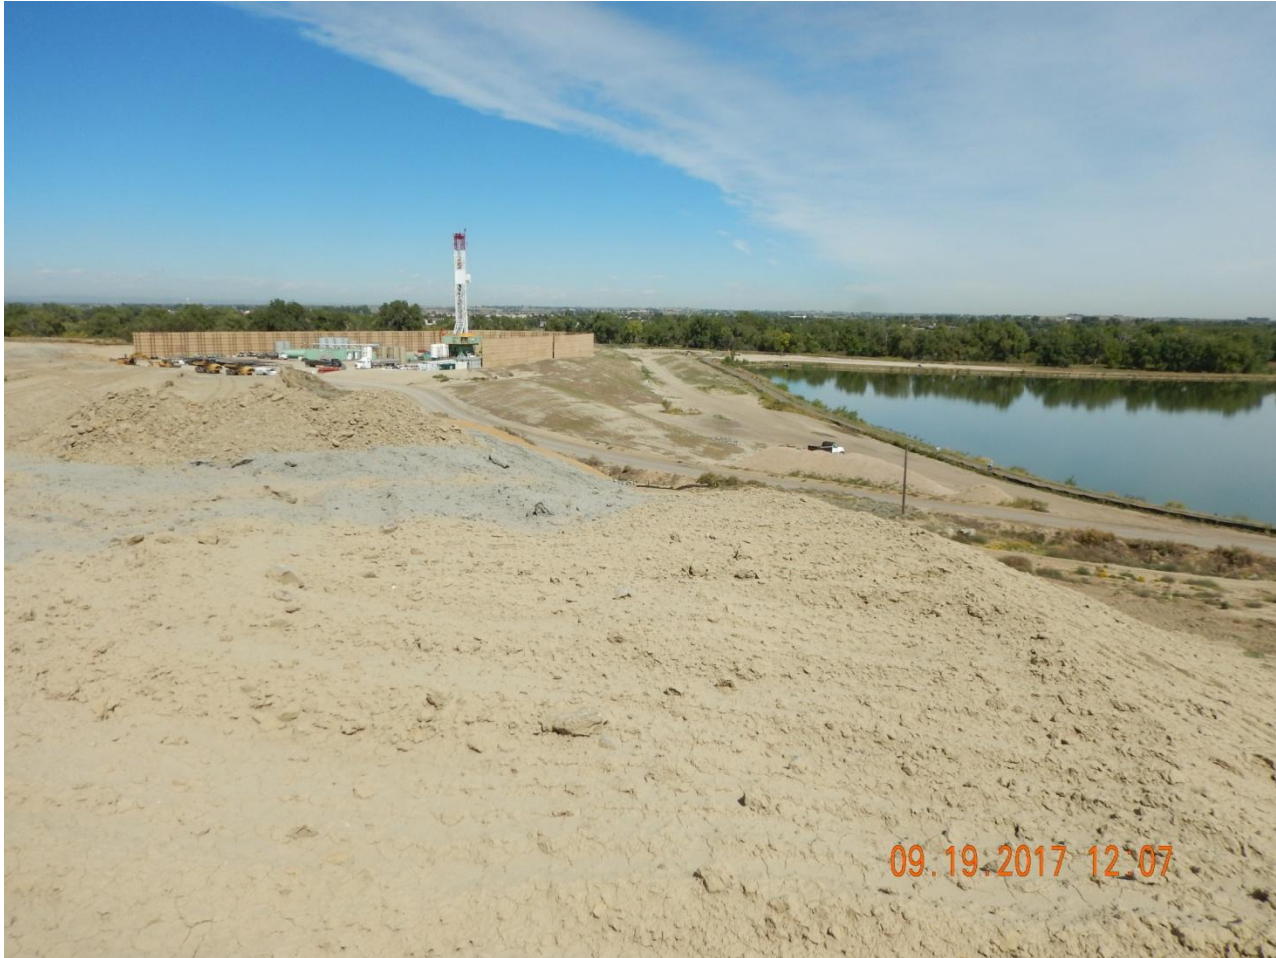
Photo 1. Photo taken from the eastern pipeline R-O-W, facing North. The Drilling FD pad is to the north with the rig on location.

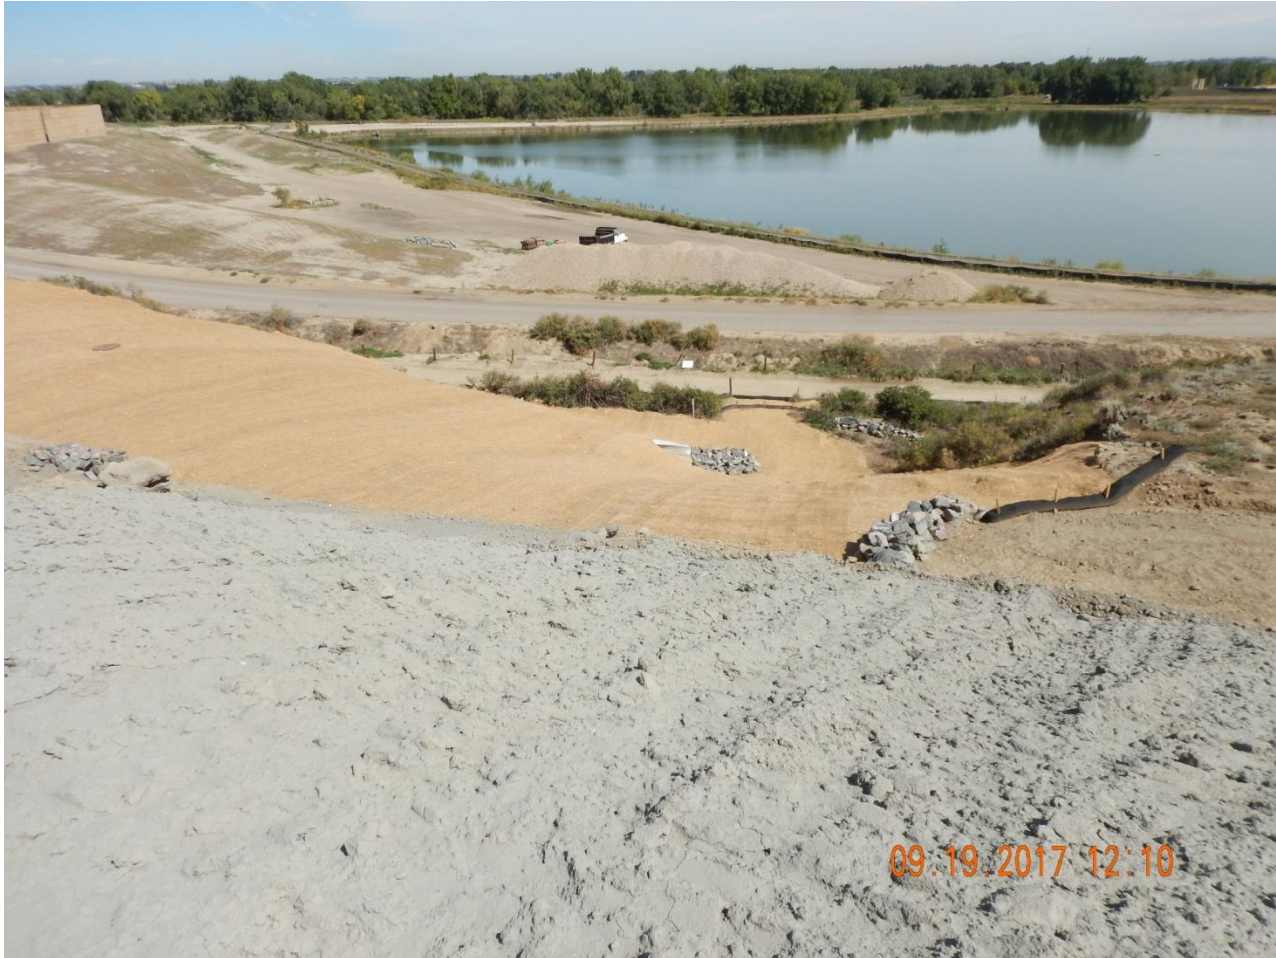
Photo 2. Photo taken from the eastern pipeline R-O-W, facing East. Erosion blanket, check dams and filtrex wattles have been installed along a portion of the eastern pipeline R-O-W.

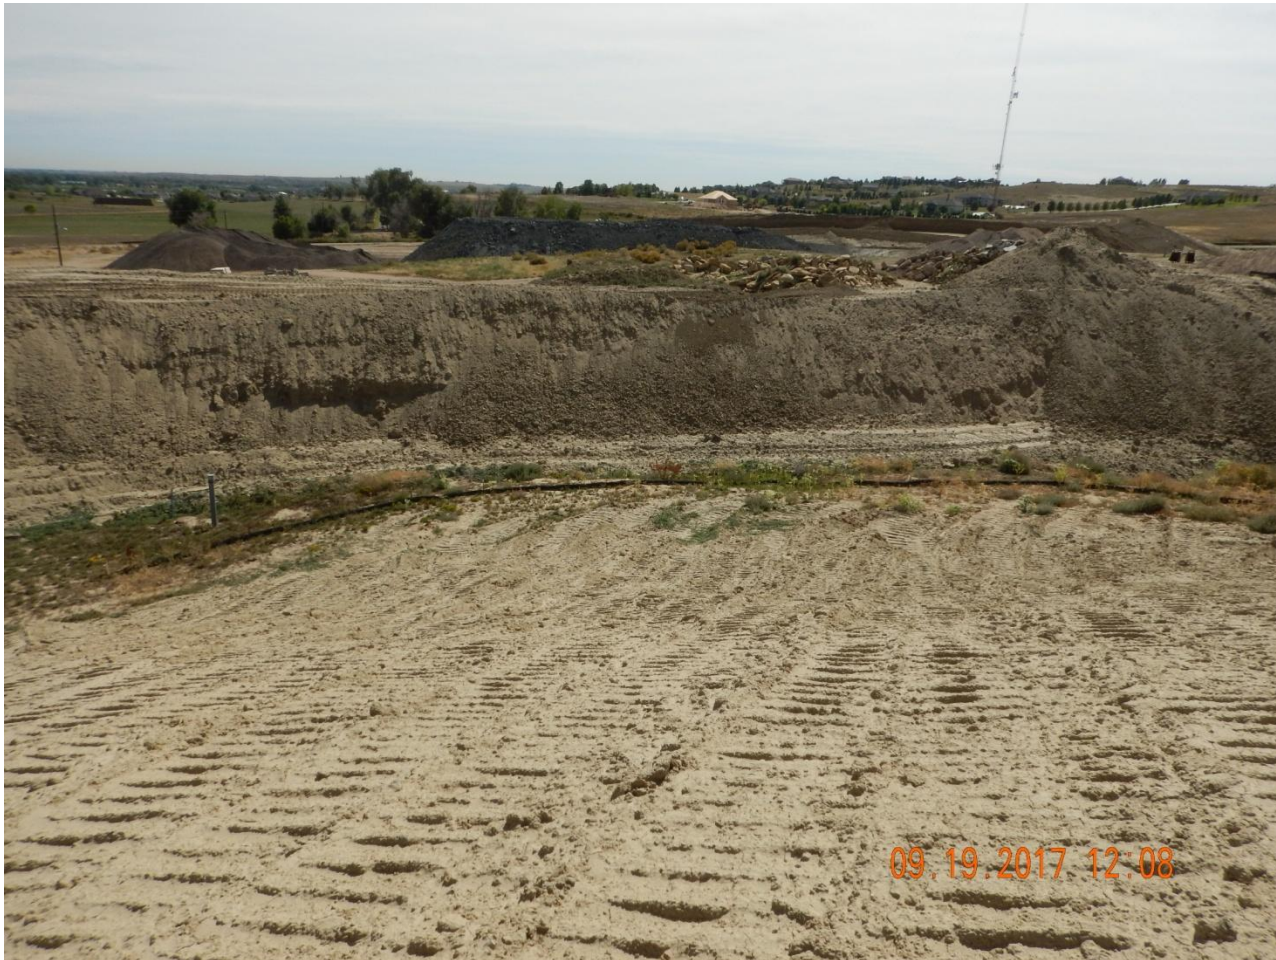
Photo 3. Photo taken from the eastern pipeline R-O-W, facing Southeast. It is unclear if some of the stockpiles are from oil and gas activities or from previous land use from the mining company. Silt fence has been installed at the toe of the slope.

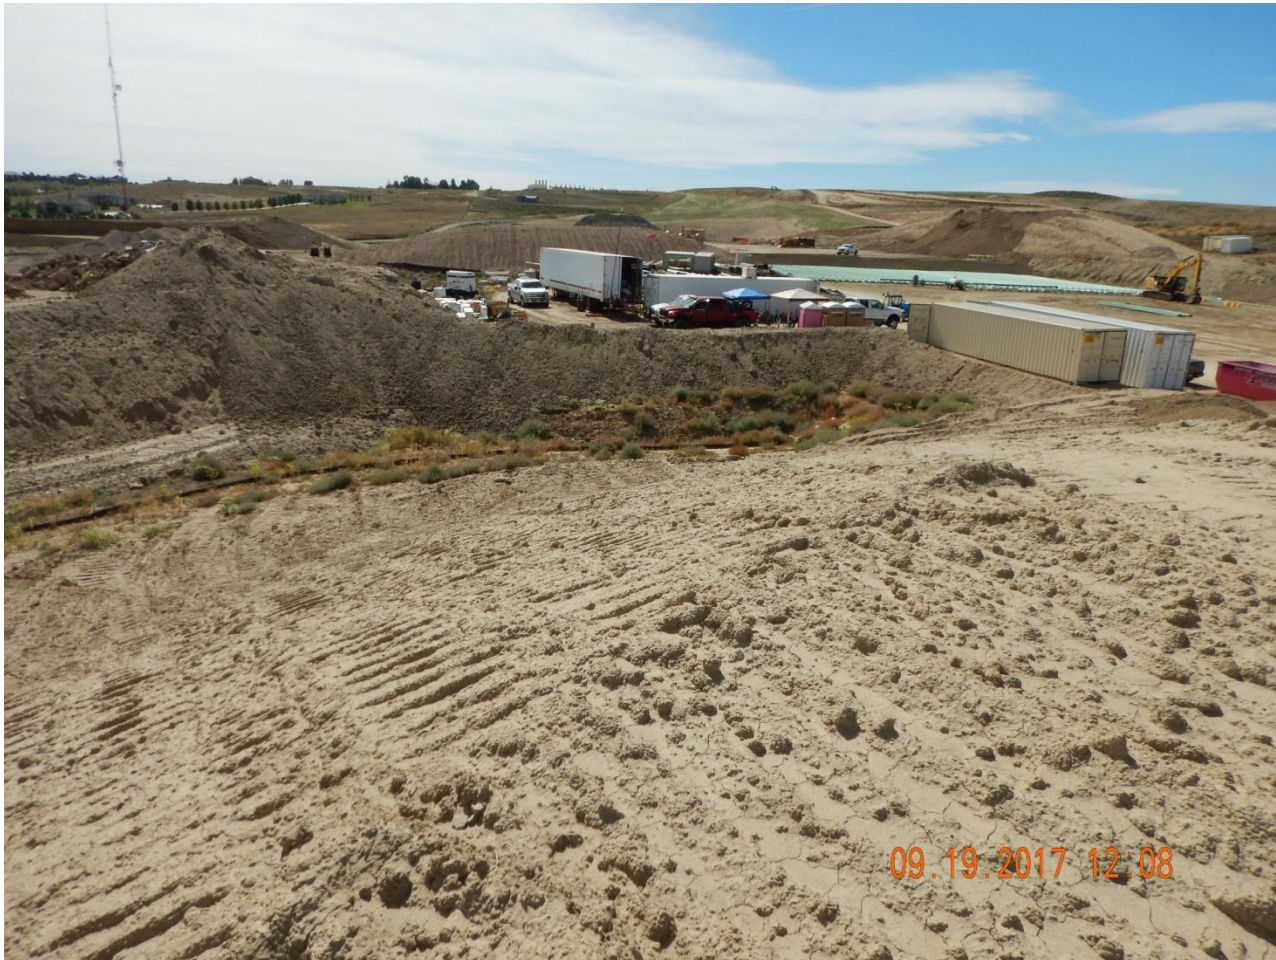
Photo 4. Photo taken from the eastern pipeline R-O-W, facing South. It is unclear if some of the stockpiles are from oil and gas activities or from previous land use from the mining company. Photo illustrates the flowline installation from the tank battery to the well location.

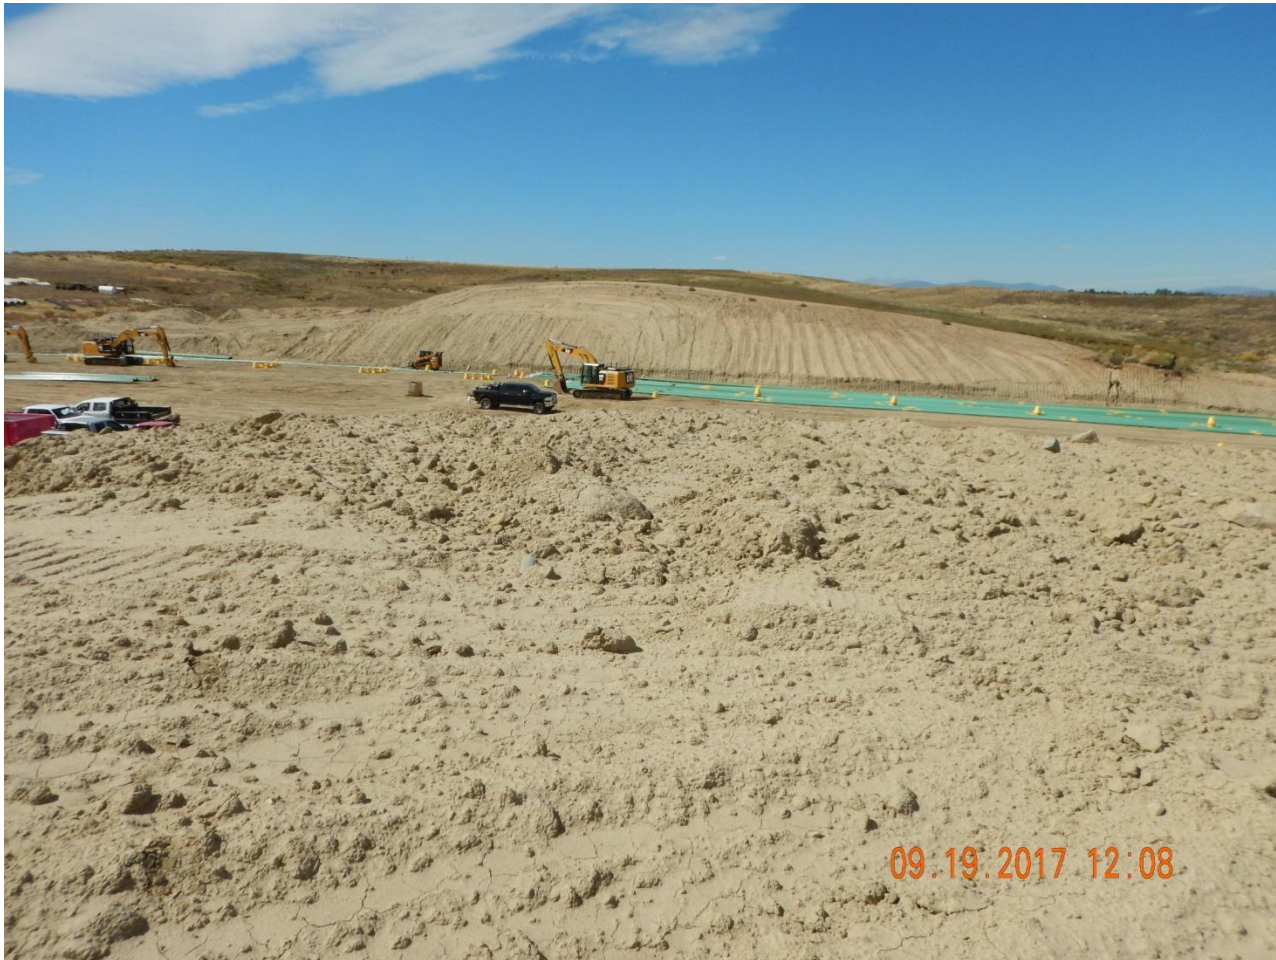
Photo 5. Photo taken from the eastern pipeline R-O-W, facing West. Photo illustrates the flowline installation from the tank battery to the well location.

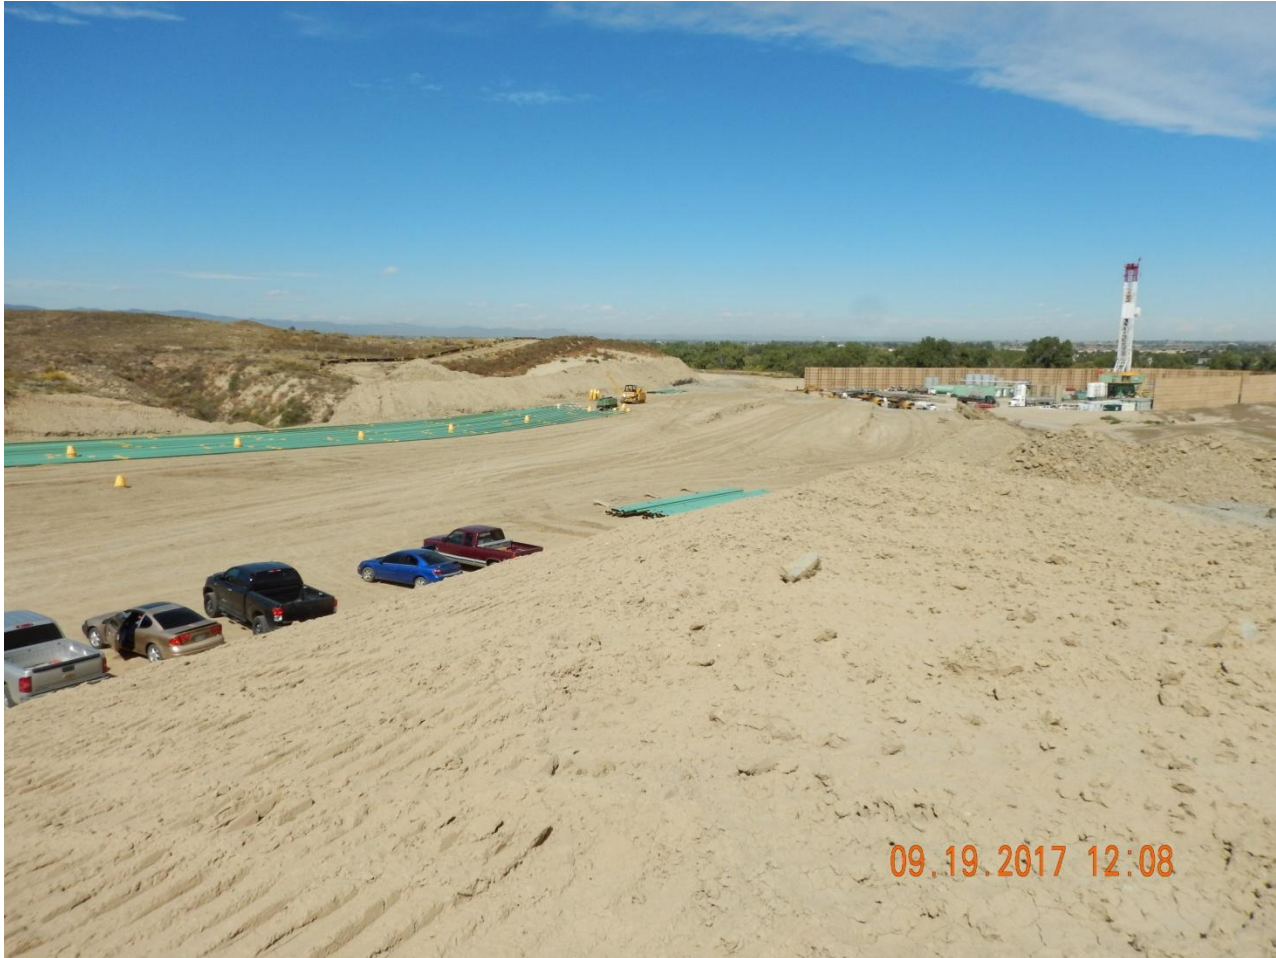
Photo 6. Photo taken from the eastern pipeline R-O-W, facing Northwest. Photo illustrates the flowline installation from the tank battery to the well location.

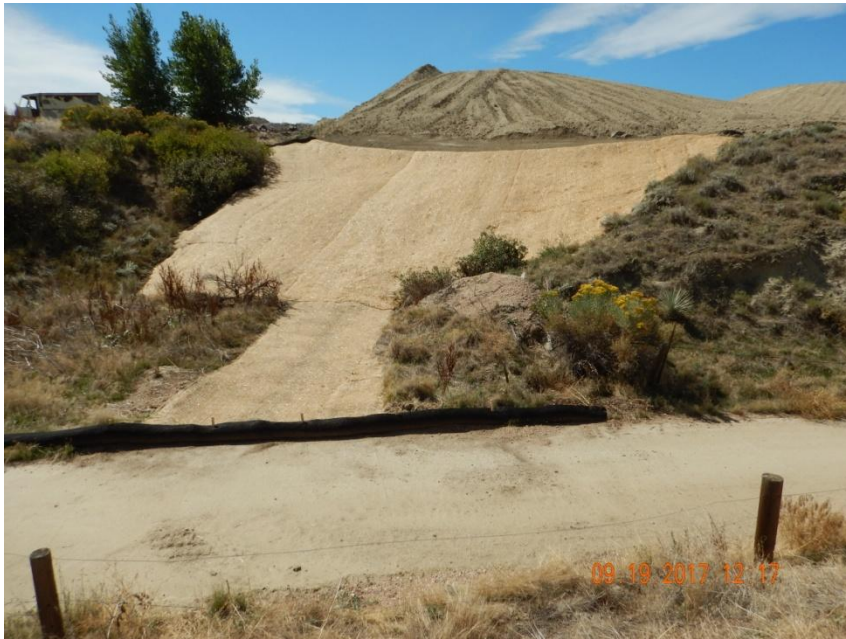
Photo 7. Photo taken from the downgradient slope of Photo 2, facing West. Erosion blanket installed along a portion of the eastern pipeline R-O-W.

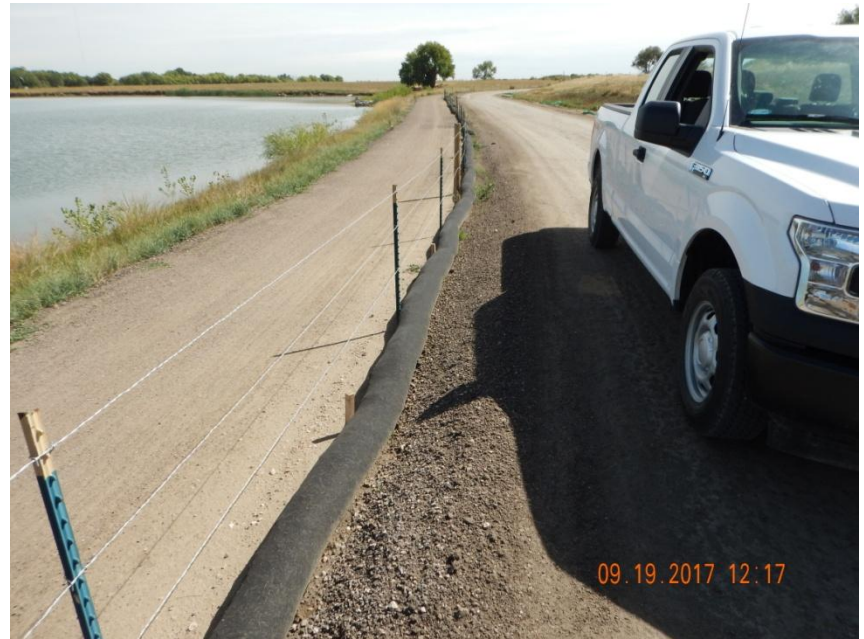
Photo 8. Photo taken from a portion of the access road, facing East. Filtrex wattles have been installed but do not appear to be properly staked. Silt fence was also installed along portions of the access road.

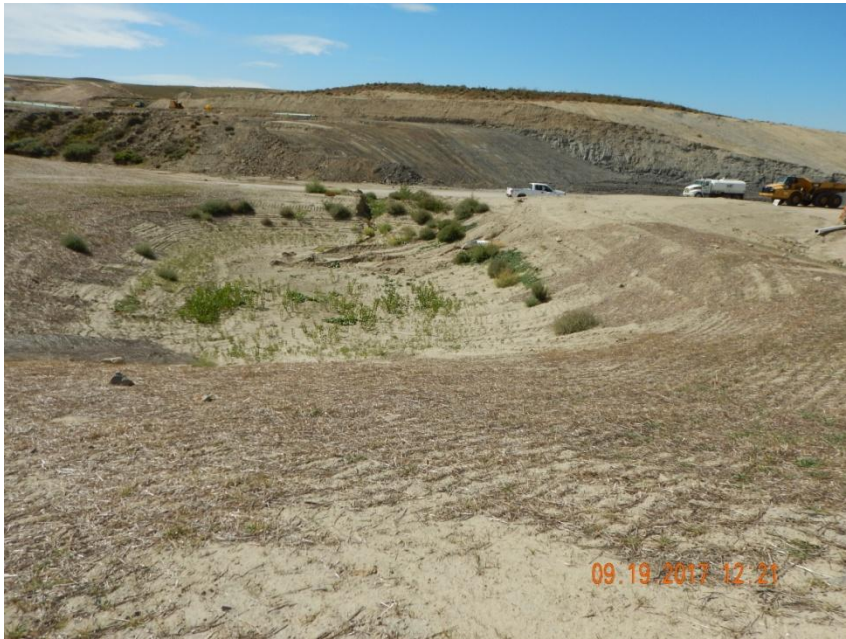
Photo 9. Photo taken from the southeast drilling pad location, facing South. Sediment basin has been installed with a stabilized outlet in conjunction with other stormwater BMPs.

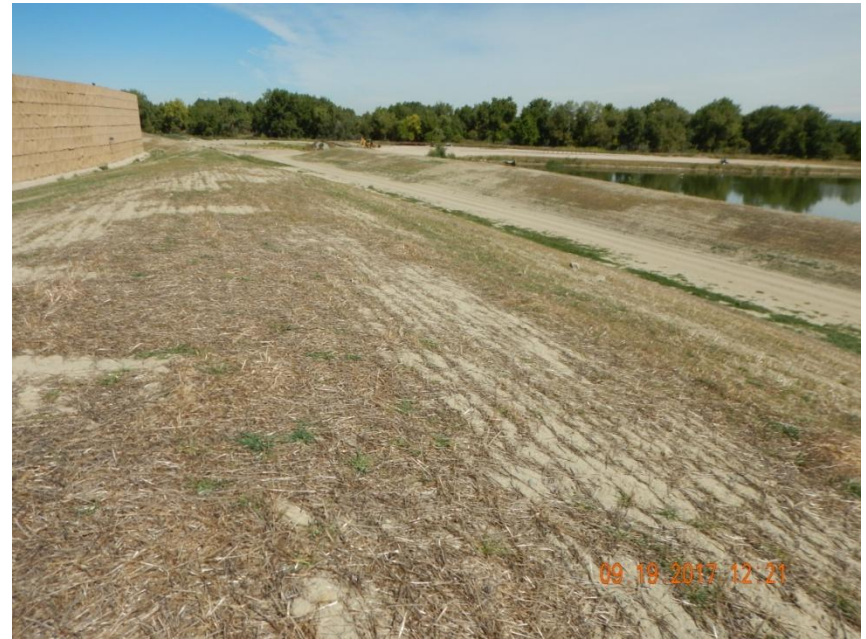
Photo 10. Photo taken from the southeast drilling pad location, facing North. Both the topsoil stockpile and other areas constructed to be a berm have been seeded and mulched. Operator indicated that a “TOPSOIL” sign would be placed to indicate the location of the topsoil. Areas do not have uniform germination but appear to be temporarily stabilized with mulch. May need additional reclamation activities for long-term self-sustaining stabilization.

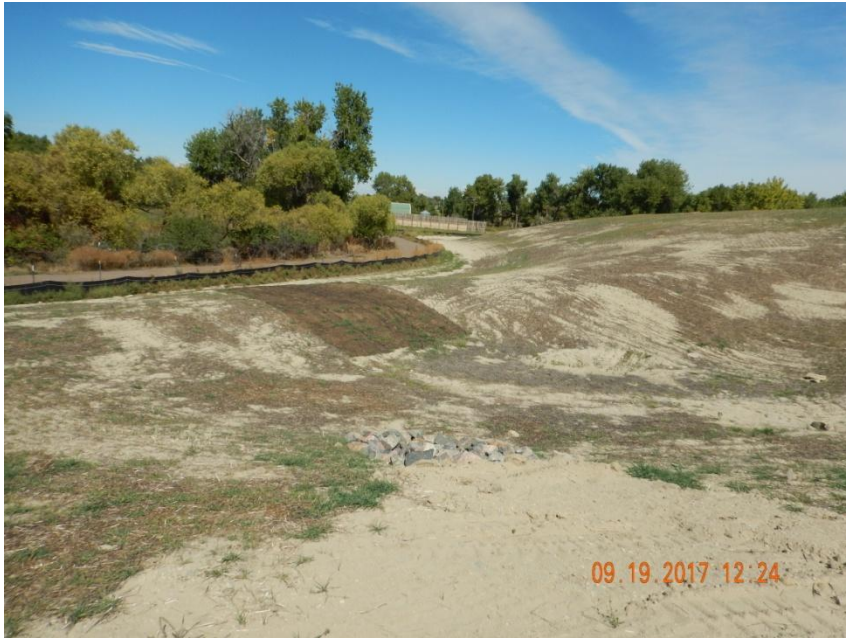
Photo 11. Photo taken from the northern location, facing North. Sediment basin has been installed with a stabilized outlet in conjunction with other stormwater BMPs. Areas do not have uniform germination and may require additional stabilization. May need additional reclamation activities for long-term self-sustaining stabilization.

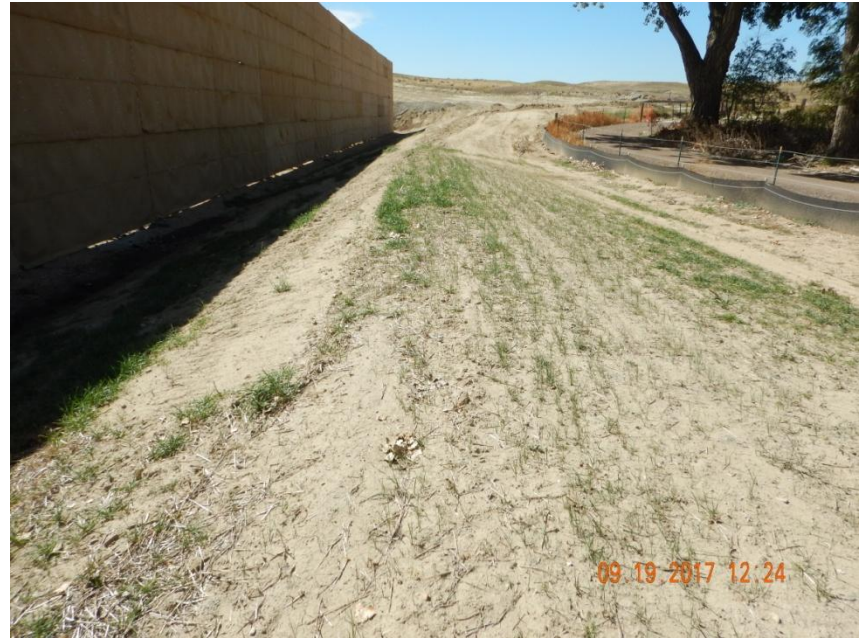
Photo 12. Photo taken from the northern location, facing Southwest. Areas constructed to be a berm have been seeded and mulched. Areas do not have uniform germination and may require additional stabilization.

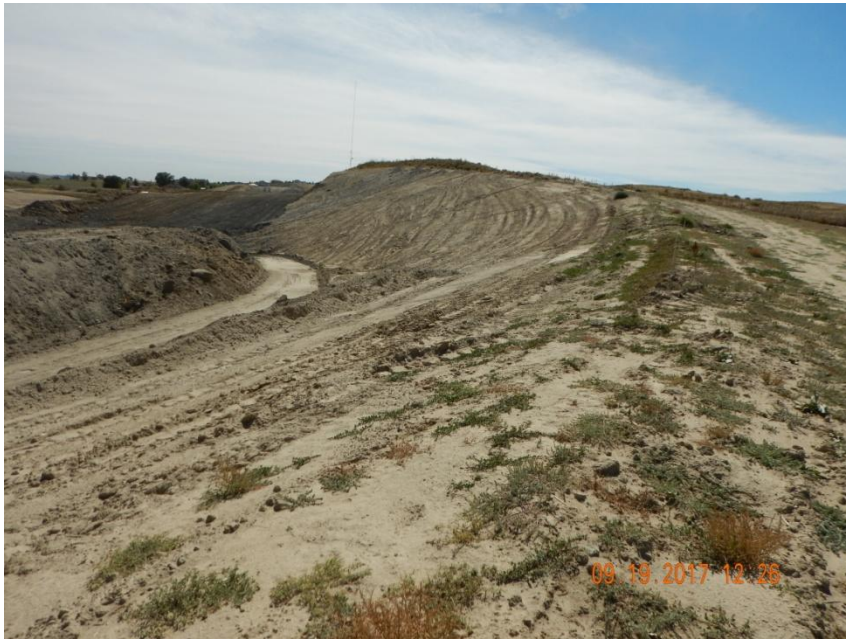
Photo 13. Photo taken from the western location, facing South. Cut slopes appear to be temporarily stabilized but will require additional long-term stabilization BMPs.

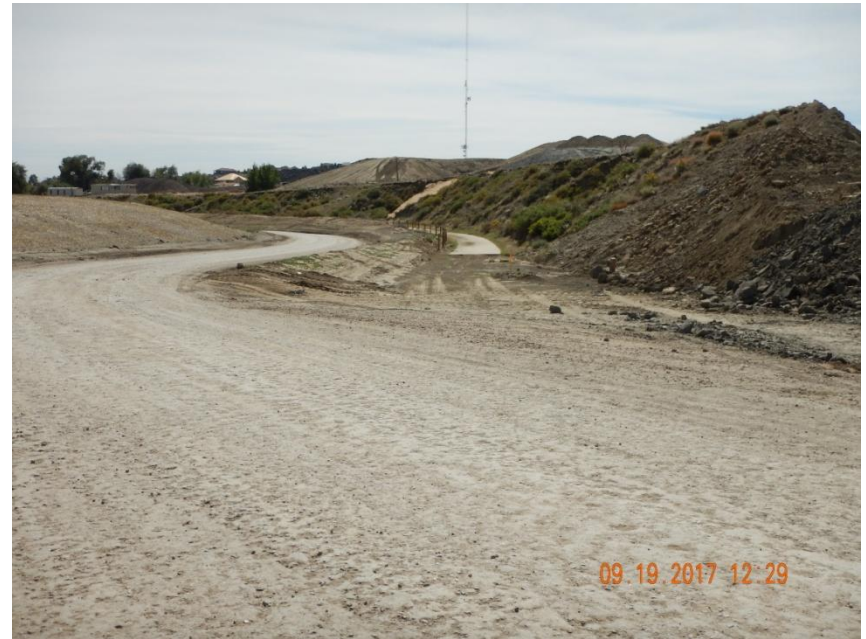
Photo 14. Photo taken from the entrance of the drilling location, facing South. Photo illustrates the Poudre Creek trail that was diverted during construction operations.
