Inspection Photos

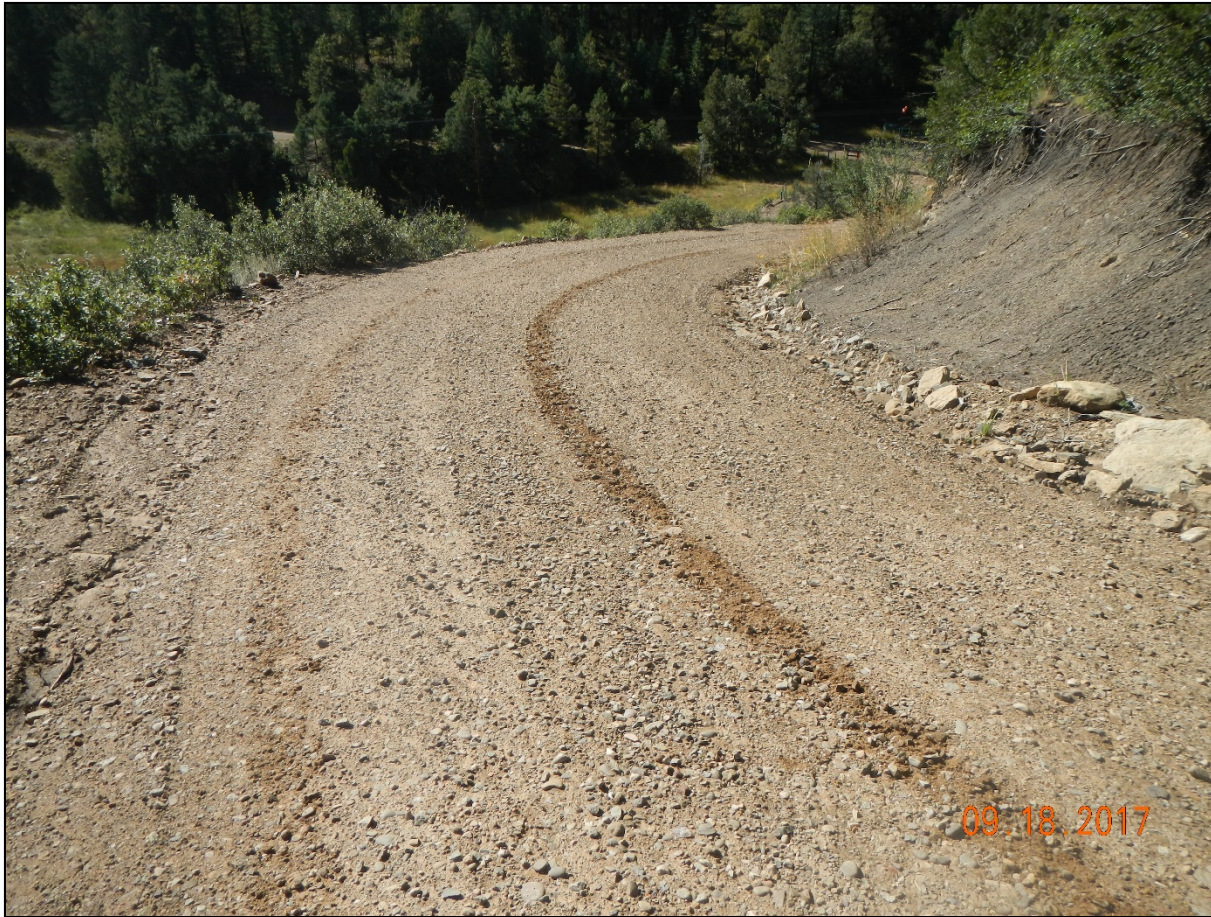
Photo 1. Facing southeast along the steep grade of the access road. Stormwater issues have been repaired.

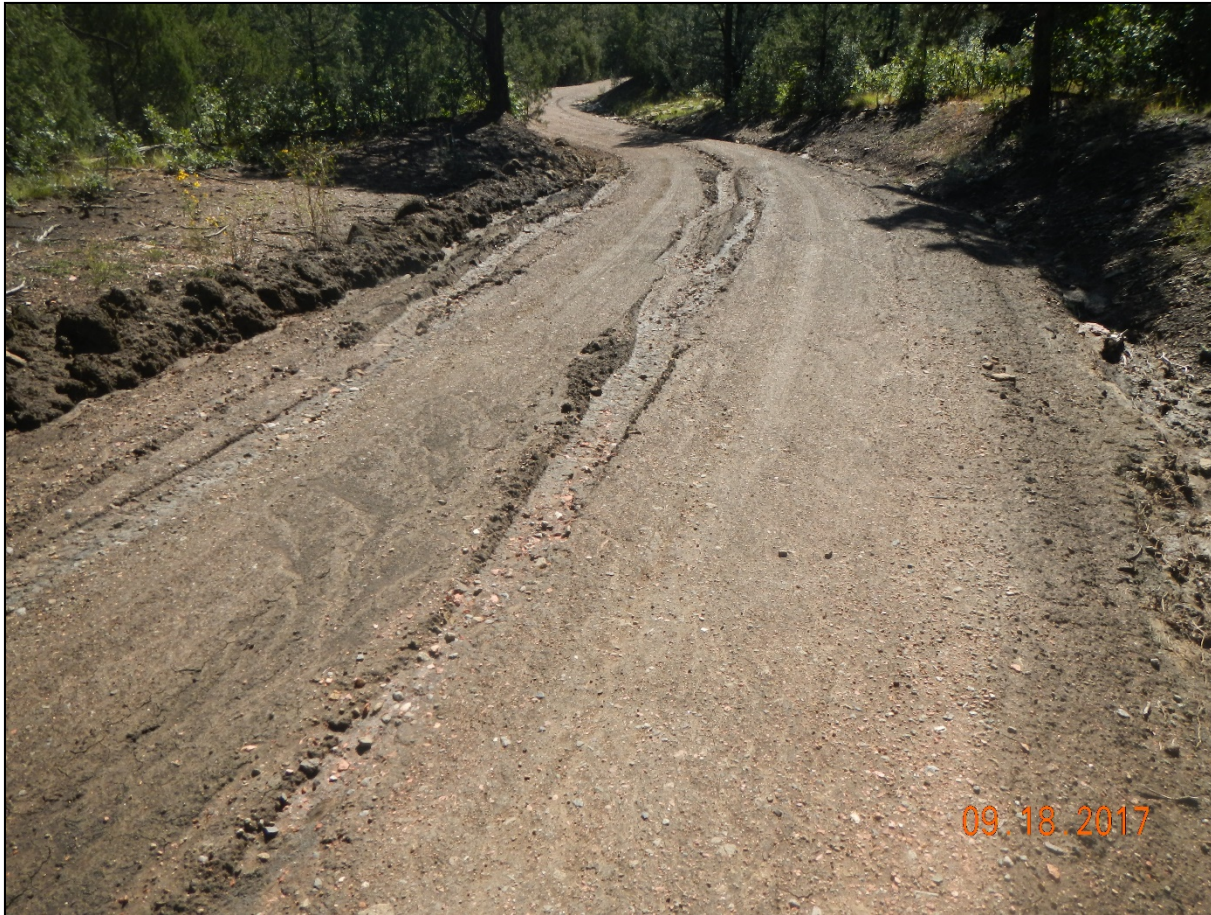
Photo 2. Facing southeast along the access road. This area was graded but does not appear to have much gravel. Stormwater issues may be more susceptible in this area.

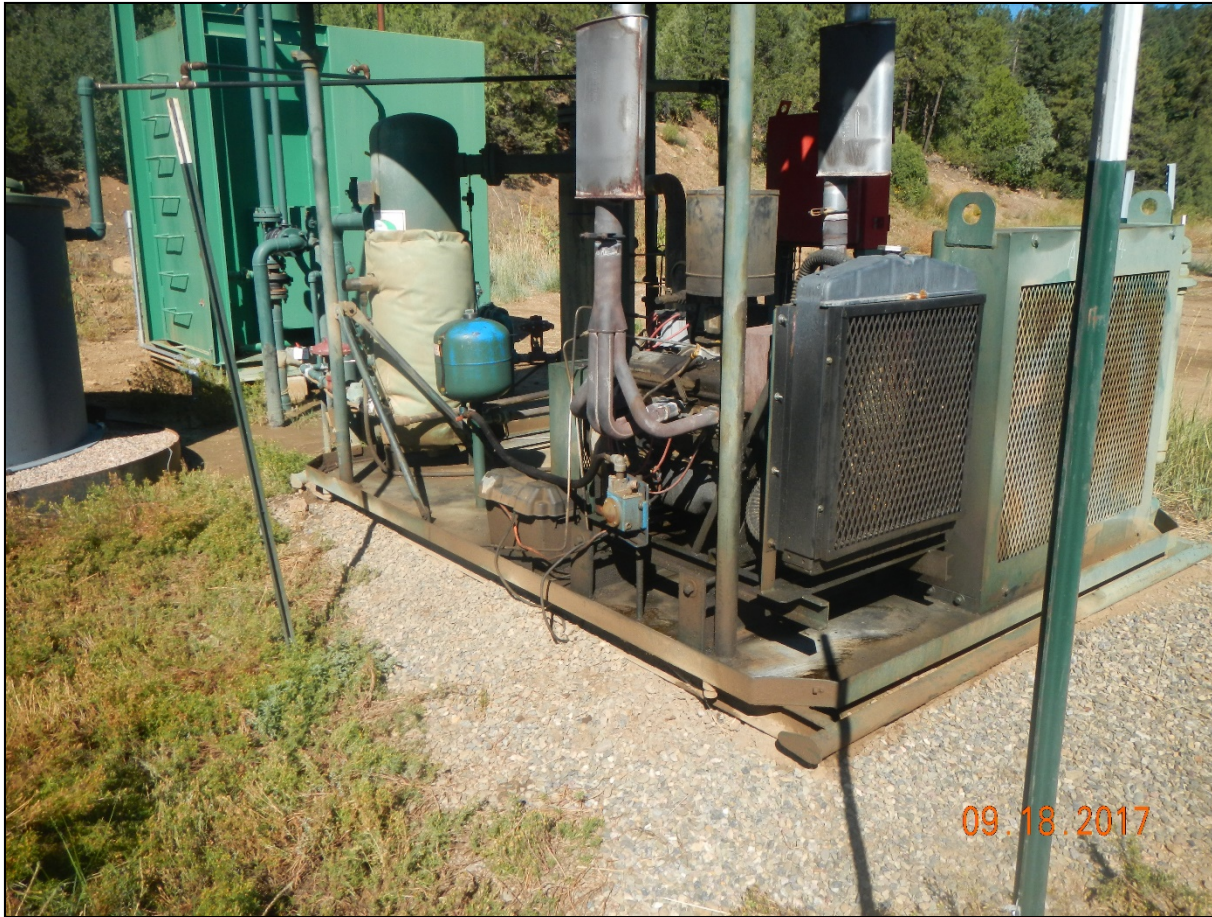
Photo 3. The oil on the engine skid was cleaned up.

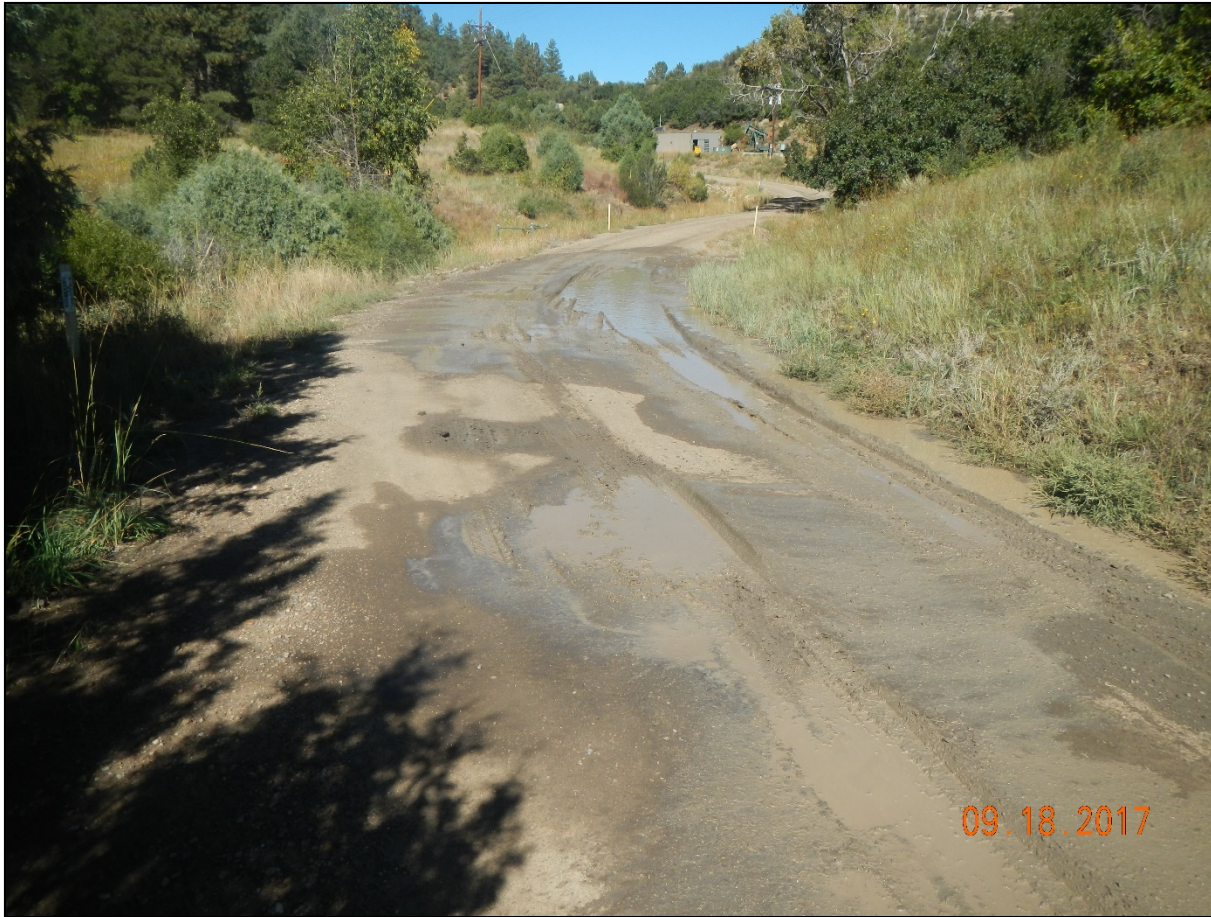
Photo 4. Facing northwest along the main road in Big Bingham Canyon. There are stormwater issues along the main road.
