Inspection Photos

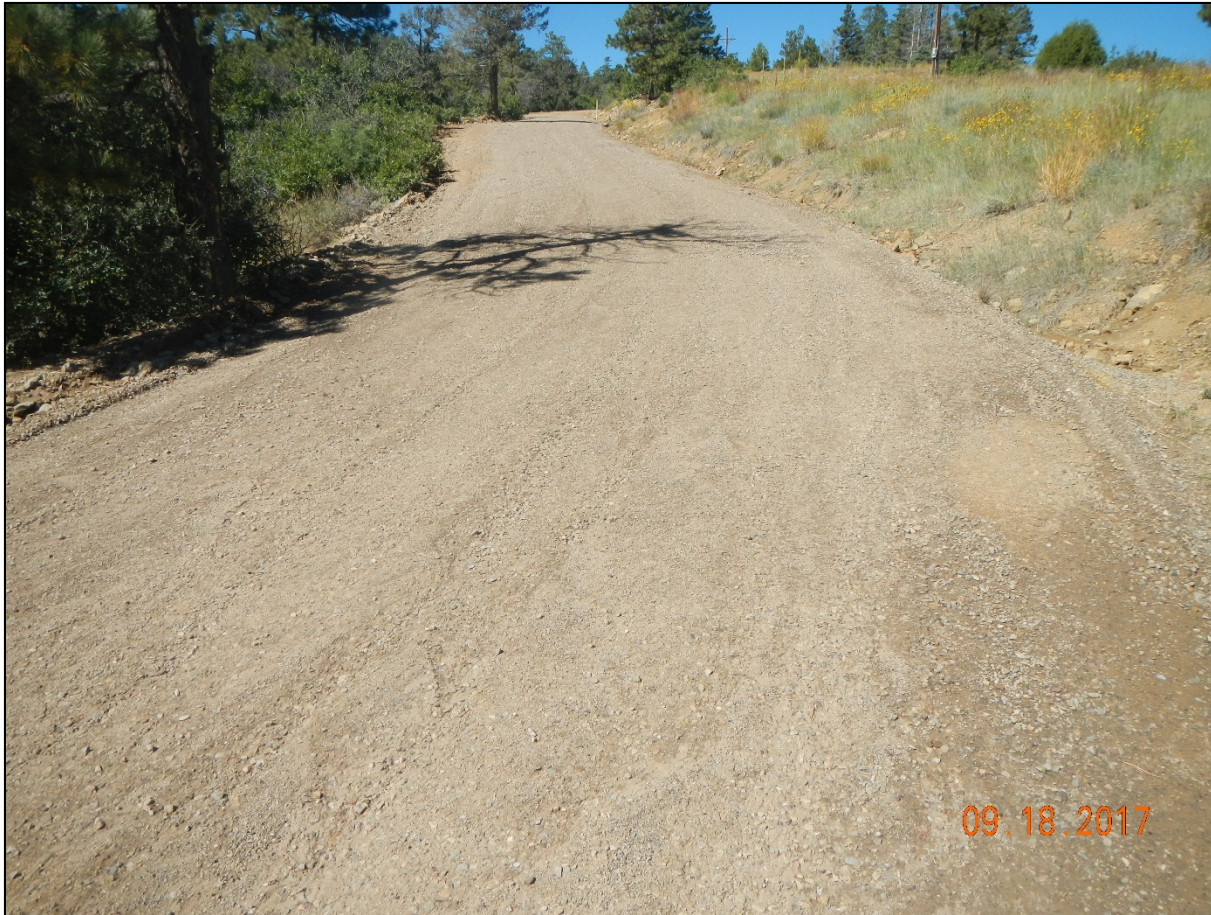
Photo 1. Facing west along the access road. Stormwater issues have been repaired.

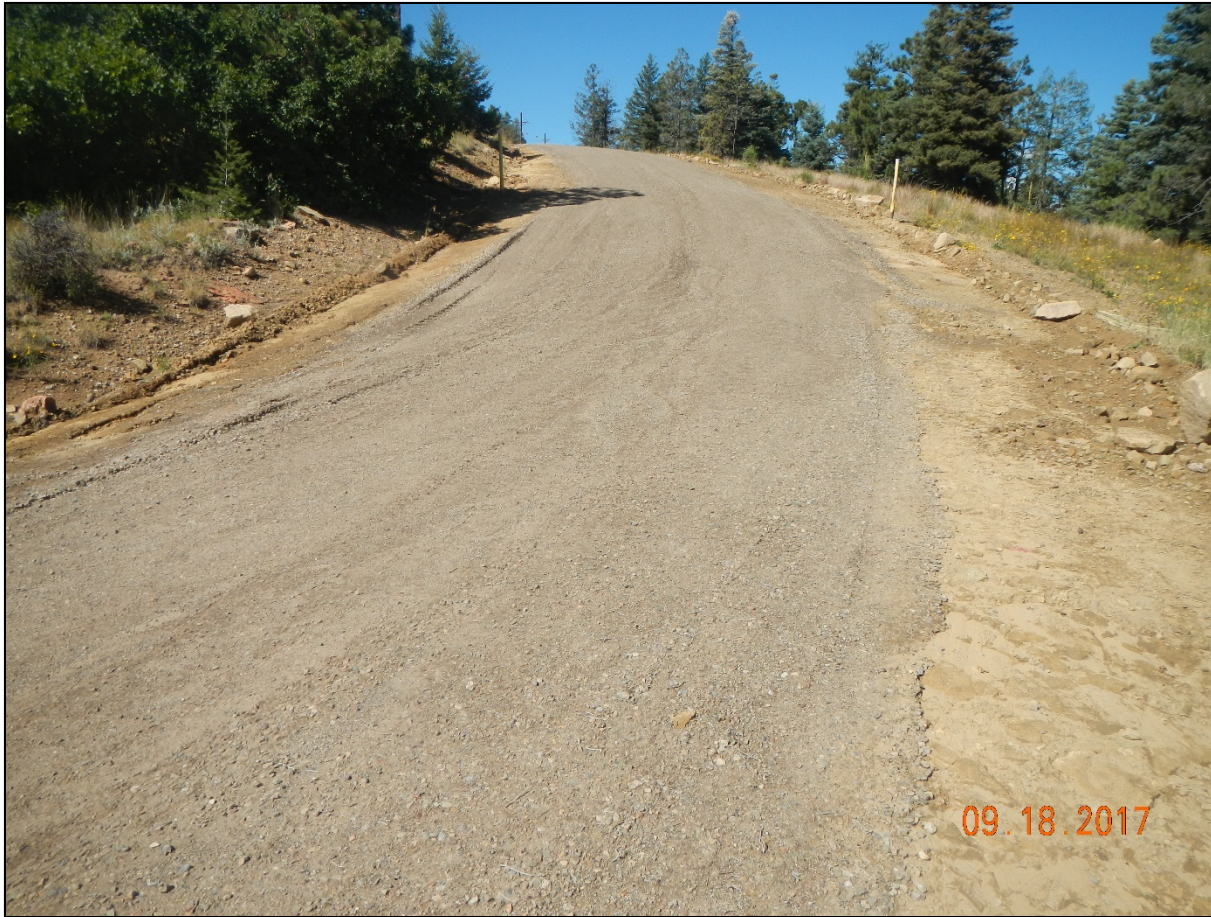
Photo 2. Facing west along the access road. Gravel was applied to the access road.
