Inspection Photos

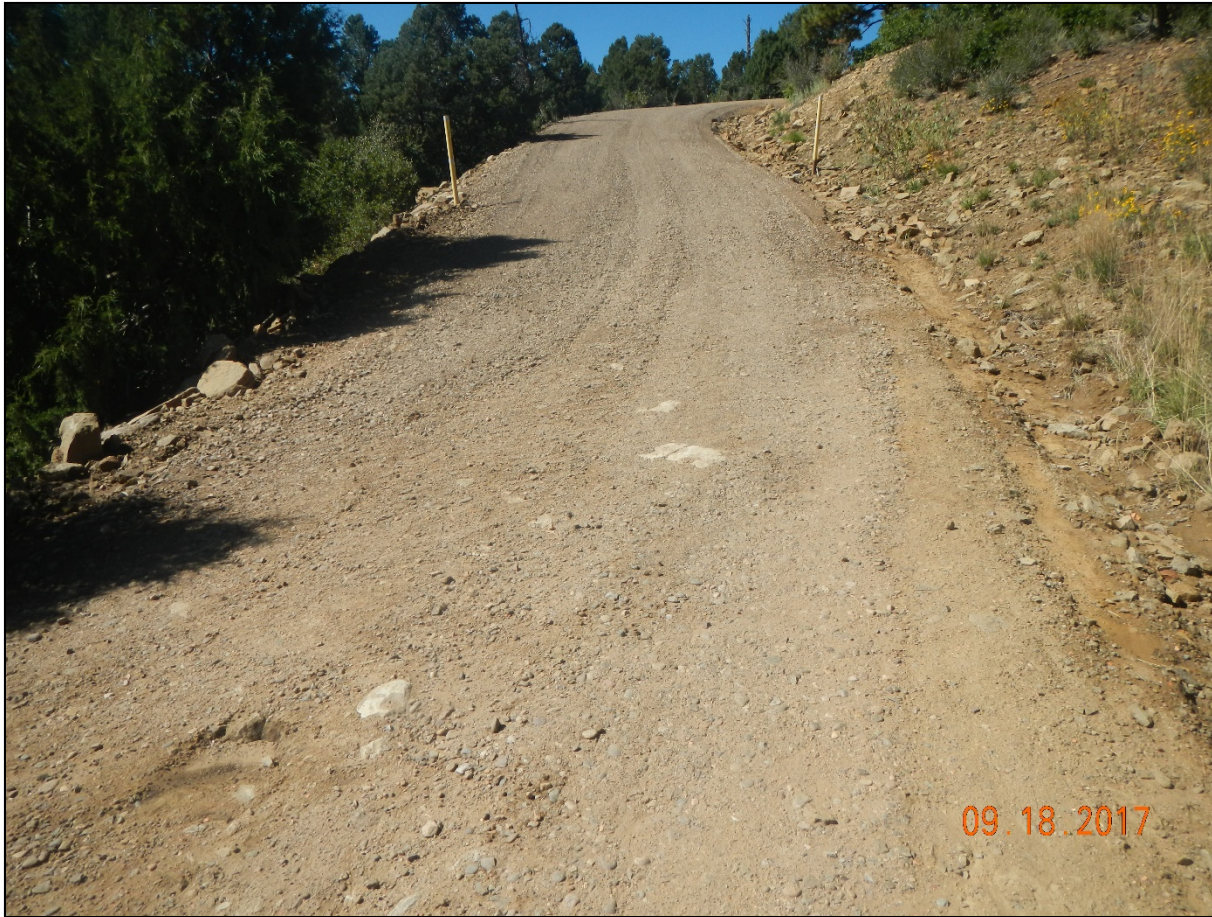
Photo 1. Facing southwest along the access road. Gravel was applied along this portion of the access road.

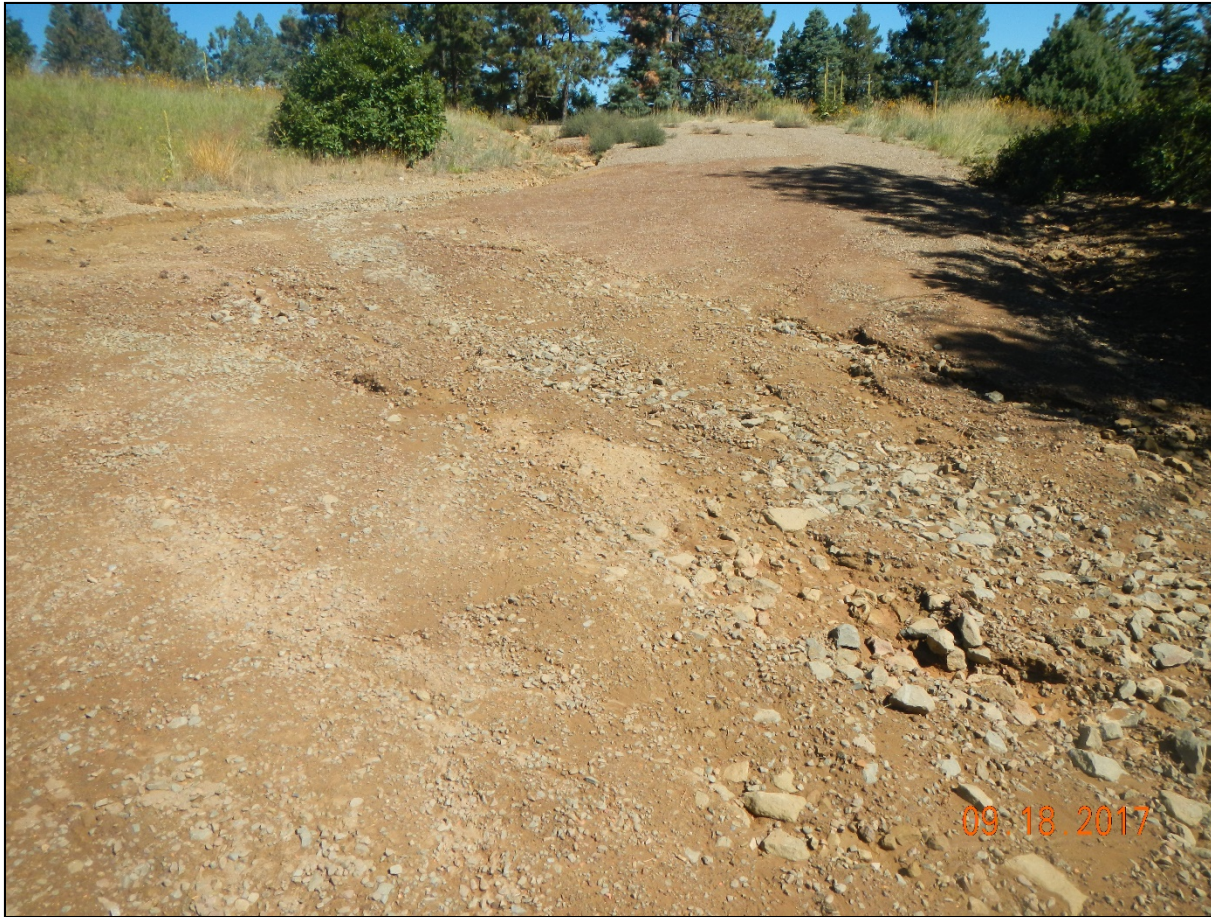
Photo 2. Facing northwest at the access road. There are signs of erosion occurring from recent storm events. This area was recently repaired and issues have already developed. A culvert may need to be installed to prevent erosion across the road.

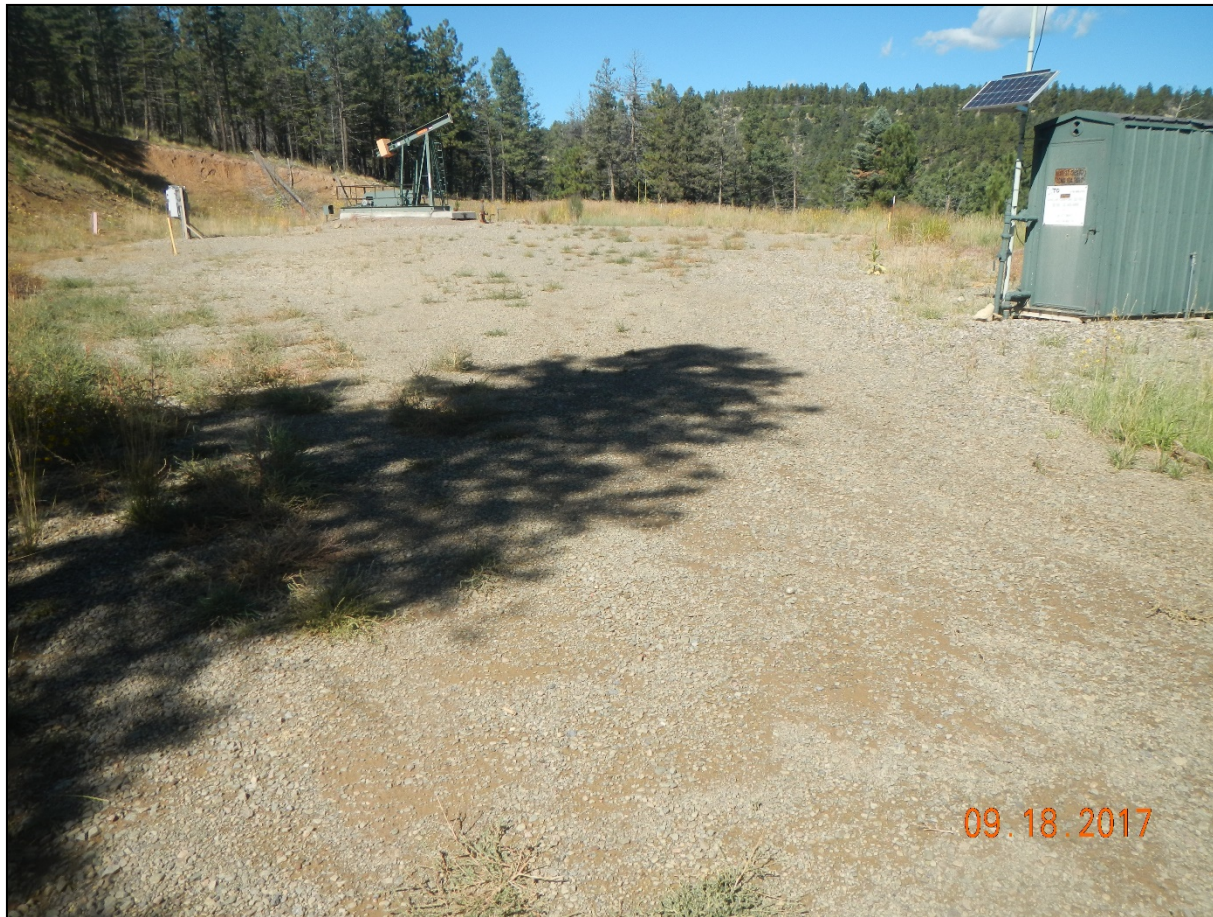
Photo 3. Facing northwest toward the location.
