Inspection Photos

Location Name: Valcar USX A 3-14

API #: 05-123-24596

Location ID: 306406

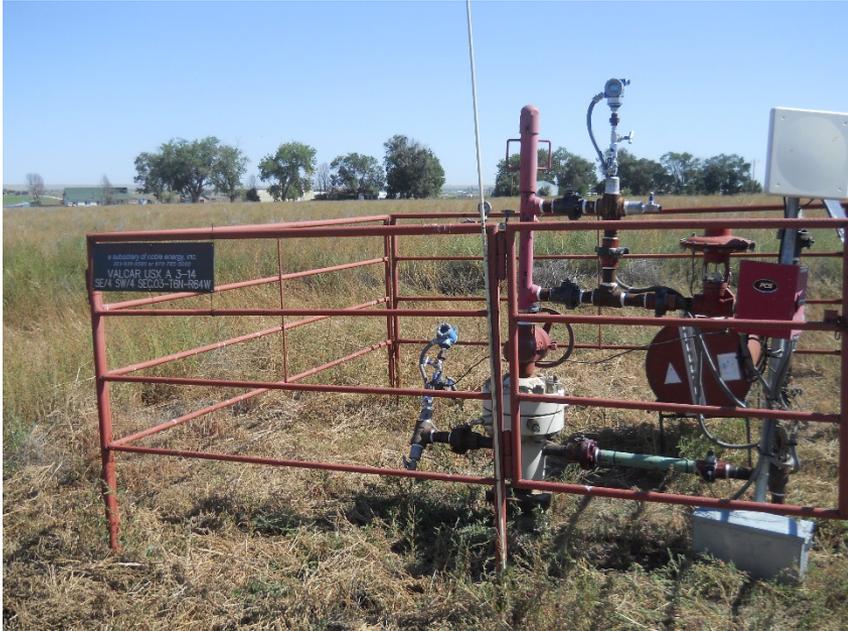
Wellheads looking east, weeds need to be controlled

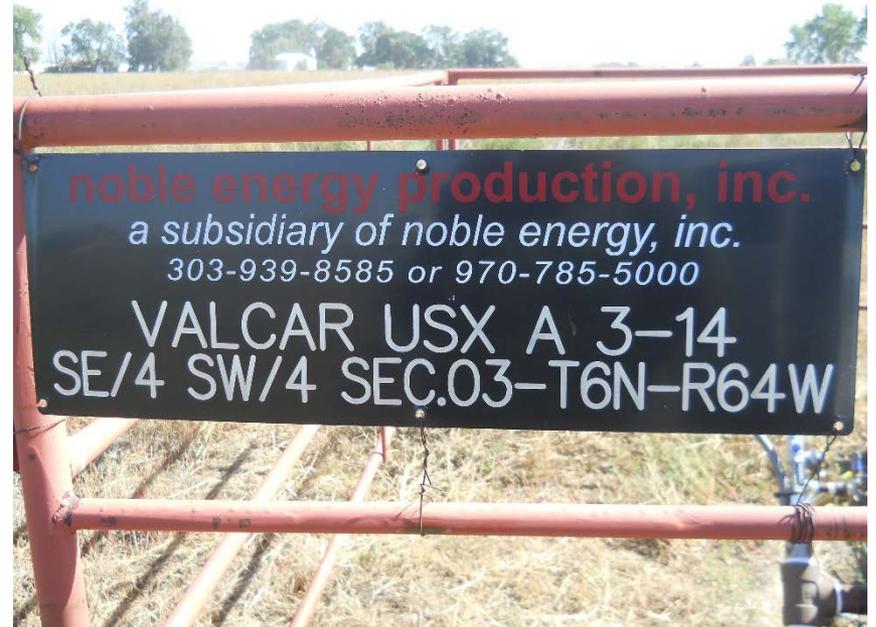
Wellhead sign showing incorrect information/disconnected emergency contact information

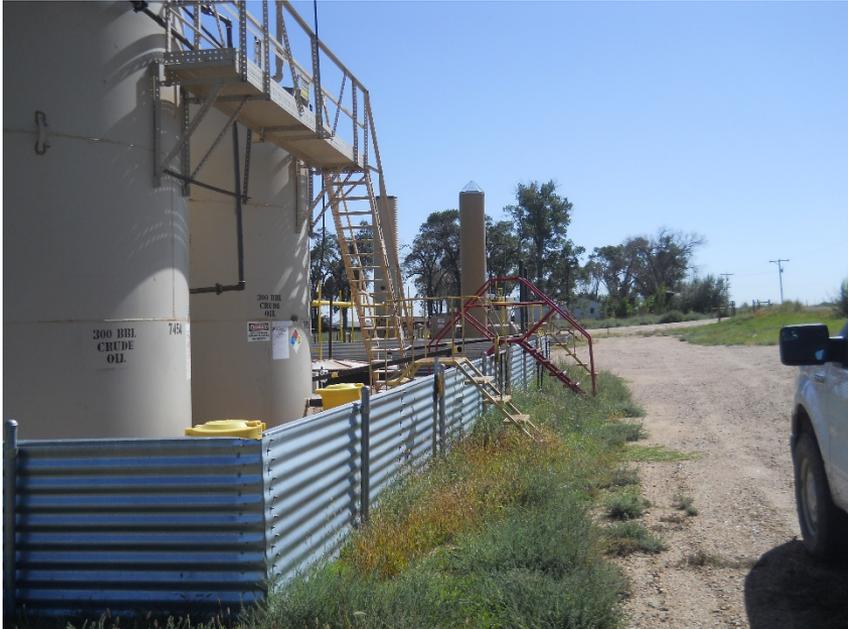
Battery looking south, weeds need to be controlled

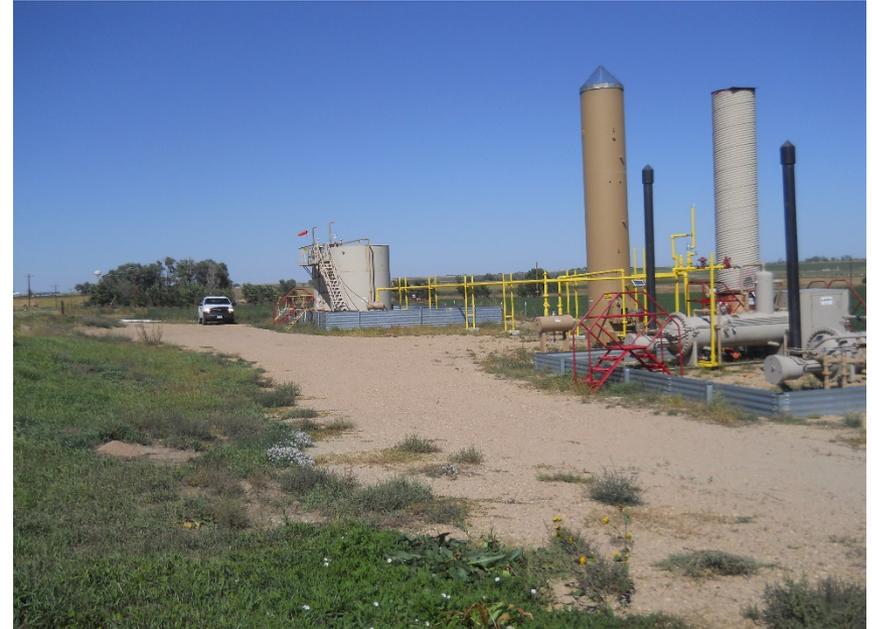
Battery looking north, weeds need to be controlled

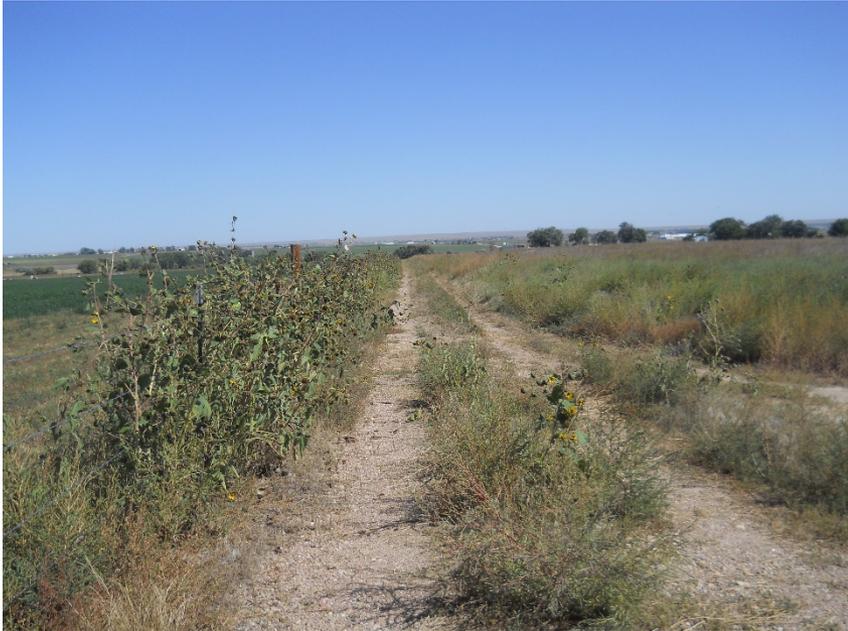
Access road from battery to wellhead looking east. Weeds need to be controlled
