Inspection Photos
Location Name: Dittmer KE Pad
API: 05-123-43441

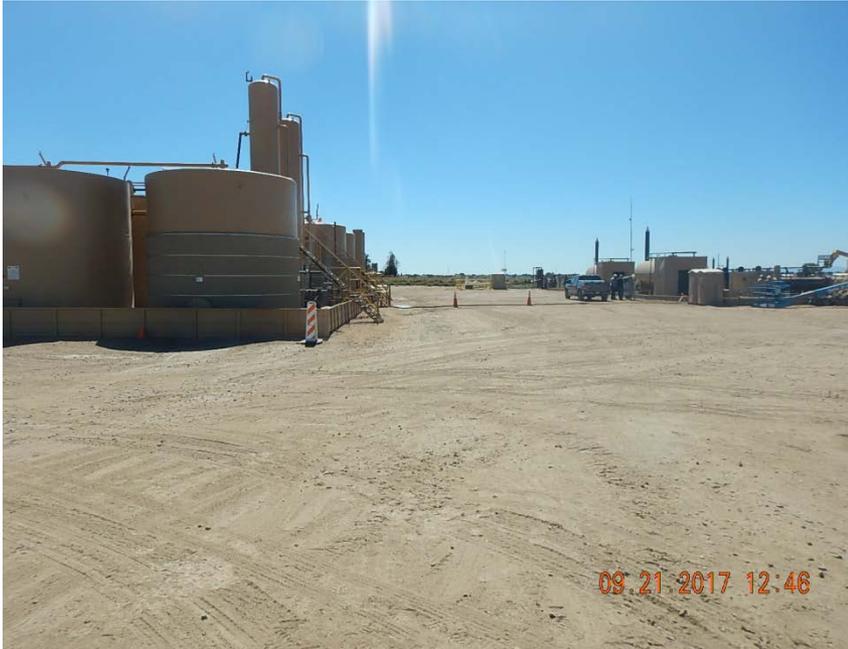
Photo 1: Location, looking S

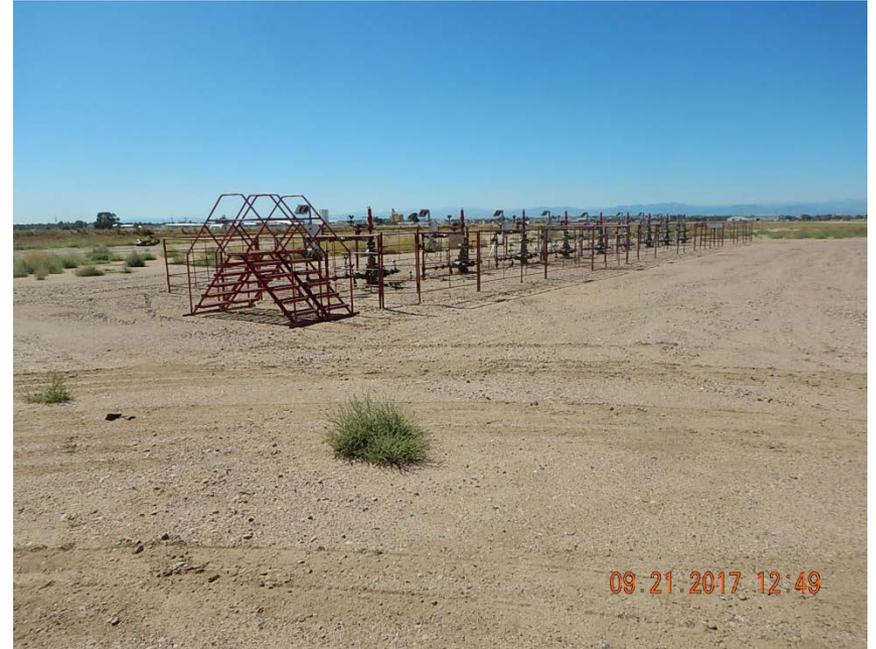
Photo 2: Wellheads, looking SW

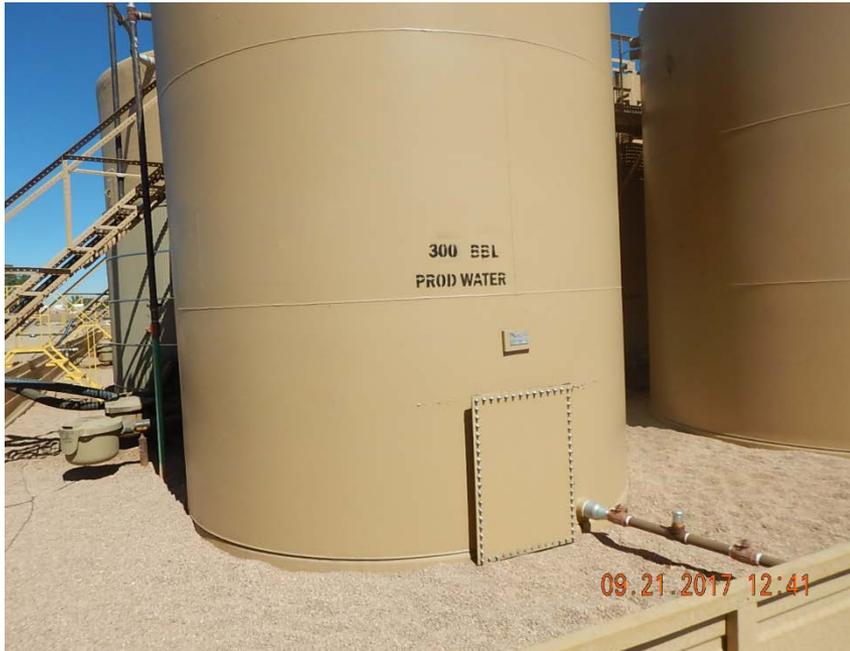
Photo 3: 300 bbl tank lacking safety placarding

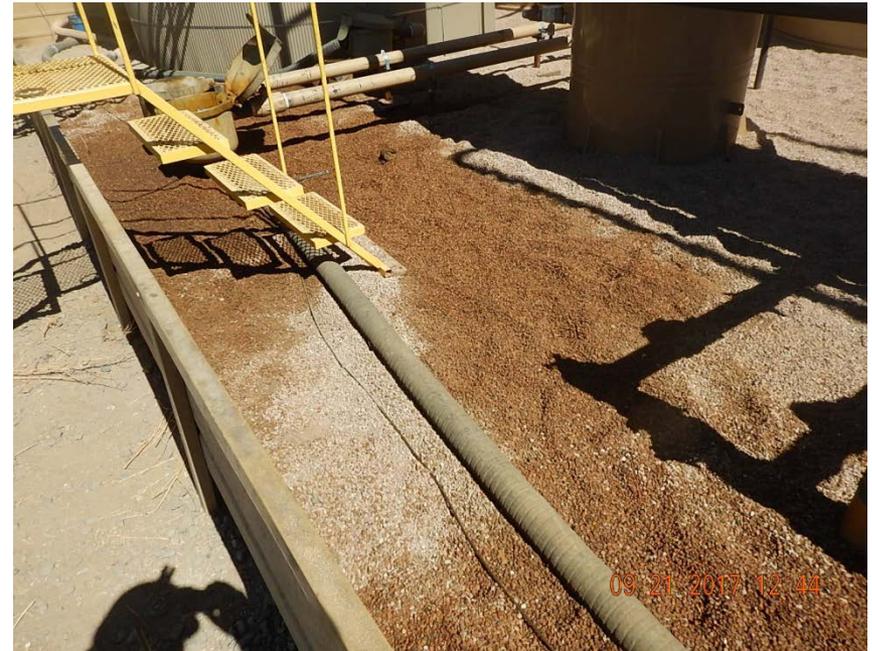
Photo 4: Stained soil in tank battery

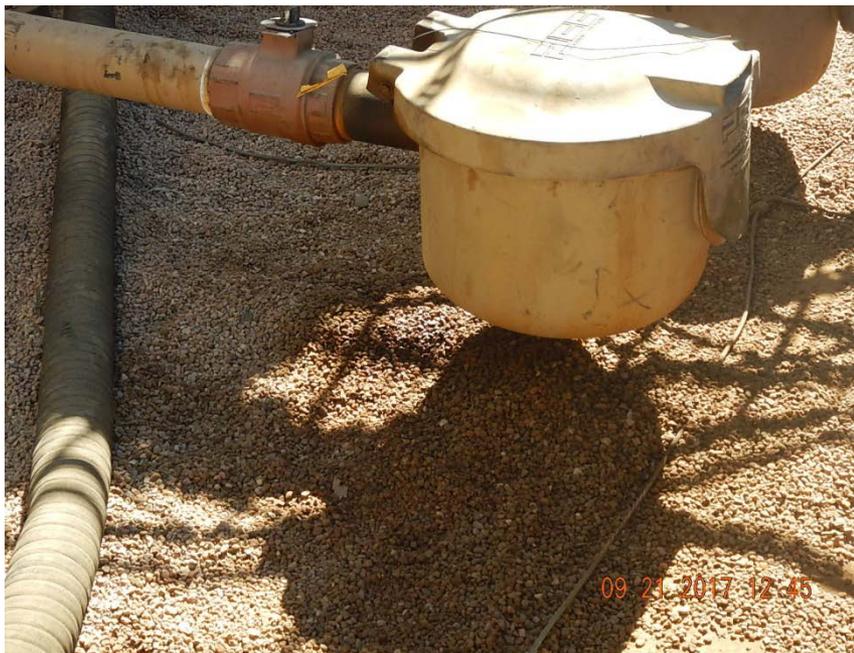
Photo 5: Stained soil at crude oil loadout.

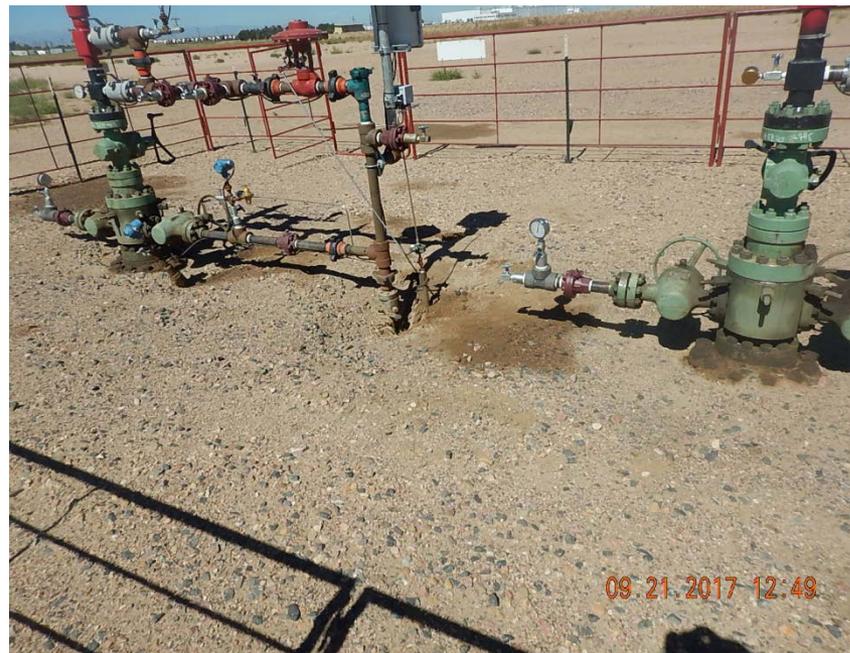
Photo 6: Stained soil at Wellheads on W side.

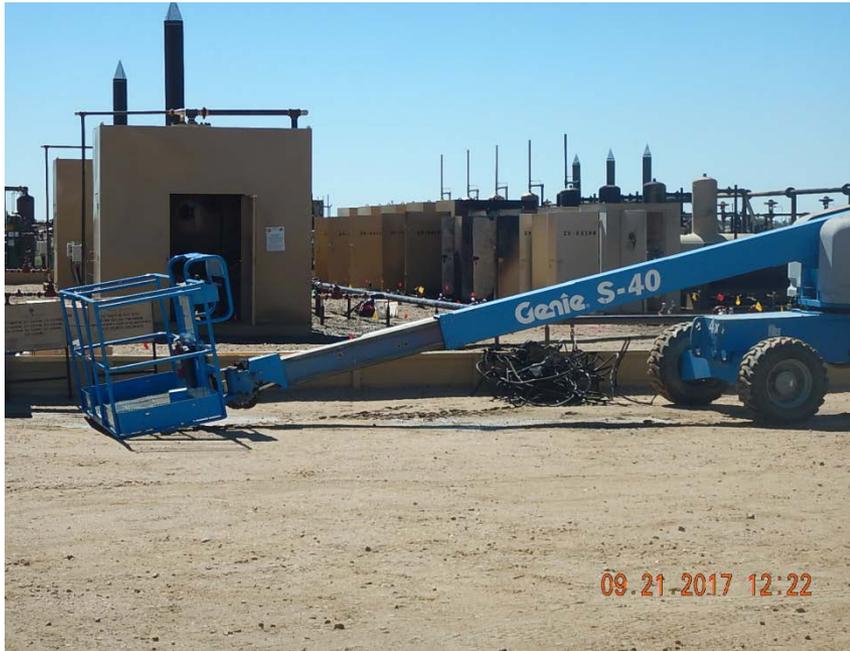
Fire damage photo

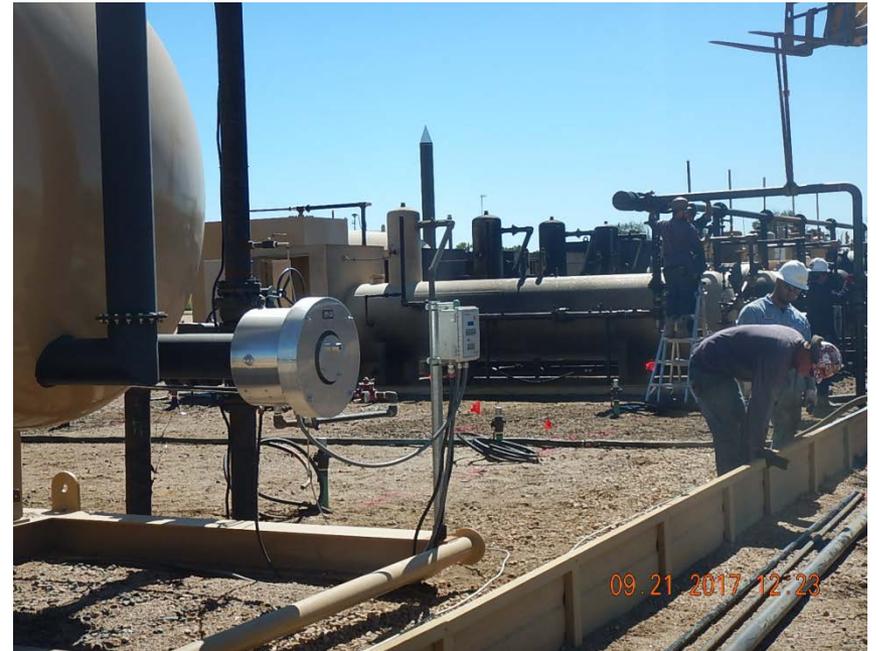
Fire damage photo

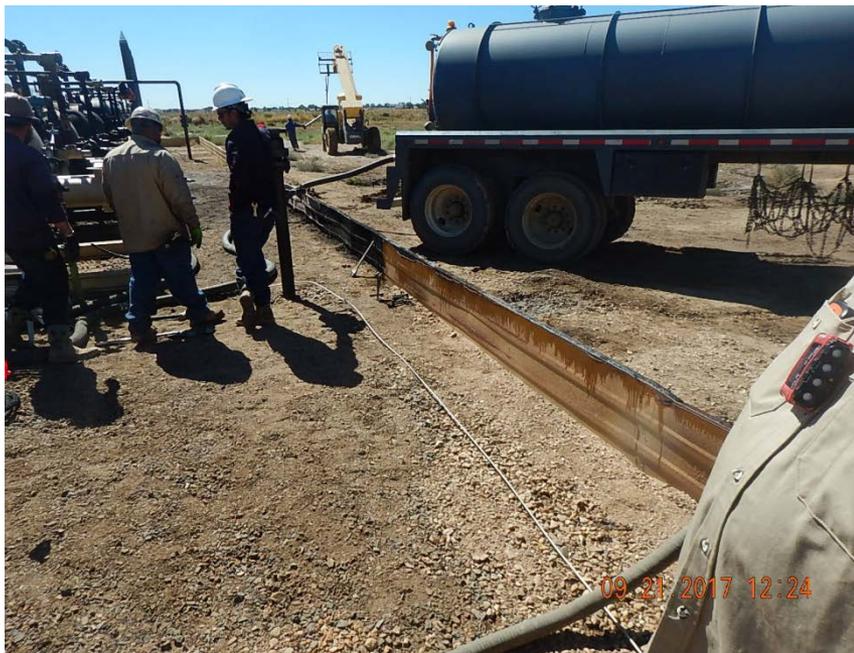
Fire damage photo

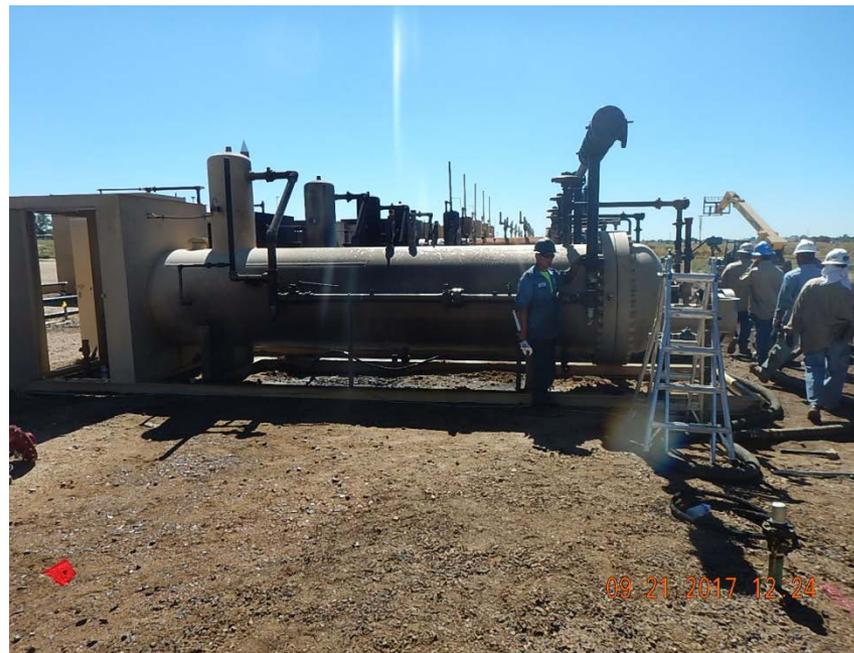
Fire damage photo

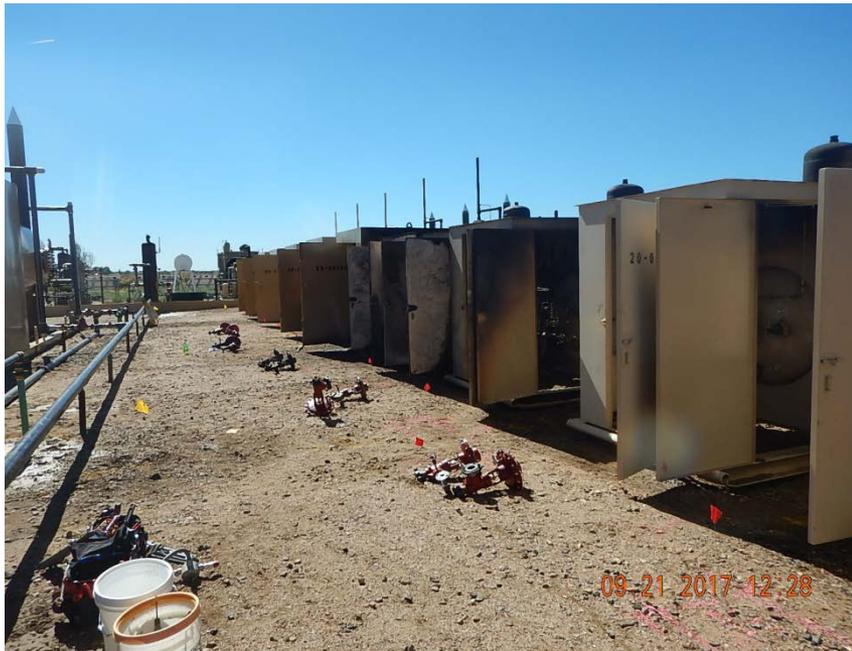
Fire damage photo

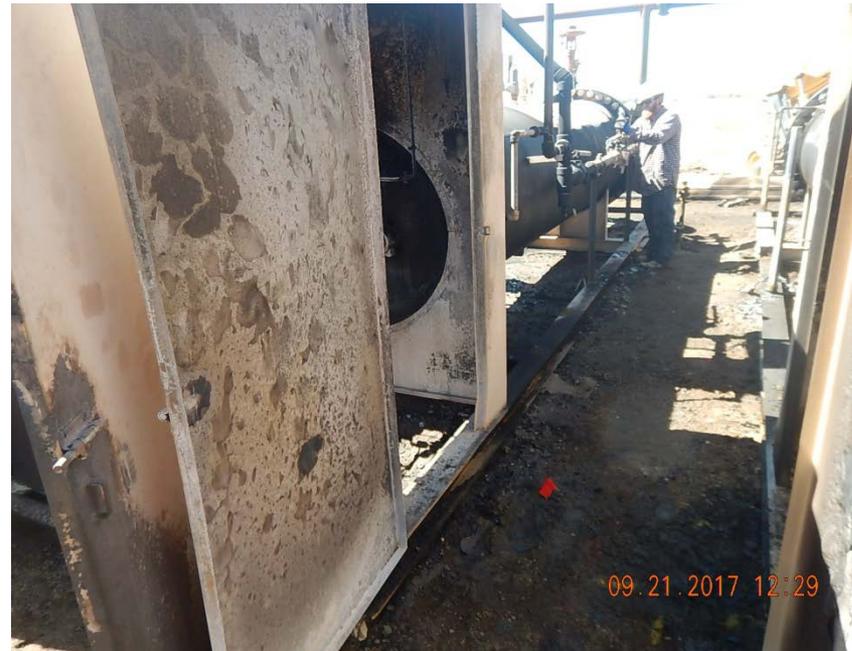
Fire damage photo

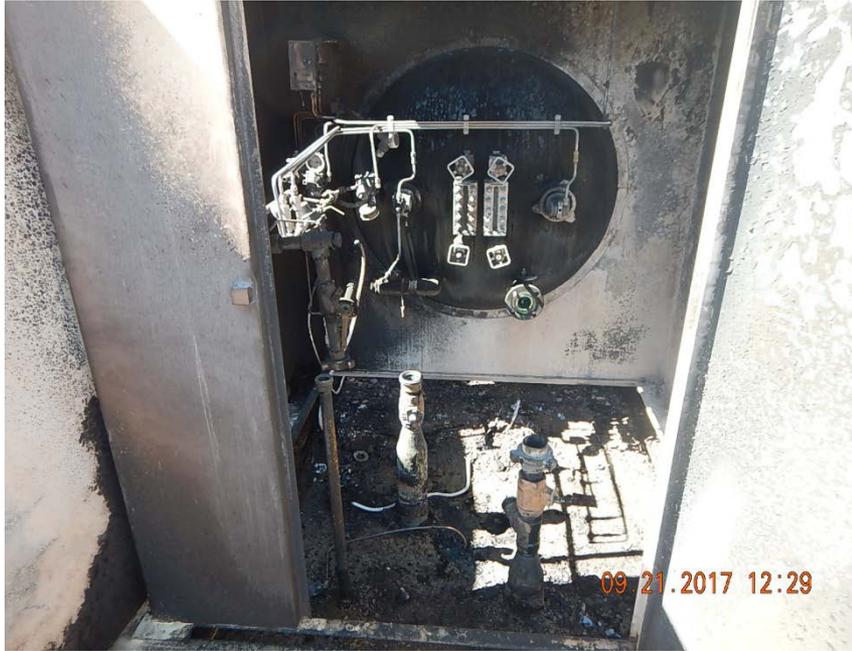
Fire damage photo

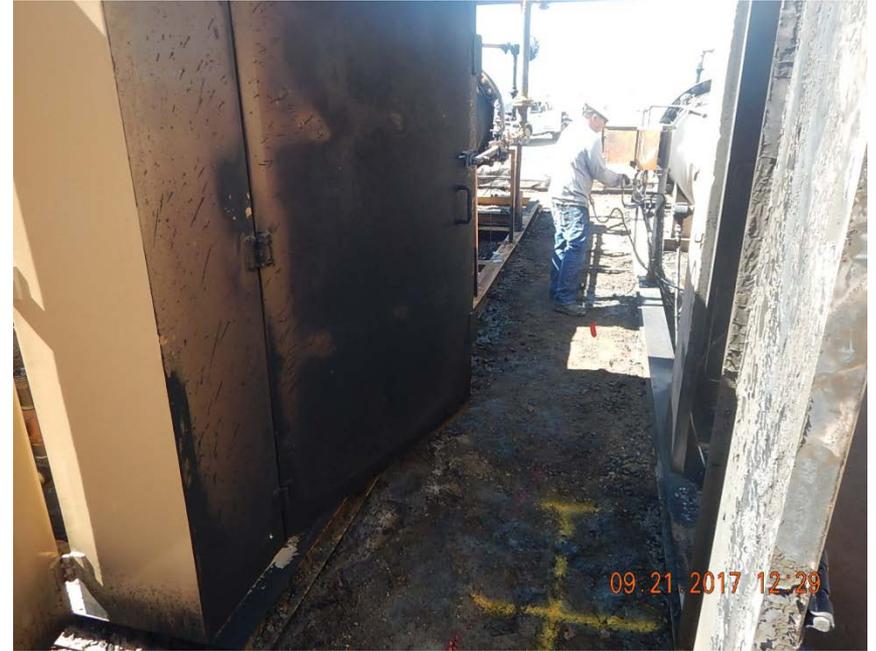
Fire damage photo

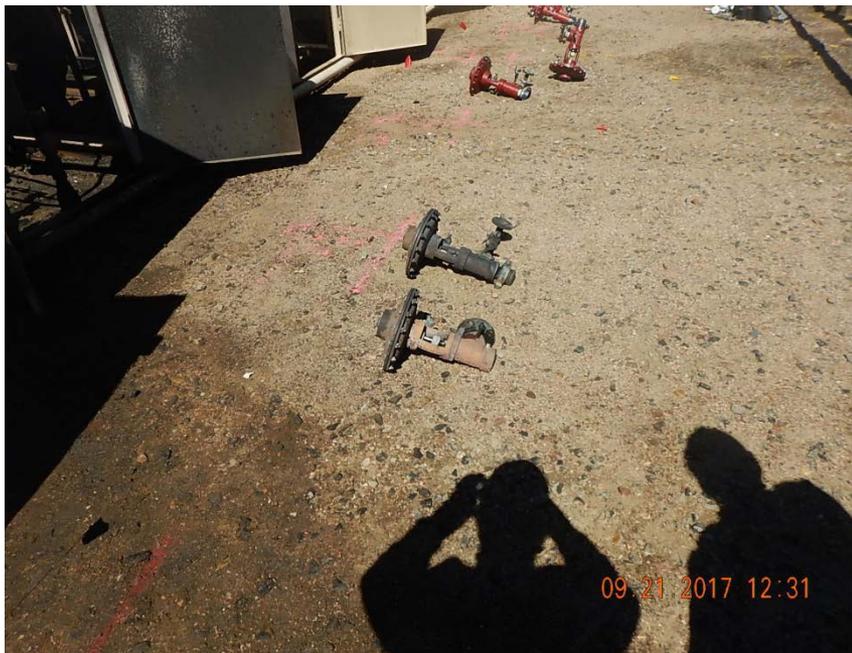
Fire damage photo
