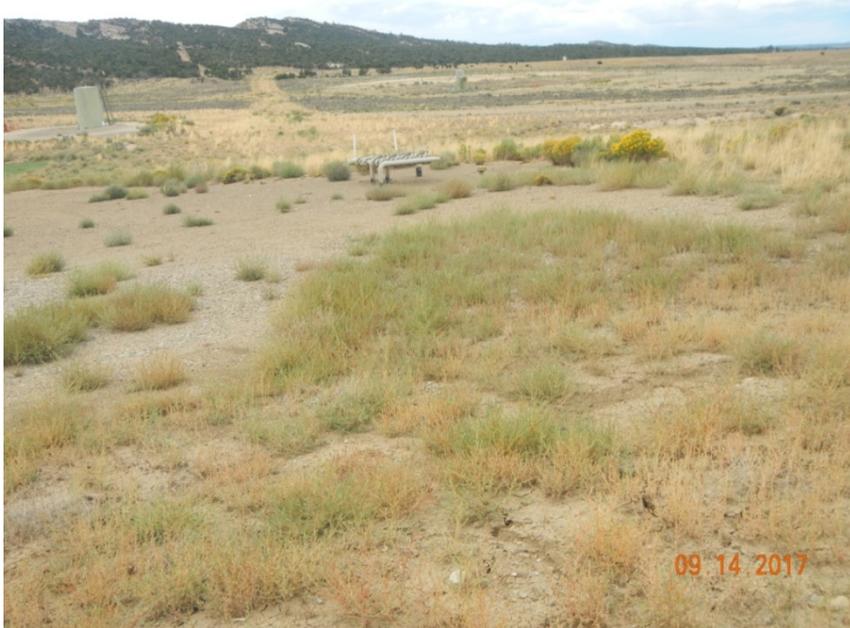
Photo 1: View of the northern portion of the project area from the northeastern corner facing westward. Equipment in the mid-ground needs to be removed. Project area needs to be reclaimed to COGCC's 1004 final reclamation rules.

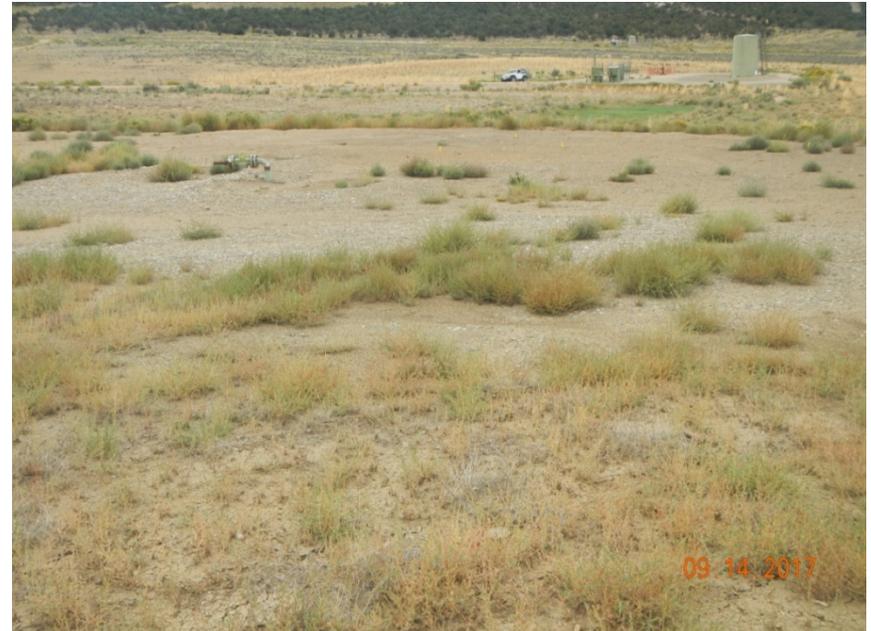
Photo 2: View of the project area from the northeastern corner facing southwestward. Metal pipe connection needs to be removed.

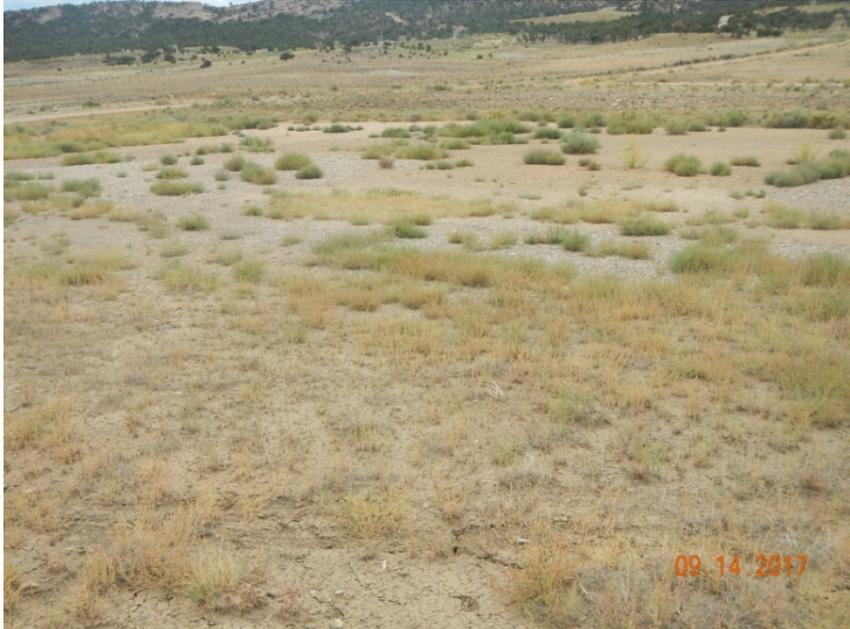
Photo 3: View of the southern portion of the project area from the northeastern corner facing southward.

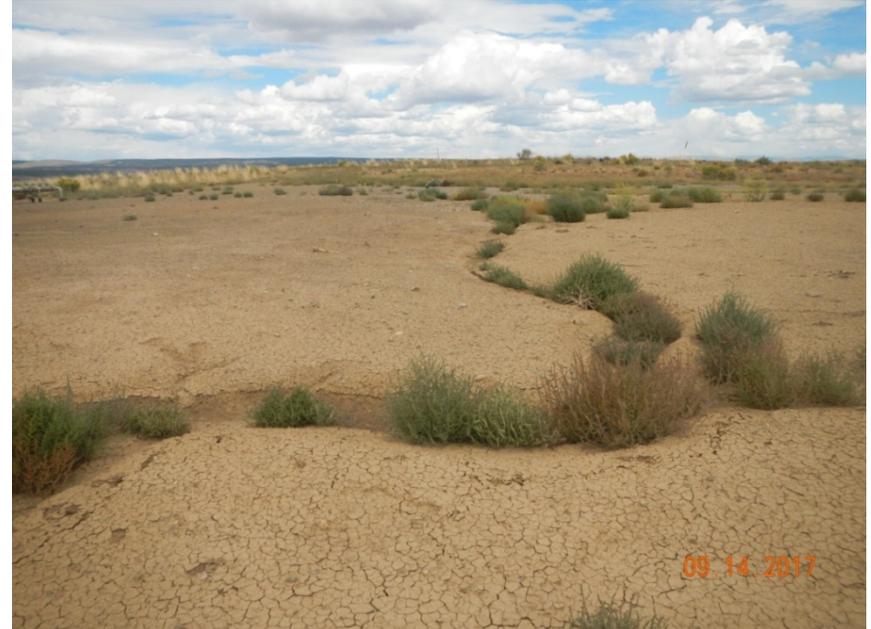
Photo 4: View of erosional channel forming within the western portion of the project area.

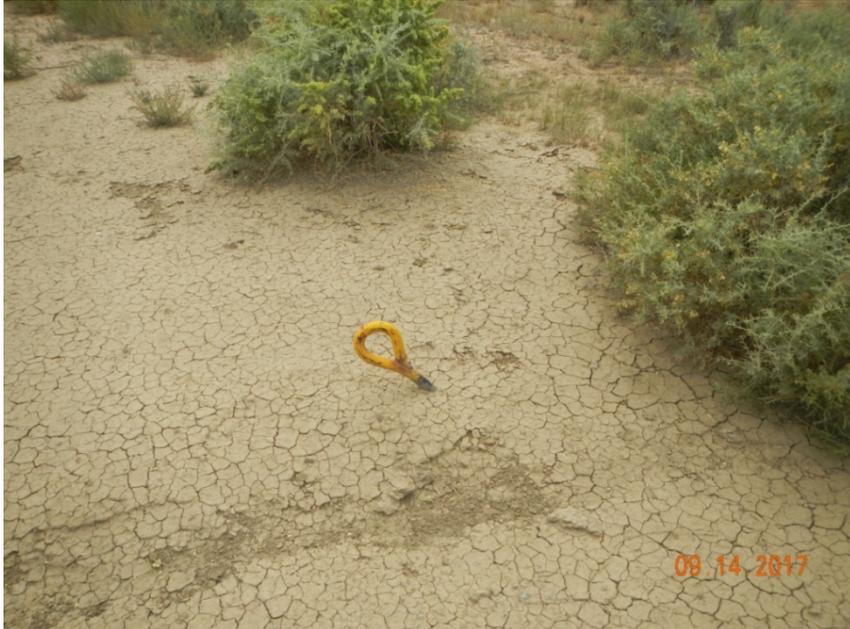
Photo 5: View of rig anchor still present within the project area. All rig anchors need to be removed.

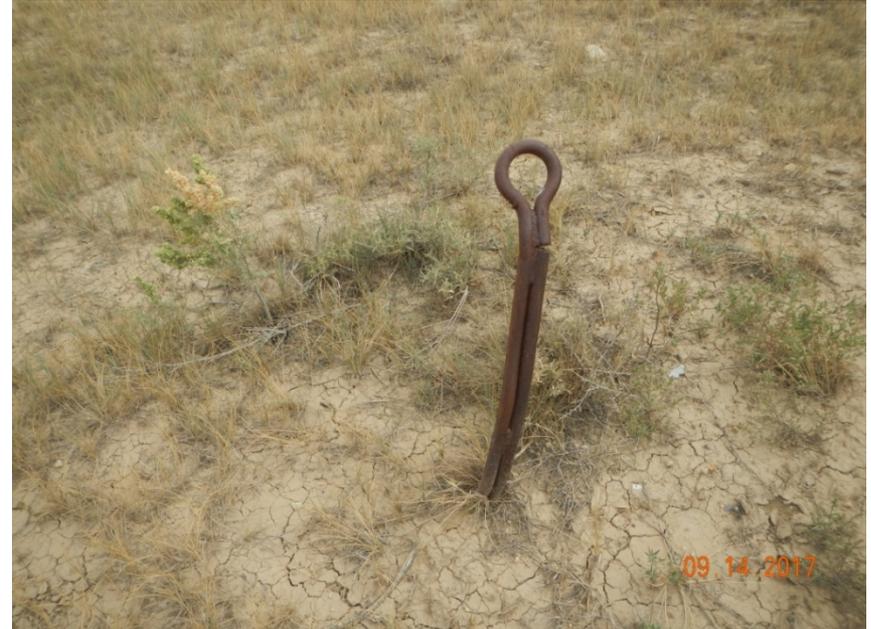
Photo 6: View of riser near the entrance to the well pad needing to be removed.

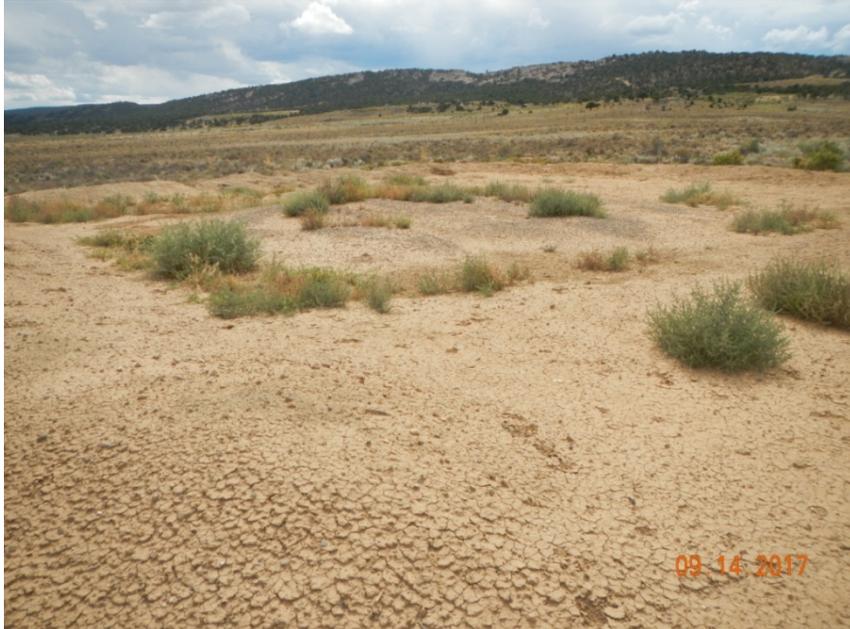
Photo 7: View of approximately 0.15 acre area south of the well pad that needs reclamation.
