Inspection Photos
Location Name: McCallum Unit 60
API: 05-057-06041

Inspection Photos
Location Name: Stover Federal 9-12 1D
API: 05-081-07825

Inspection Photos
Location Name: Spetter 5-8
API: 05-081-06548

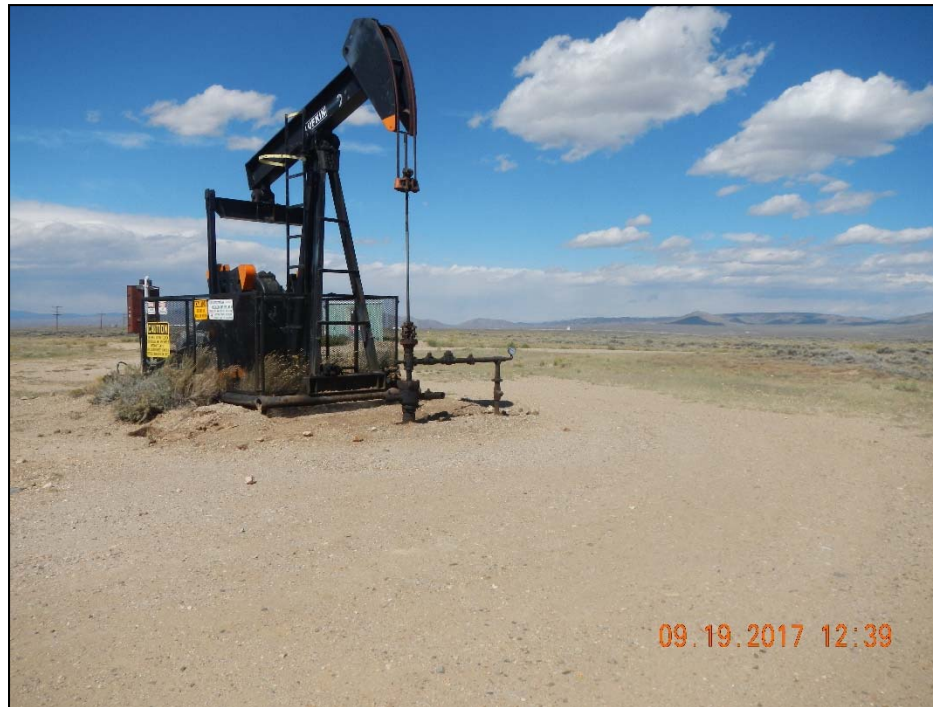
Photo 1. Overview of location taken at entrance facing northeast.

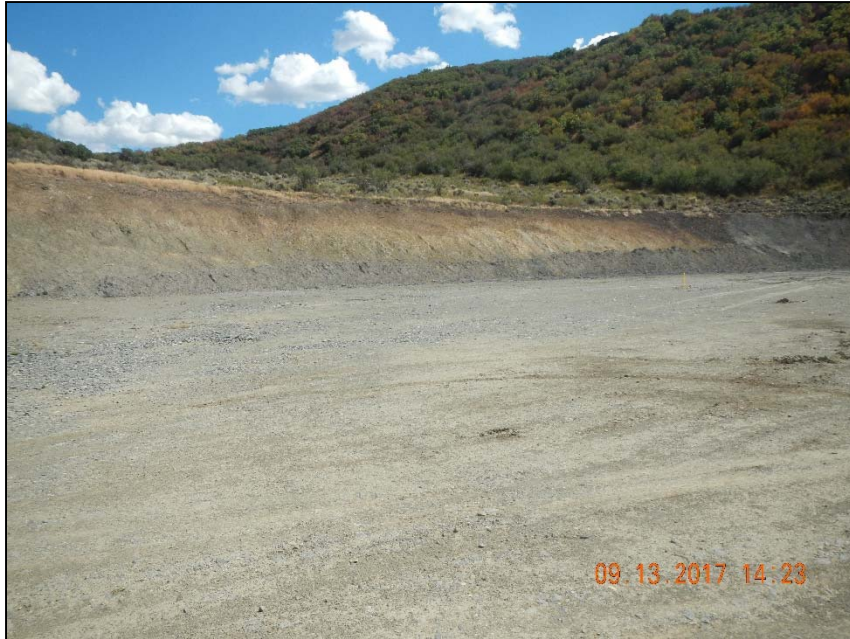
Photo 1. Cuttings stored on location.

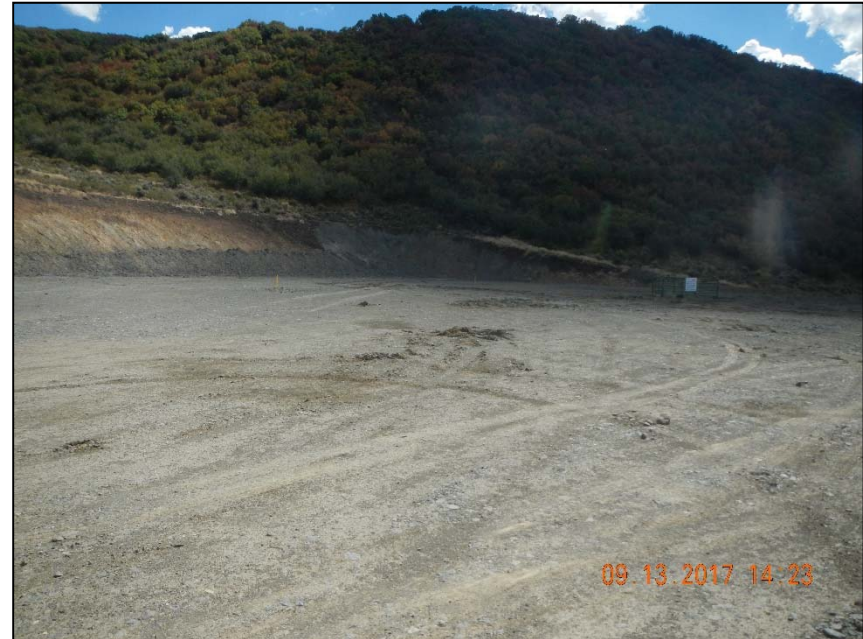
Photo 2. Overview of location taken at entrance facing south.

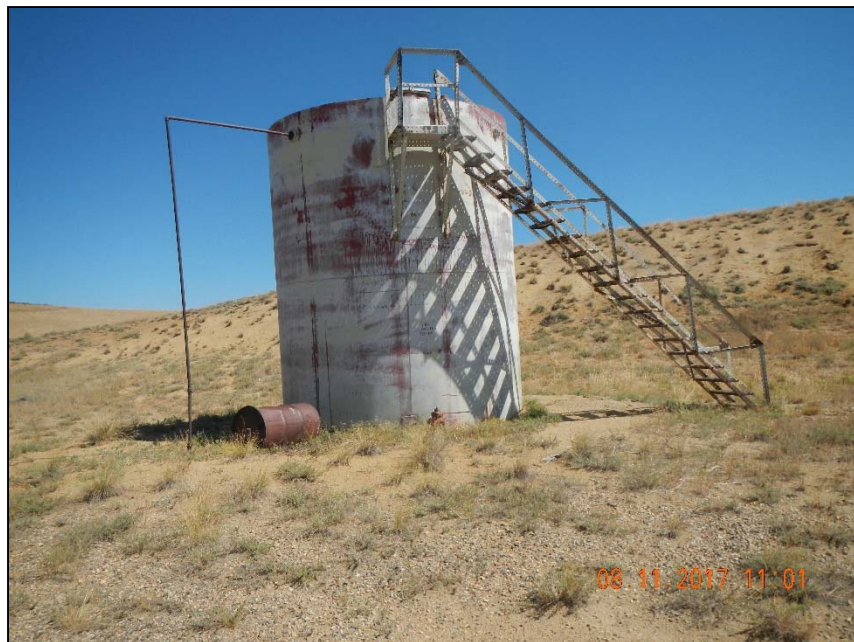
Photo 4. Tank with no label and no berm. Container with no secondary containment next to tank.

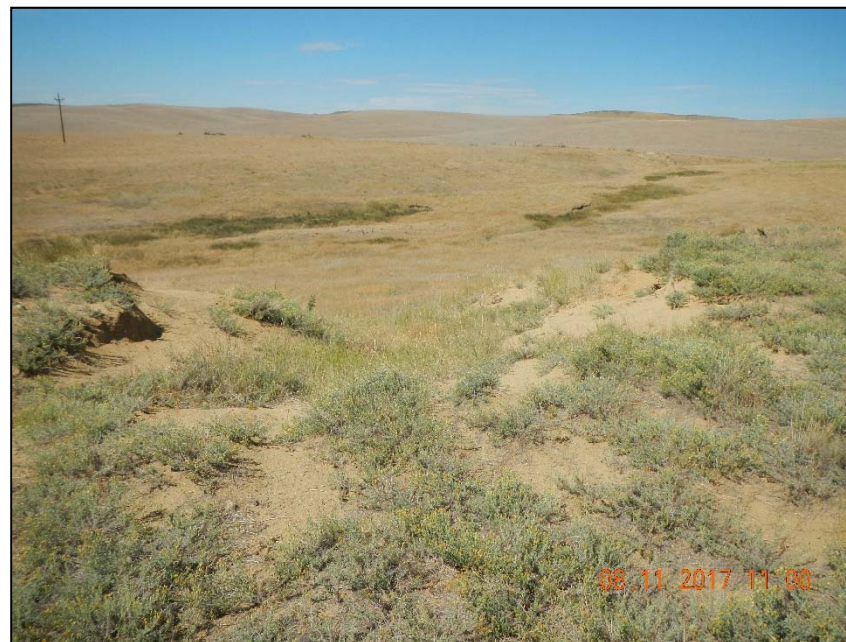
Photo 5. Example of erosion occurring on west side of location.
