COGCC conducted an inspection of the Wells Ranch USX AA23 location (Location ID 429615) on September 12, 2017 (Document 684904341). During that inspection, COGCC made the following observations:

Name: Wells Ranch USX AA23

Location ID: 429615

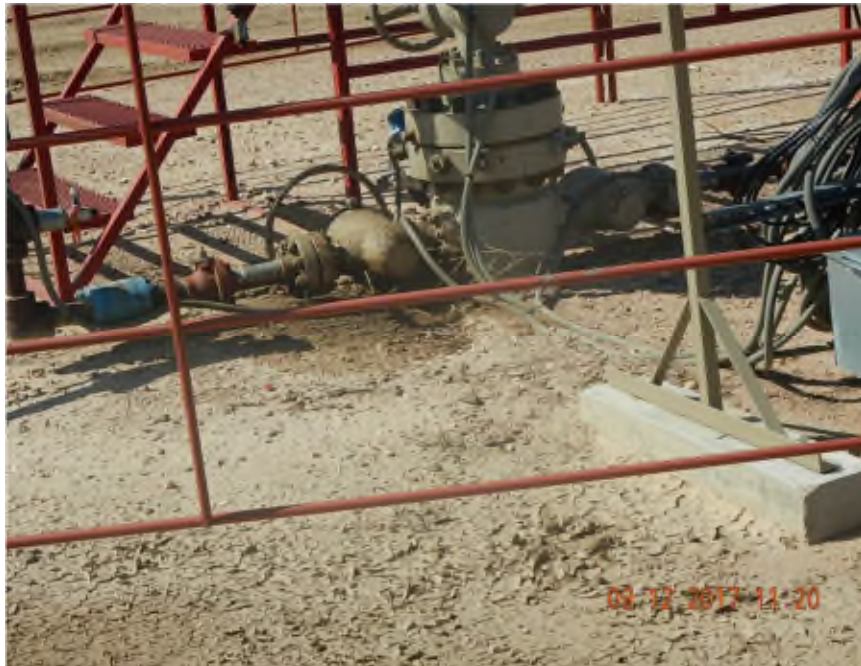
2. Equipment: Stained soil at wellhead. Remove or remediate stained soil; Securely fasten all valves, pipes, and fittings to ensure good mechanical condition, inspect at regular intervals and maintain in good mechanical condition per Rule 605.d.

Photo 3: Stained soil at wellhead

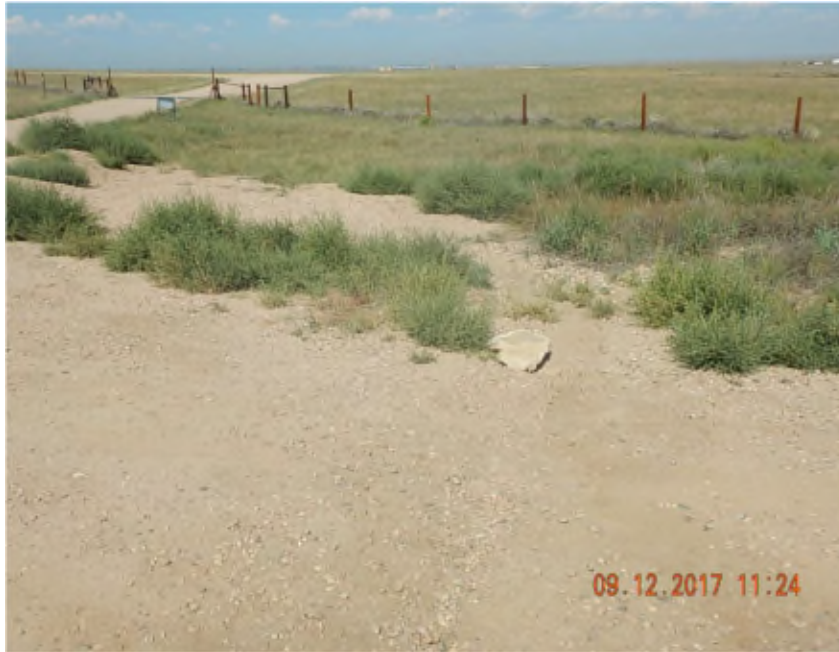
3. Storm Water: Stormwater erosion on NW side of location. Install or repair required BMPs per Rule 1002.f.

Photo 4: Stormwater erosion on NW side of location

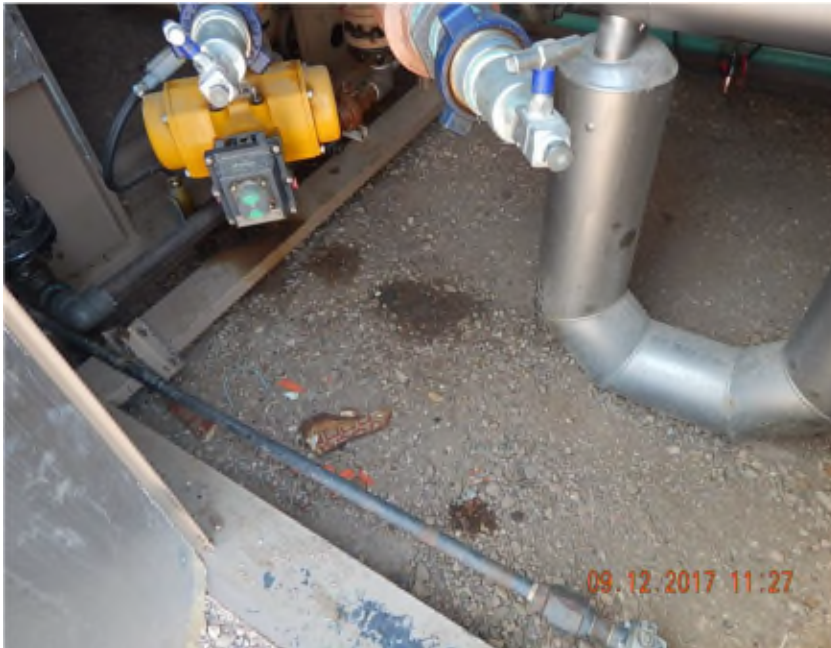
1. Equipment: Stained soil in separator housing. Remove or remediate stained soil; Securely fasten all valves, pipes, and fittings to ensure good mechanical condition, inspect at regular intervals and maintain in good mechanical condition per Rule 605.d.

Photo 5: Stained soil in separator housing
