**Inspection Photos**  
**Location Name: Lilli Unit #2-8**  
**API: 05-123-13638**

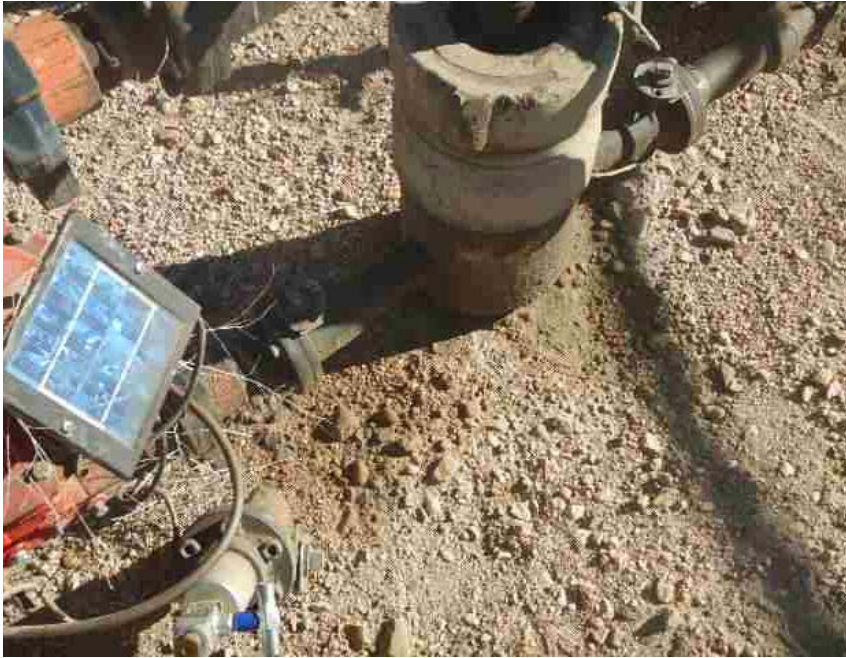
**Photo from prior inspection for comparison**

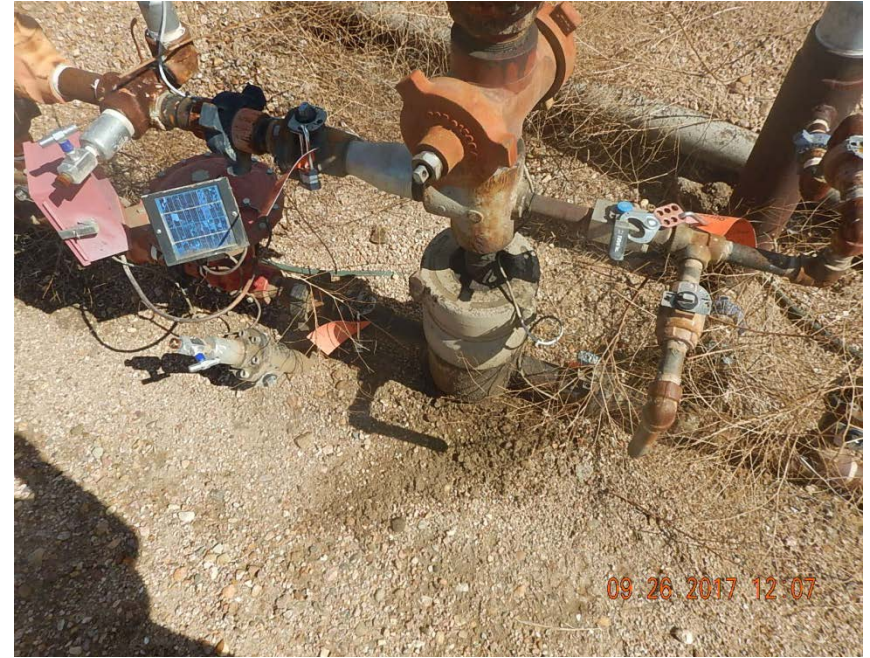
**Photo 3: Stained soil removed**

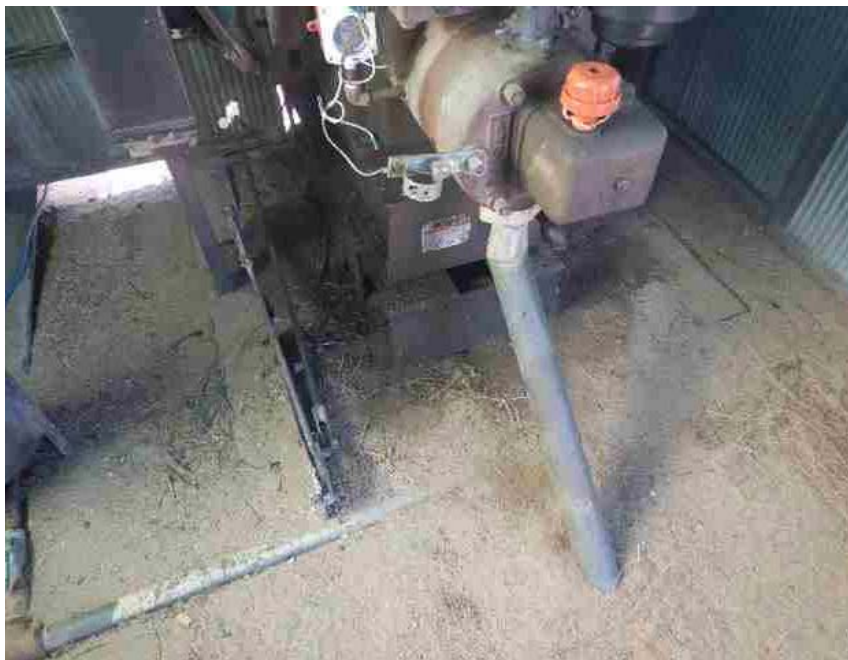
**Photo from prior inspection for comparison**

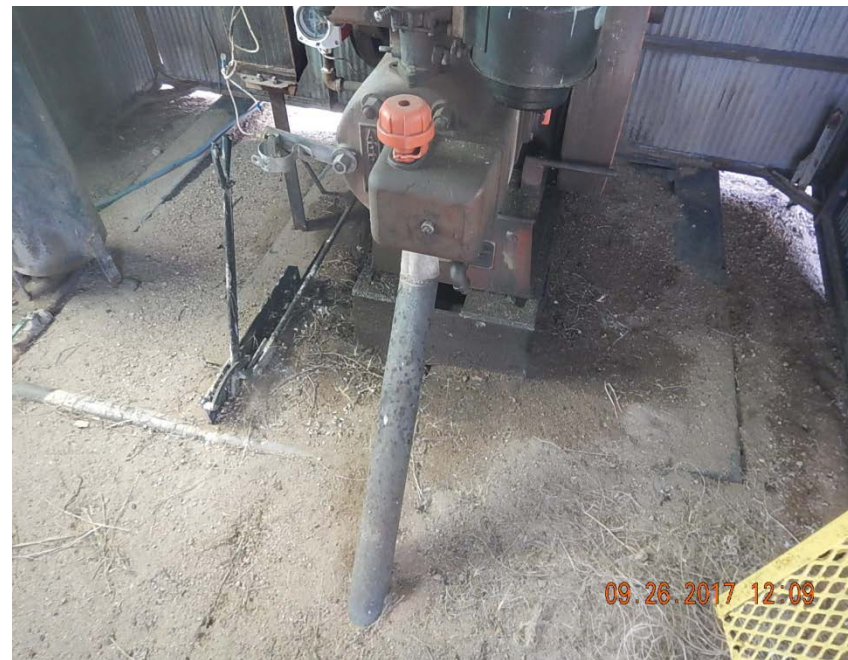
**Photo 4: Stained soil being remediating**

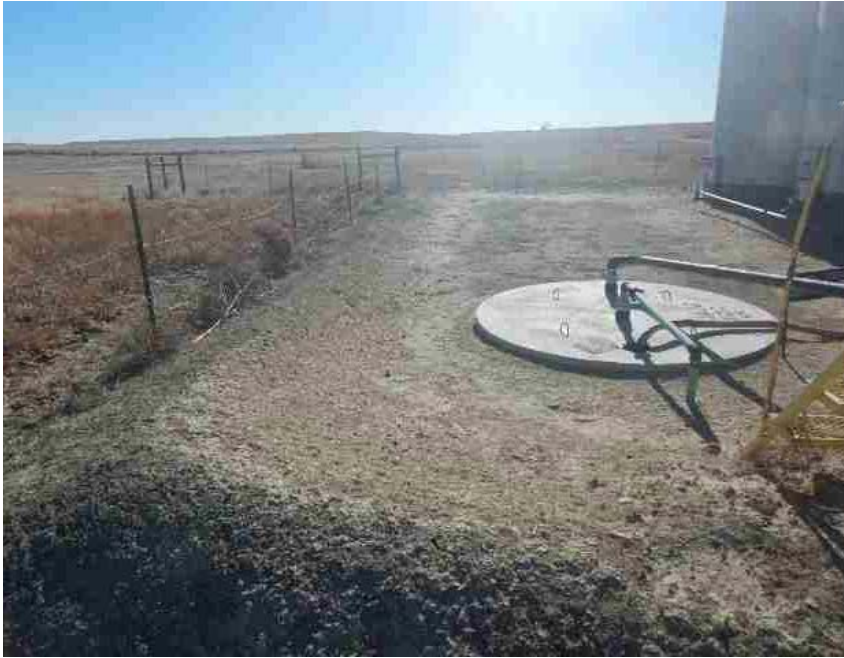
**Photo from prior inspection for comparison**

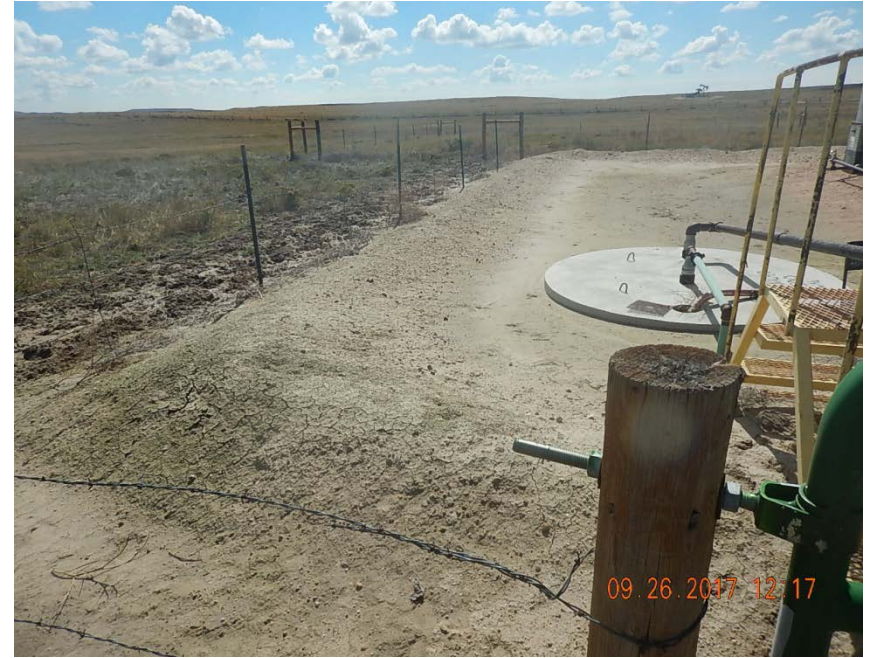
**Photo 3: Low berms at tank battery**

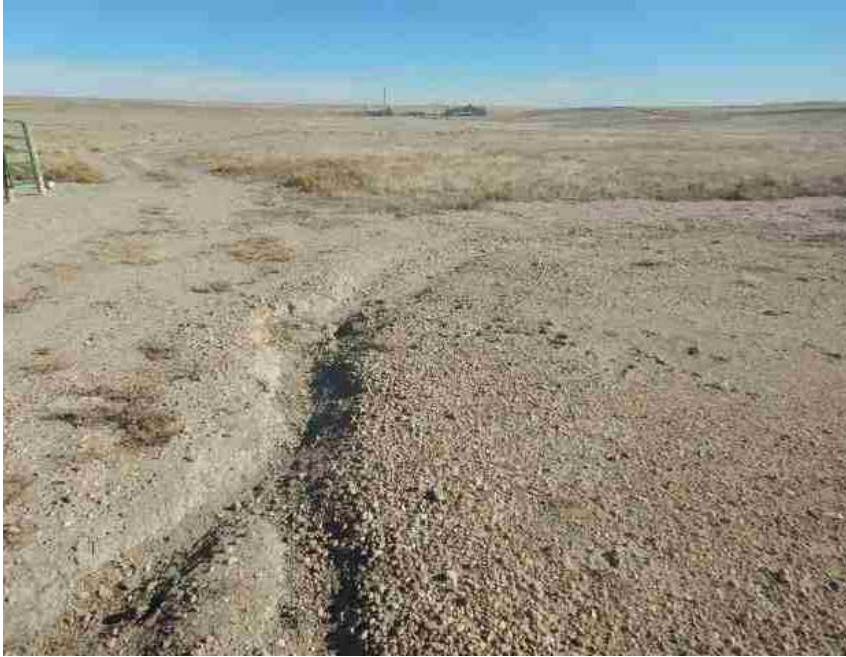
**Photo from prior inspection for comparison**

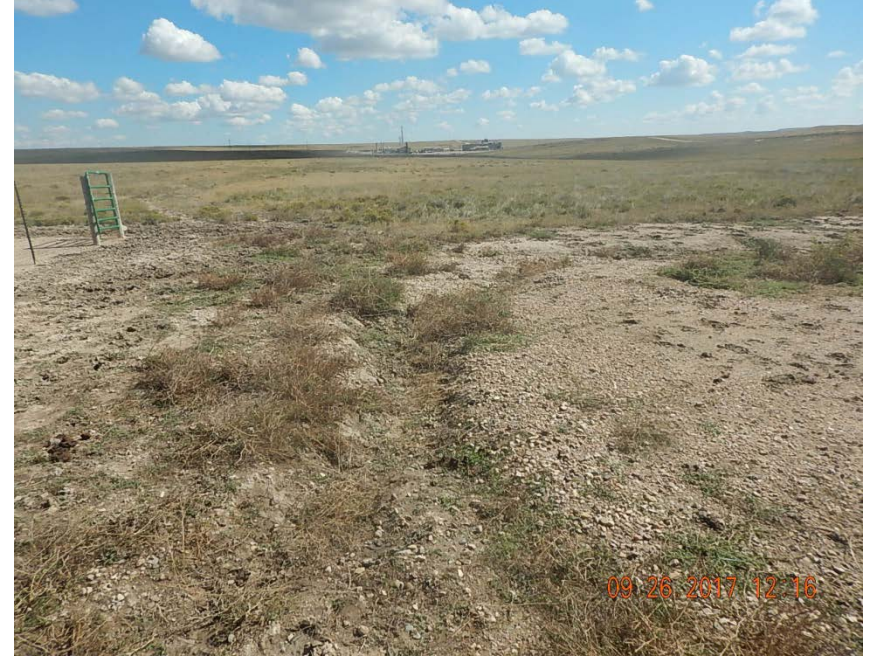
**Photo 5: Stormwater erosion at location, between treater and battery.**
