Inspection Photos
Location Name: Hoffman #34-10
API: 05-123-20097

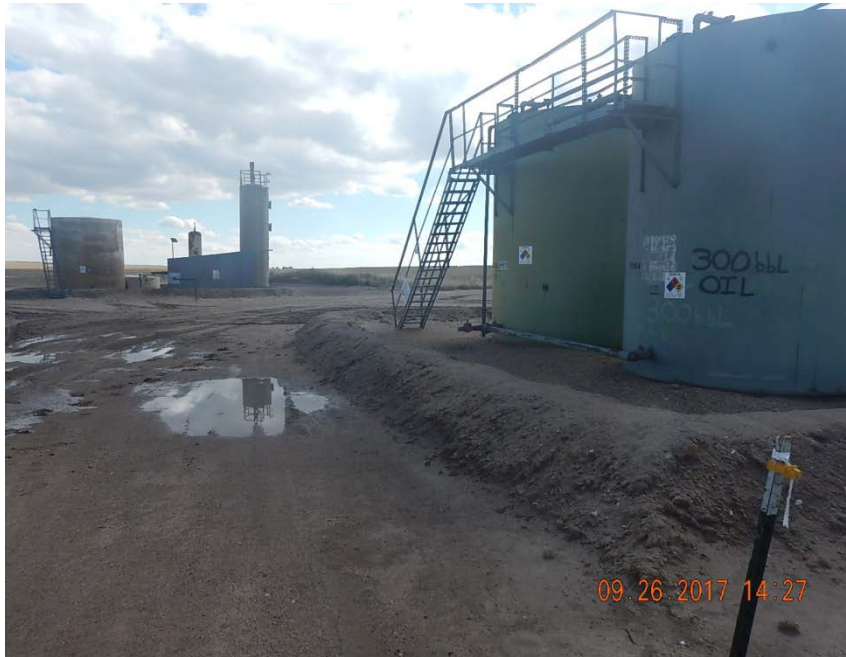
Photo 1: Location, looking SE

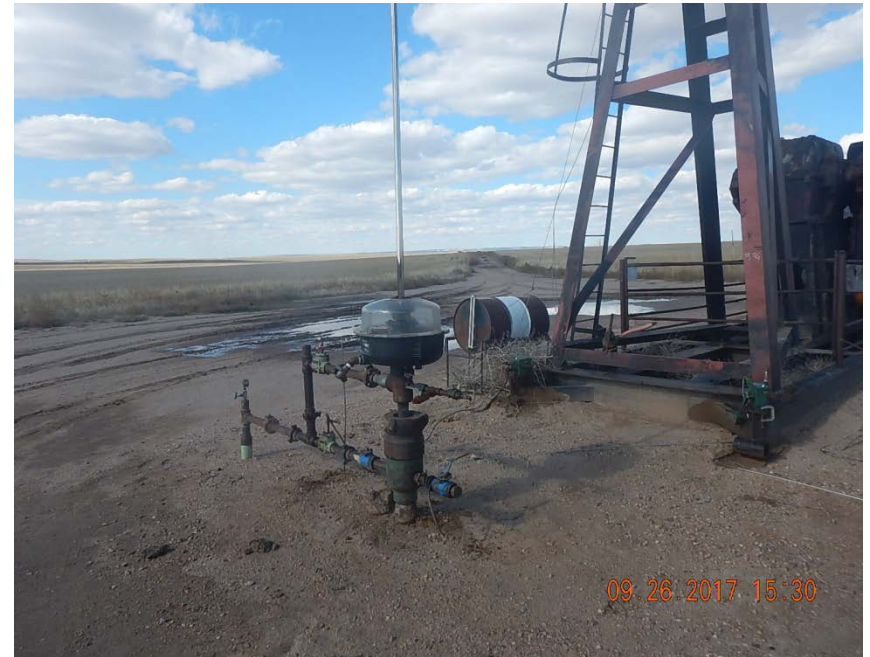
Photo 2: Wellhead, looking NE

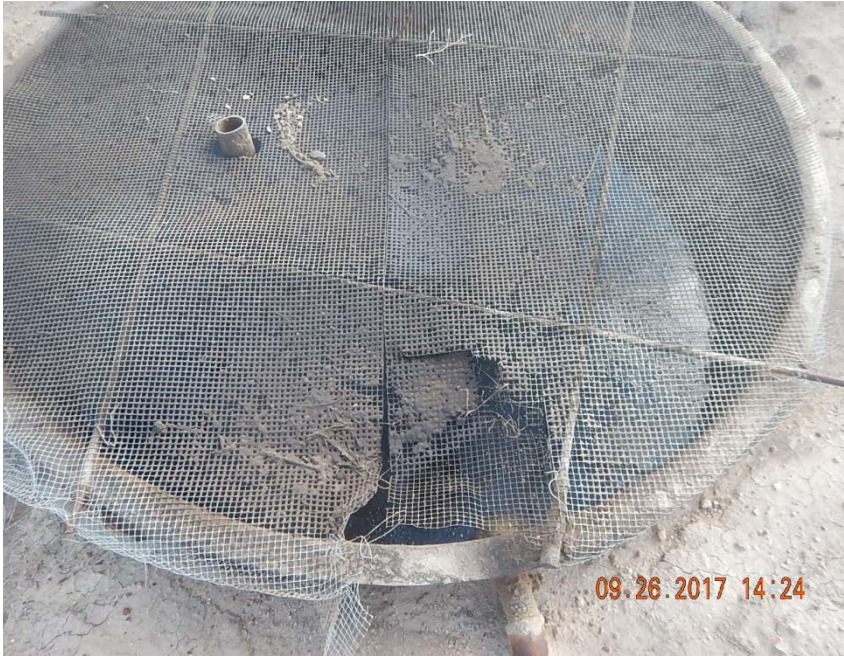
Photo 3: Gap in mesh on open top skim

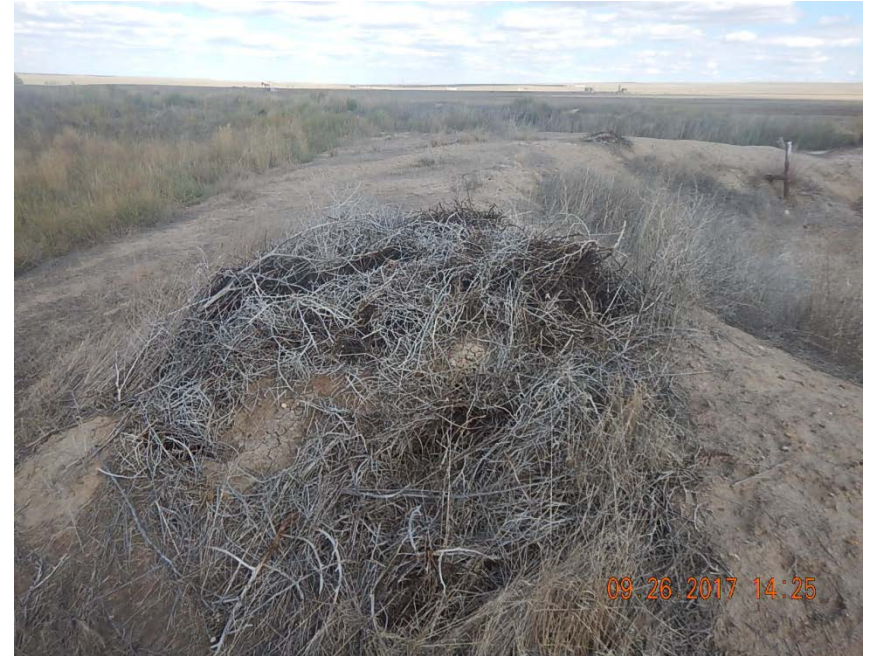
Photo 4: Stained weed debris at NW corner of southern pit

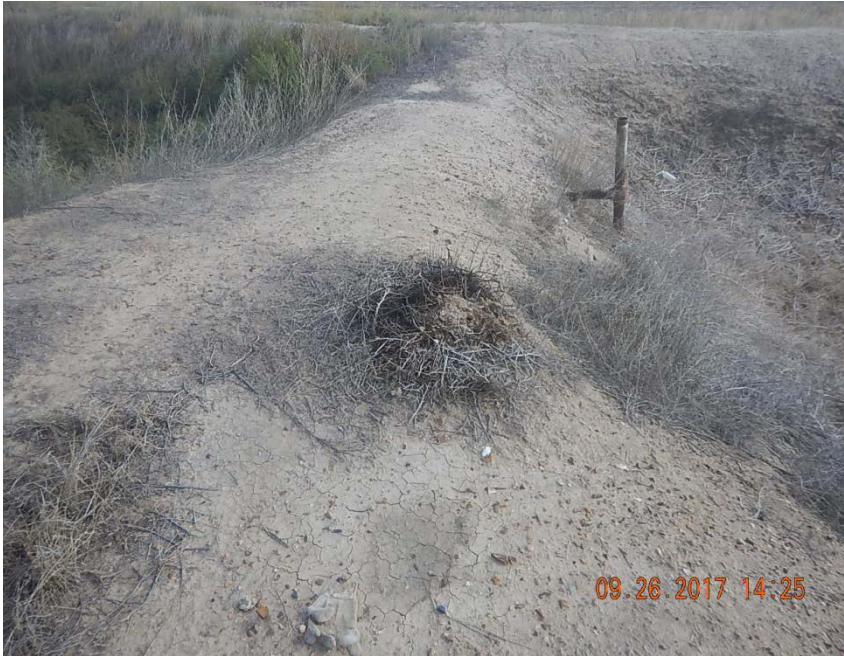
Photo 5: Oily weed debris in between pits

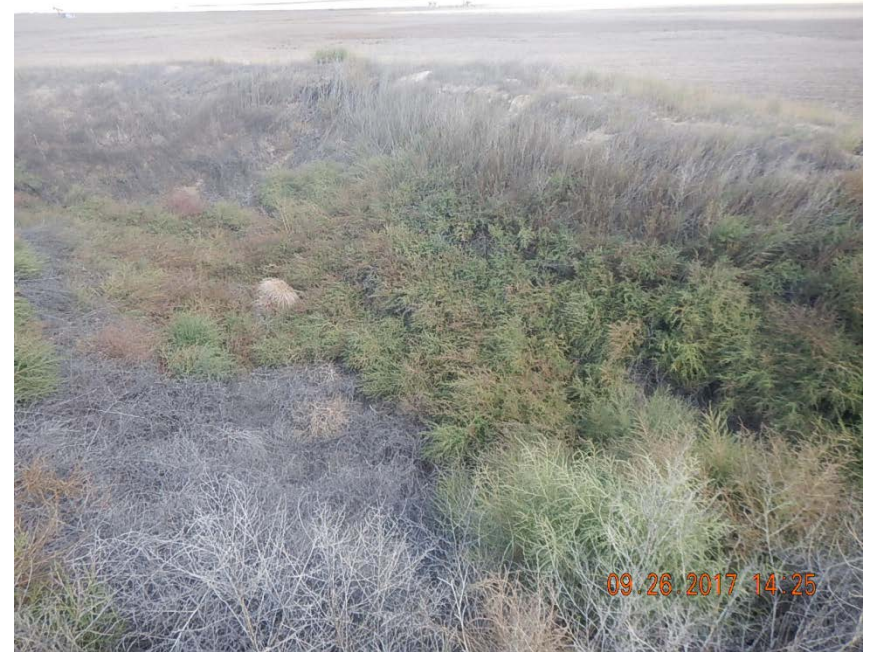
Photo 6: Weeds in northern pit

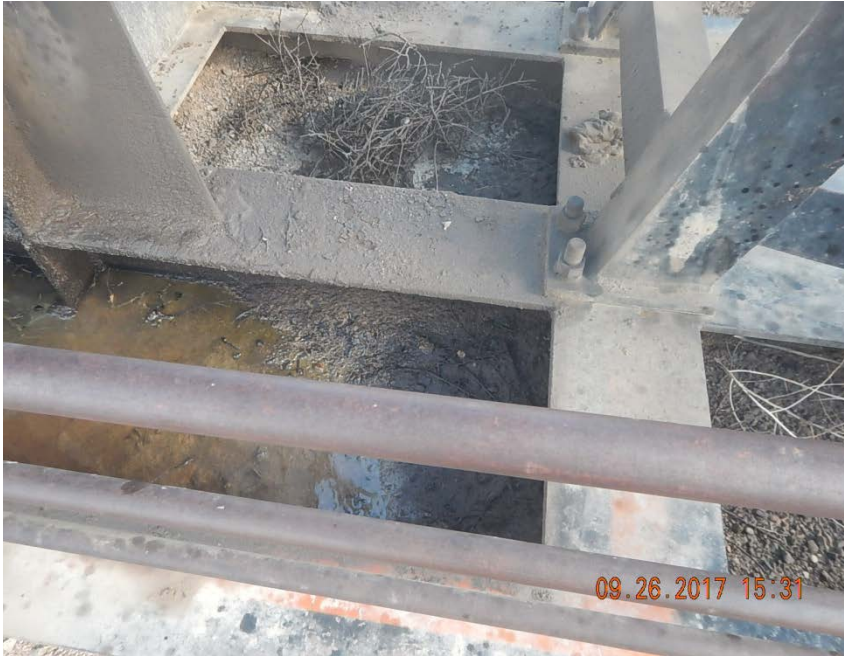
Photo 7: Stained soil, oily fluid at pump jack

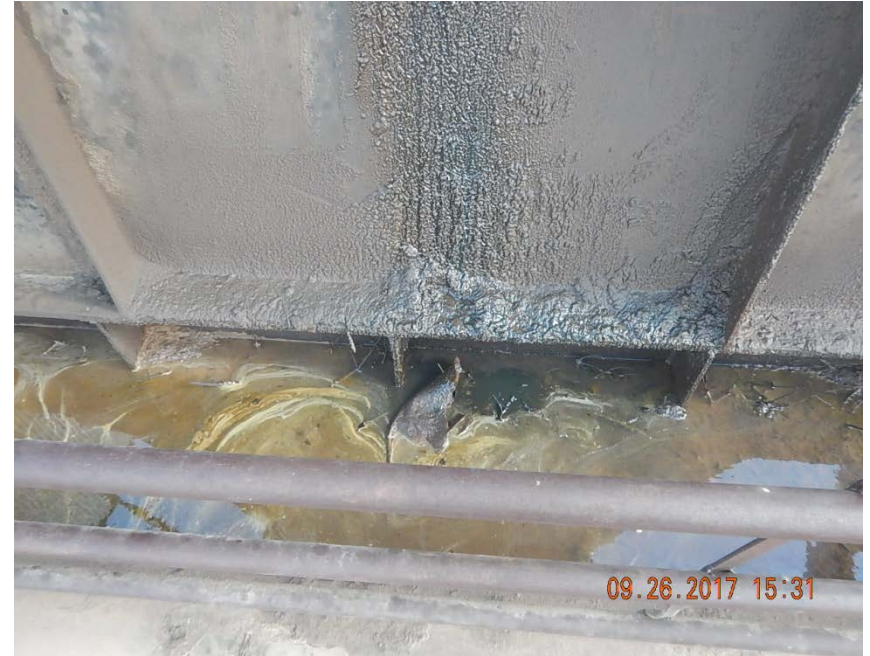
Photo 8: Stained soil, oily fluid at pump jack

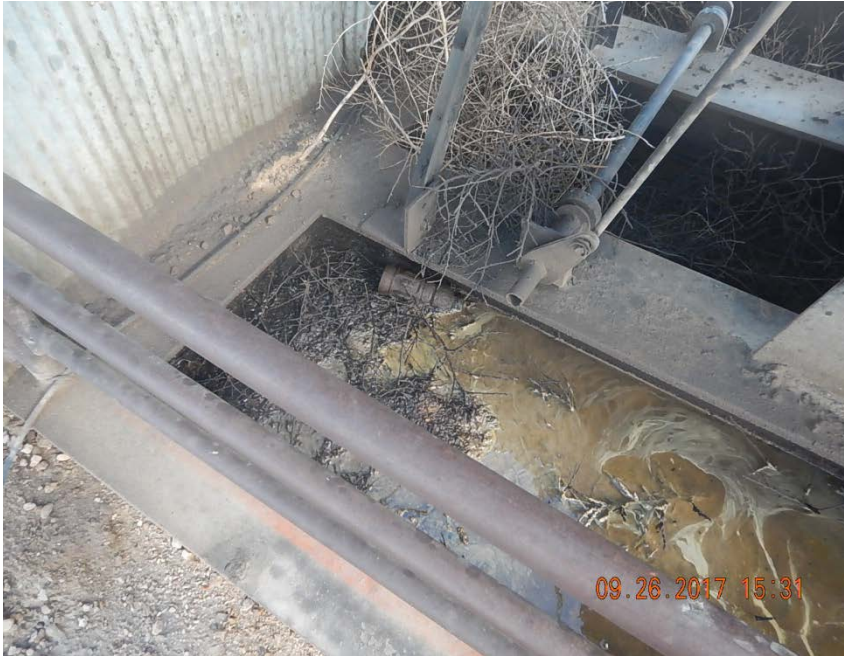
Photo 9: Stained soil, oily fluid at pump jack

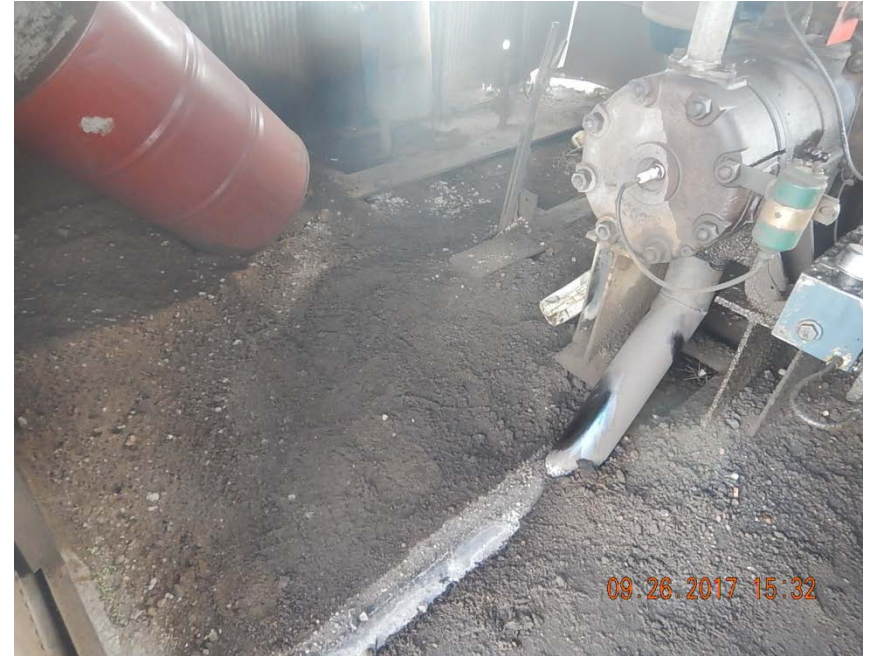
Photo 10: Stained soil at ajax engine

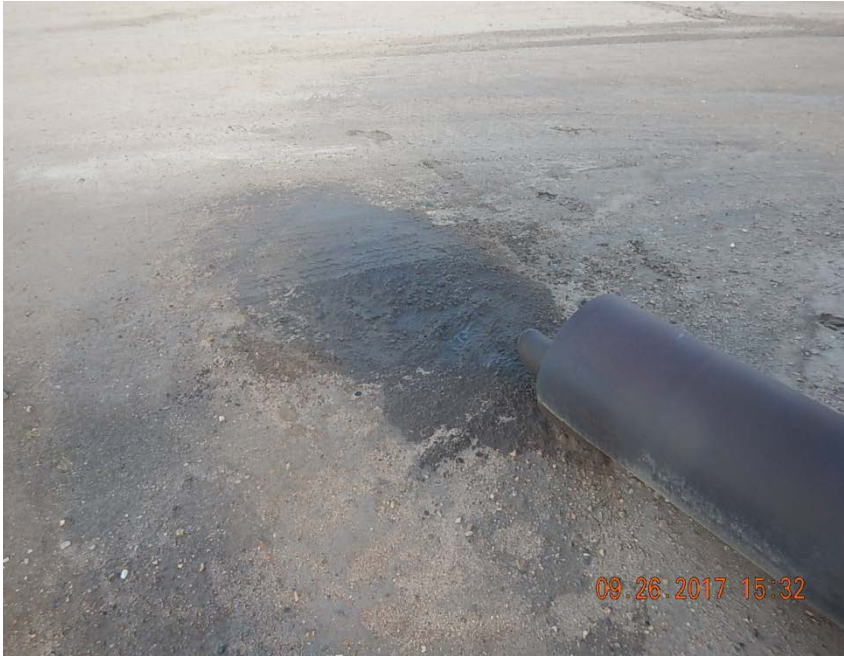
Photo 11: Stained soil at ajax exhaust
