Inspection Photos
Location Name: Critter Creek #3-04H
API: 05-123-31973

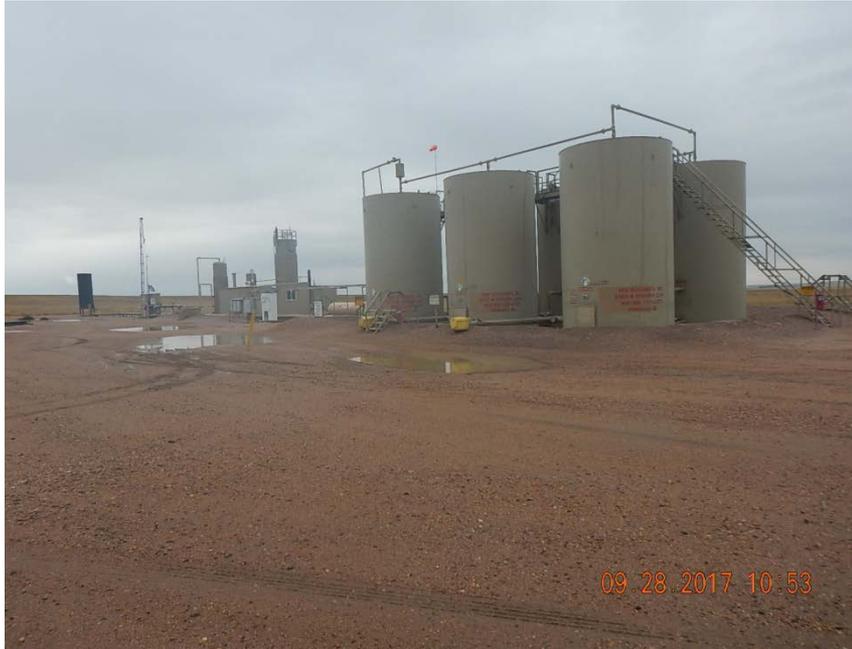
Photo 1: Location looking SW

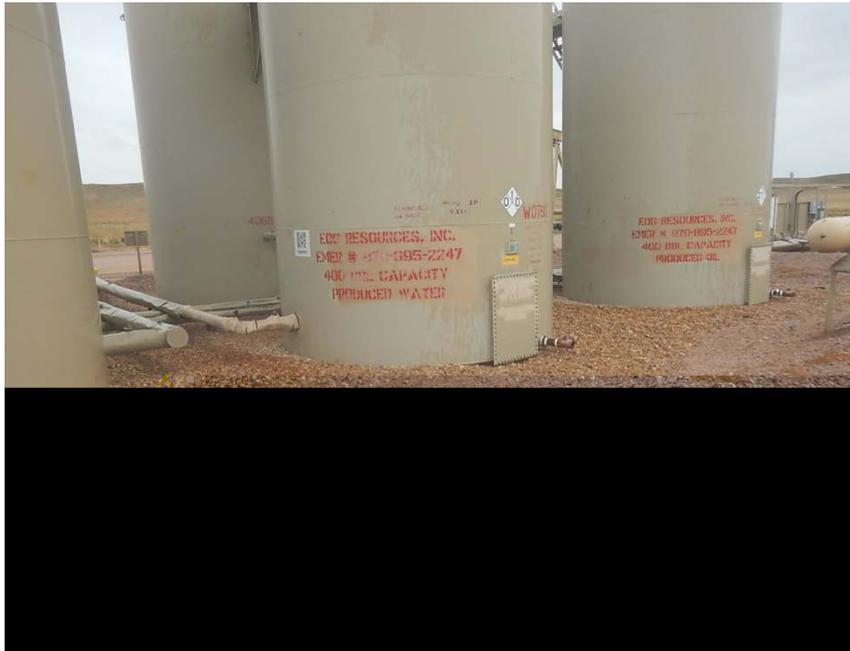
Photo 3: Tank stenciling is for prior operator.

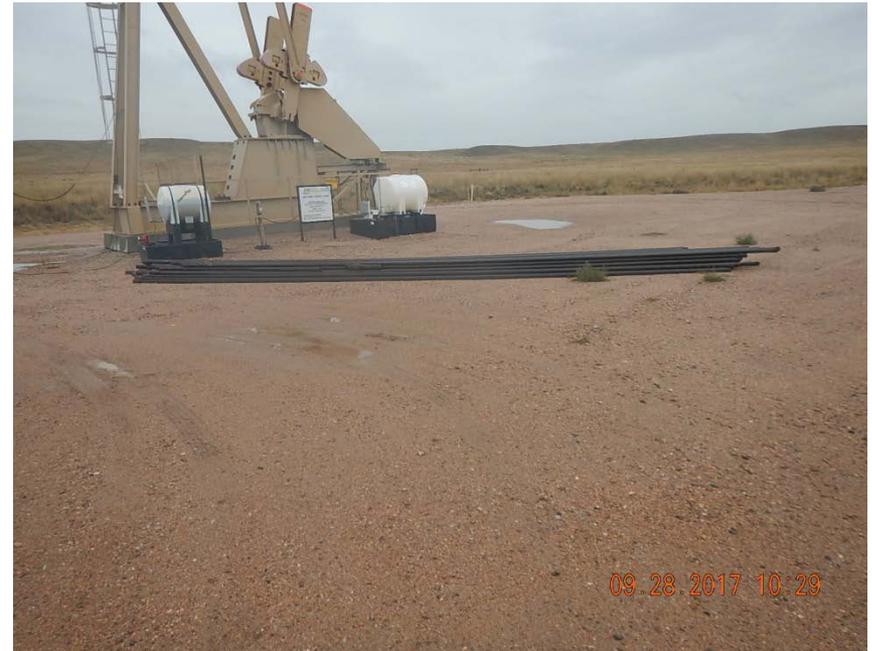
Photo 4: Unused pipe at wellhead.

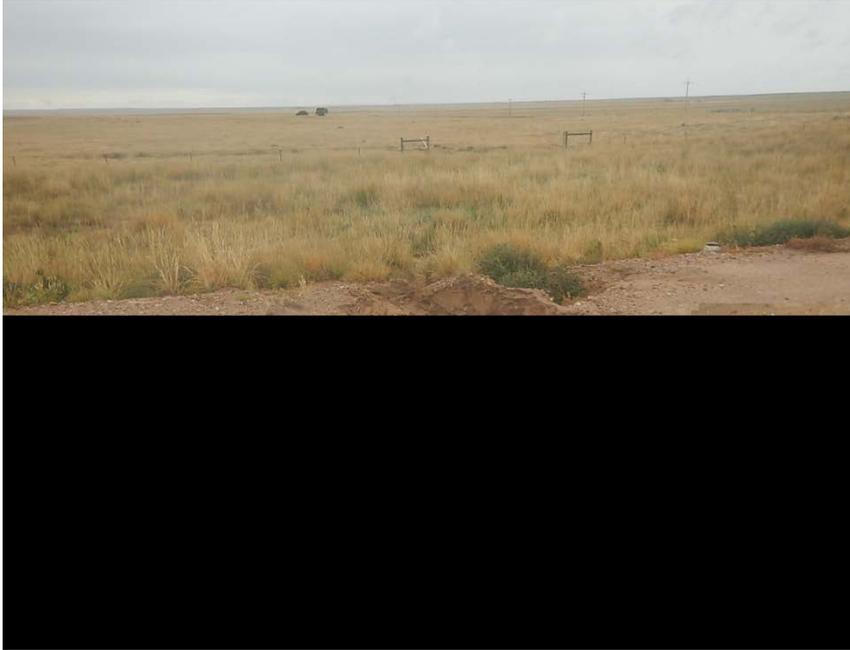
Photo 5: Stormwater erosion on S side of location

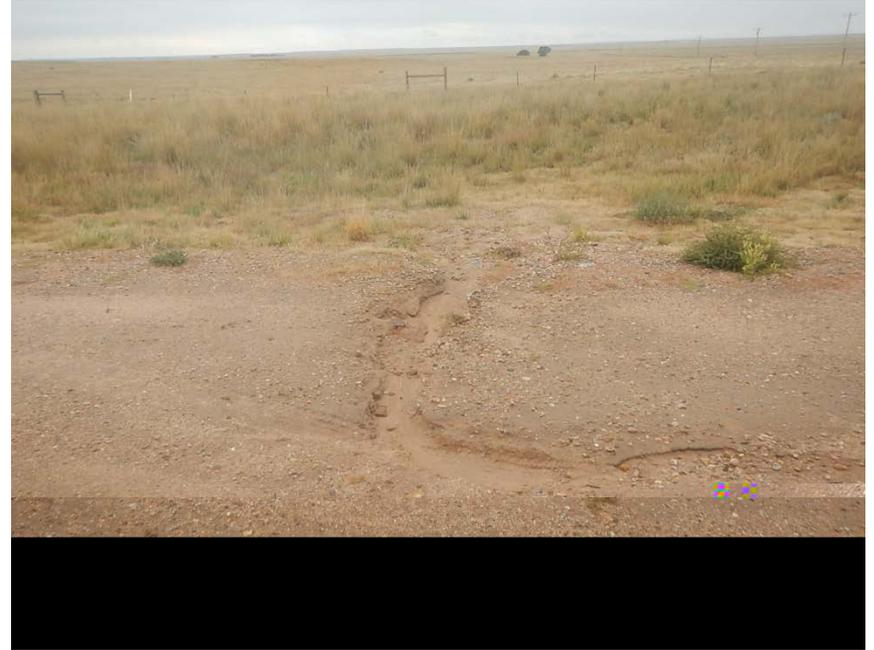
Photo 6: Stormwater erosion on S side of location
