- Padgett 32 – 6 4 - 2
- 05-067-08660

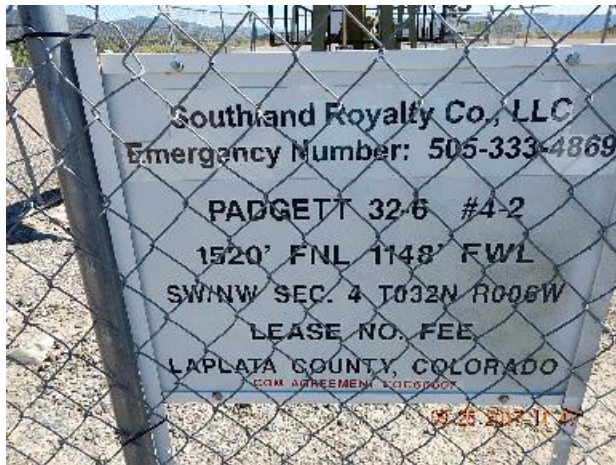
Photo 1: Wellhead sign.

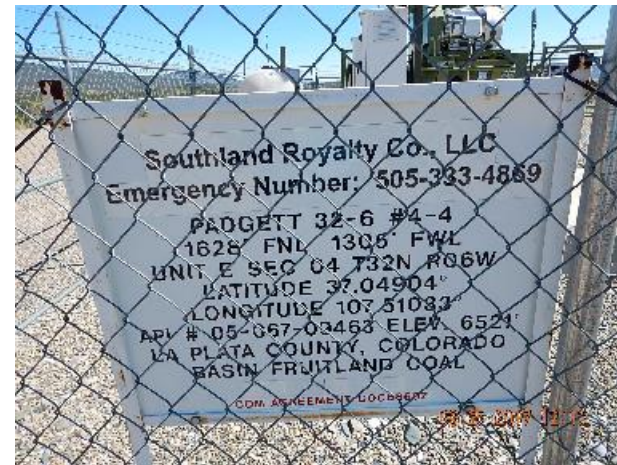
Photo 2: Wellhead sign.

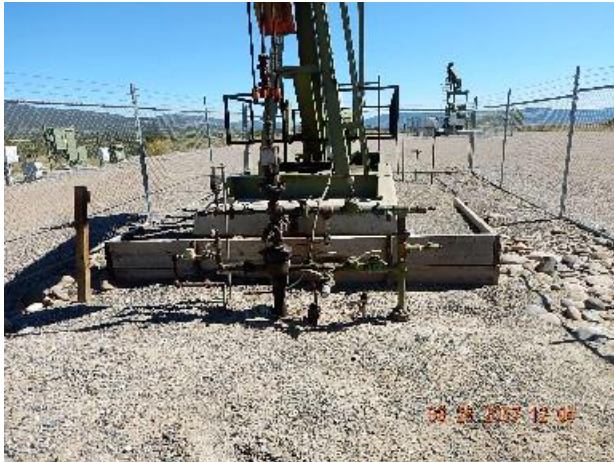
Photo 3: Unused riser/flowline at 4 - 2 wellhead.

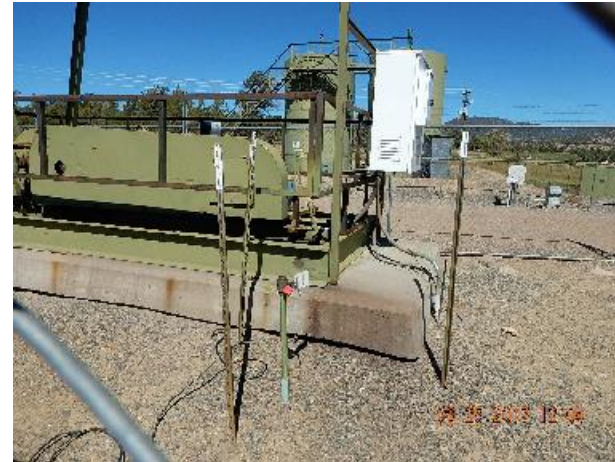
Photo 4: Unused riser/flowline at 4 – 2 wellhead.

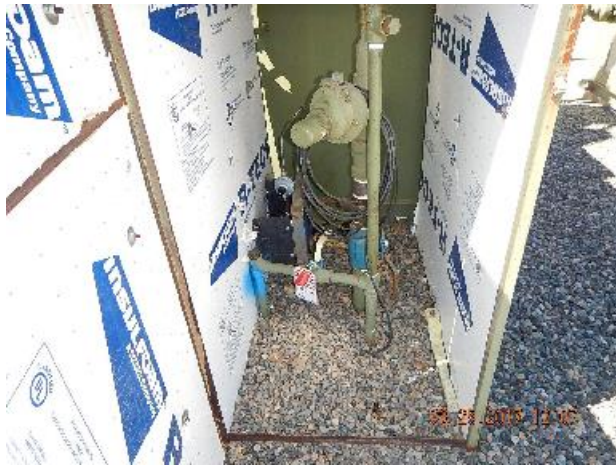
Photo 5: Unused riser/flowline at 4 – 2 separator.

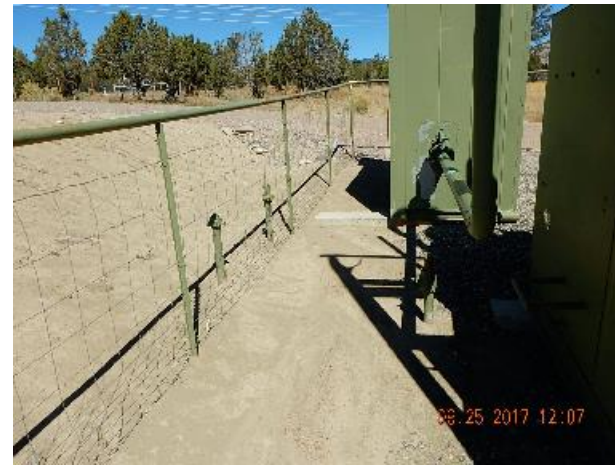
Photo 6: (3) unused riser/flowline behind 4 – 2 separator.

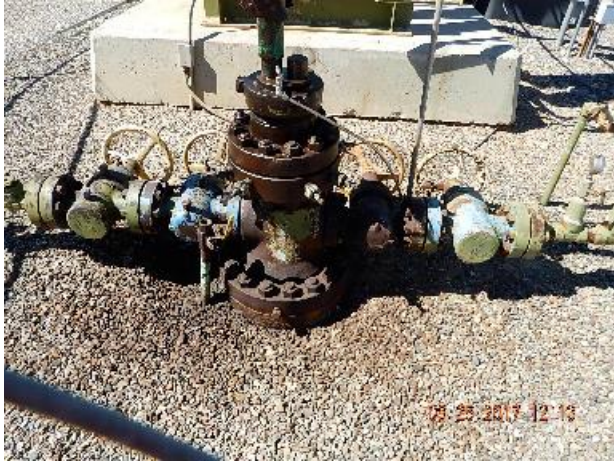
Photo 7: Impacted soil and gravel at wellhead.

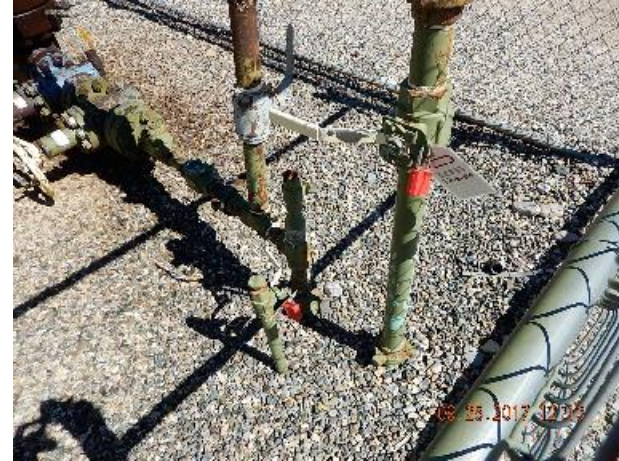
Photo 8: Unused riser/flowlines by 4 – 4 wellhead.

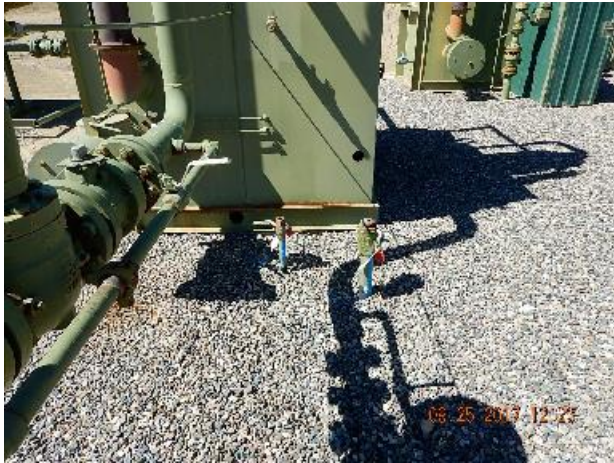
Photo 9: Unused riser/flowlines by 4 – 4 separator.

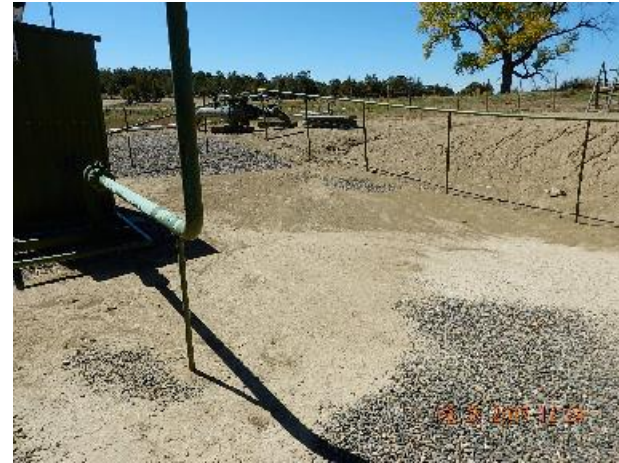
Photo 10: Sediment plume from stormwater run on behind production equipment..

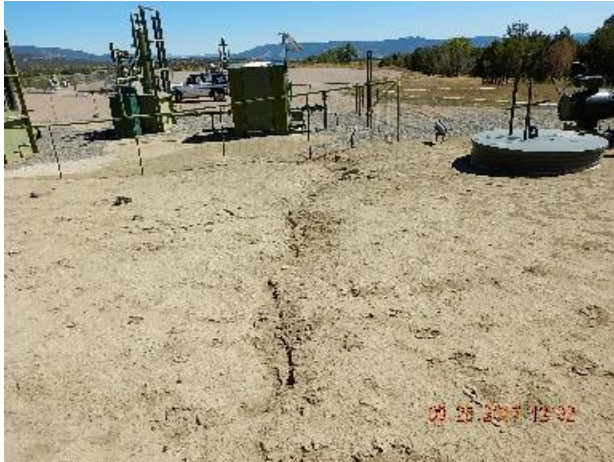
Photo 11: Erosion channel carrying stormwater and sediment into production area.

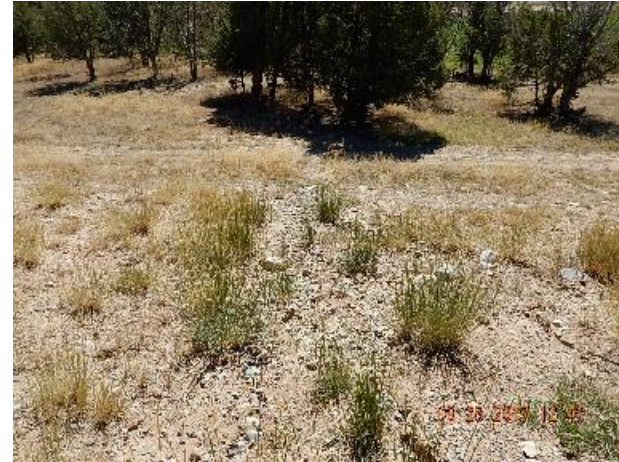
Photo 12: Erosion channel off SE corner of location.

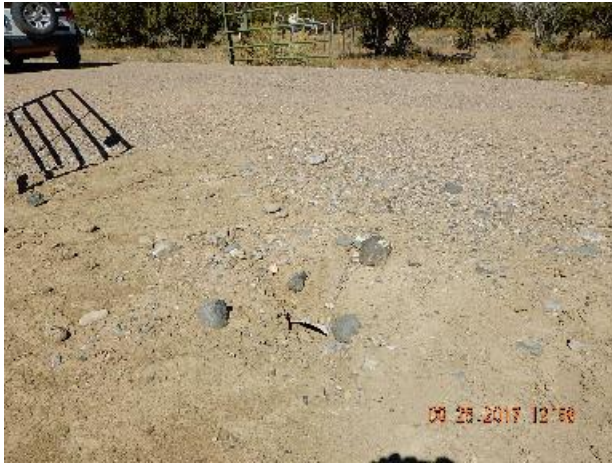
Photo13: Full culvert at entrance to location.

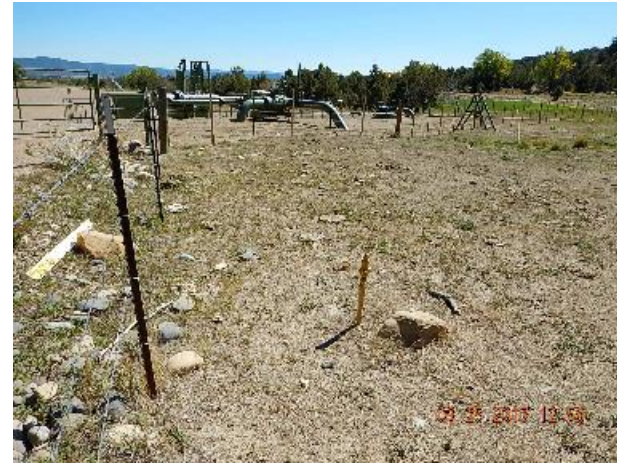
Photo 14: Unused riser/flowline just outside entry to location.
