Inspection Photos
Location Name: McIntyre 1-3 ST
API: 05-081-06608

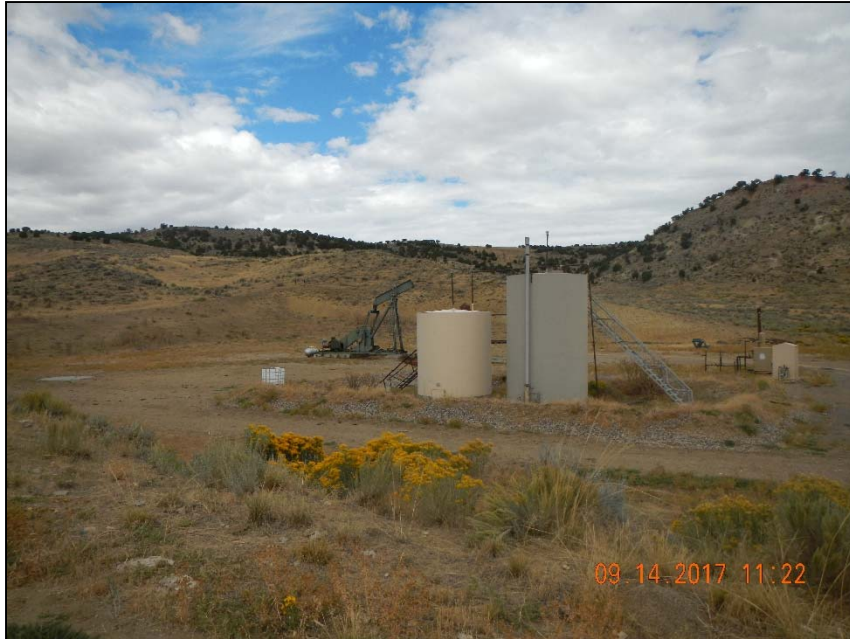
Photo 1. Overview of location taken at entrance facing northeast.

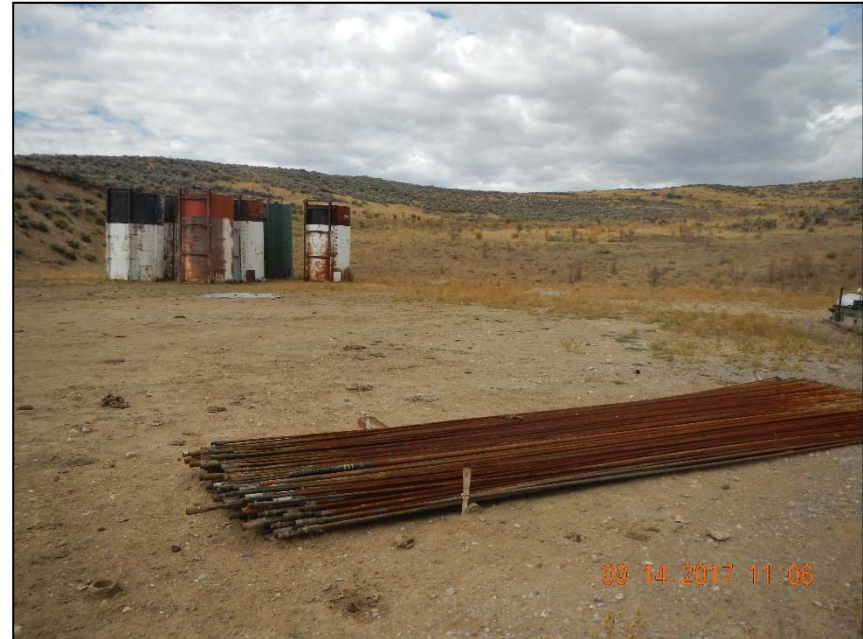
Photo 2. Frack tanks and tubing stored on location.

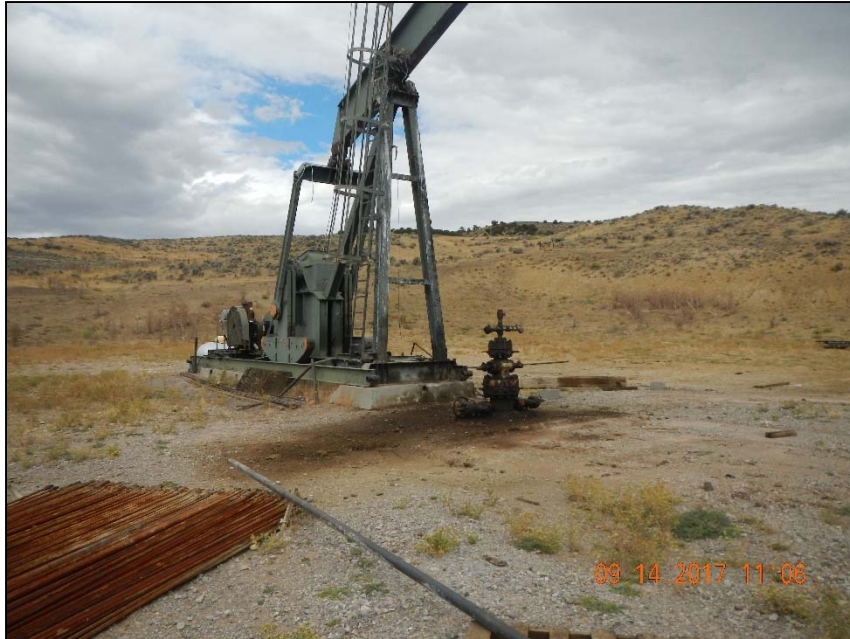
Photo 3. Stained soil at wellhead.

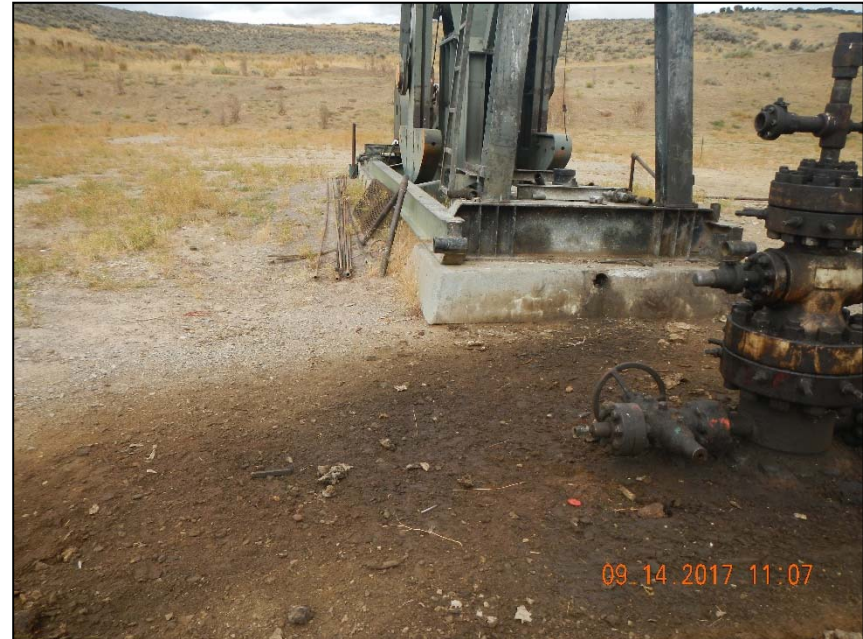
Photo 4. Close-up of stained soil at wellhead.

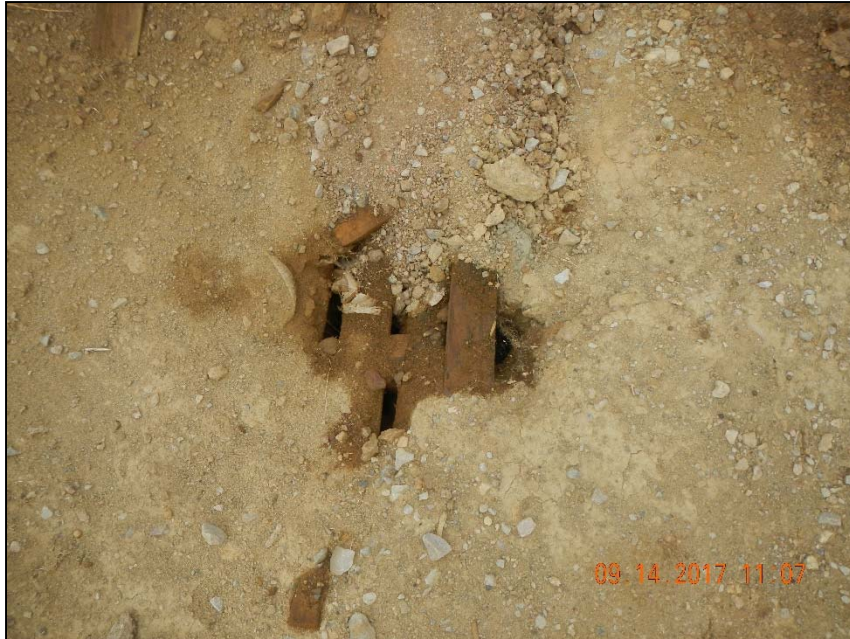
Photo 5. Partially covered rathole with fluid present.

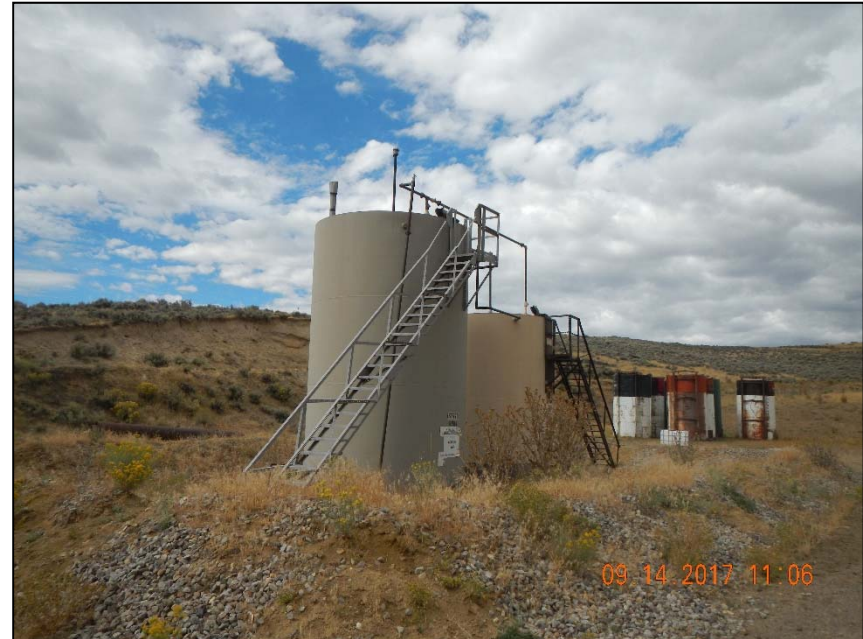
Photo 6. Vegetation growing on and in berm.

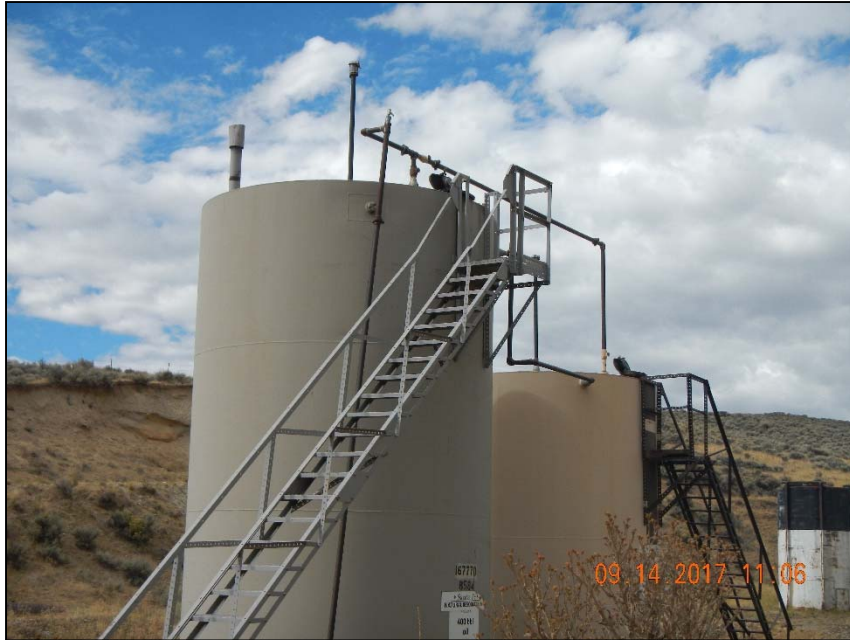
Photo 7. Gauge hatches open on both tanks.

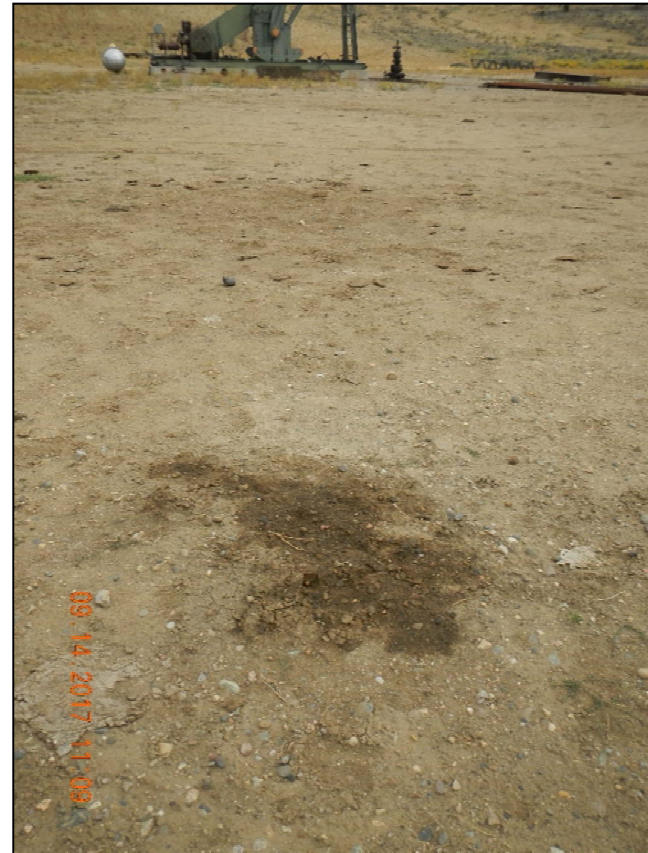
Photo 8. Stained soil on location.
