Inspection Photos

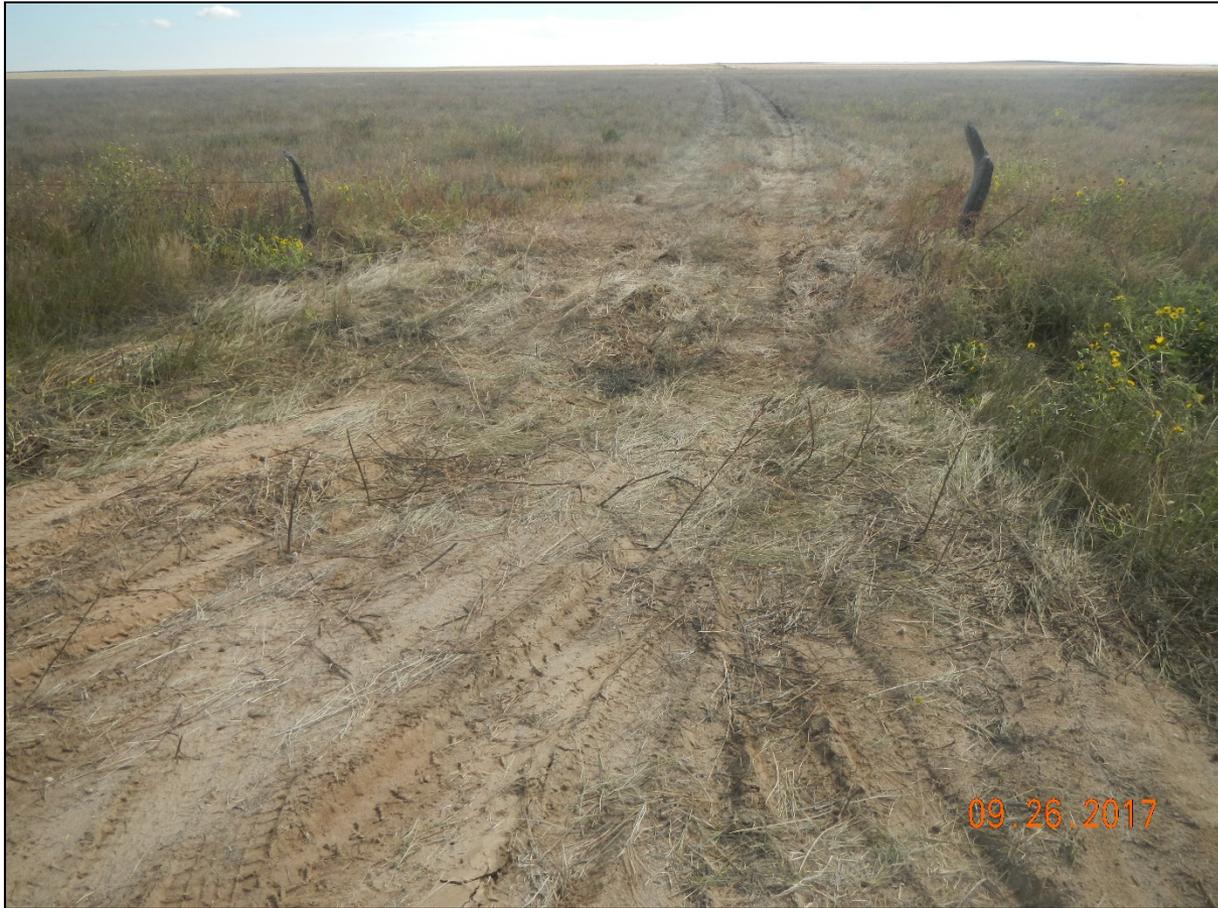
Photo 1. Facing east at the beginning of the access road. Contractor was preparing to install tracking pad. Operator must ensure tracking pad is installed to prevent sediment tracking onto county road.

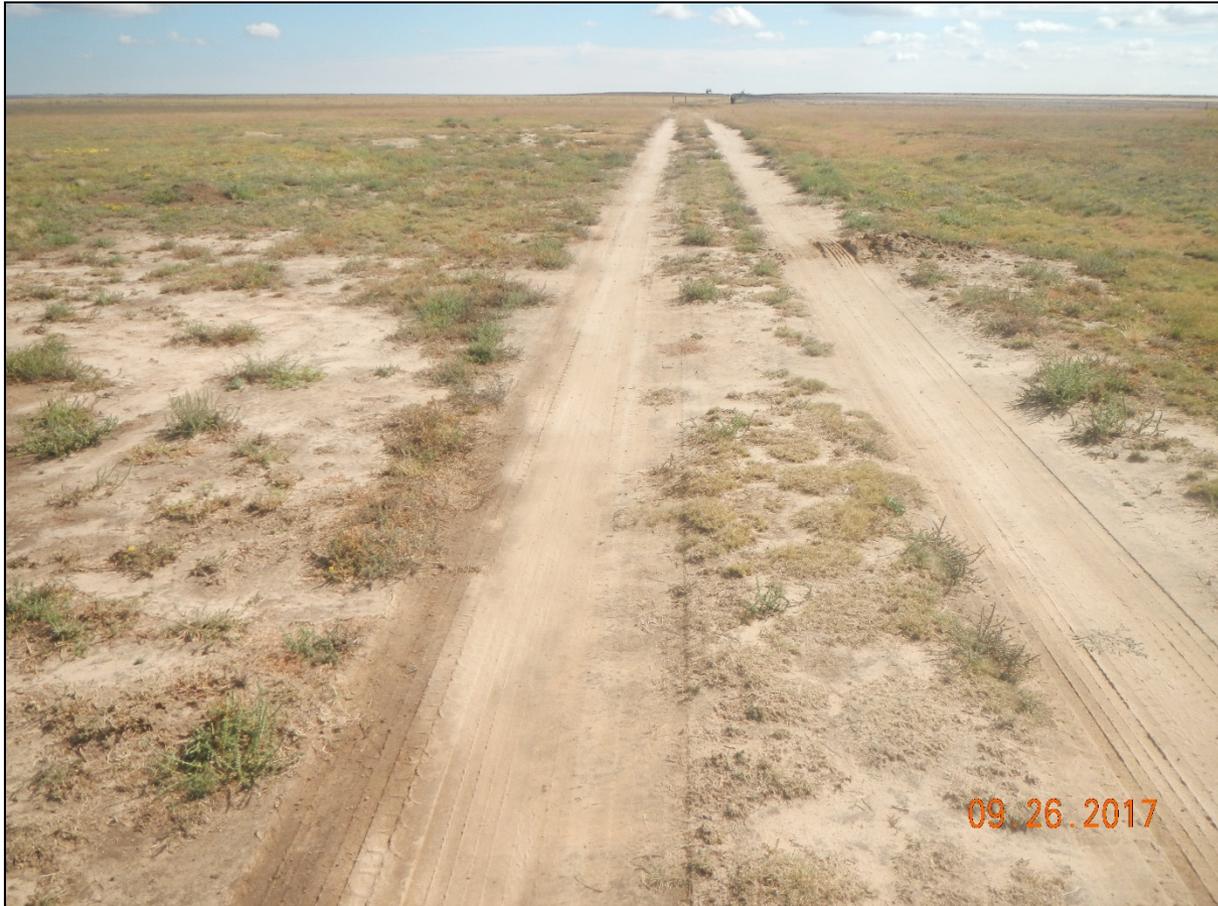
Photo 2. Facing east along the access road. Vehicle traffic needs to be restricted to prevent unnecessary disturbance.

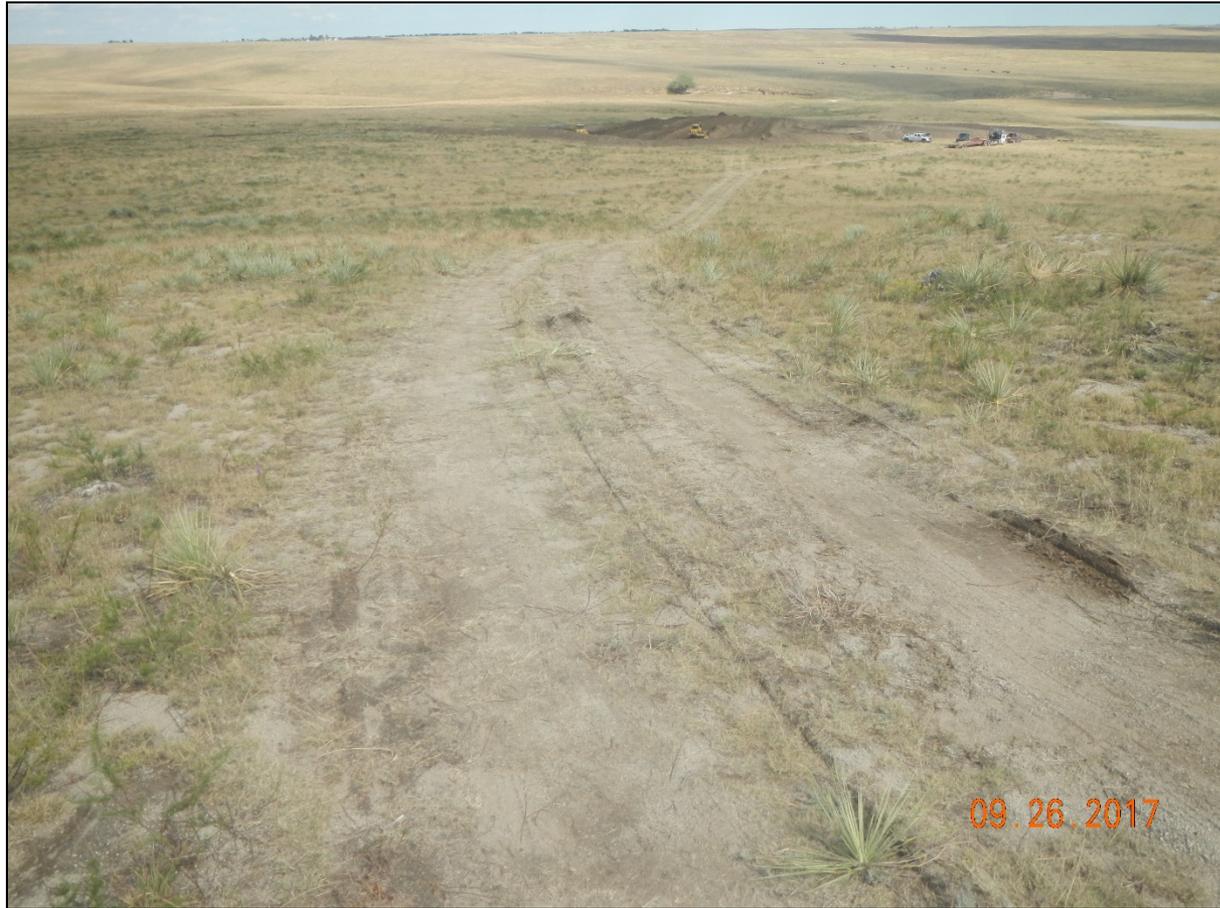
Photo 3. Facing northeast along the access road toward the location. Contractor indicated a different access point may be used due to steepness of this hill. The operator must ensure access is restricted to avoid additional disturbance.

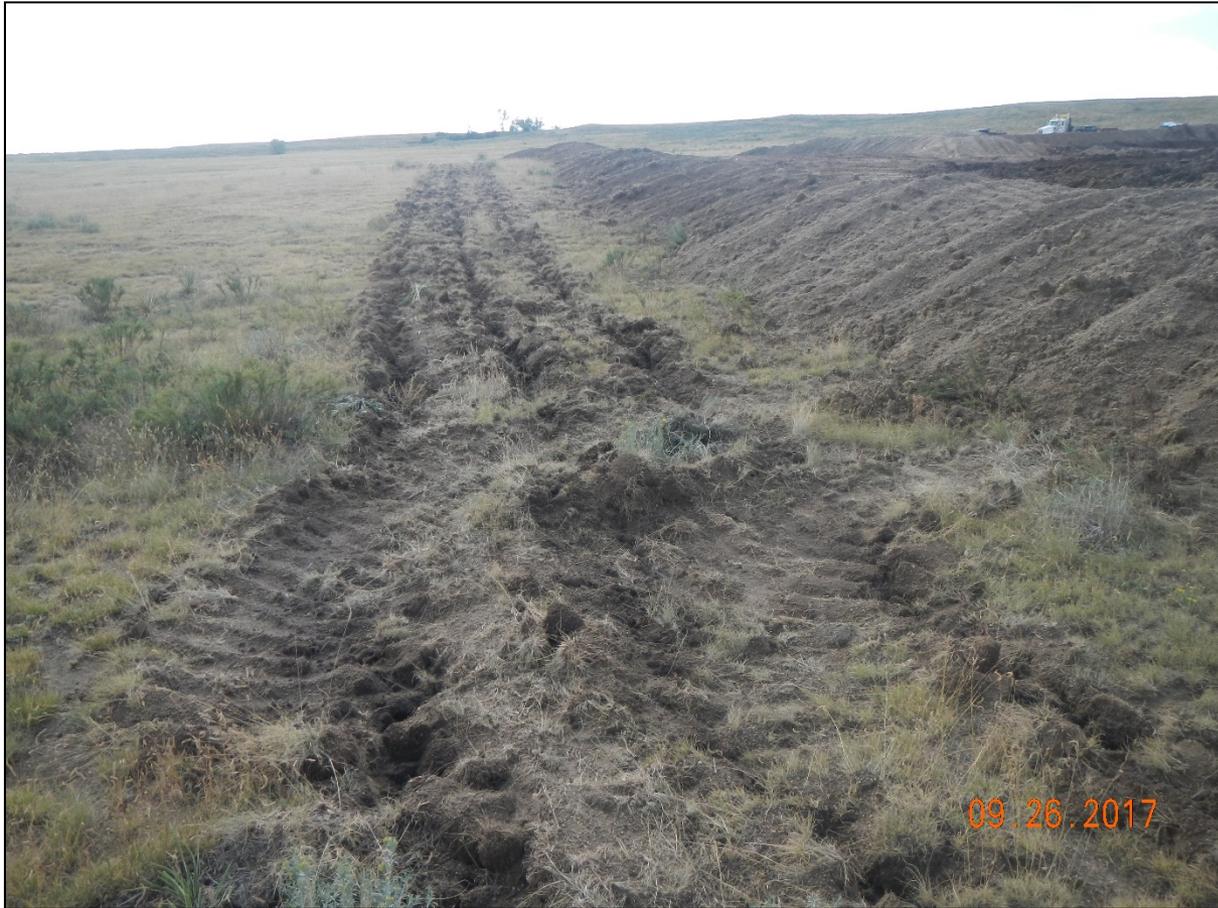
Photo 6. Facing south along the east side of the location. A soil berm is constructed around the perimeter and surface roughening has been created around the perimeter.
