Inspection Photos

Operator: NOBLE ENERGY INC - 100322

Location ID: 323052

Inspection Doc. Number: 682502628

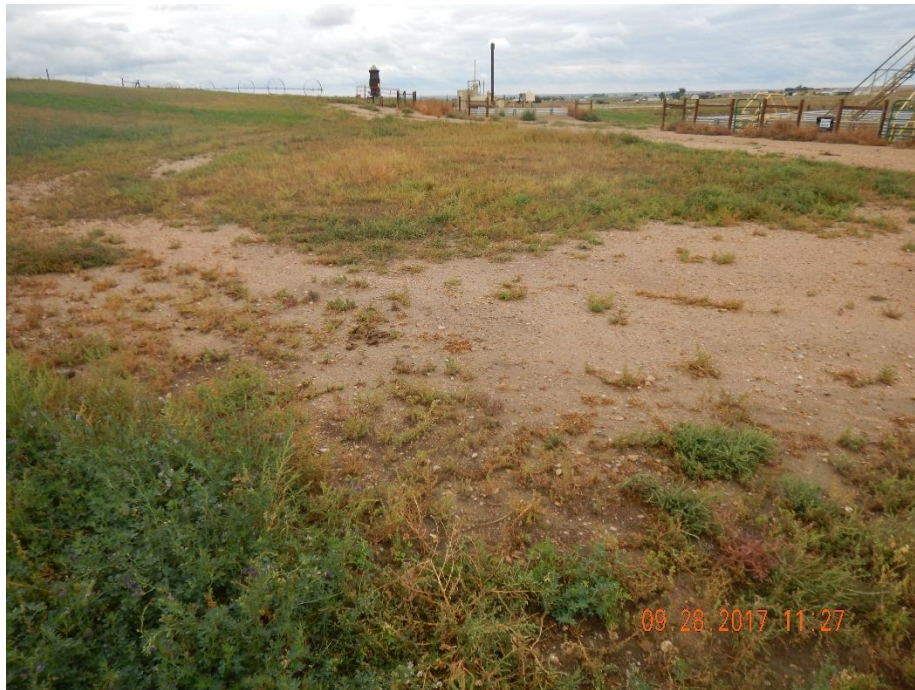
Photo 1: Photo taken from the south end of the well location. Corrective actions from previous inspections required operator to perform reclamation activities to reclaim the well site and access road by 7/31/2017. Gravel remains, location is predominantly undersirable weedy plant species; No reclamation activities appear to have been conducted.

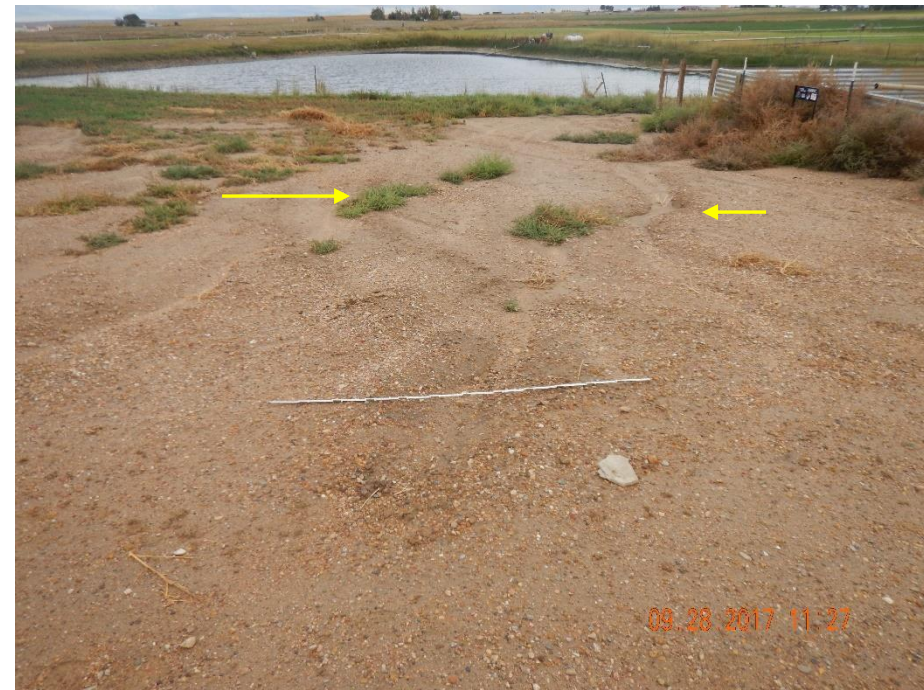
Photo 2: Photo taken from the battery location, facing east. Previous inspections dated 6/30/2017 and 8/17/2017 required operator to repair erosion and install required BMPs to prevent further degradation. Photo shows stormwater erosion has not been repaired and no BMPs have been installed. 6 foot measuring stick for reference.

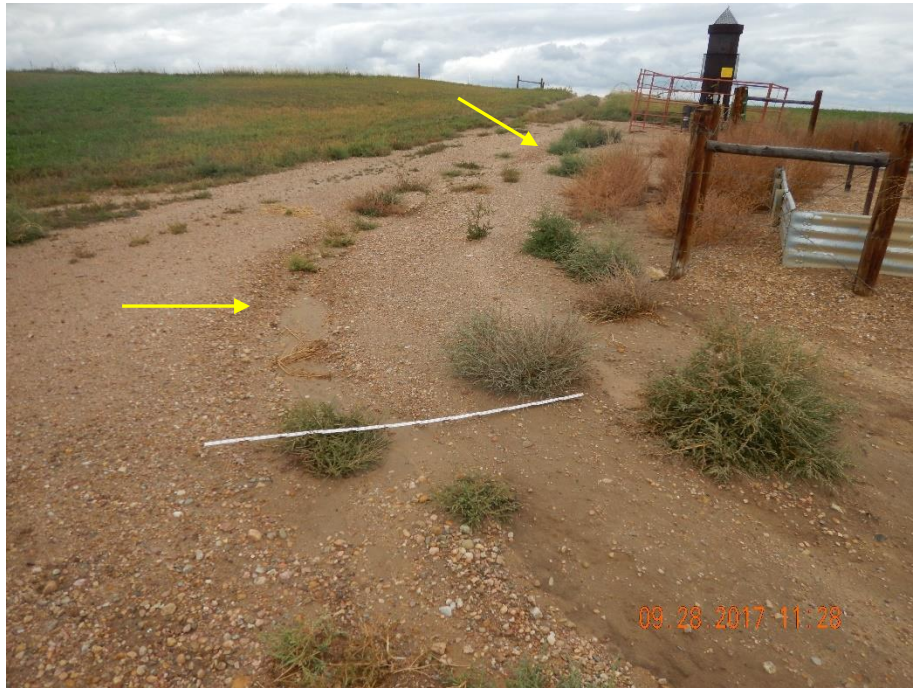
Photo 3: Photo taken from the north end of the battery facility, facing north. See comments in photo 2.

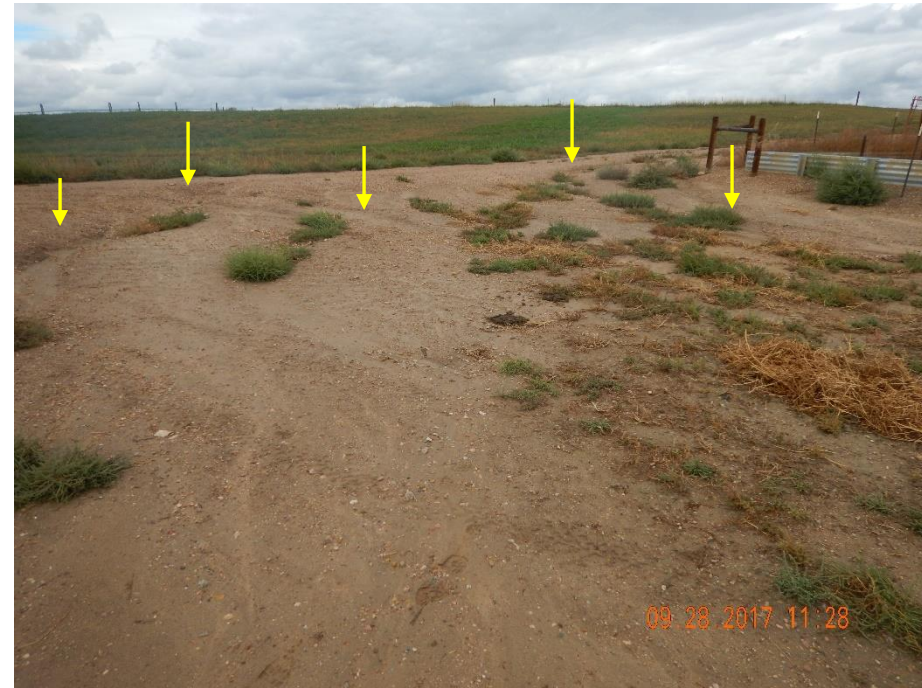
Photo 4: Photo taken from the battery facility, facing northeast. See comments in photo 2.

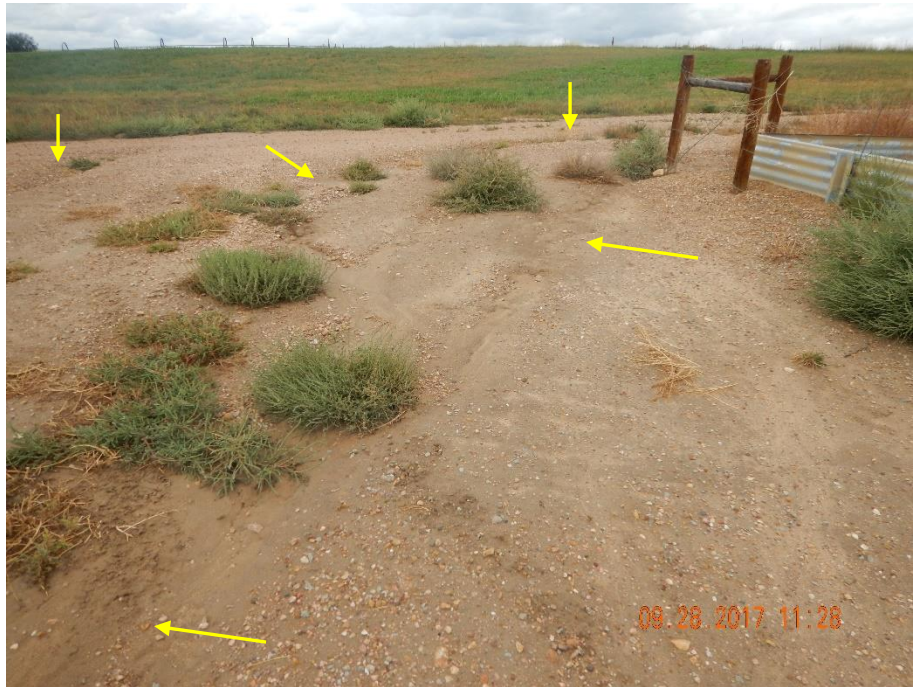
Photo 5: Photo taken from the battery facility, facing west. See comments in photo 2.

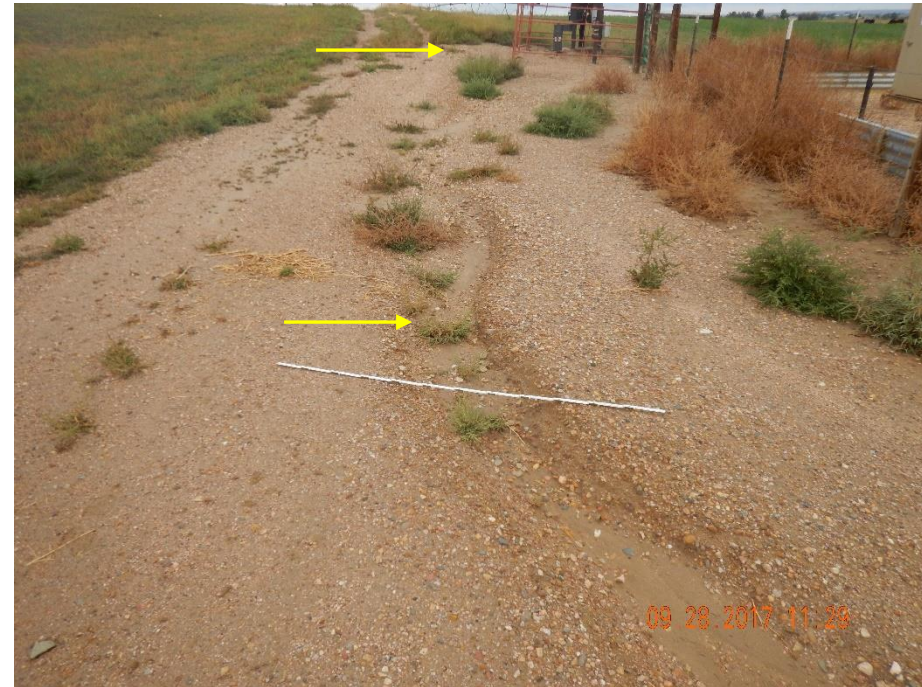
Photo 6: Photo taken from the north end of the battery location, facing north along the access road. Photo shows stormwater appears to have concentrated uphill on the access road, channelized and run onto the battery facility causing the erosion degradation seen on location. The eastern rut of the access road shows sign of head-cutting and incising. 6 foot measuring stick for reference.

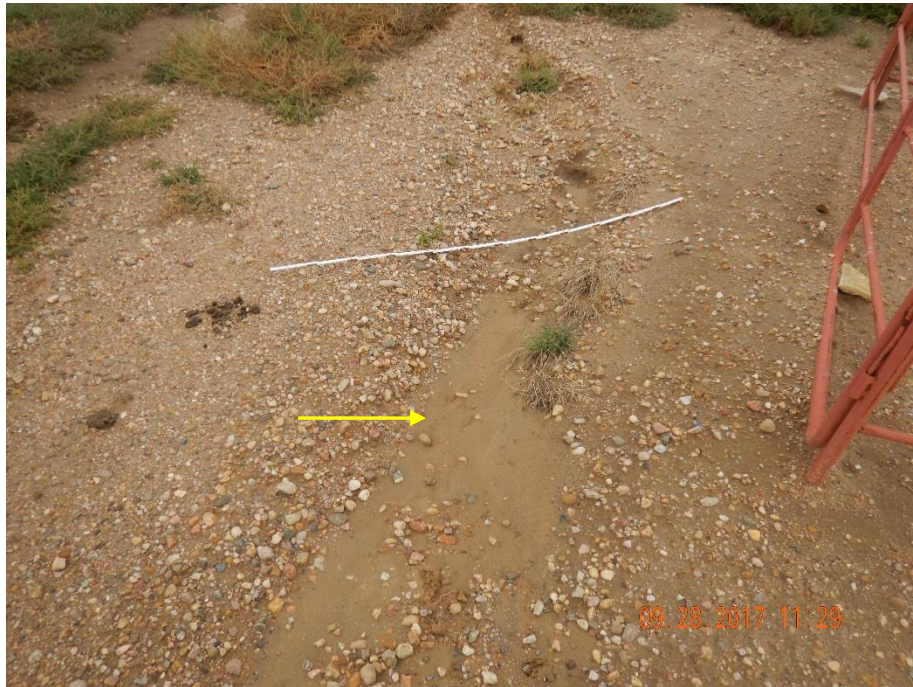
Photo 7: Photo taken from the north end of the battery facility. Photo shows areas of sediment deposition caused by sediment laden stormwater discharge. 6 foot measuring stick for reference.

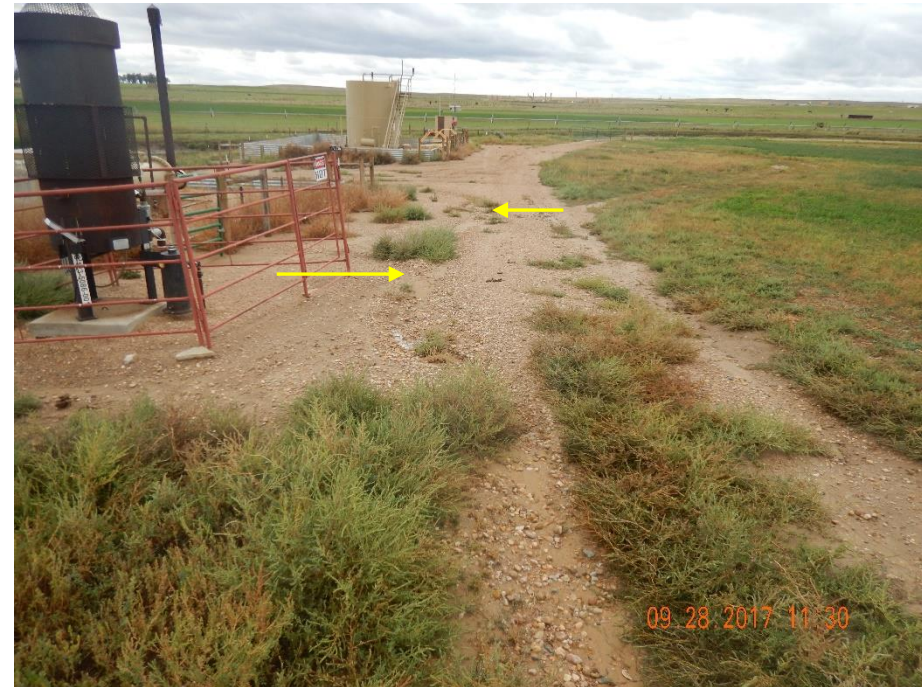
Photo 8: Photo taken from the north end of the battery location, facing south. Photo shows stormwater appears to have concentrated uphill on the access road, channelized and run onto the battery facility causing the erosion degradation seen on location. The eastern rut of the access road shows sign of head-cutting and incising.

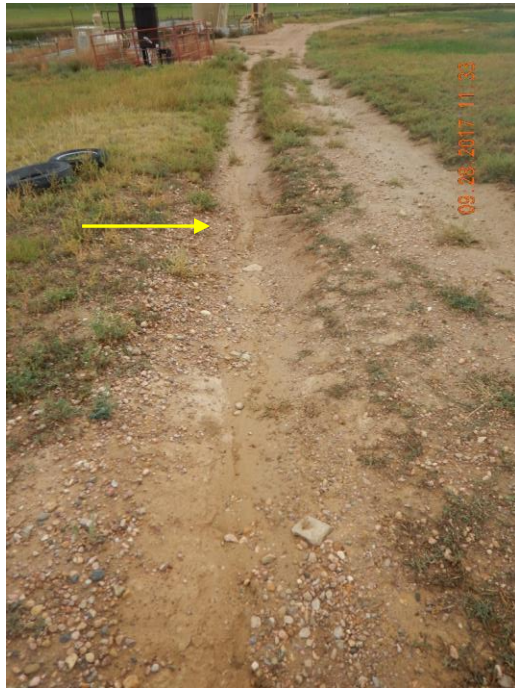
Photo 9: Photo taken from the access road north of the location. Photo shows areas of the access road where head-cutting and incising due to stormwater erosion becomes first evident.

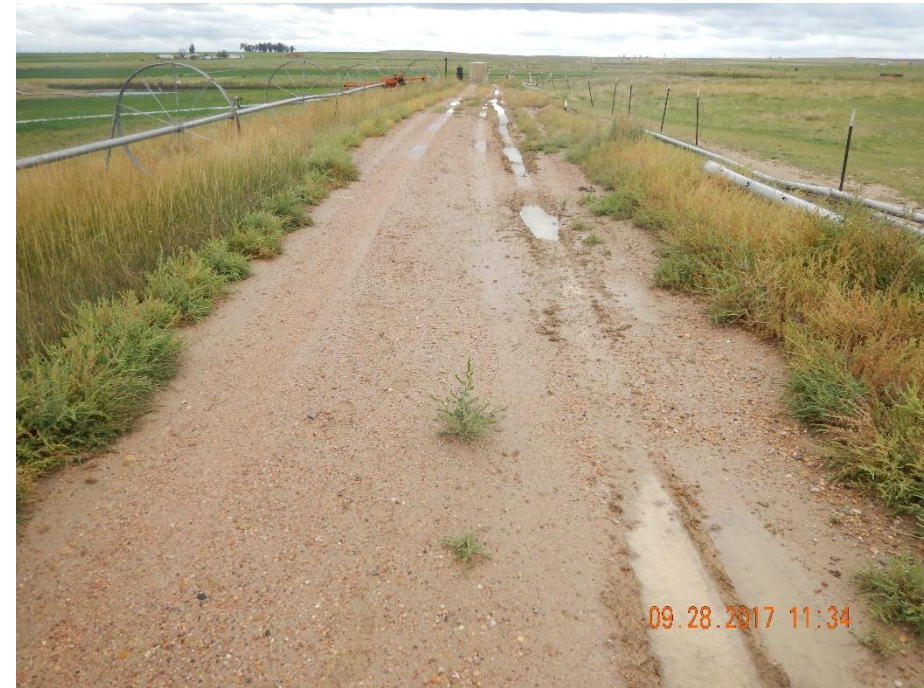
Photo 10: Photo taken from the access road, north of the location, facing south. Inspection doc. #682502370 on 6/30/2017 documented that ruts were beginning to form on the access road, and advised maintenance. Photo shows no maintenance has occurred on access road, and it appears that travel over the access road during inclement weather conditions has caused further degradation. Water accumulation seen here due to recent rain event.

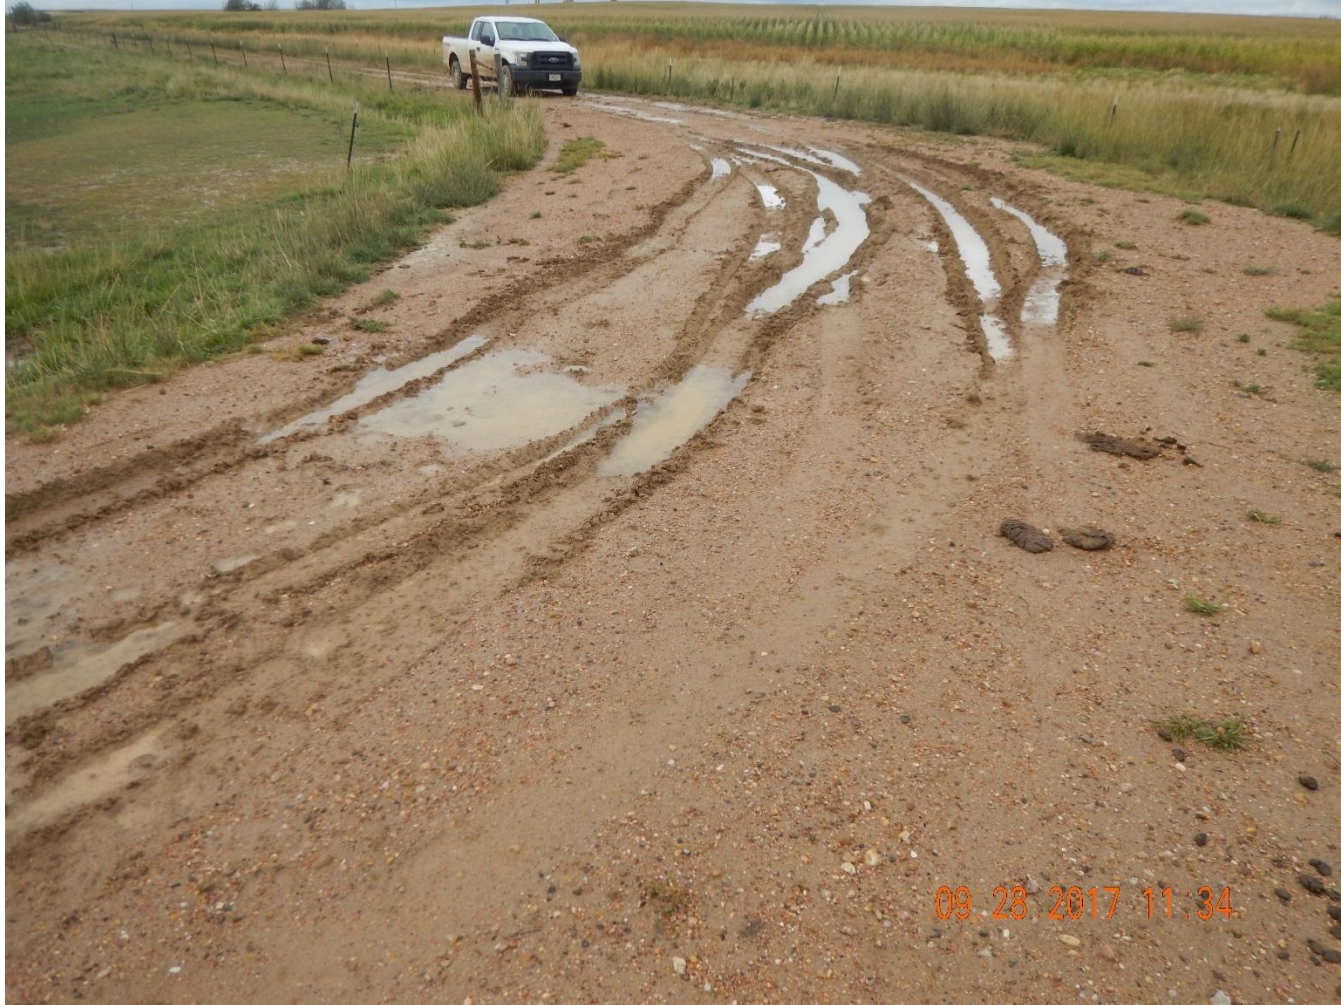
Photo 11: Photo taken from the access road, north of the location, facing northwest. Photo shows no maintenance has occurred on access road, and it appears that travel over the access road during inclement weather conditions has further degraded the access road. Inspector parked and accessed the location via foot to prevent any additional damage.
