- Southern Ute 33 – 10; 15 - 3
- 05-067-08833

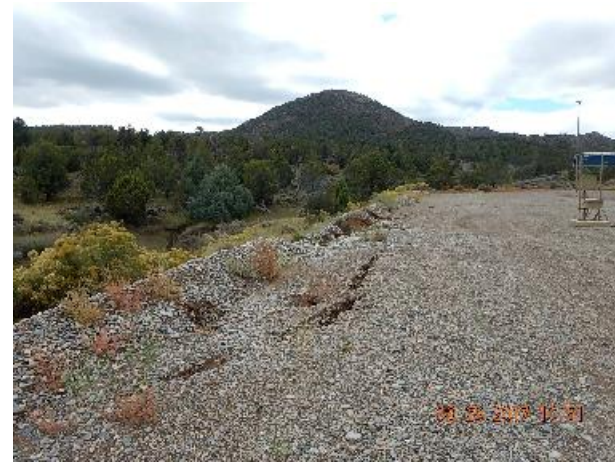
Photo 2: Separation in E fill slope.

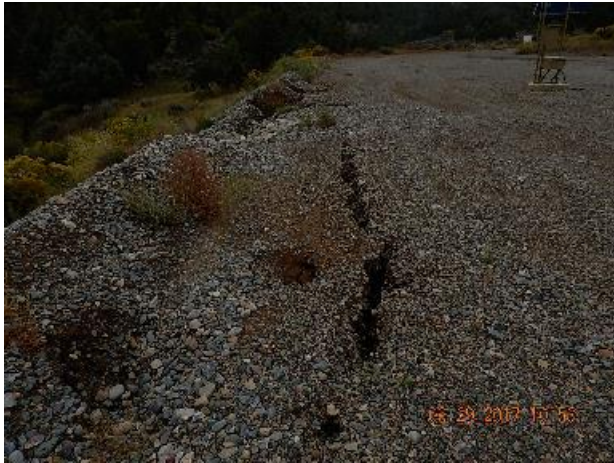
**Photo 3: Closer view of separation.**

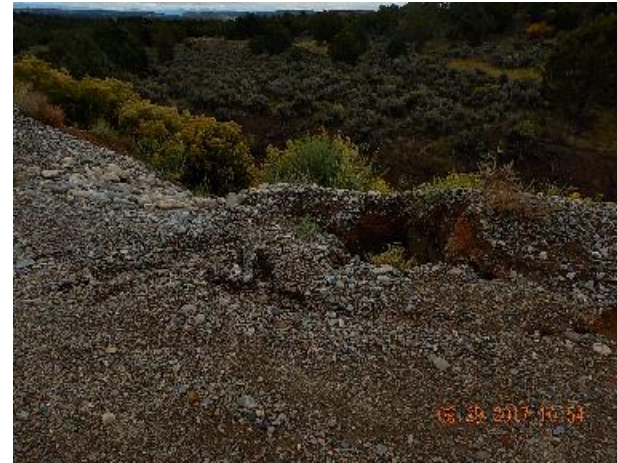
**Photo 4: Collapse in E fill slope.**

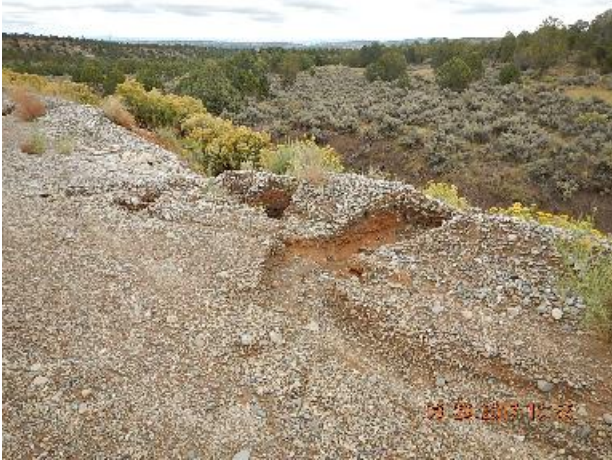
**Photo 5: Erosion channel off E fill slope.**

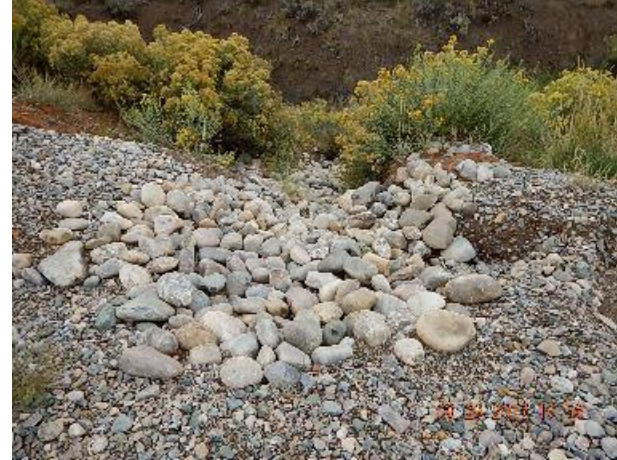
**Photo 6: Erosion channel repair.**

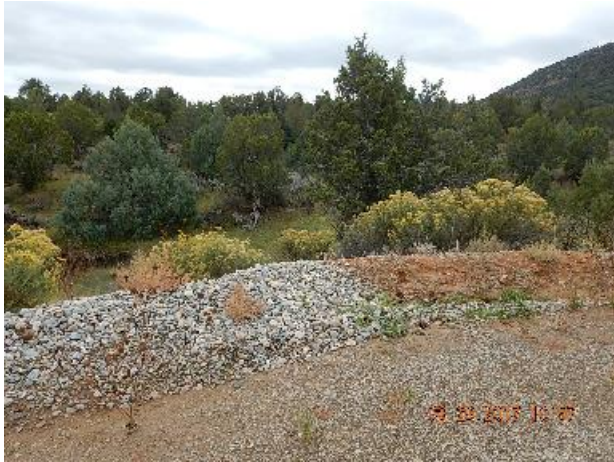
**Photo 7: Repair in SE corner.**

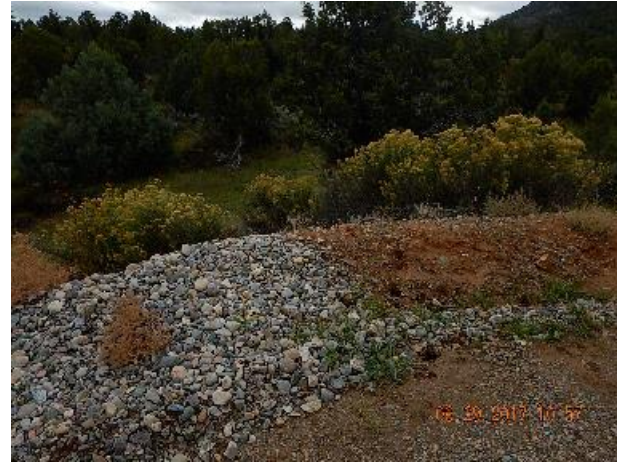
**Photo 8: Closer view of repair in SE corner.**
