Final Reclamation Inspection

October 4, 2017

Operator: CHESAPEAKE OPERATING LLC- 16660

API: 05-123-34079

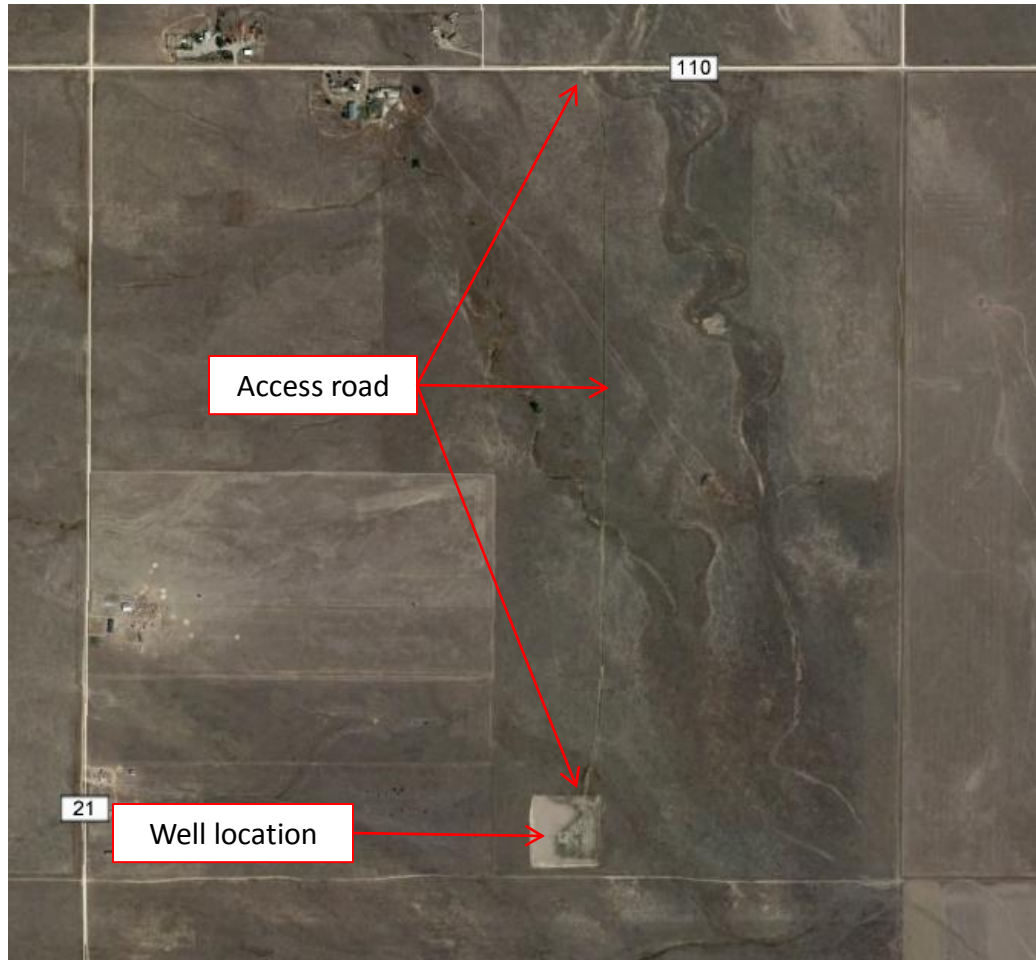
Google Earth imagery taken September 7, 2016 illustrating the ~0.9 mile access road and location that has not been reclaimed. Well was plugged December 21, 2012.

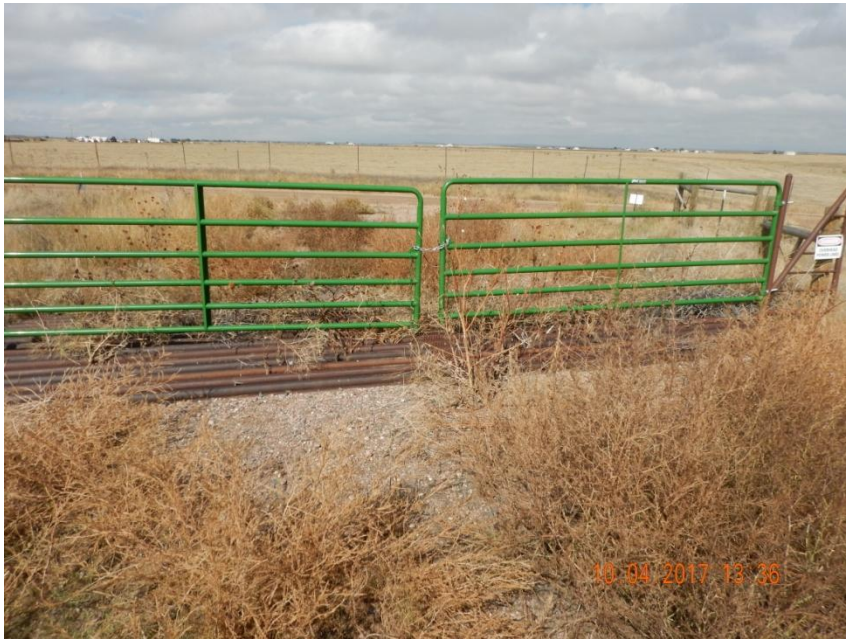
Photo 1. Photo taken from the entrance of the location off CR110, facing North. Russian thistle growing throughout the access road portions of the road.

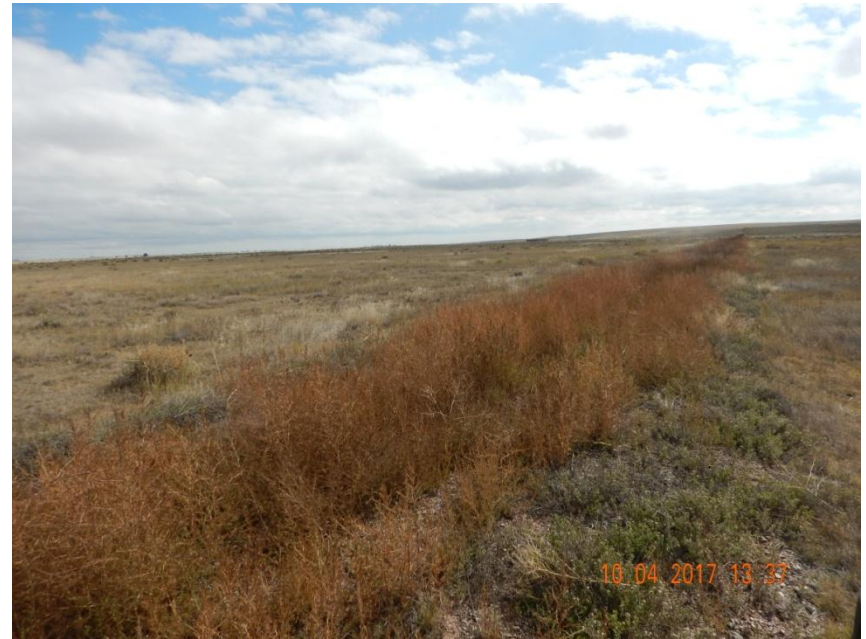
Photo 2. Photo taken from a portion of the access road, facing South. Russian thistle growing throughout the access road portions of the road, gravel still on access road, and access road has not been contoured or seeded.

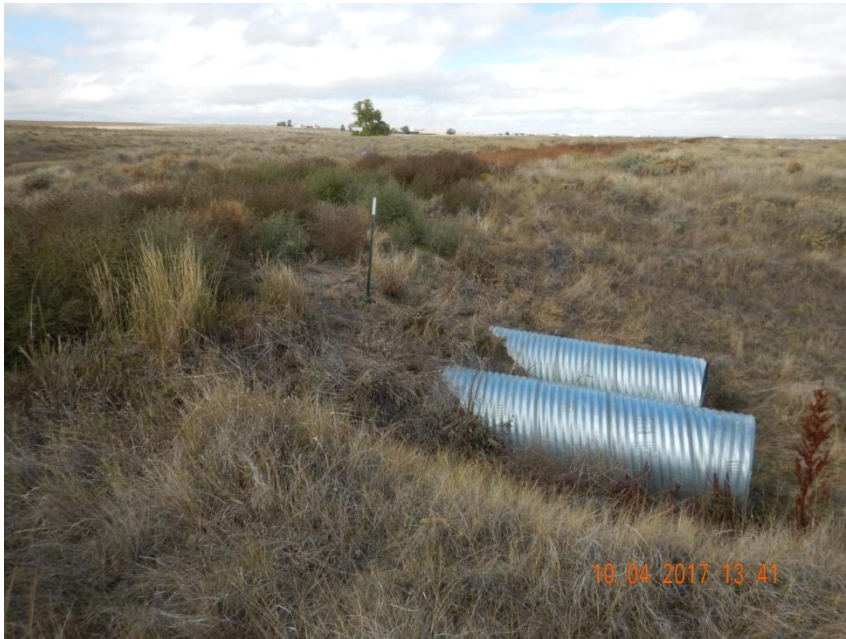
Photo 3. Photo taken from a portion of the access road at an intermittent stream crossing, facing North. Culverts need to be removed per Rule 1004.

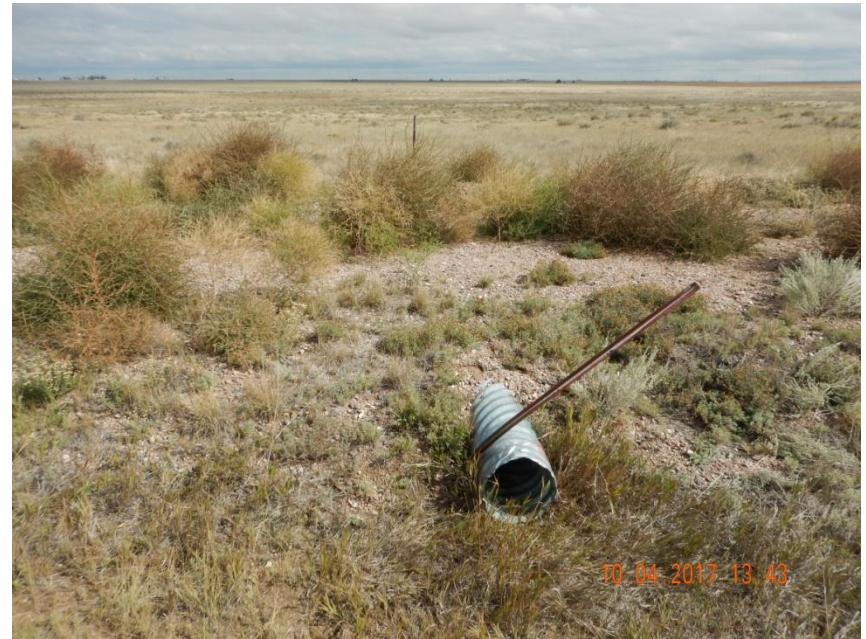
Photo 4. Photo taken from another portion of the access road, facing East. Culverts need to be removed per Rule 1004.

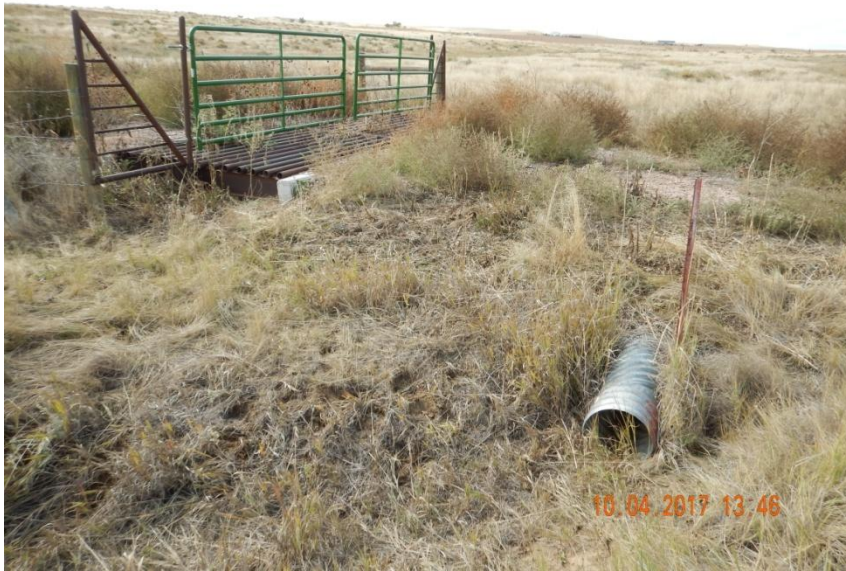
Photo 5. Photo taken from the entrance of the location, facing West. Culvert, cattle guards, and fence have all been left at location.

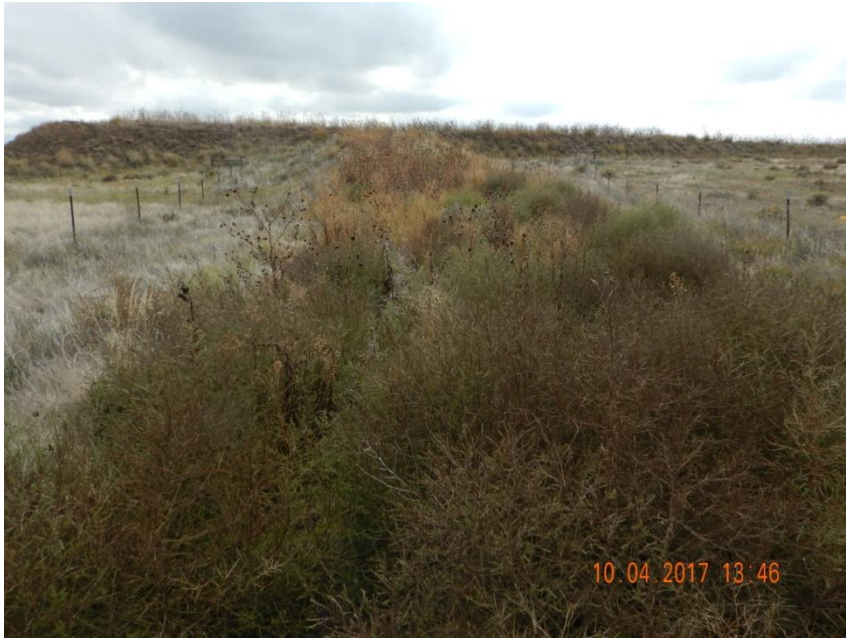
Photo 7. Photo taken from just beyond the gate shown in Photo 5, facing South. Russian thistle growth continues throughout access road.

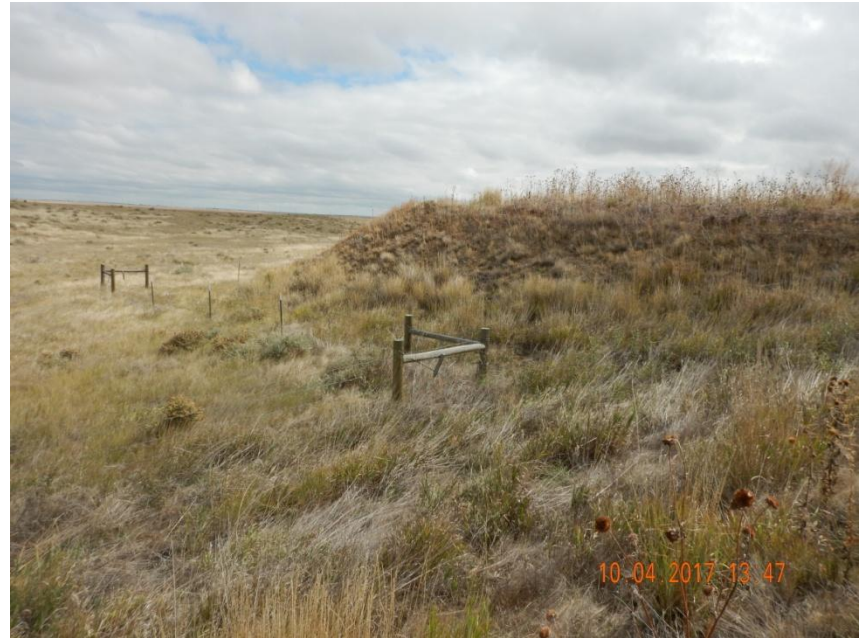
Photo 8. Photo taken north of the well pad, facing Southeast. Photo illustrates the fill slope that indicates this location has never been reclaimed per Rule 1004 standards.

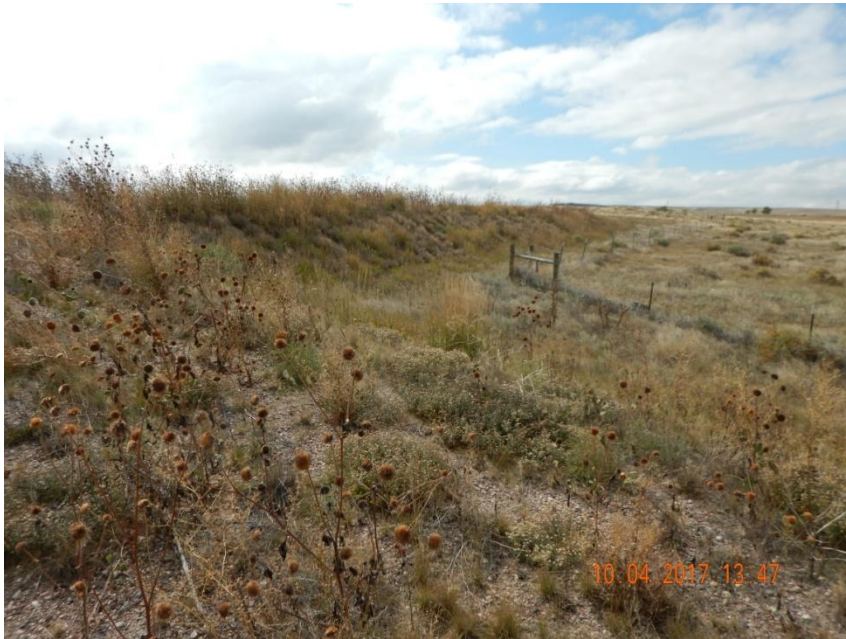
Photo 9. Photo taken north of the well pad, facing Southeast. Refer to Photo 8 for the description of the observations.

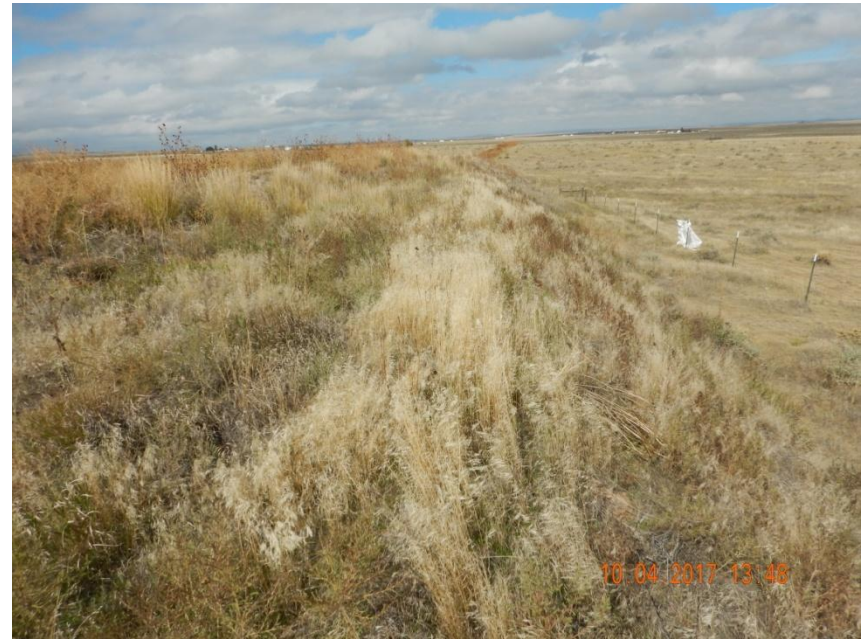
Photo 10. Photo taken from the eastern well pad, facing North. Refer to Photo 8 for the description of the observations.

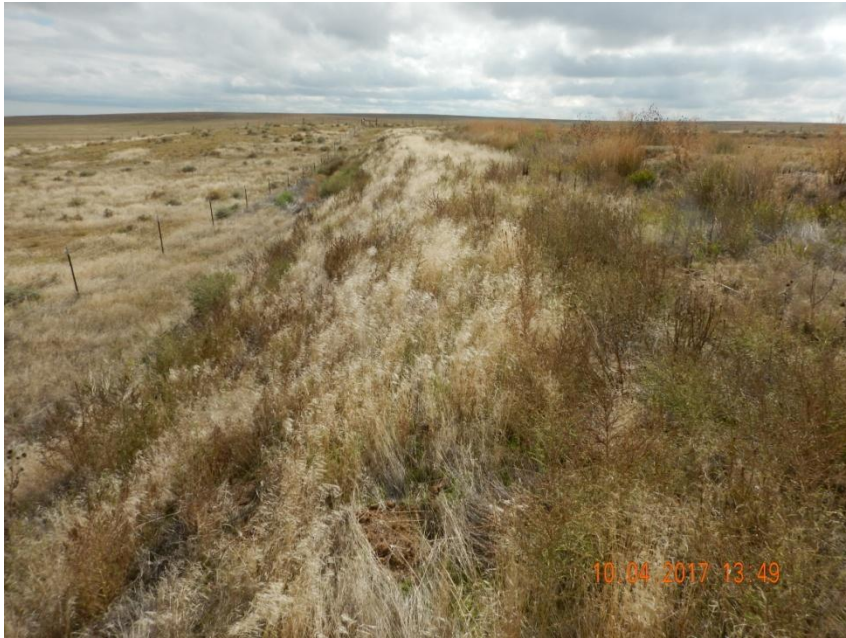
Photo 11. Photo taken from the eastern well pad, facing South. Refer to Photo 8 for the description of the observations.

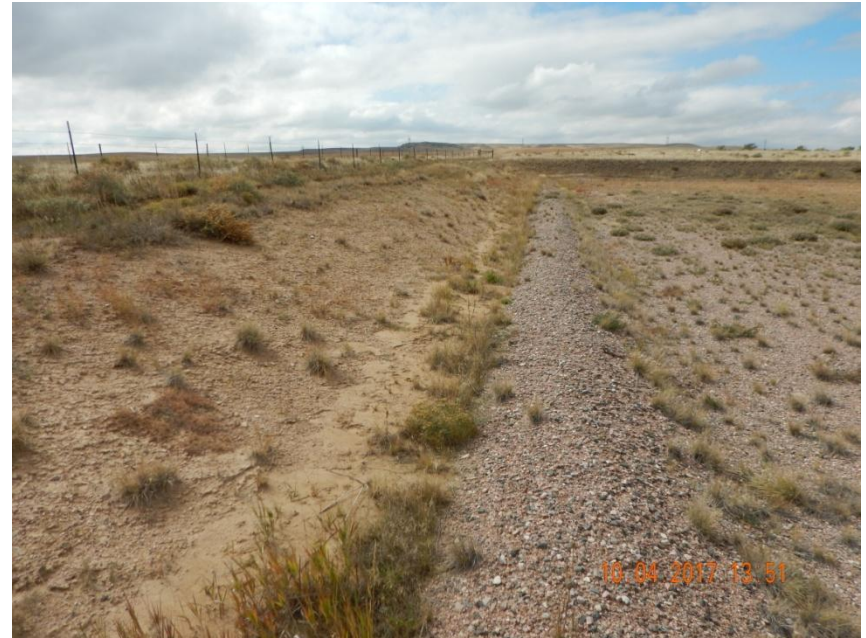
Photo 12. Photo taken from the southern location, facing West. Operator has not performed reclamation as cut slopes and gravel are evident throughout the location.

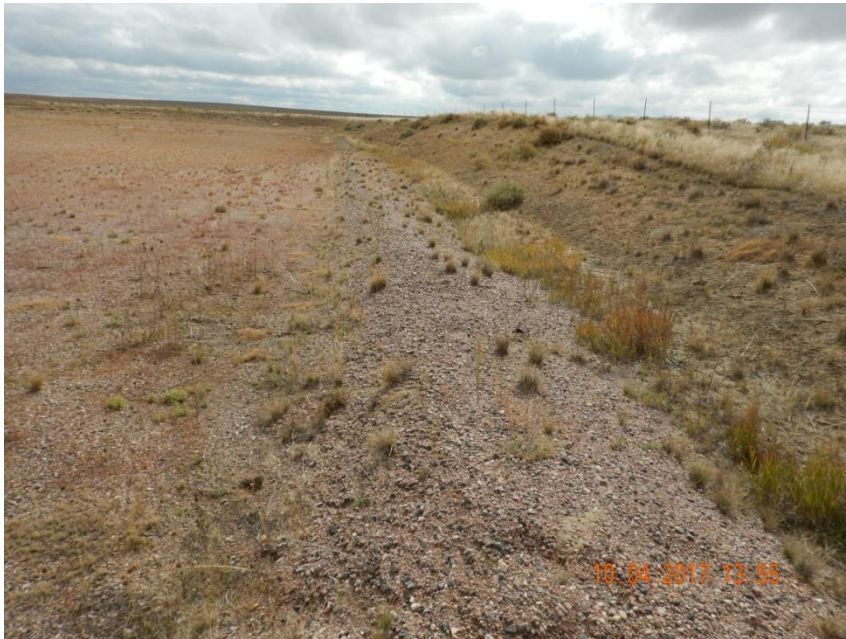
Photo 13. Photo taken from the northwestern well pad, facing South. Refer to Photo 12 for the description of the observations.

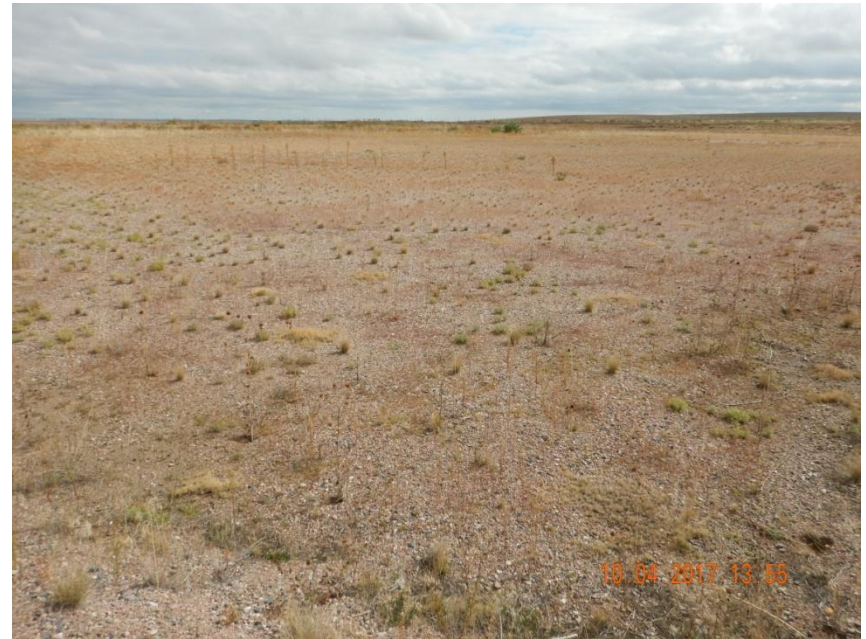
Photo 14. Photo taken from the northwestern well pad, facing Southeast. Refer to Photo 12 for the description of the observations.

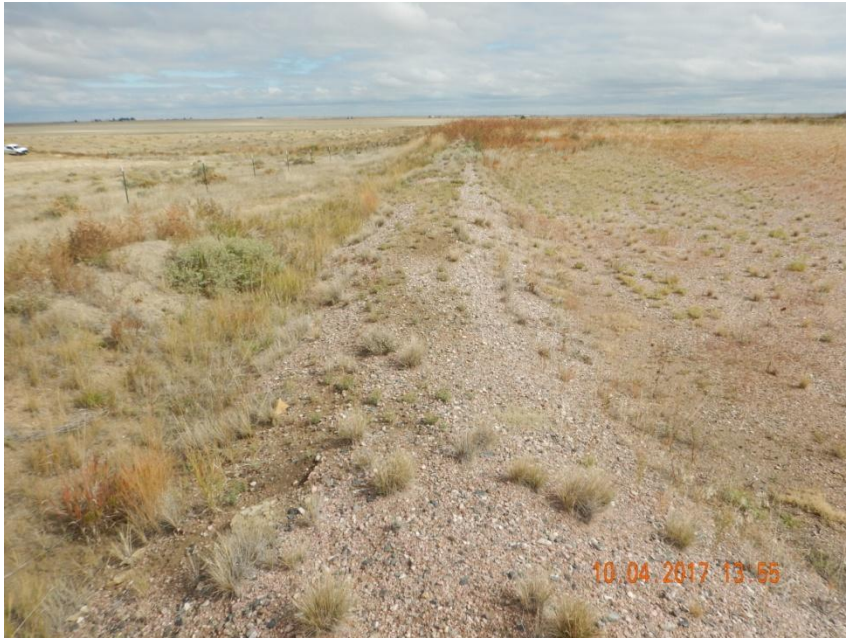
Photo 15. Photo taken from the northwestern well pad, facing East. Refer to Photo 12 for the description of the observations.

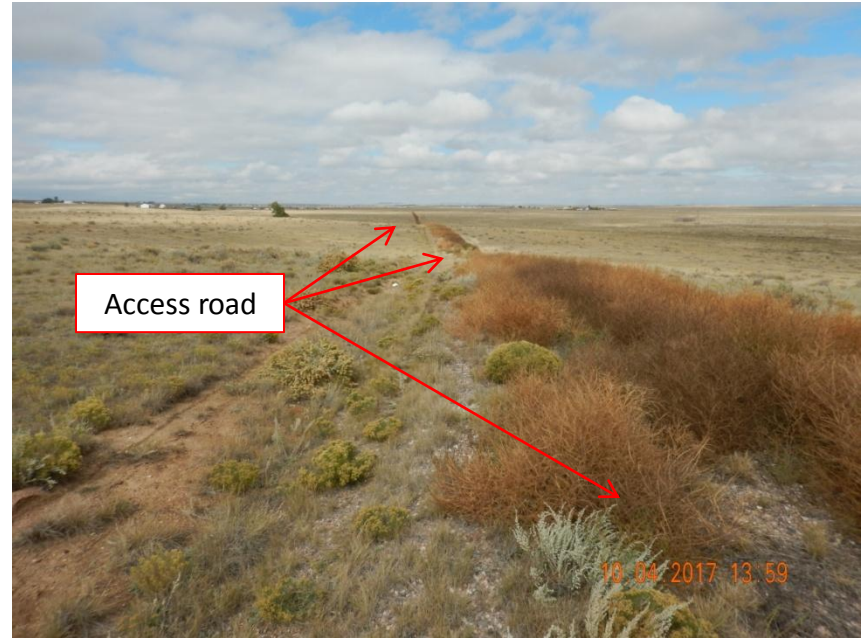
Photo 16. Photo taken just north of the well pad, facing North. Photo illustrates the Russian thistle that is growing throughout the access road.
