Inspection Photos
Location Name: Graefe 1
Facility ID: 317527

SW¼ NW¼ Section 26 Township 9 North Range 62 West

COLORADO
Oil & Gas Conservation
Commission
Department of Natural Resources

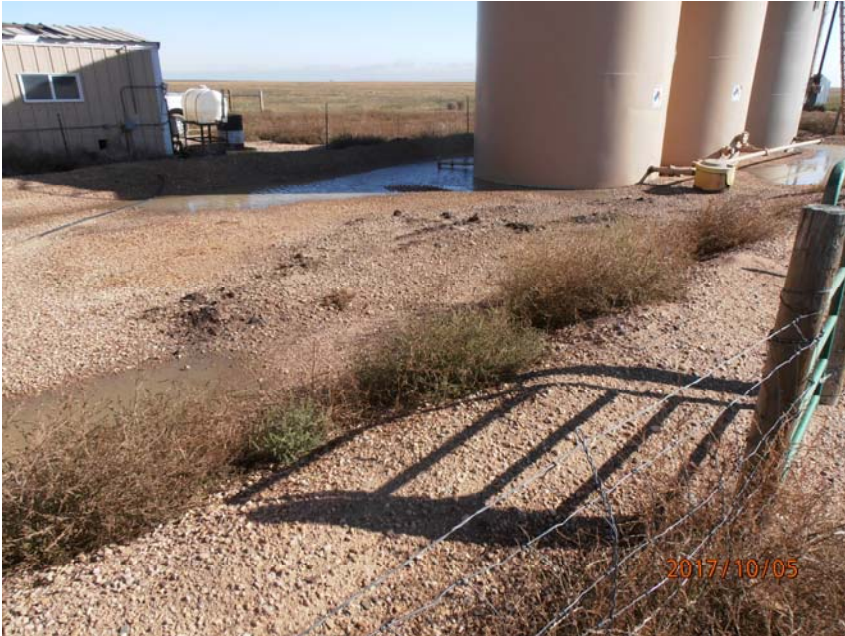
Photo 1: Oily soil in tank battery. Standing water is stormwater.

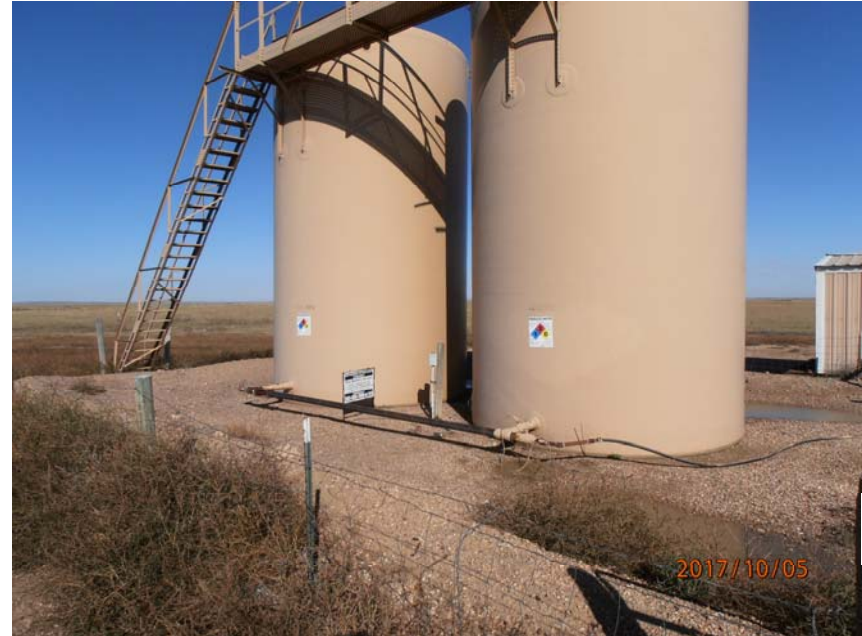
Photo 2: Produced water ASTs.

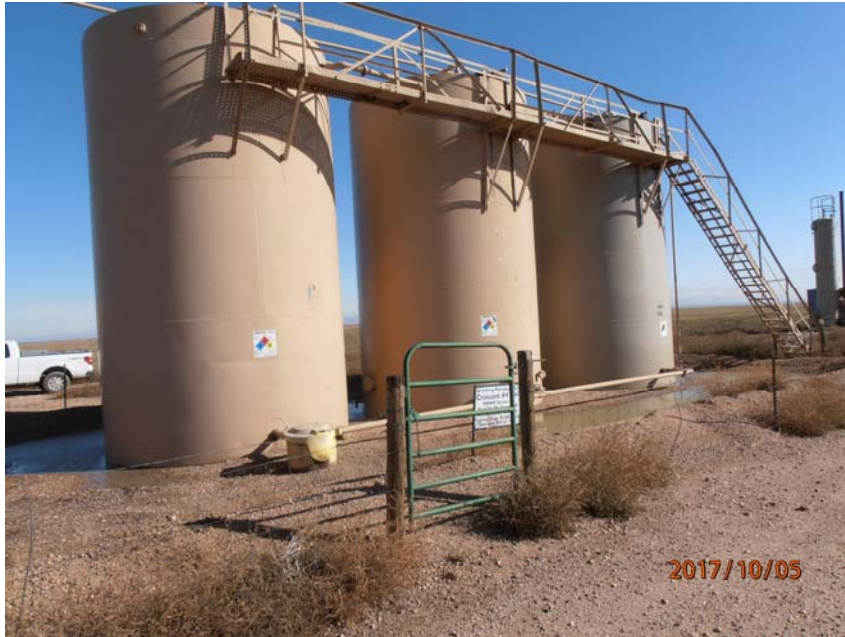
Photo 3: Crude Oil ASTs.

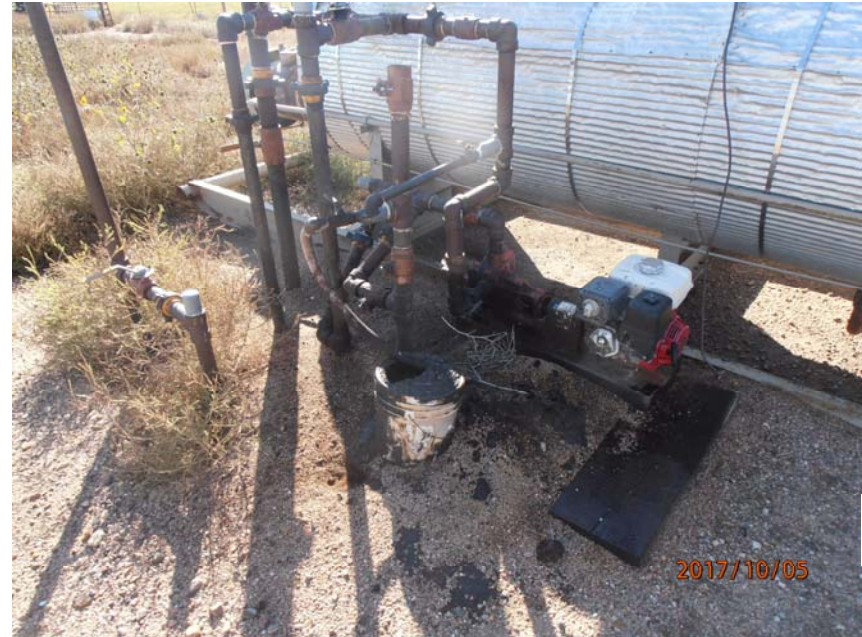
Photo 4: Oily soil at pump adjacent flowlines and horizontal separator.

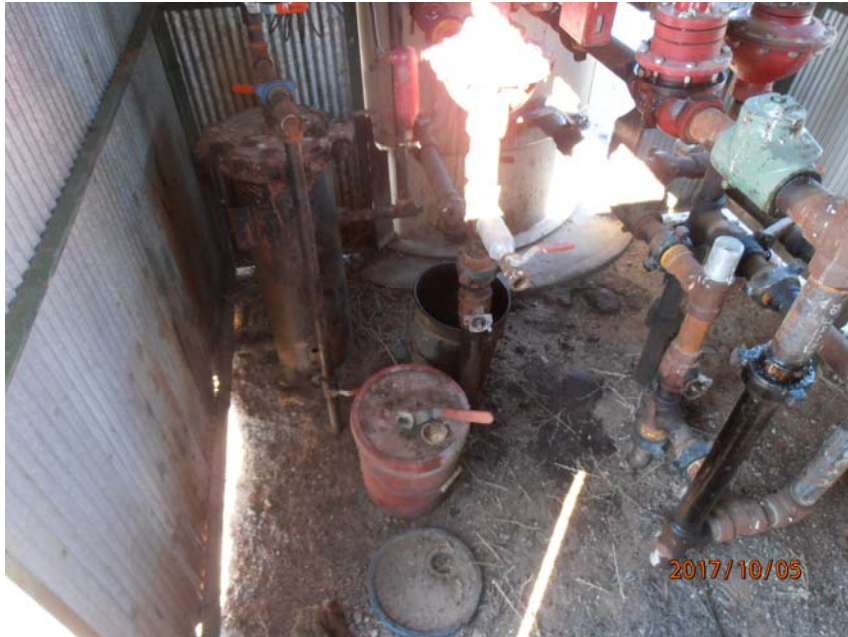
Photo 5: Oily soil inside vertical treater building.

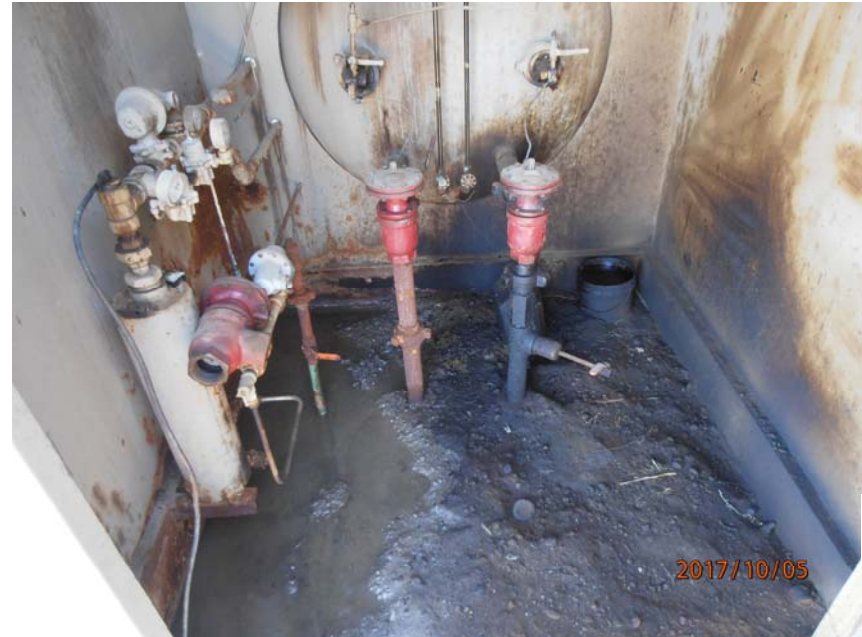
Photo 6: Oily soil inside horizontal treater shed.

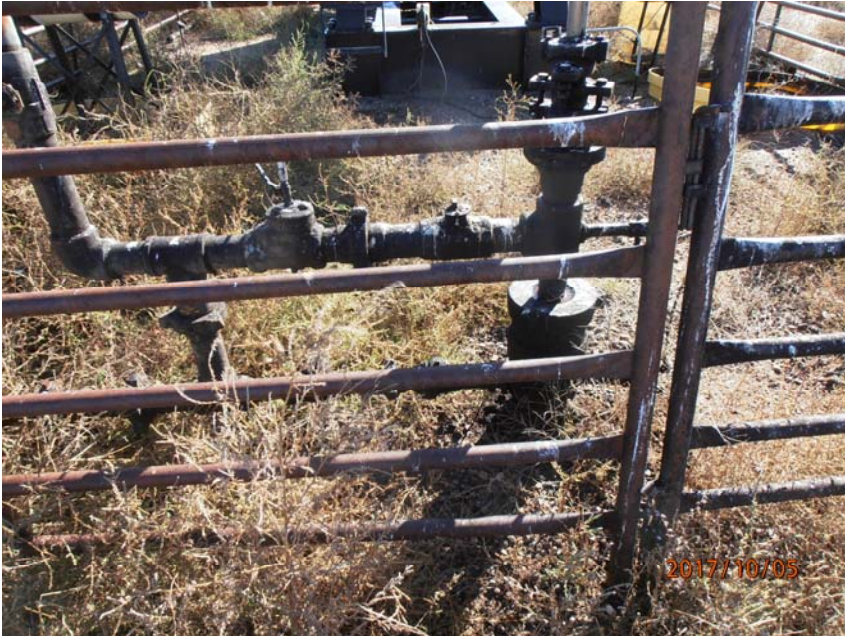
Photo 7: Oily soil at wellhead.

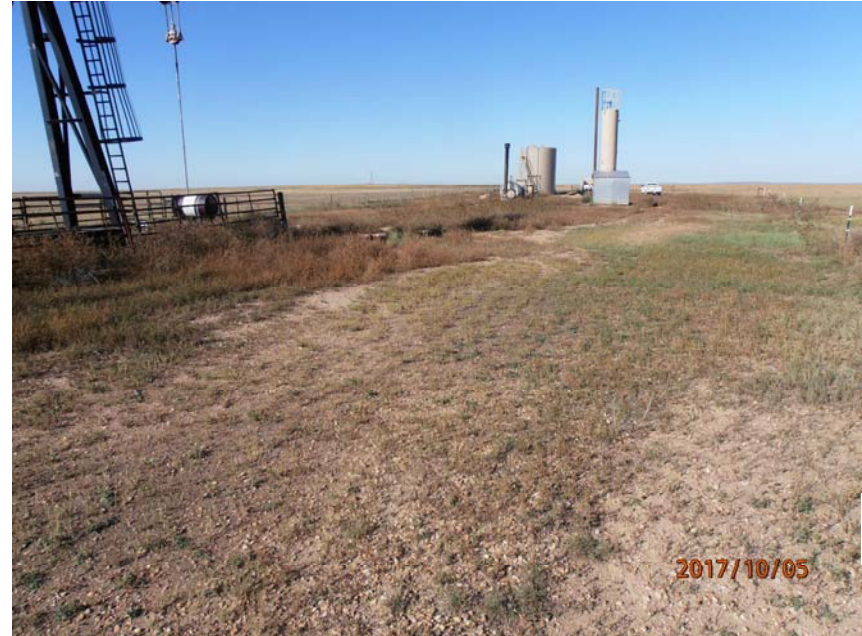
Photo 8: Weeds on location.

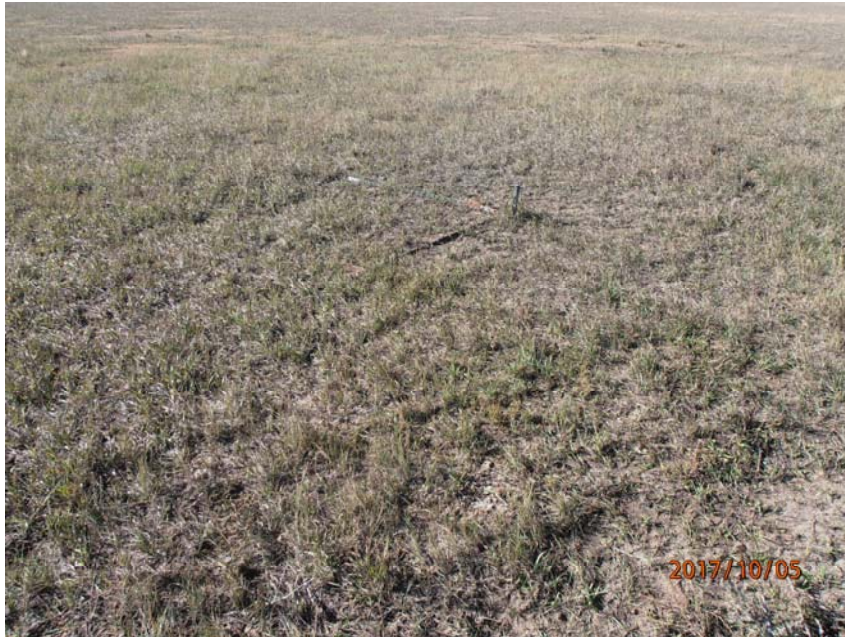
Photo 9: Unmarked deadman.

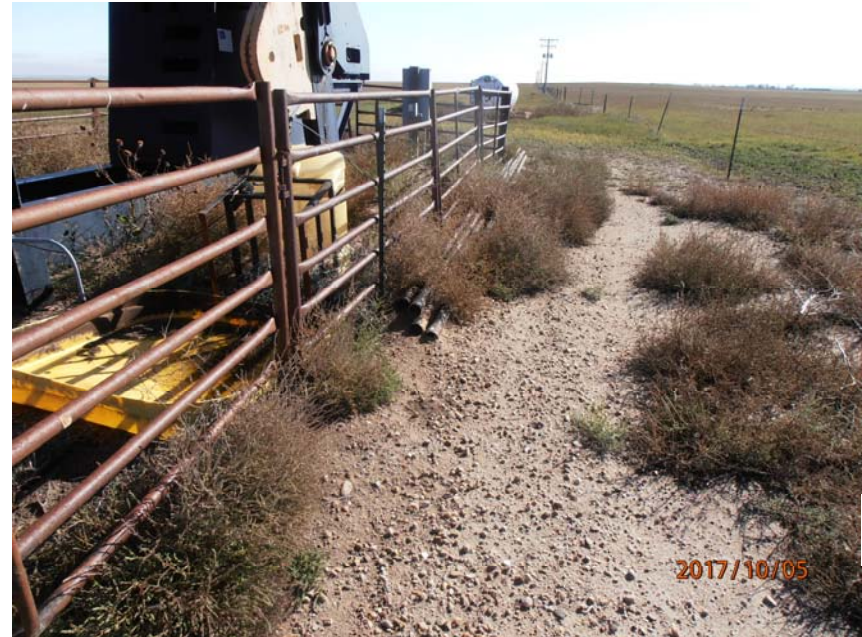
Photo 10: Unused pipe adjacent pumjack.

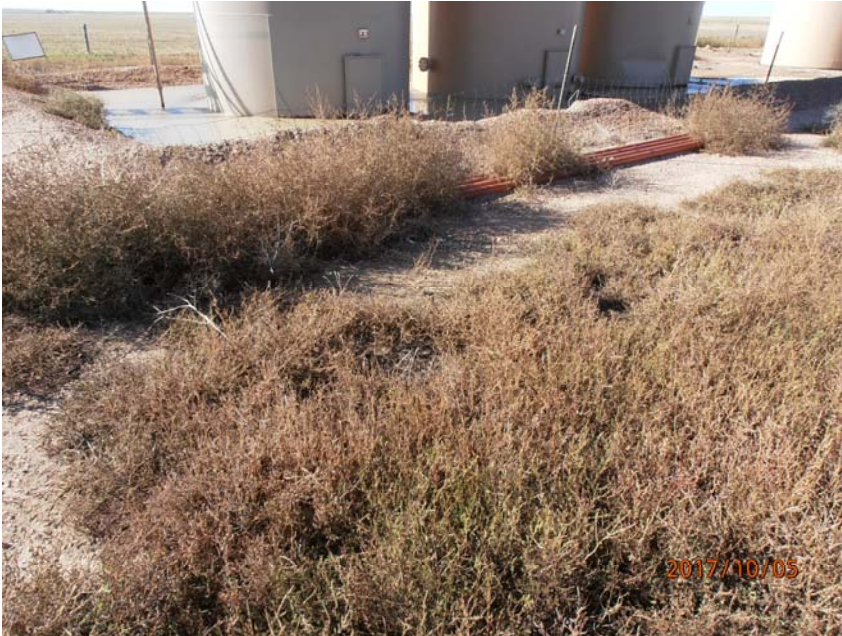
Photo 11: Unused piping and weeds at tank battery.

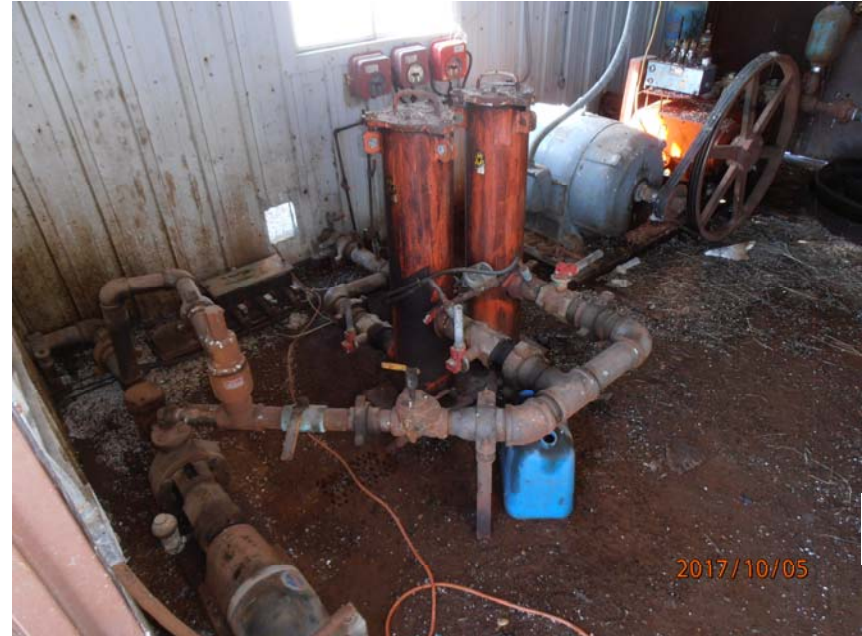
Photo 12: Leaks inside injection pumphouse.

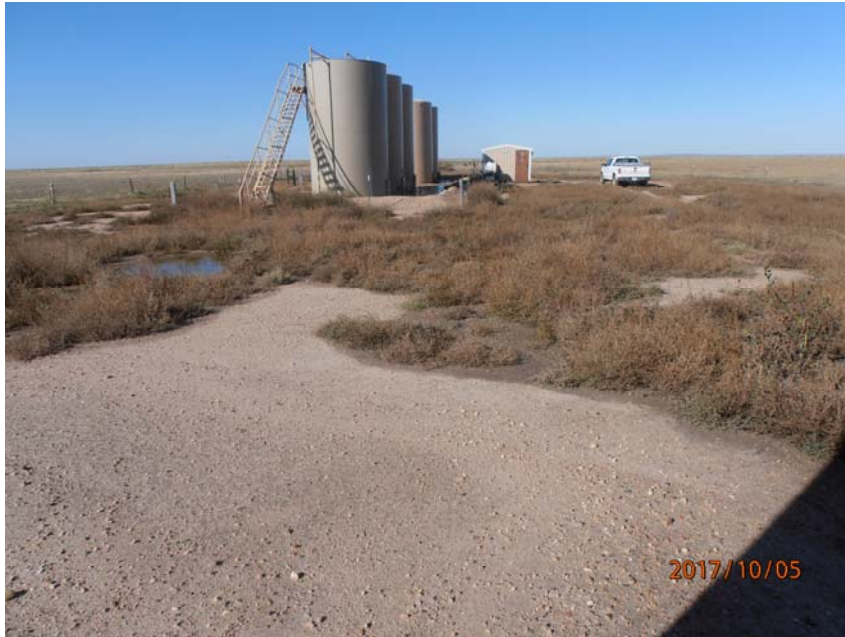
Photo 13: Overview of location, weeds on location.
