Inspection Photos

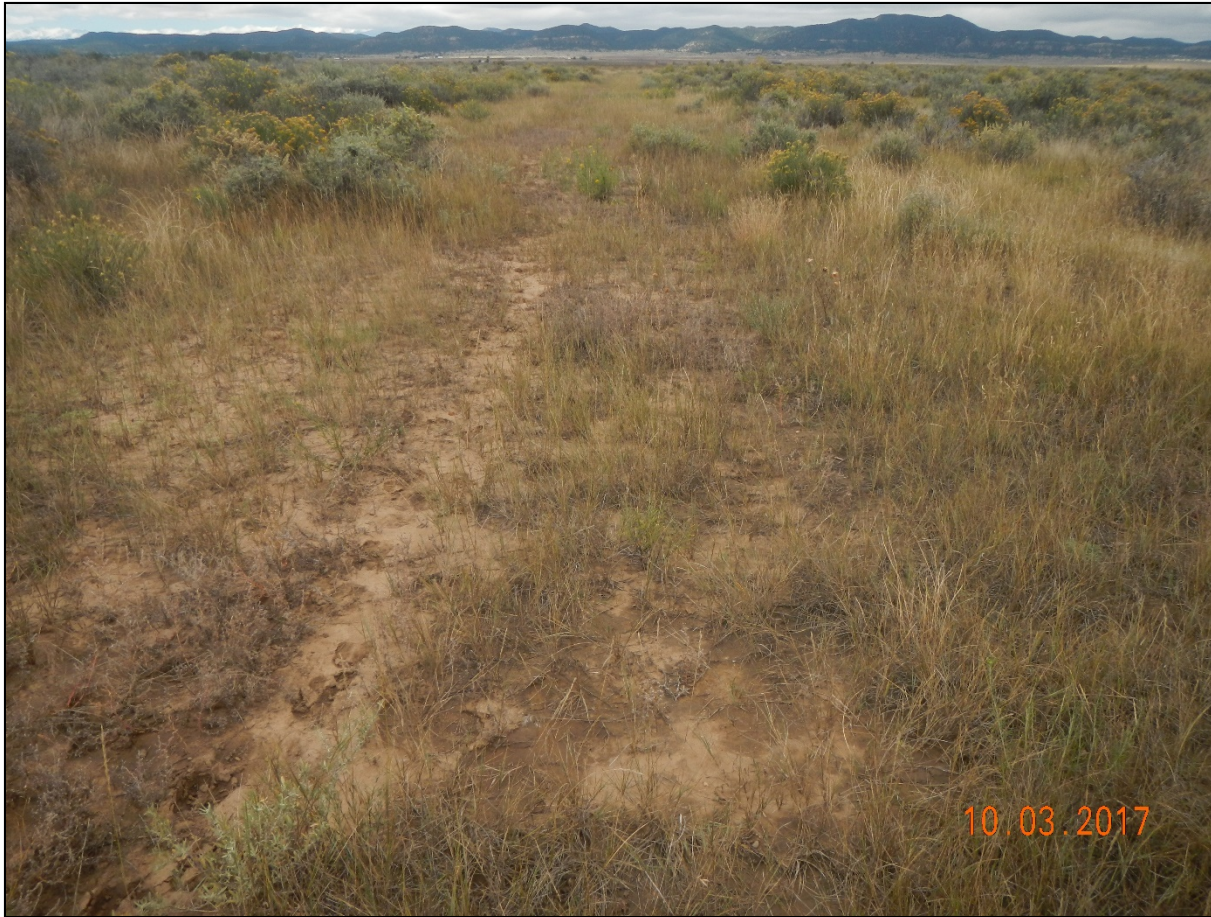
Photo 1. Facing west along the former access road.

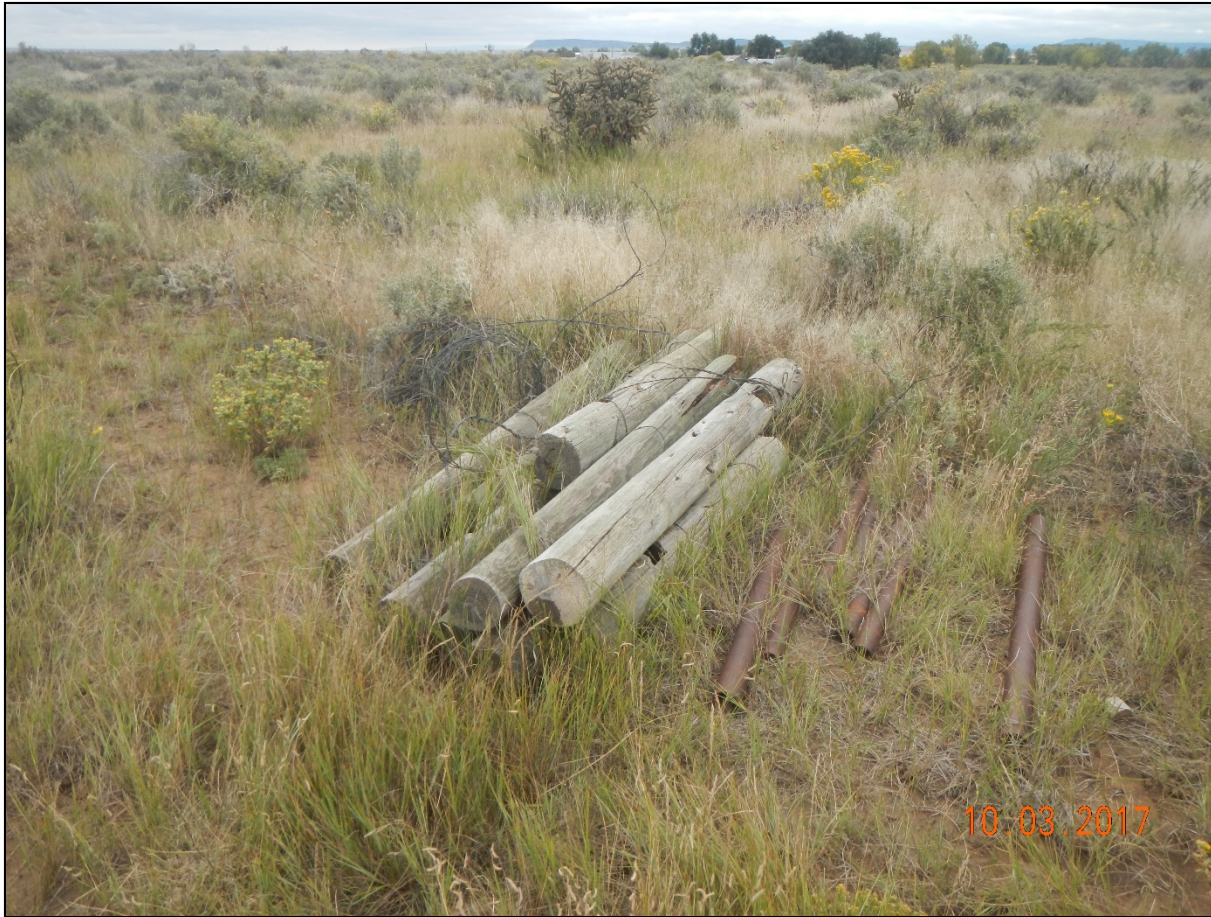
Photo 2. There are post and wire that remain at the east side of the location.

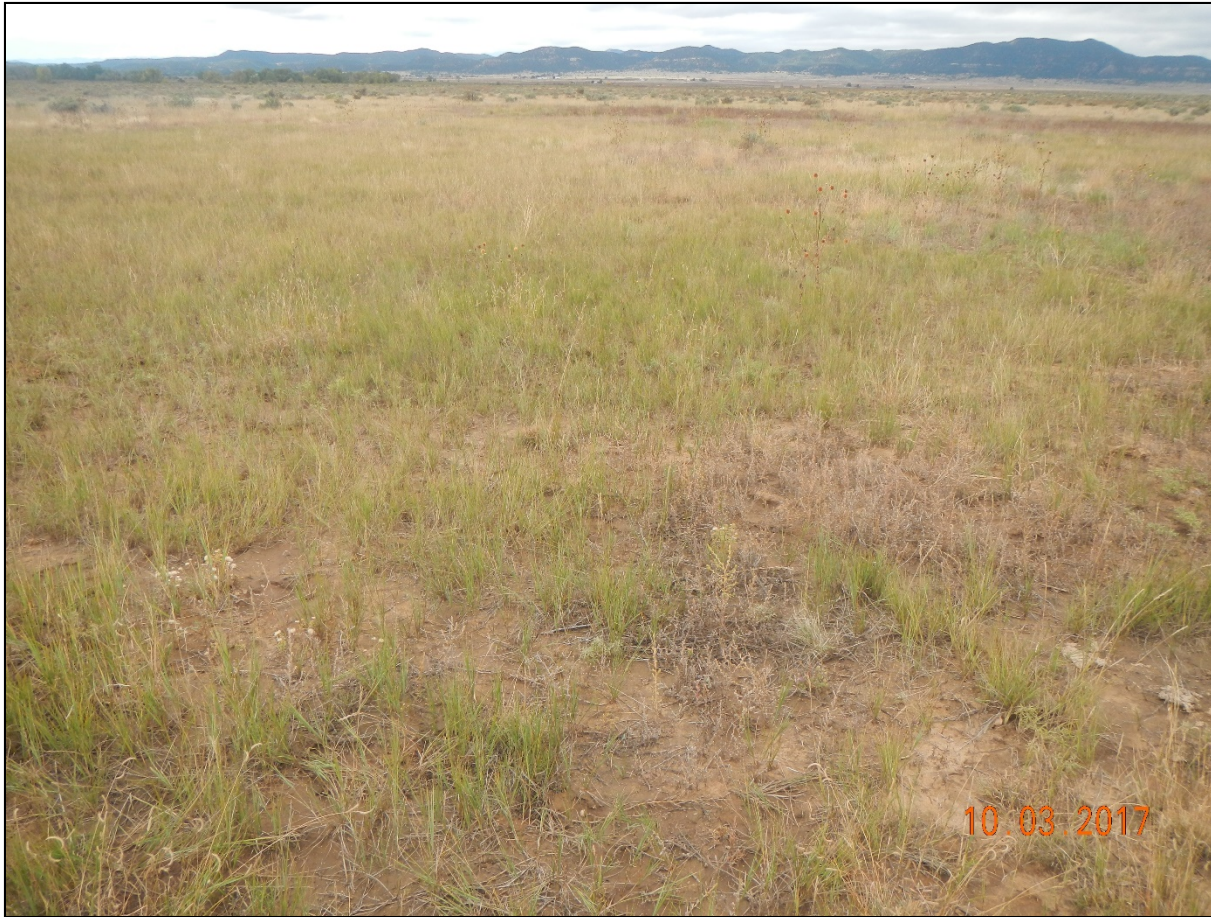
Photo 3. Facing west toward the location. The desirable vegetation along the eastern portion of the location has re-established.

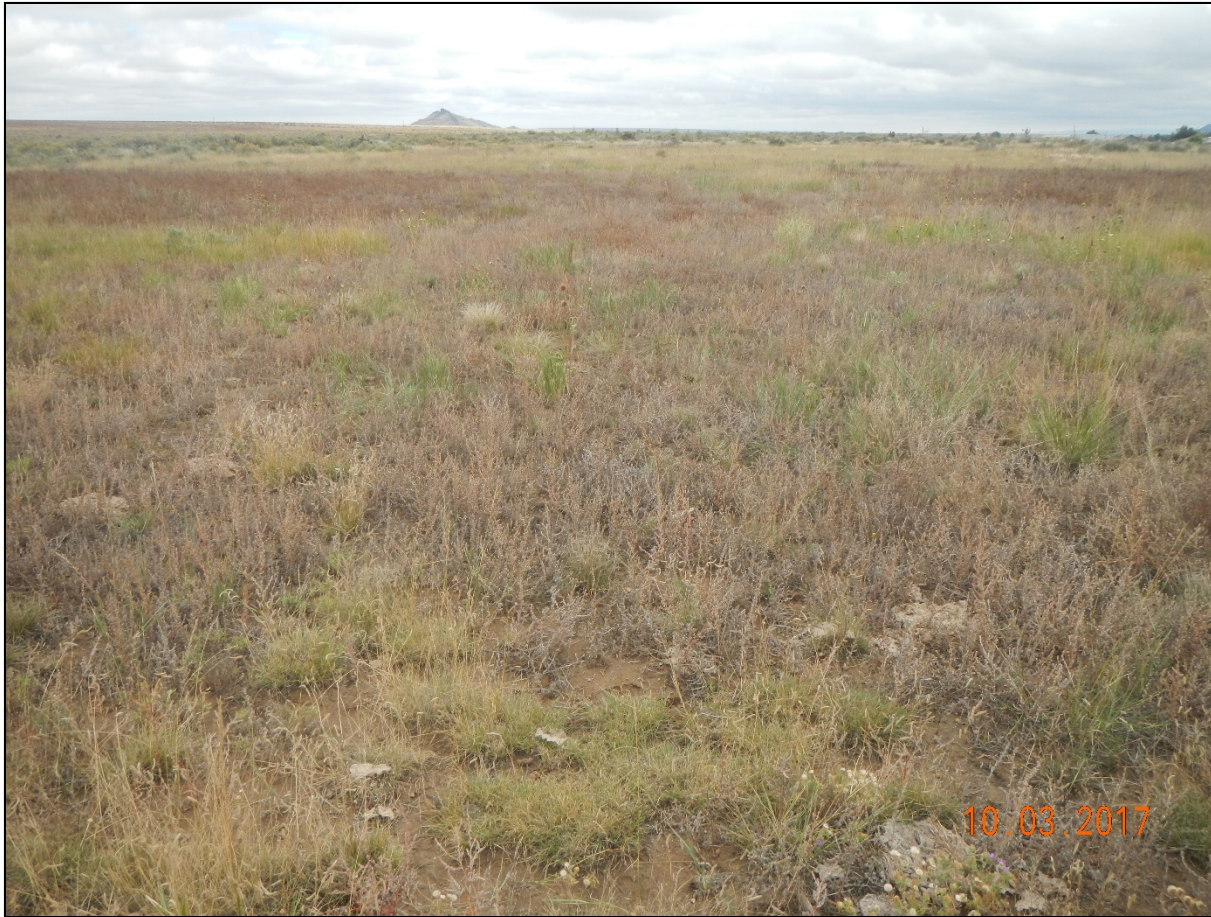
Photo 4. West side of the location facing east. The desirable vegetation has not adequately established at the western portion of the location.

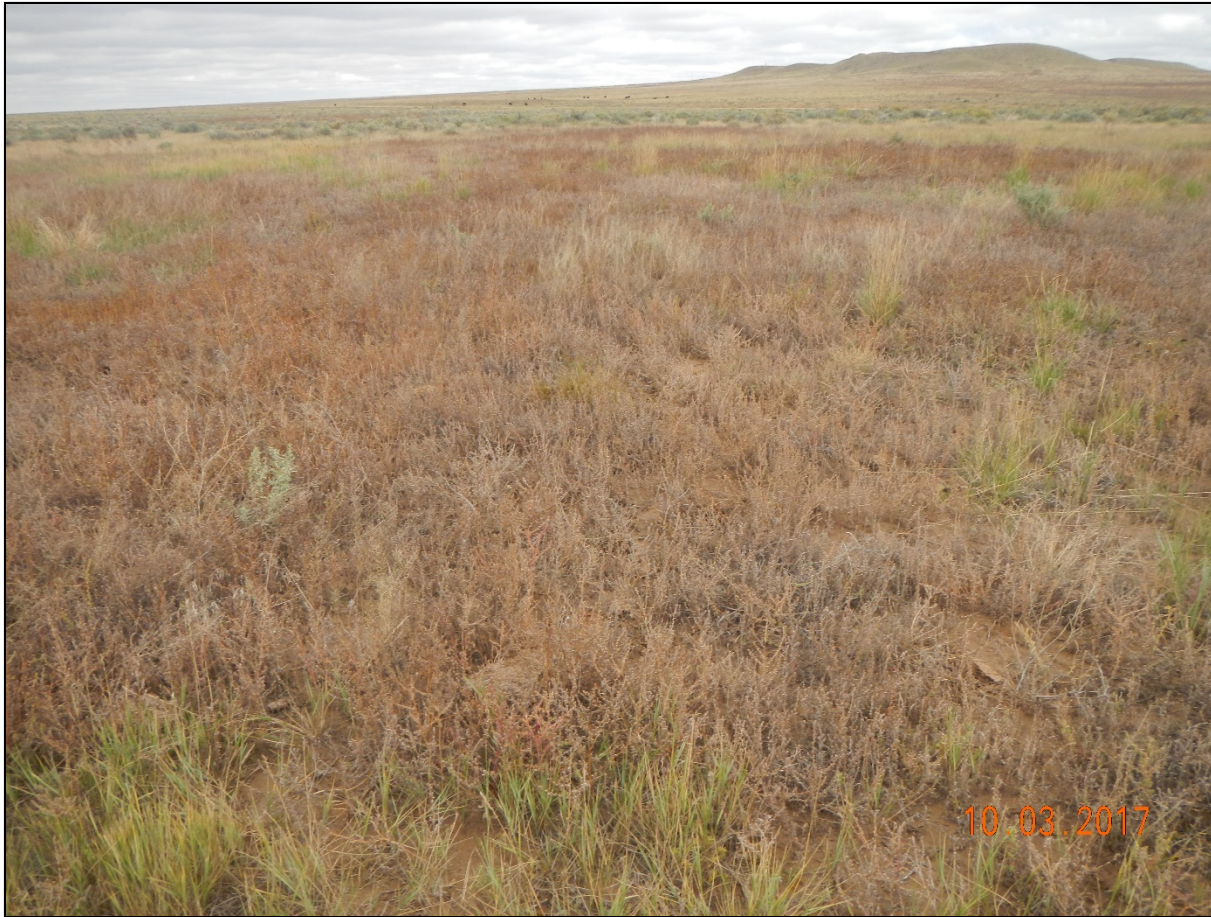
Photo 5. West side of the location facing northeast. The brown vegetation is undesirable weed growth (Kochia).

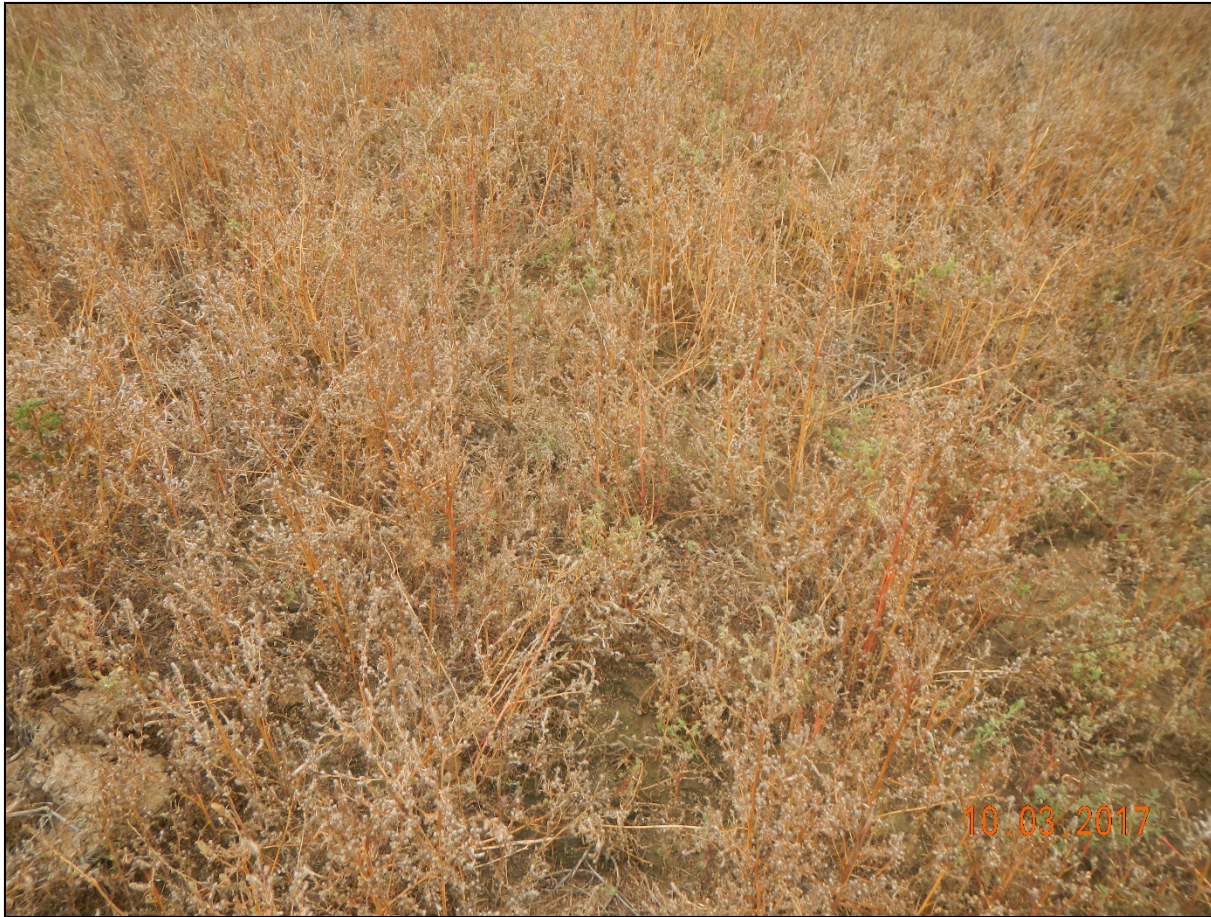
Photo 6. There is undesirable weed growth throughout the western portion of the location.

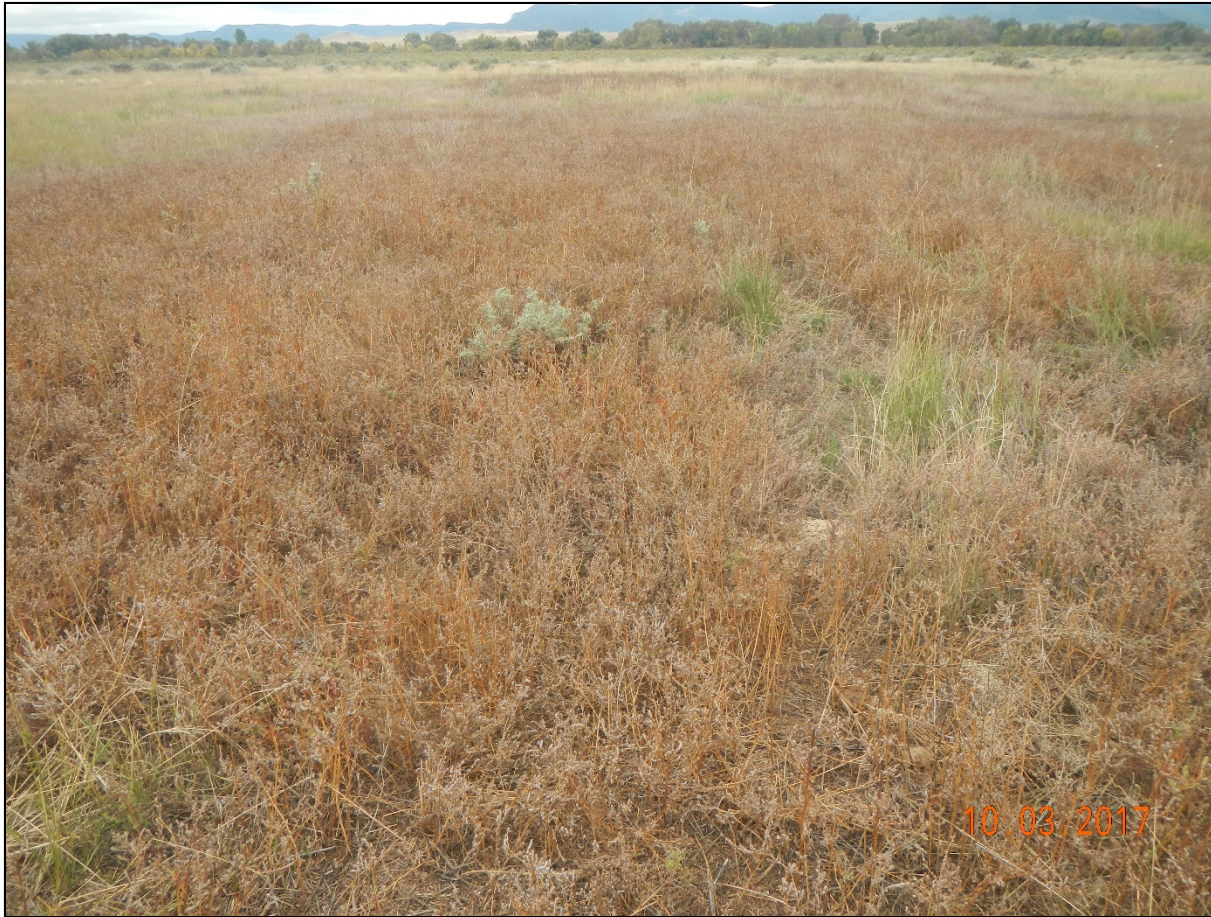
Photo 7. North side of the location facing southwest. This area does not have adequate desirable vegetation establishment.

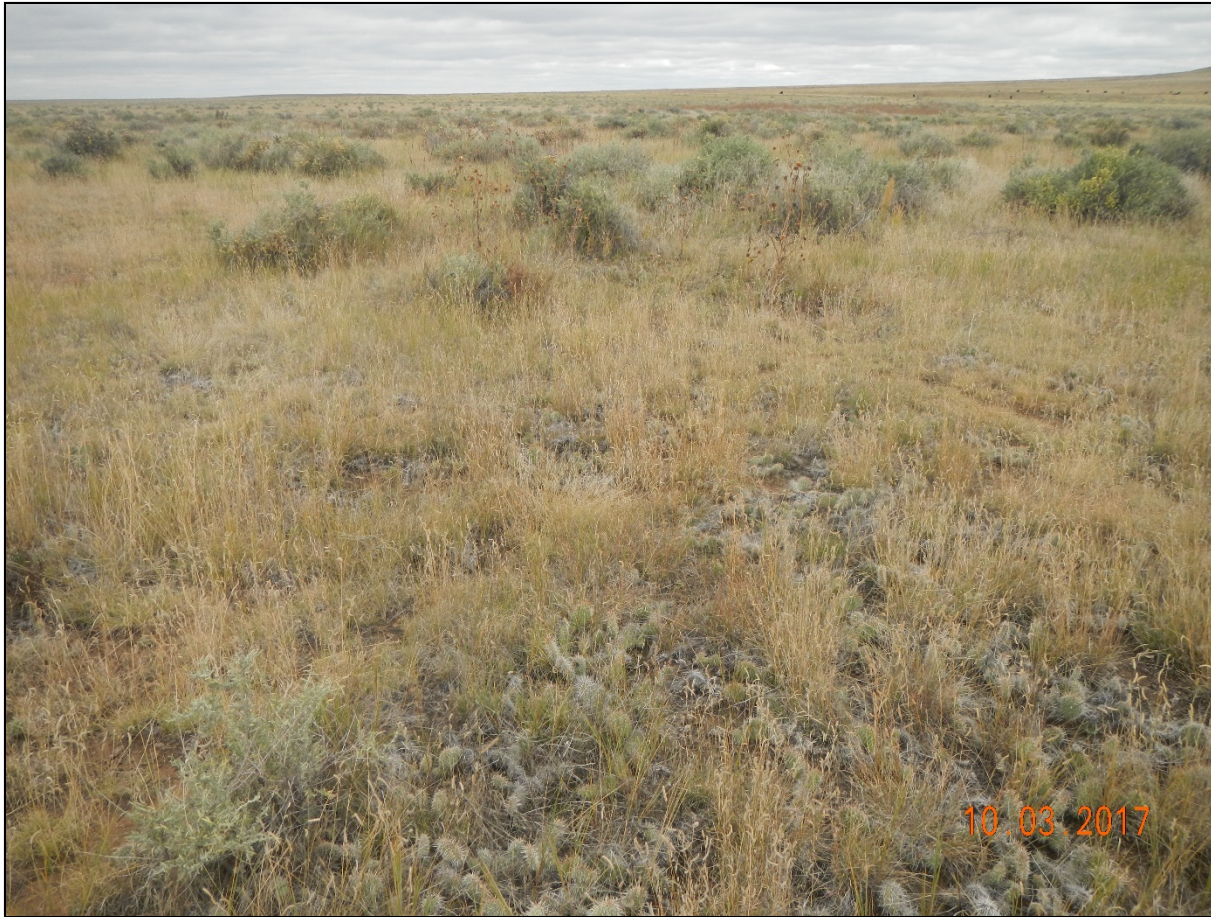
Photo 8. Facing north off the location toward the undisturbed vegetation.
