Inspection Photos  
Location Name SP 431-14  
API: 05-045-19704

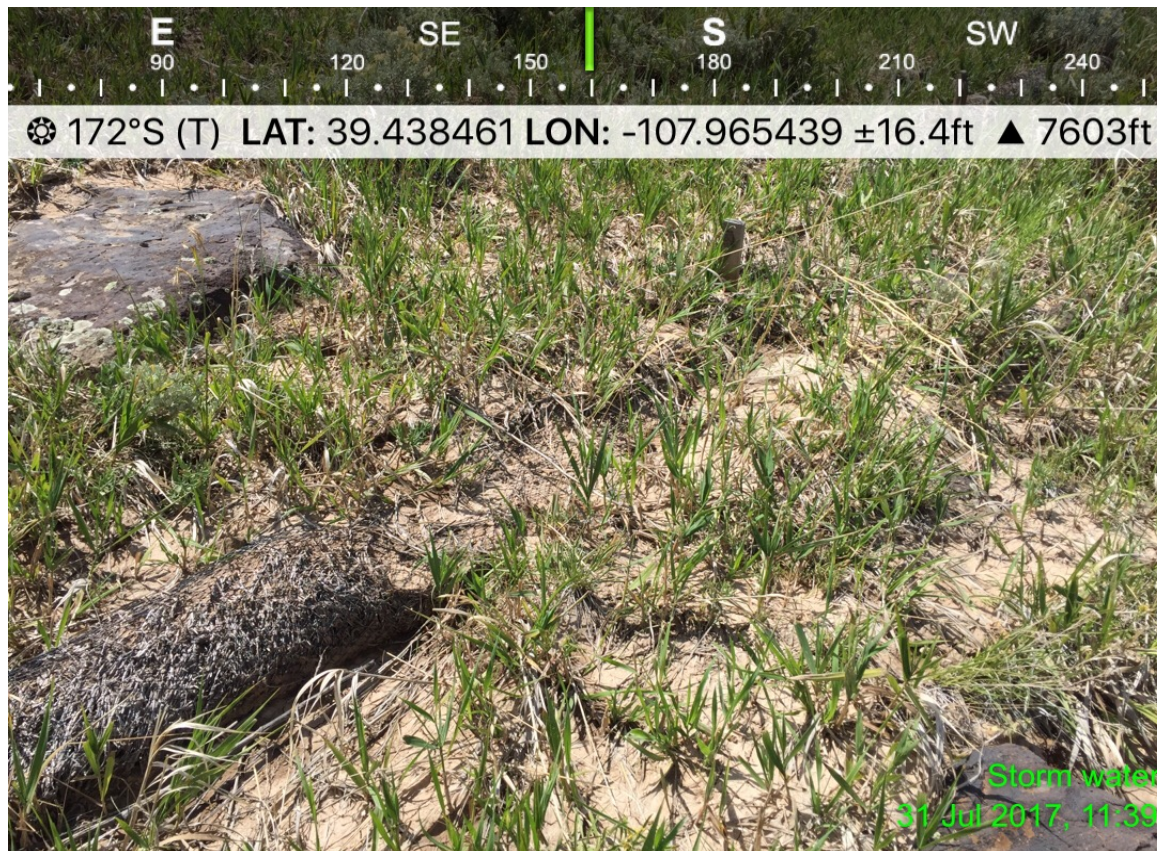
**Photo 1. BMP damaged or not maintained**
