## Inspection Photos

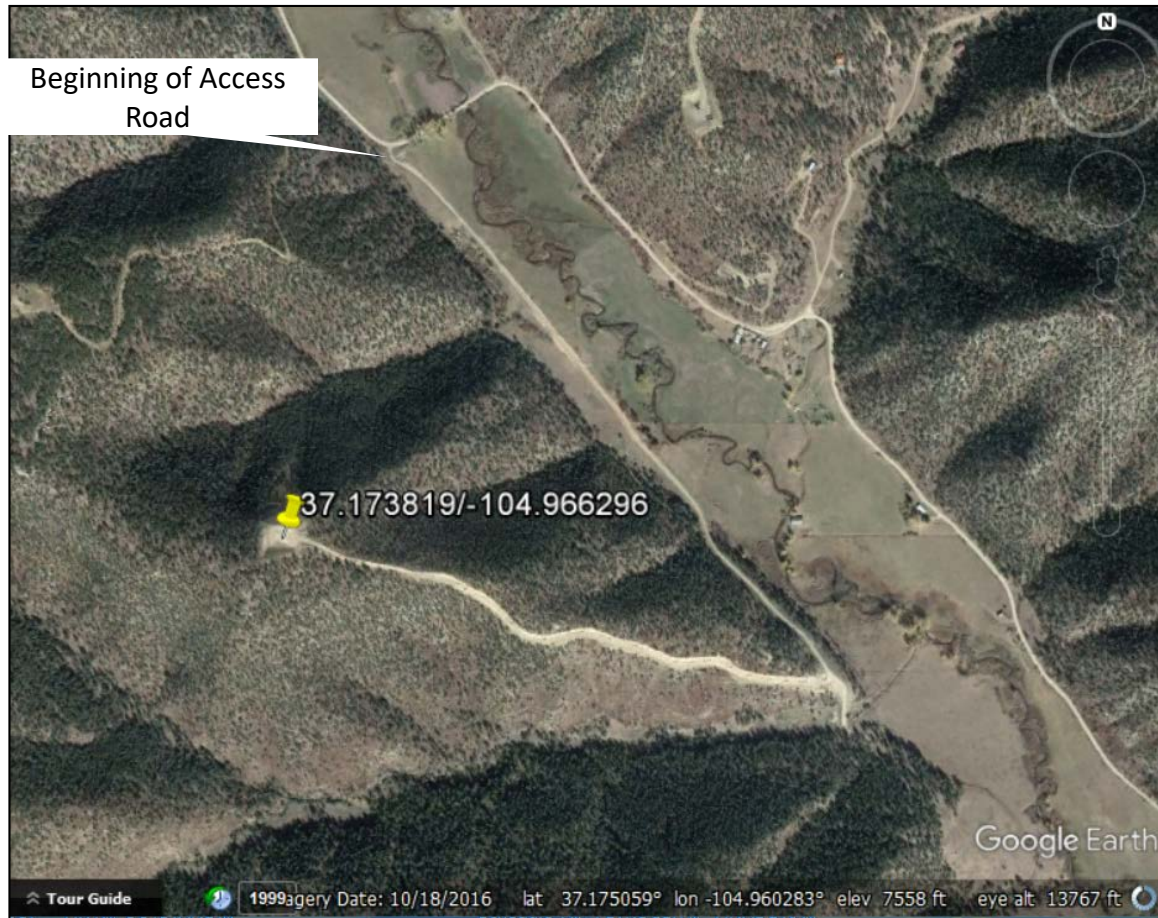
**Photo 1.** 2016 aerial image of the access road and location.

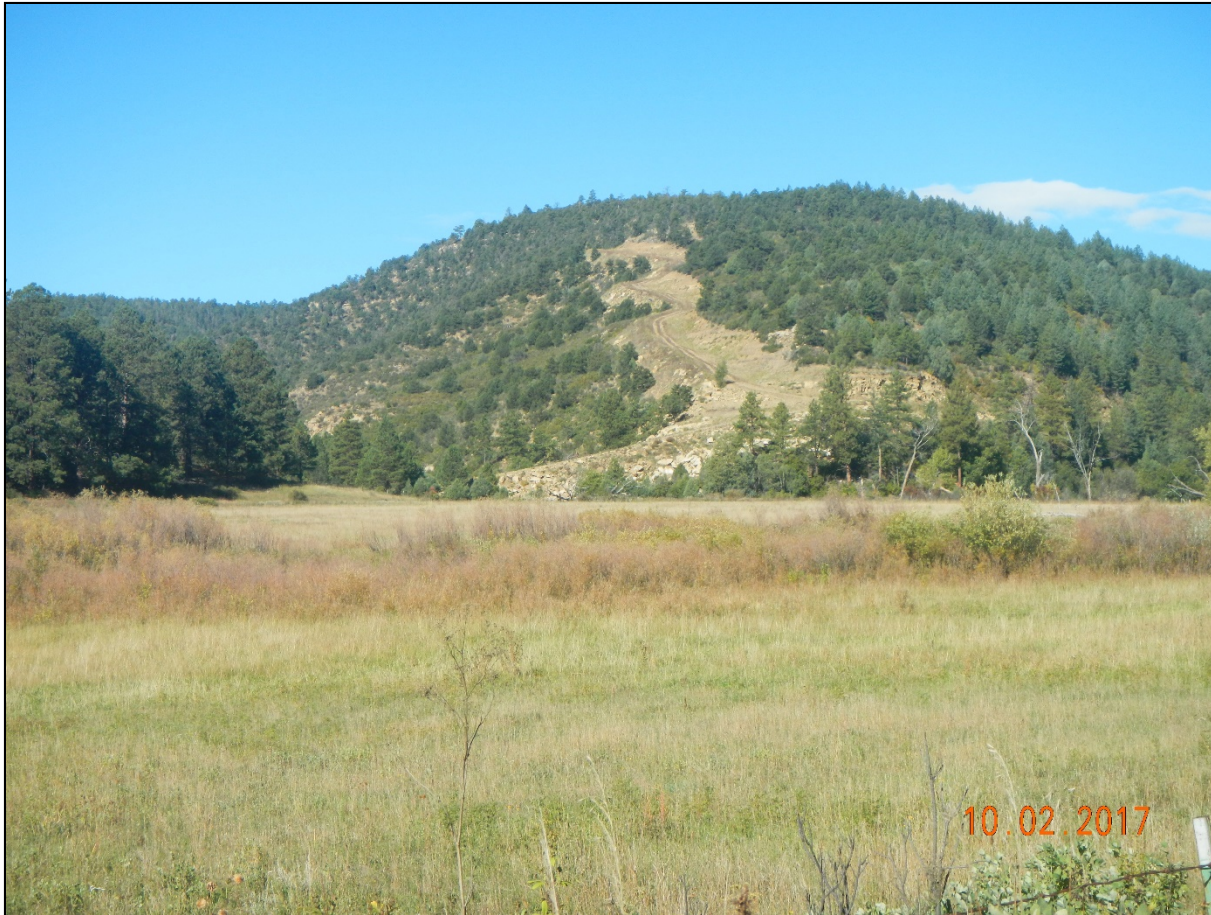
**Photo 2.** View of the access road from the county road.

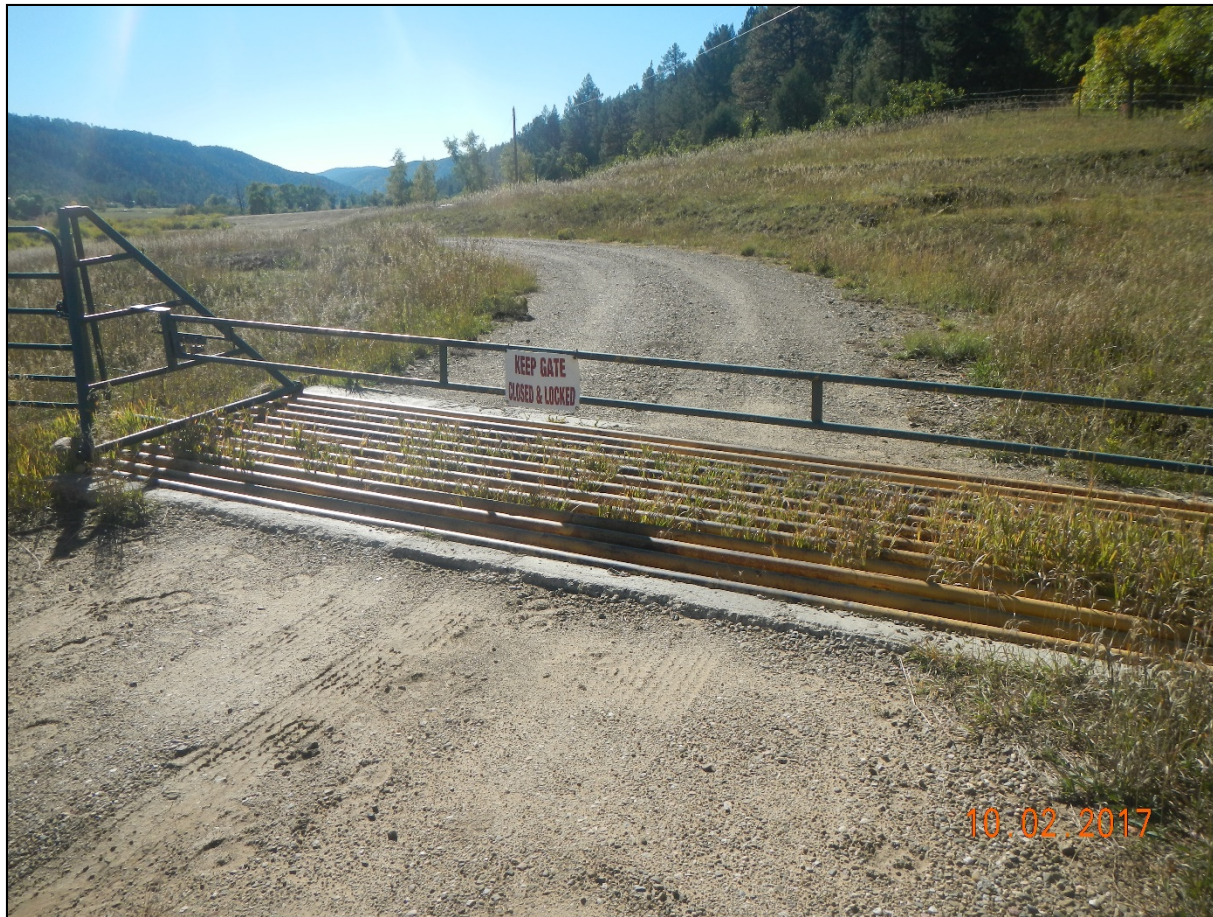
**Photo 3.** Beginning of the access road.

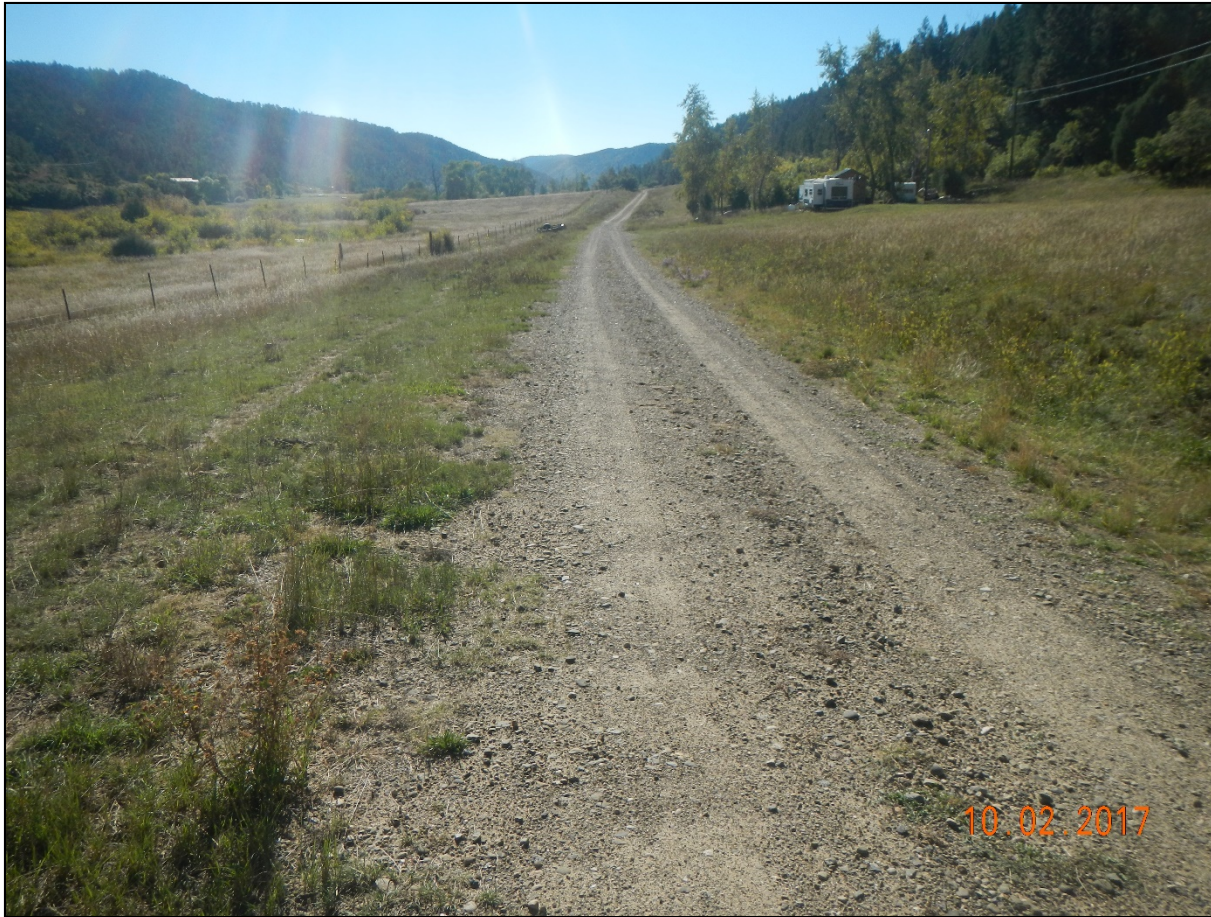
**Photo 4.** Facing southeast along the access road.

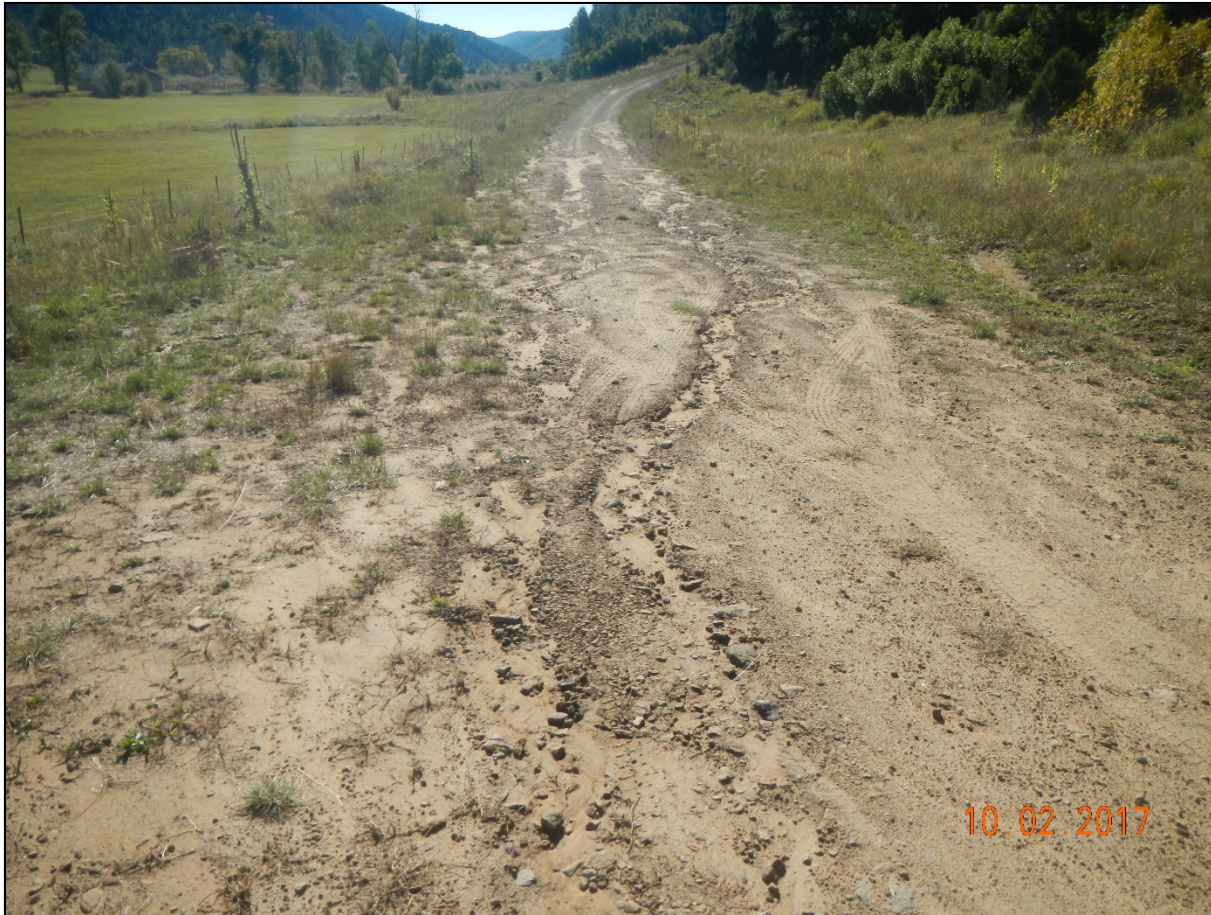
**Photo 5.** Facing southeast along the access road. There are stormwater issues occurring in this area.

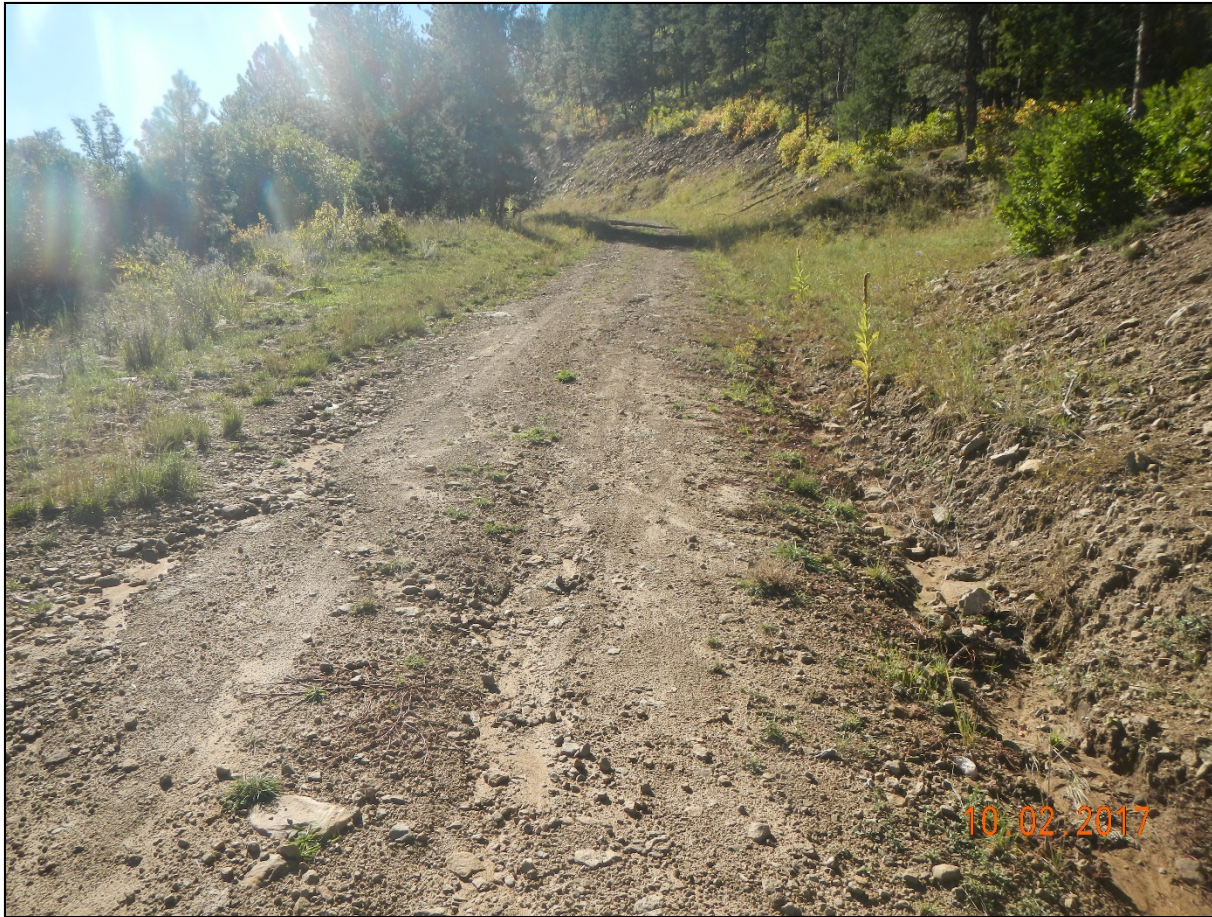
**Photo 6.** Facing southeast, the access road begins to ascend the hillside.

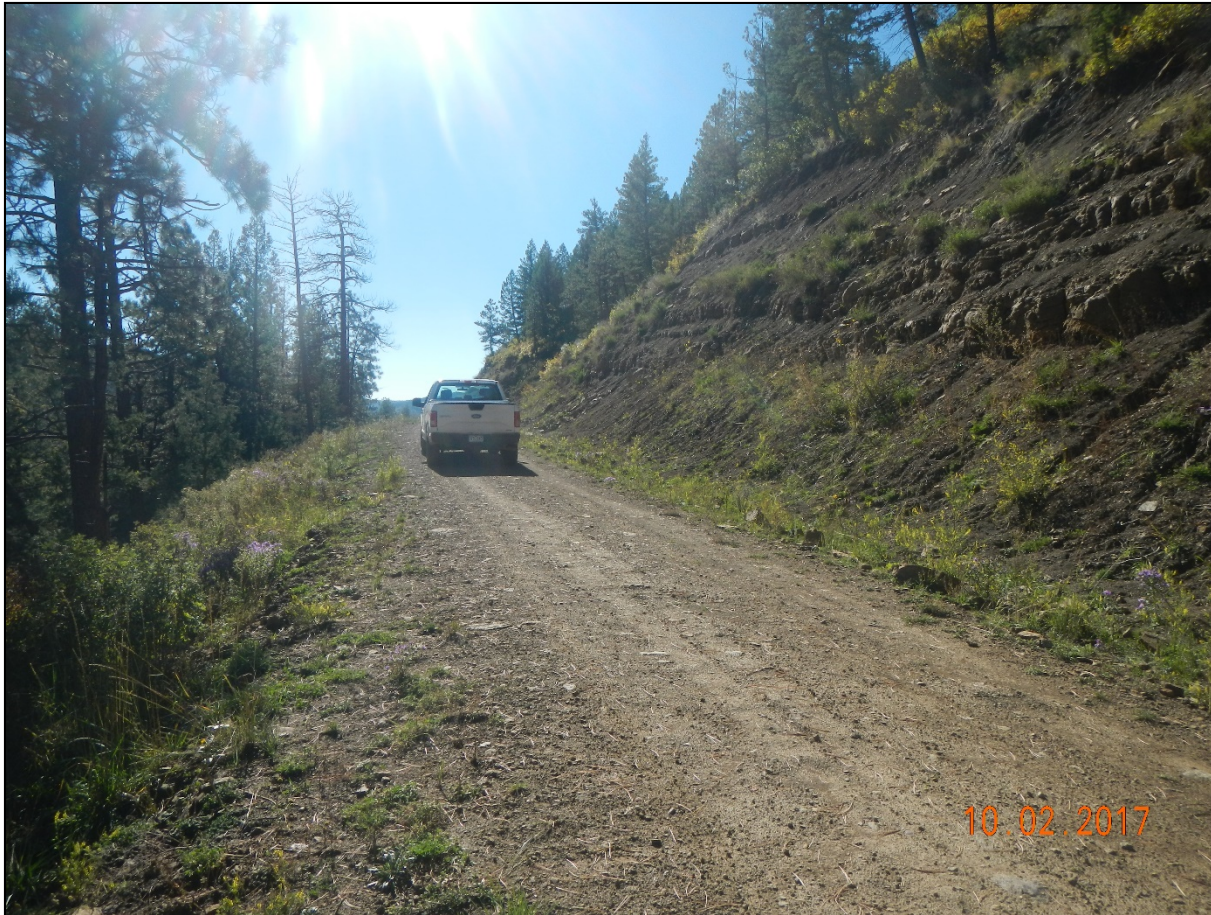
**Photo 7.** Facing southeast along the access road.

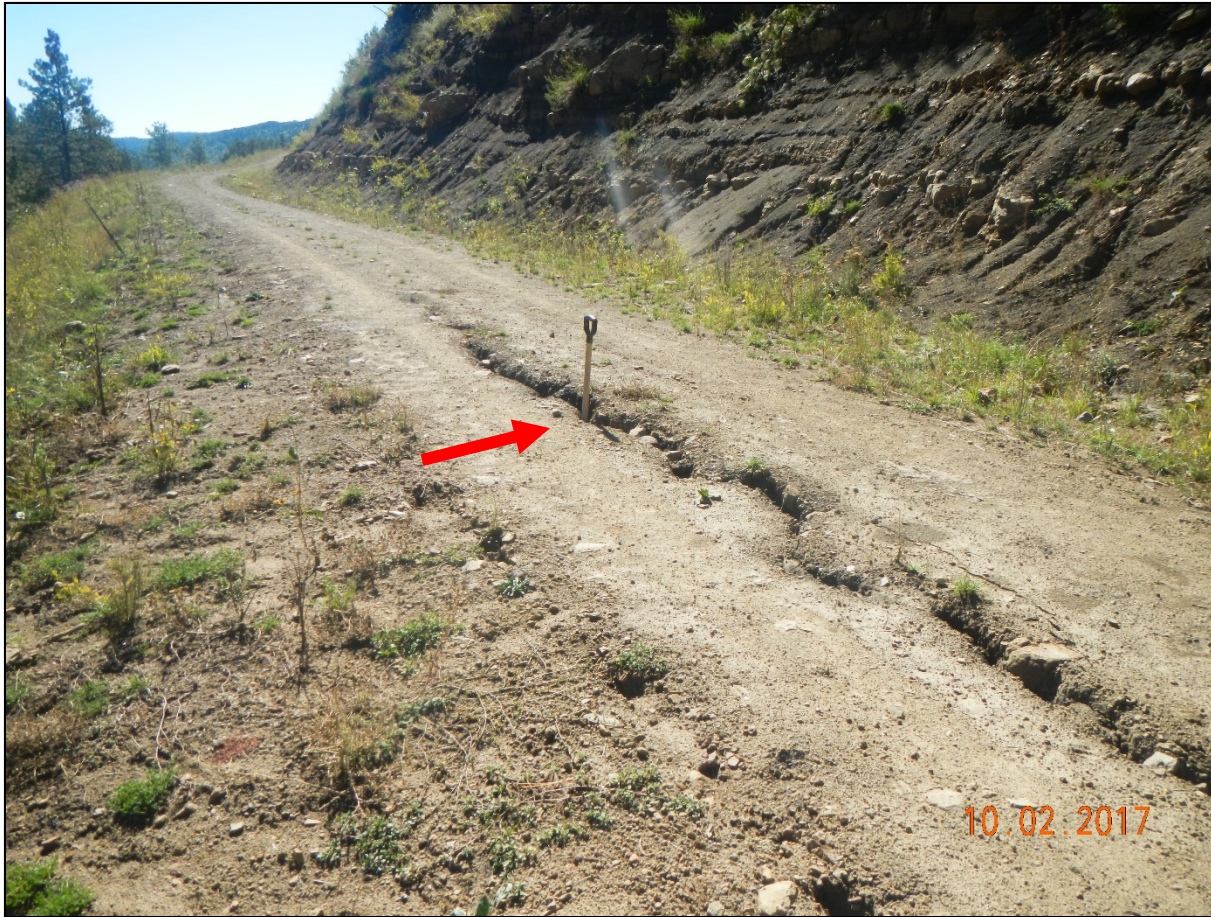
**Photo 8.** Facing southeast along the access road. There is signs of potential sloughing along the road. Arrow points to 3.5 ft. shovel placed into the surface opening.

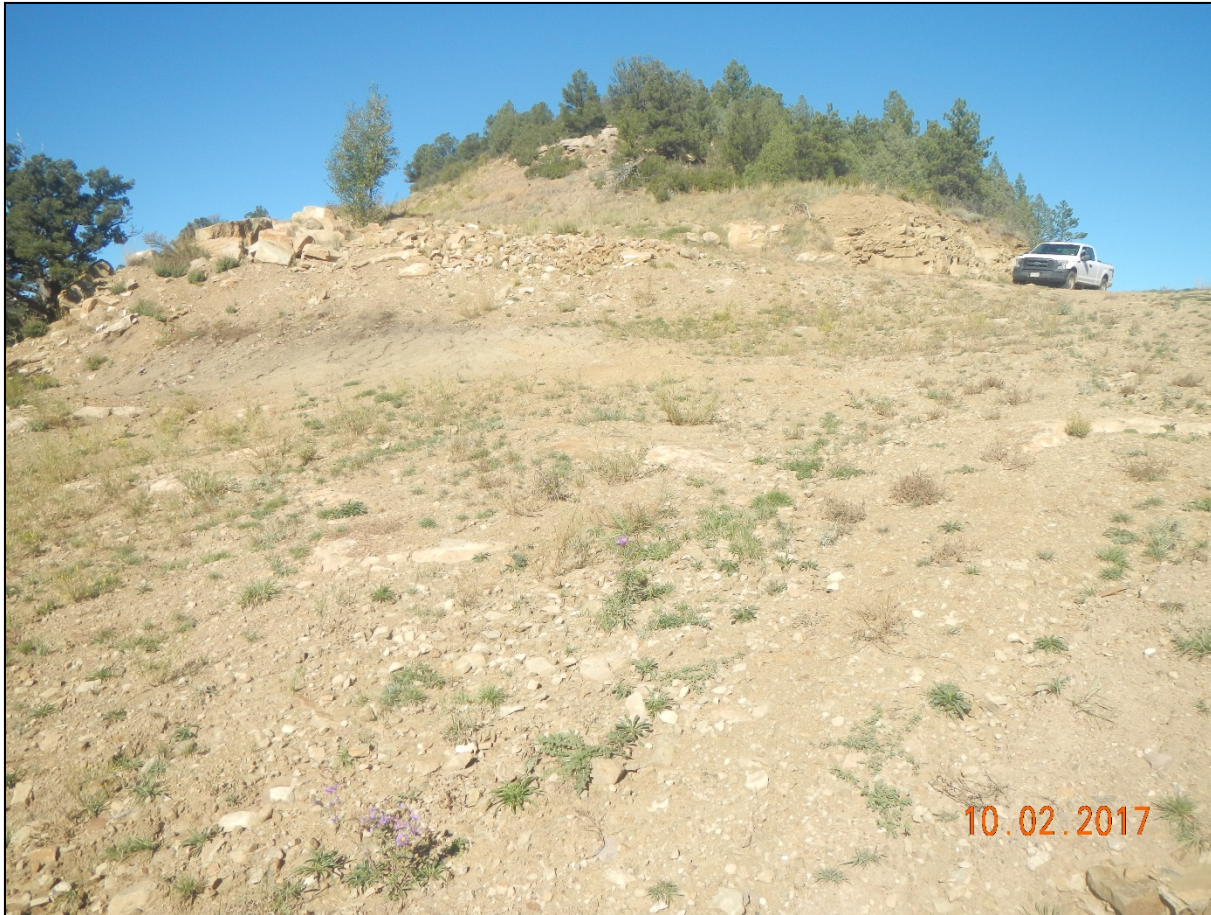
**Photo 9.** Facing northwest where the access road turns and ascends up the hillside.

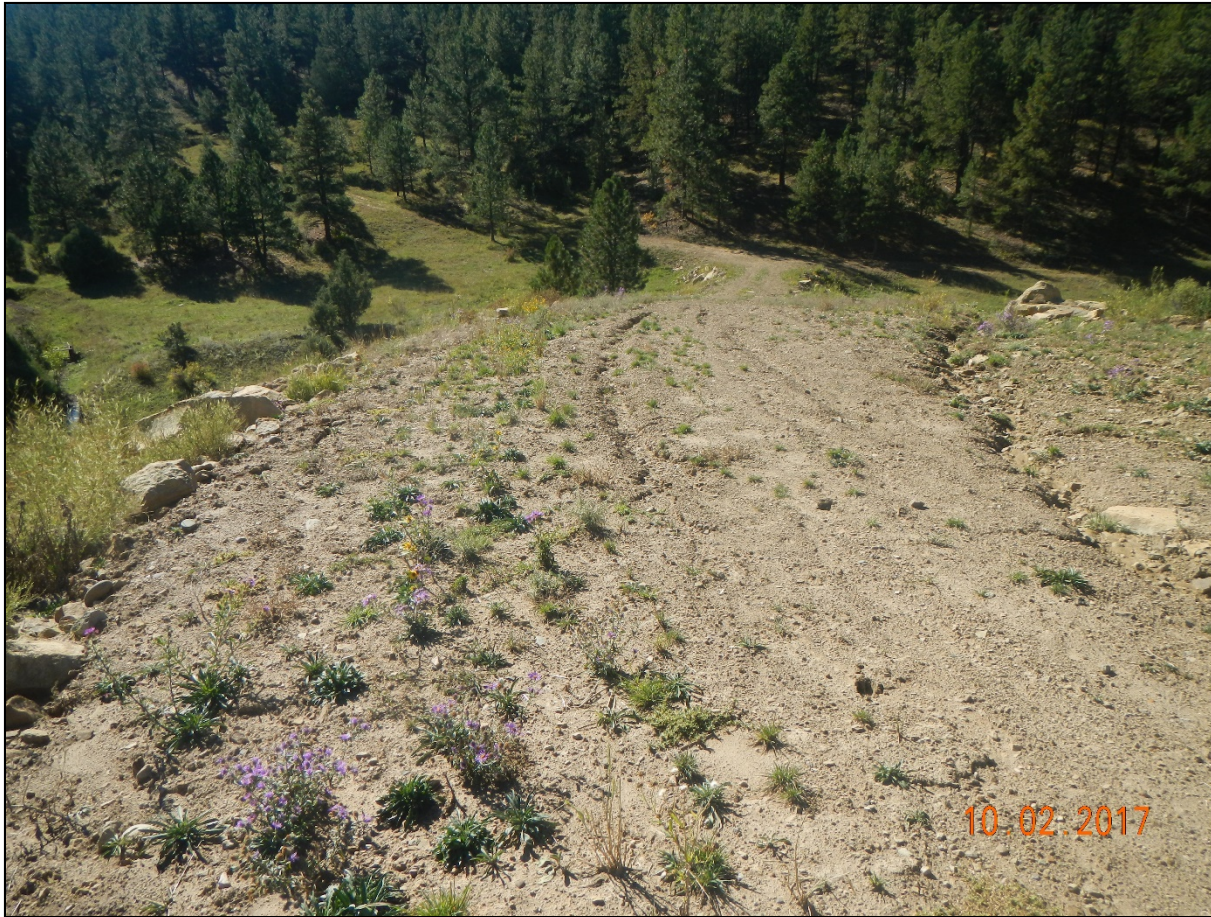
**Photo 10.** Facing south where the access road continues to the bottom of the canyon. There are erosion issues occurring down the road.

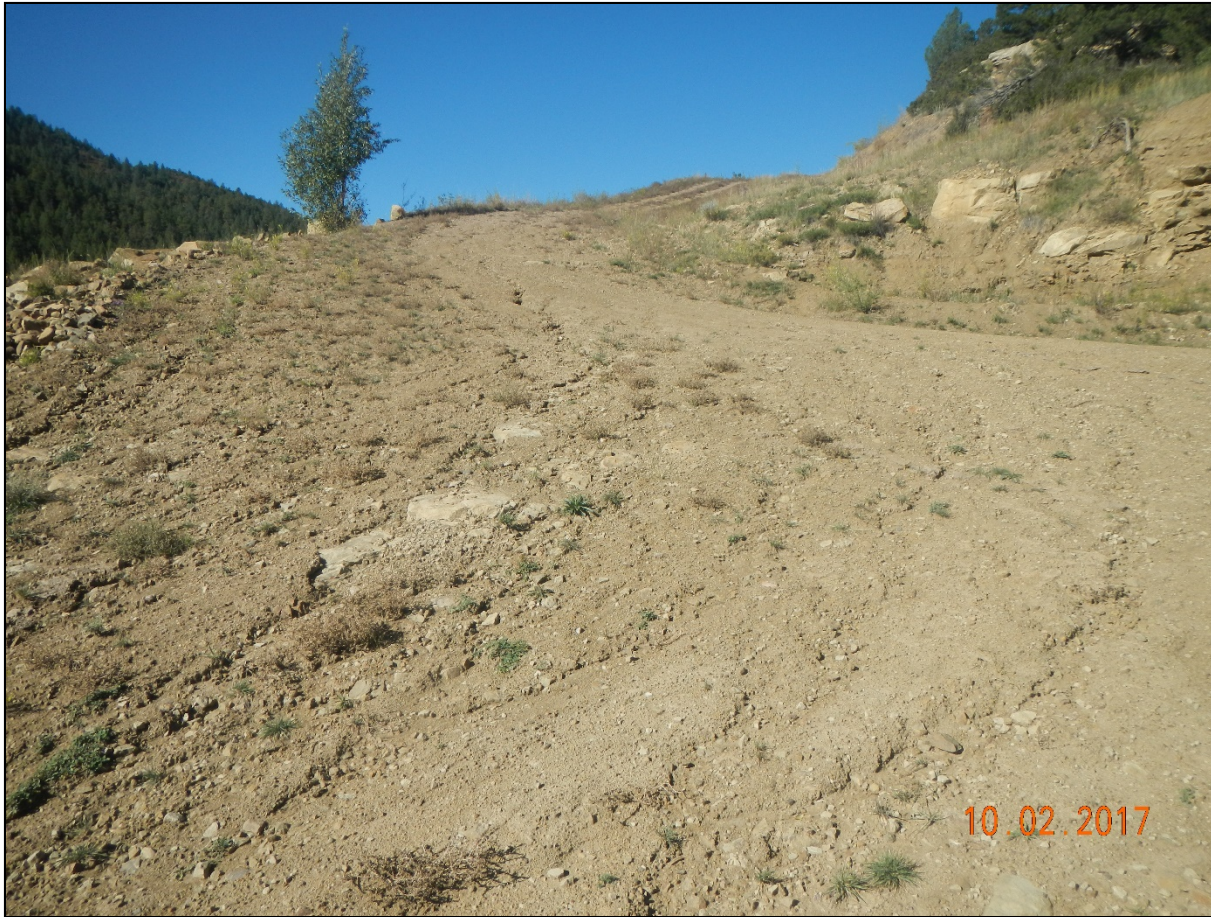
**Photo 11.** Facing northwest where the access road turns and ascends the hillside. There are signs of erosion occurring down the road.

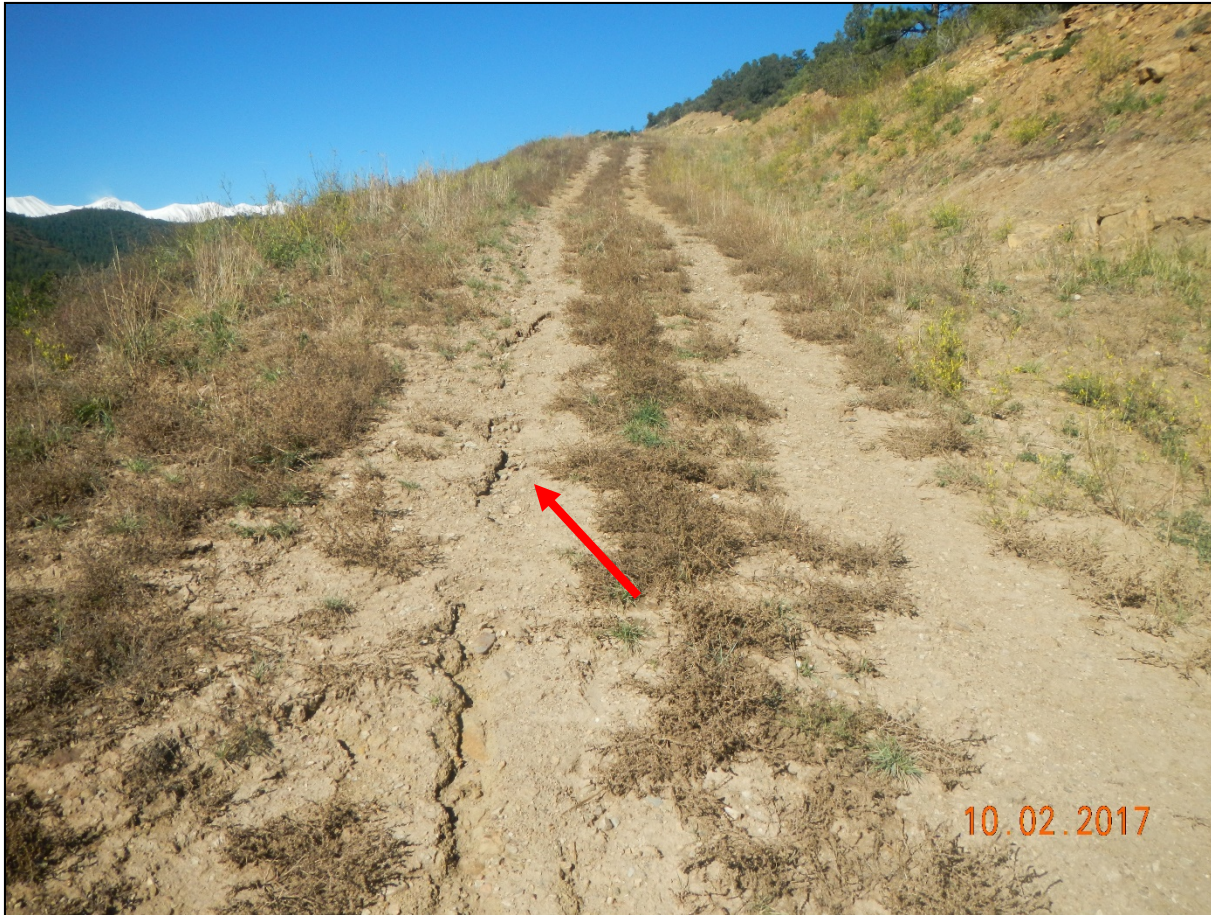
**Photo 13.** Facing northwest where the access road ascends the hillside. There are signs of erosion rilling occurring down the road.

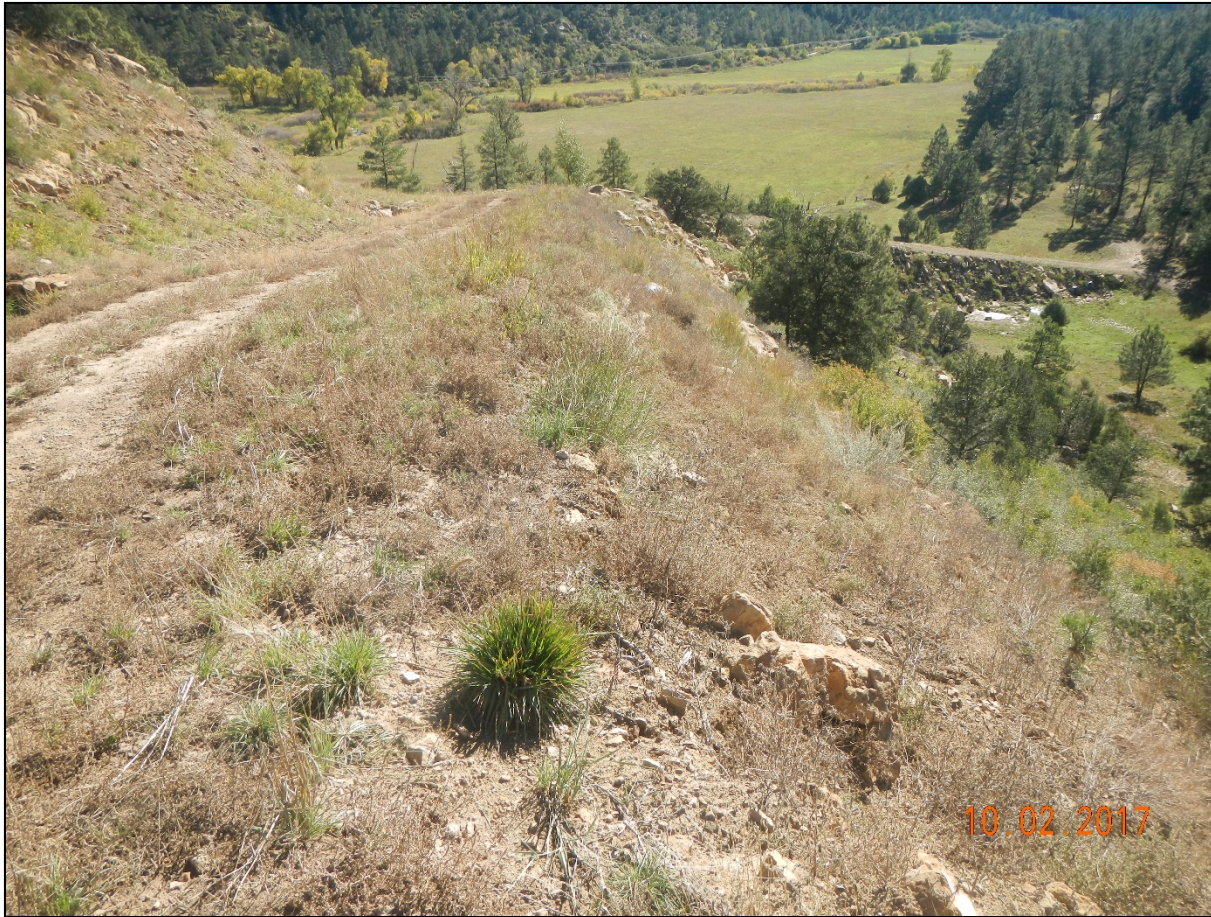
**Photo 13.** Facing southeast back down the access road. There is predominately undesirable vegetation along the fill slope.

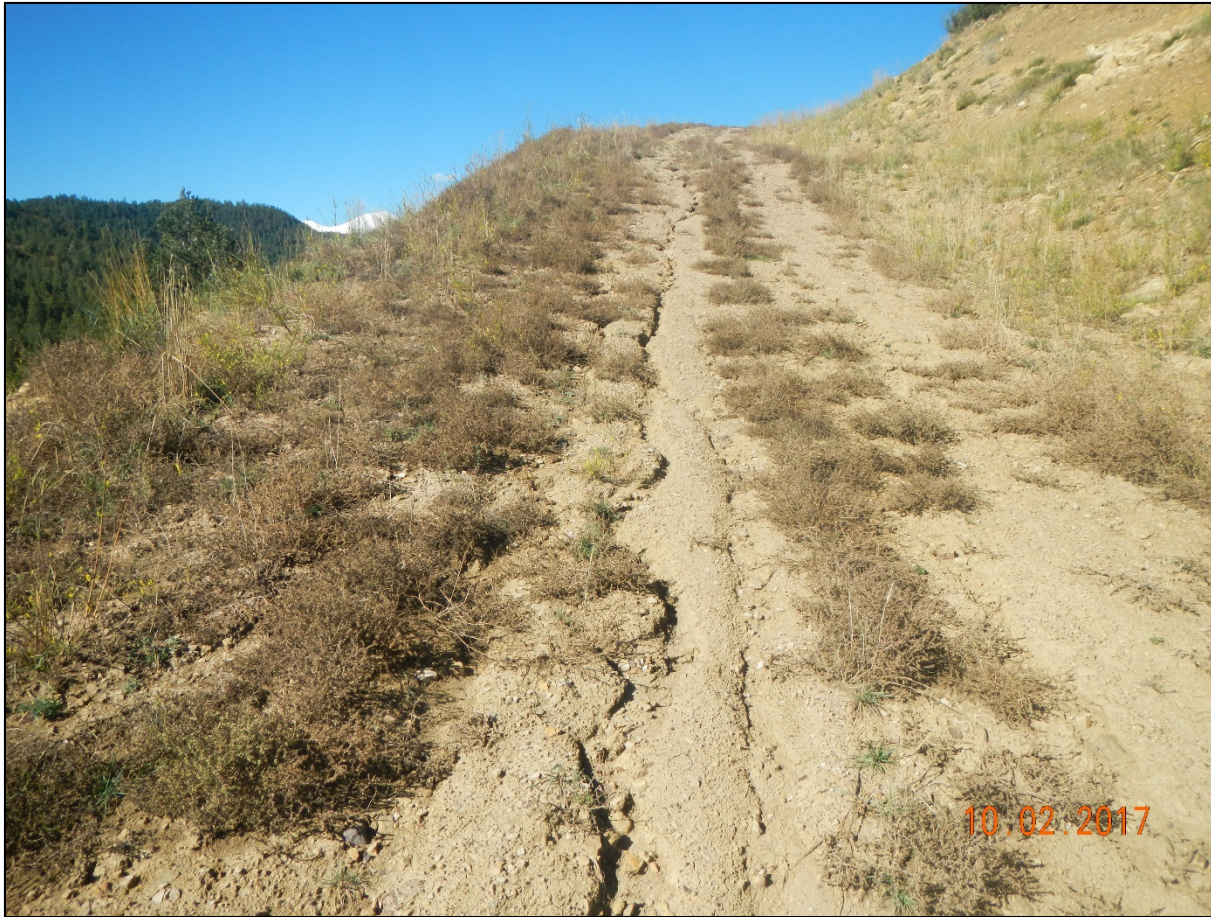
**Photo 14.** Facing northwest where the access road ascends the hillside. There are signs of erosion rilling occurring down the road.

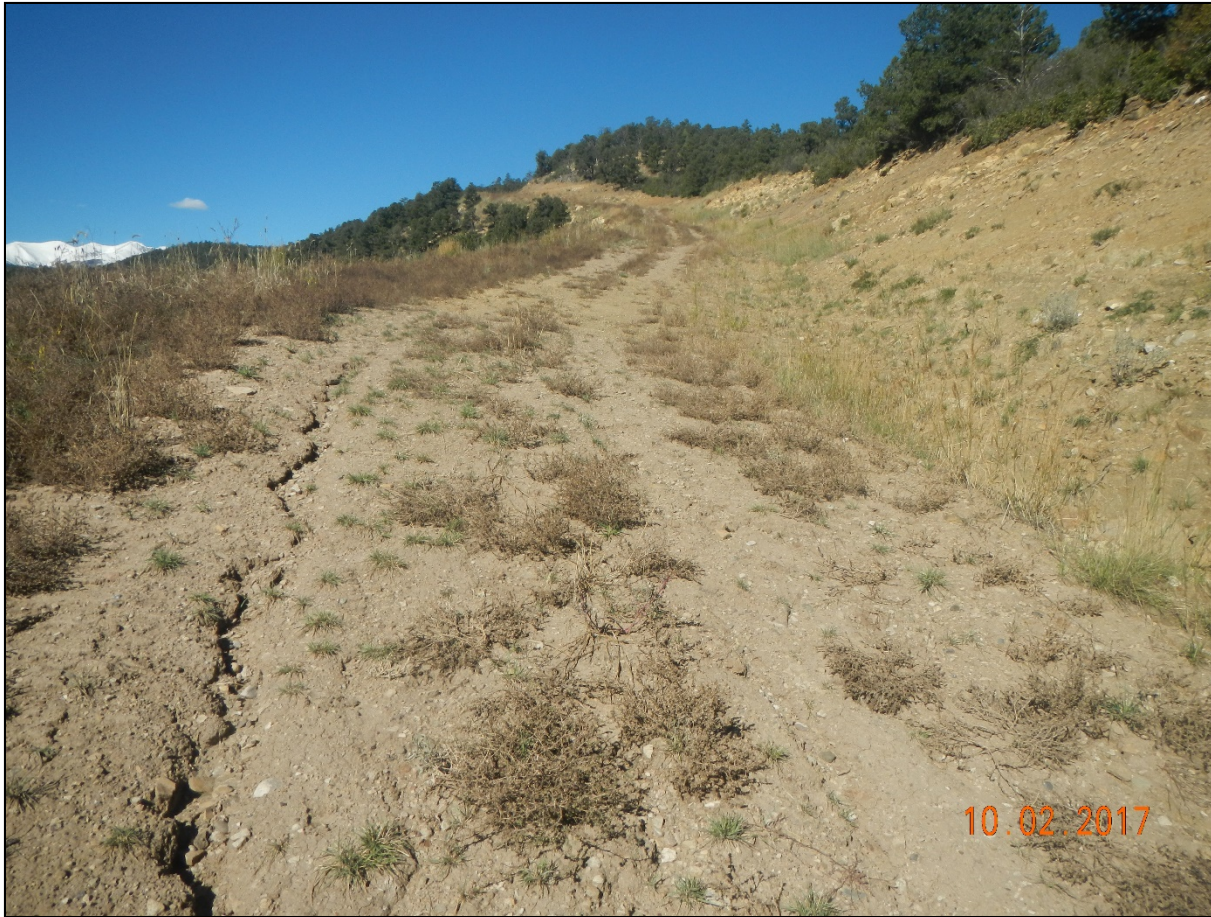
**Photo 15.** Facing northwest where the access road ascends the hillside. There are signs of erosion rilling occurring down the road.

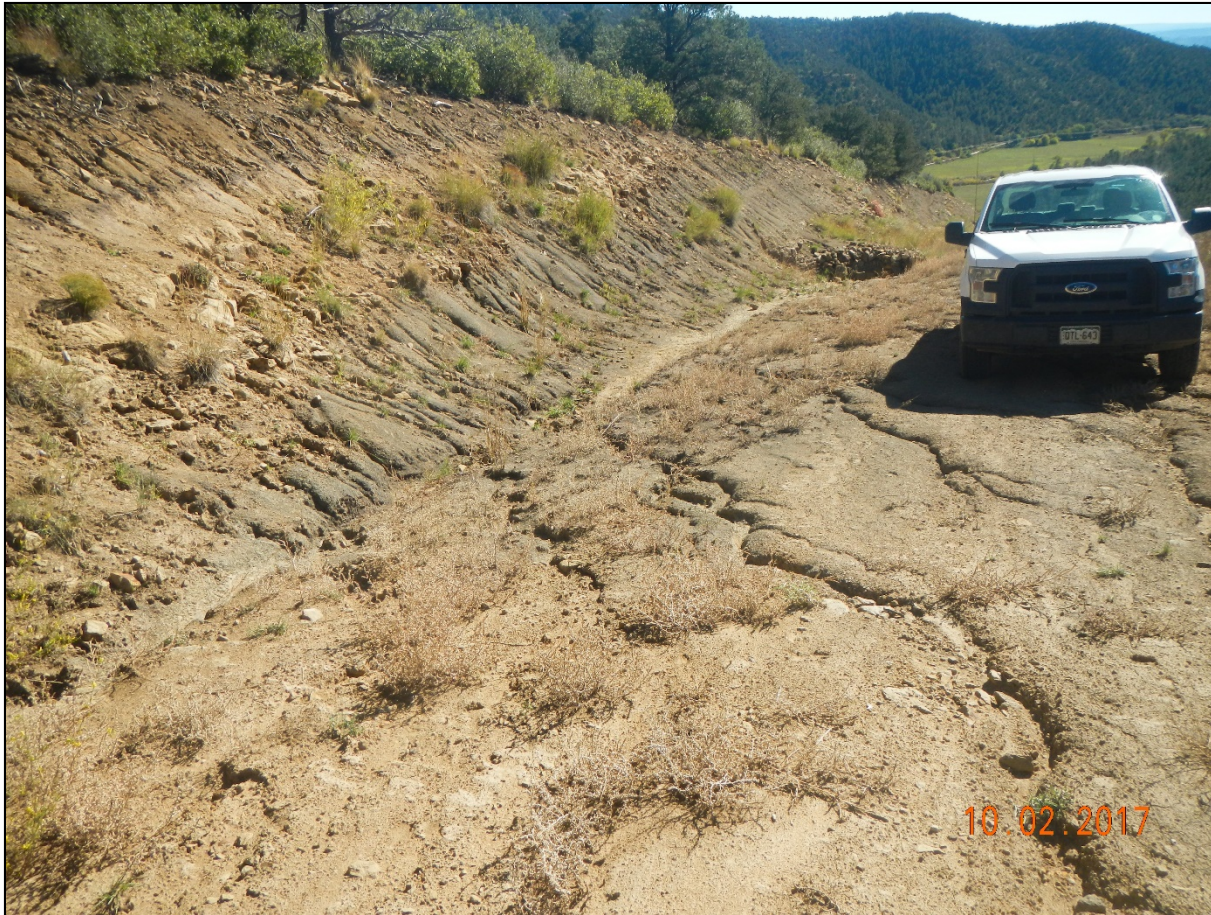
**Photo 16.** Facing back down the road. The cut slope is not adequately stabilized and there is erosion occurring down the road.

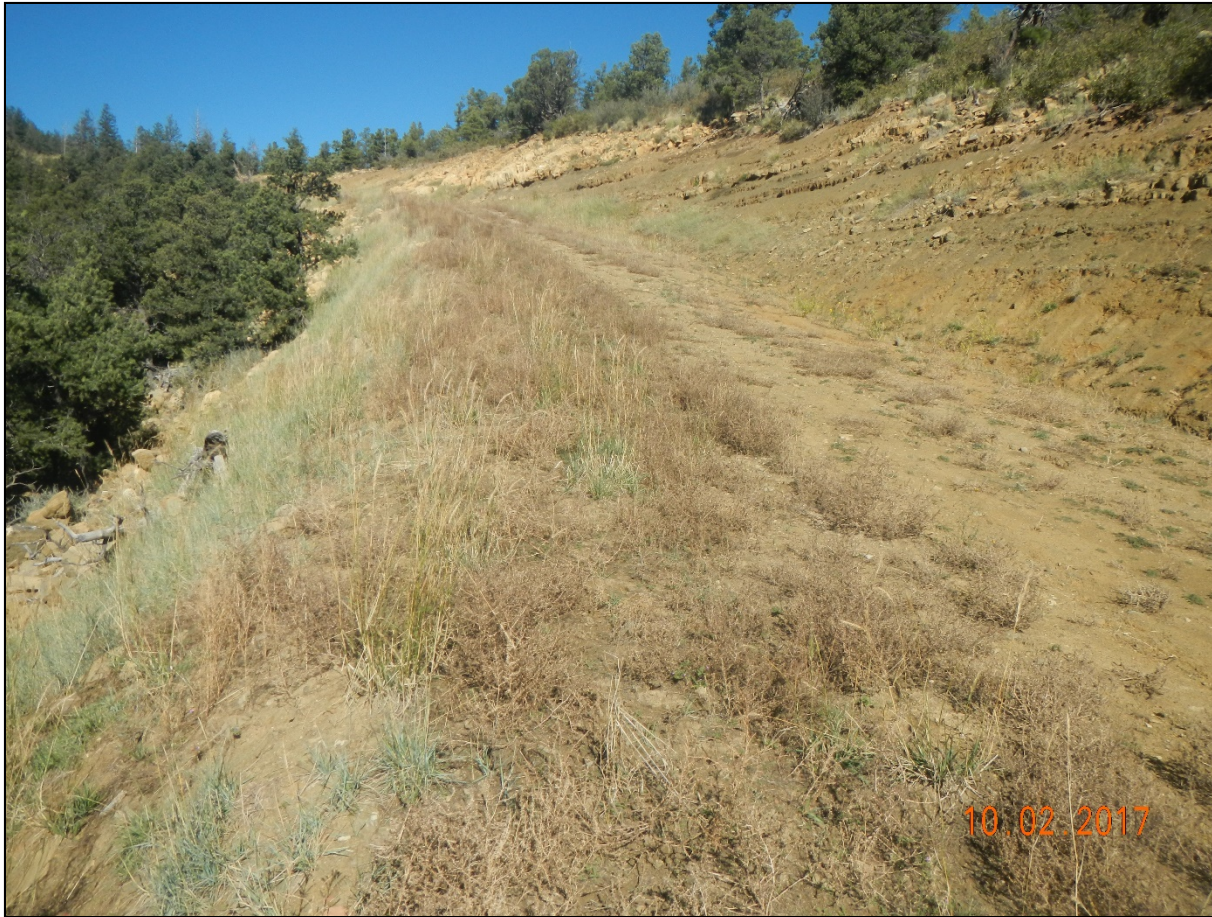
**Photo 17.** Facing northwest along the access road.

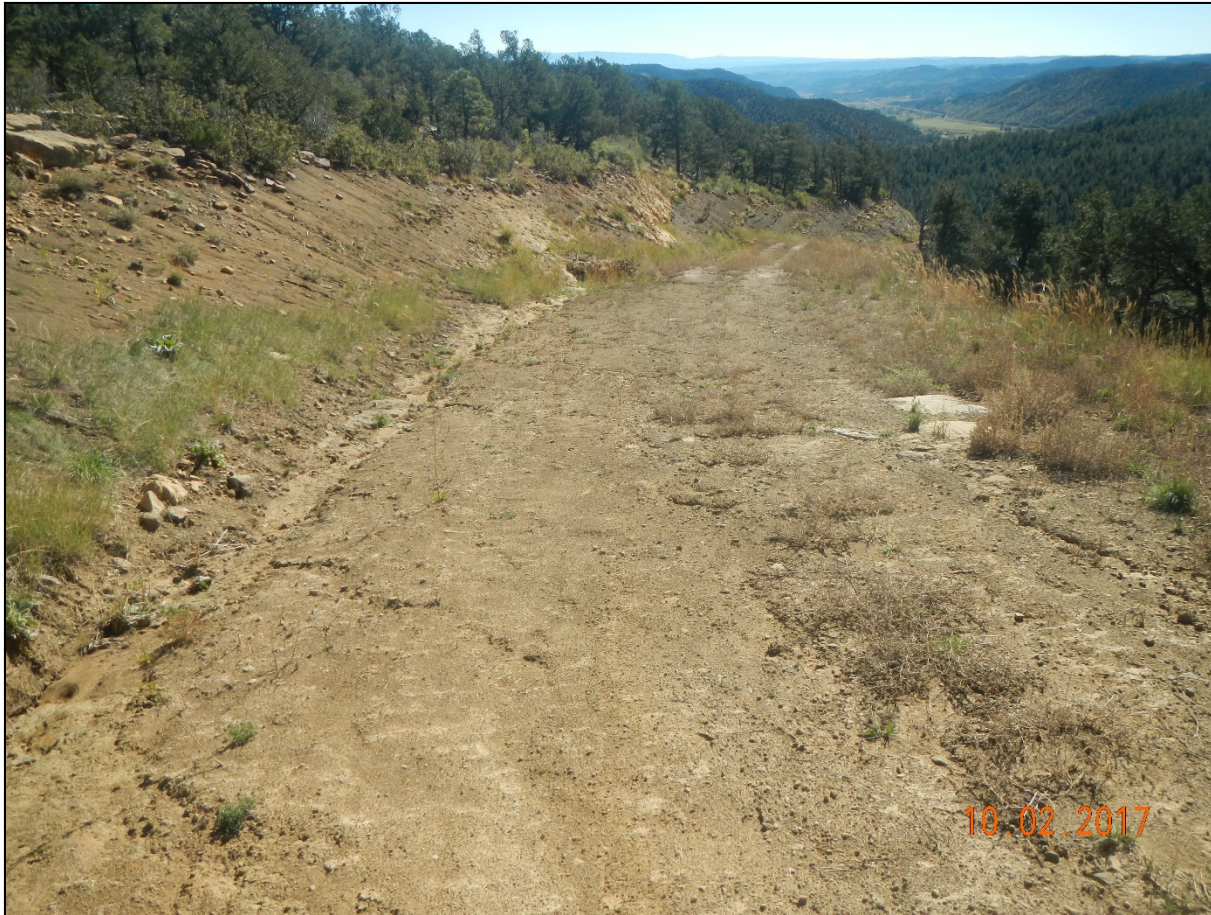
**Photo 18.** Facing back toward the southeast down the access road.

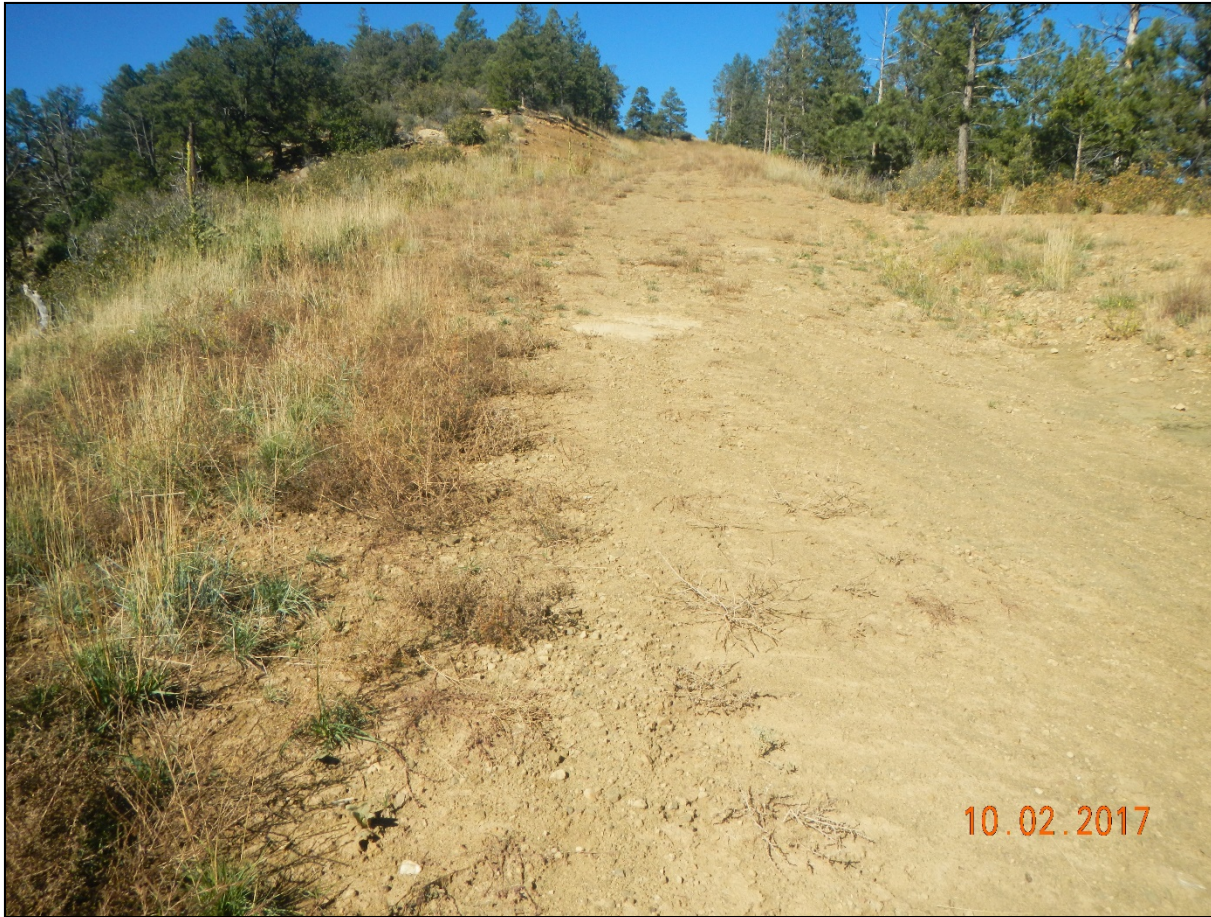
**Photo 19.** Facing northwest where the access road ascends to the top of the hill where the well pad is located.

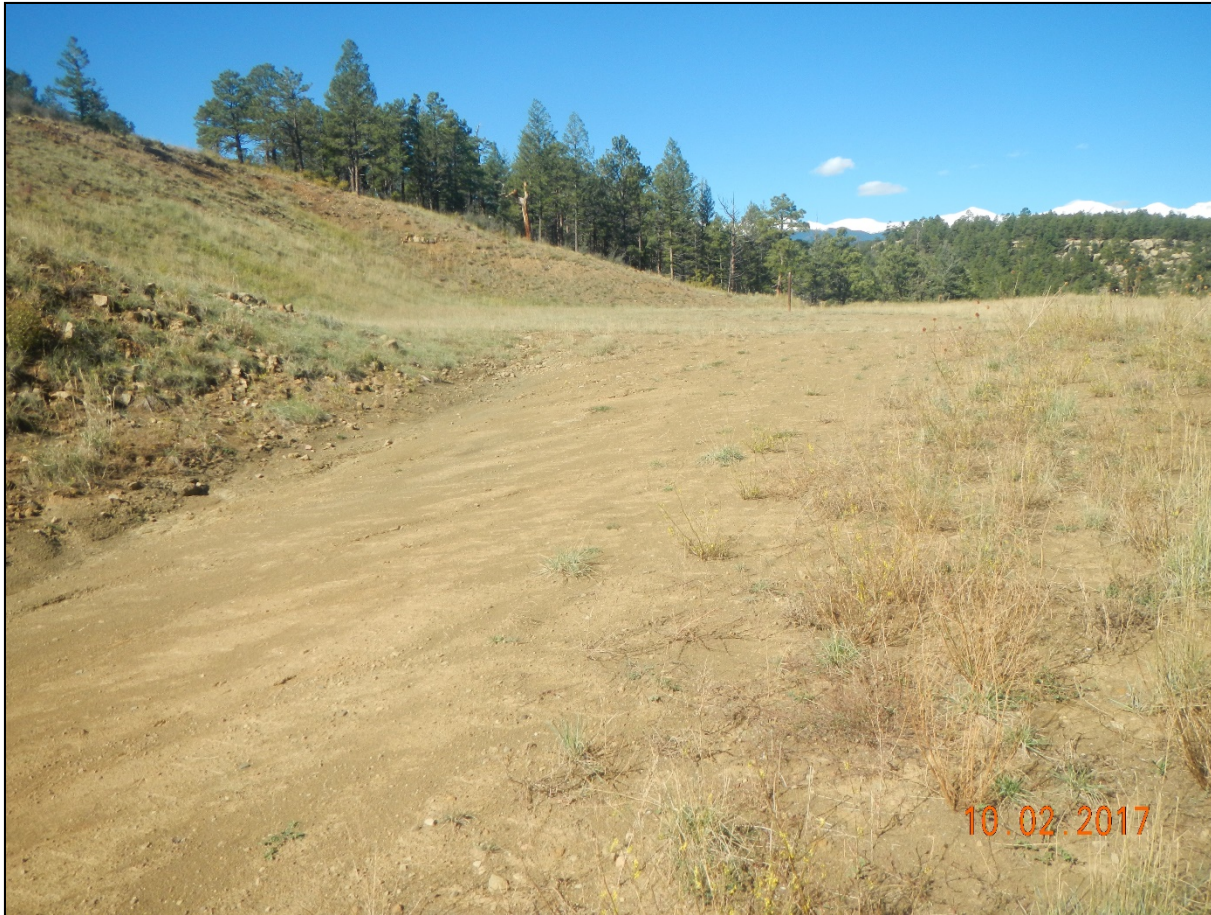
**Photo 20.** Facing northwest toward the location.
