## Inspection Photos

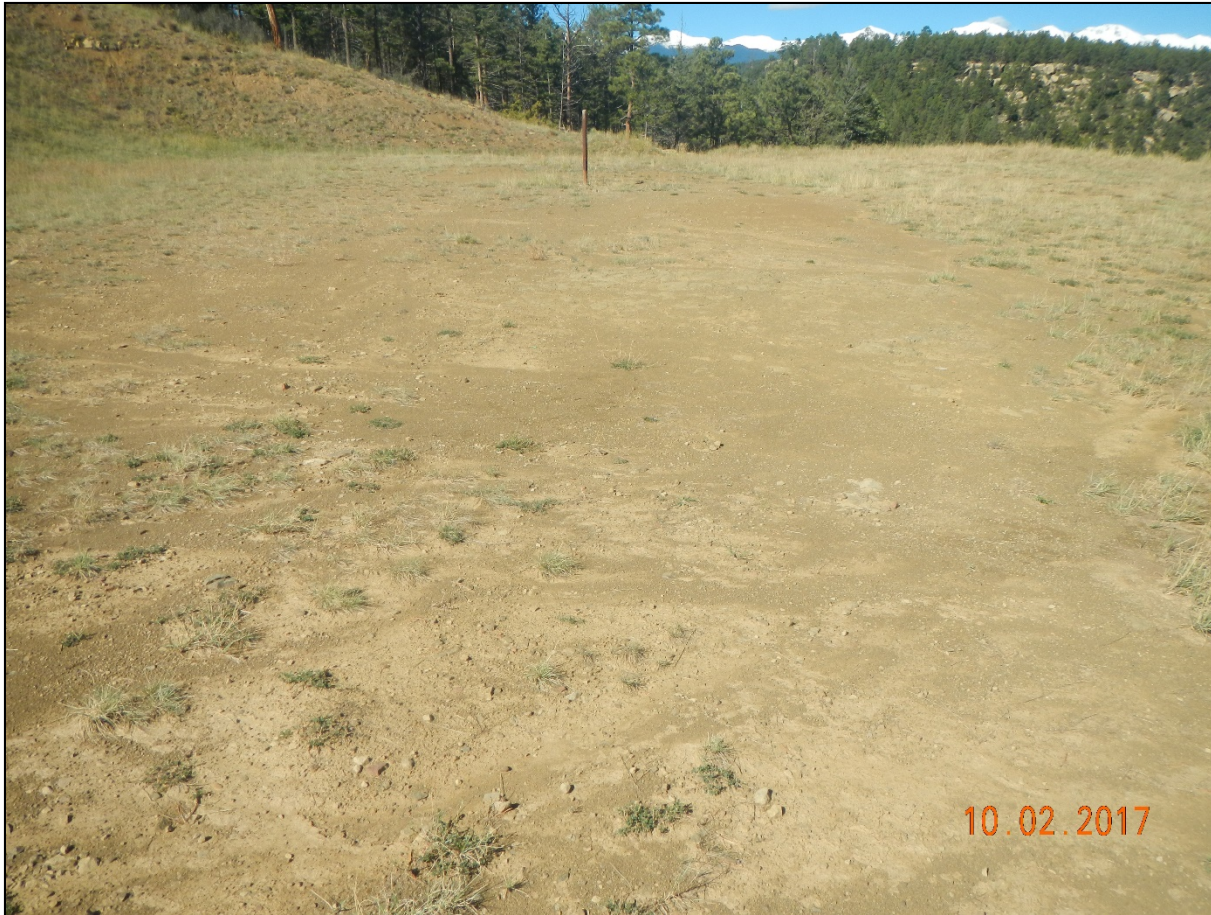
**Photo 21.** Facing northwest at the location.

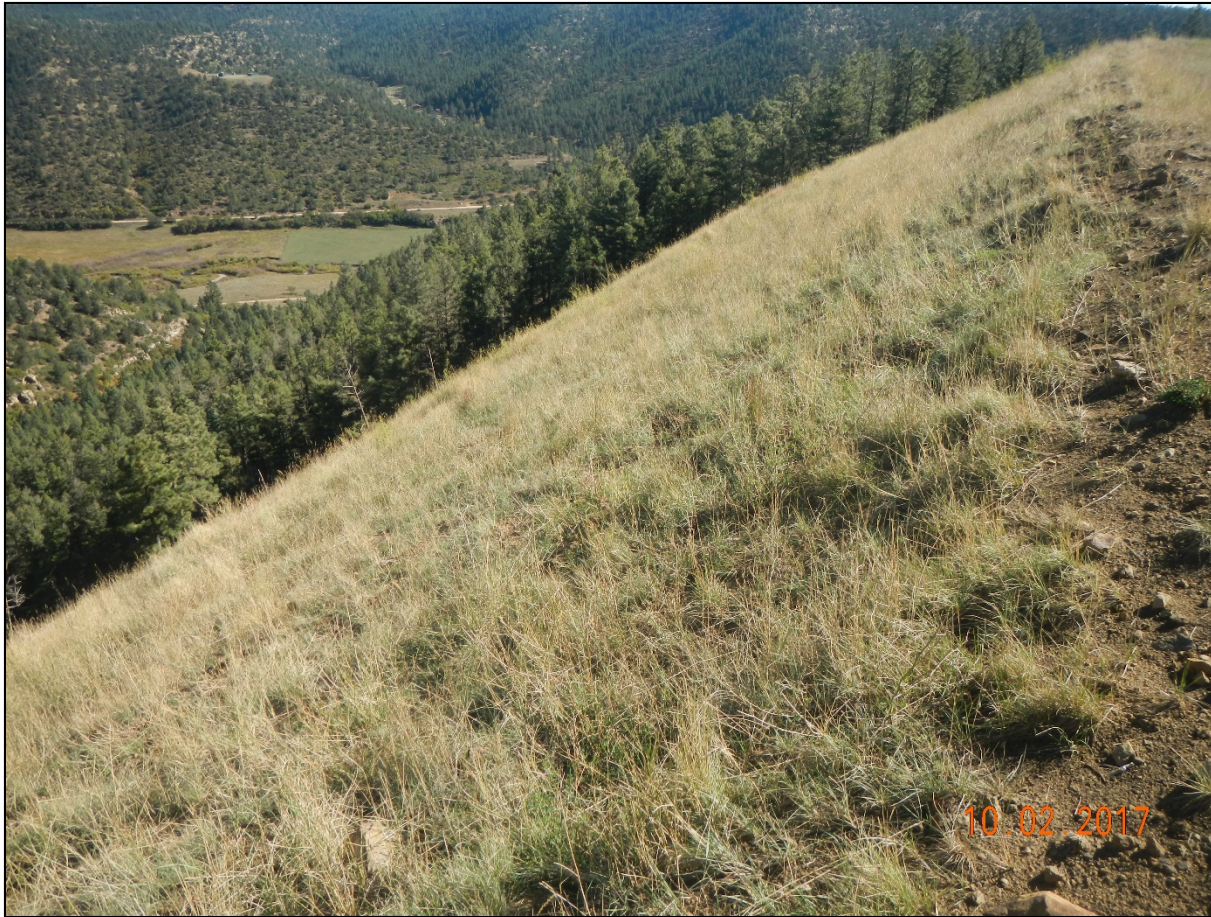
**Photo 22.** Facing east toward the fill slope of the location.

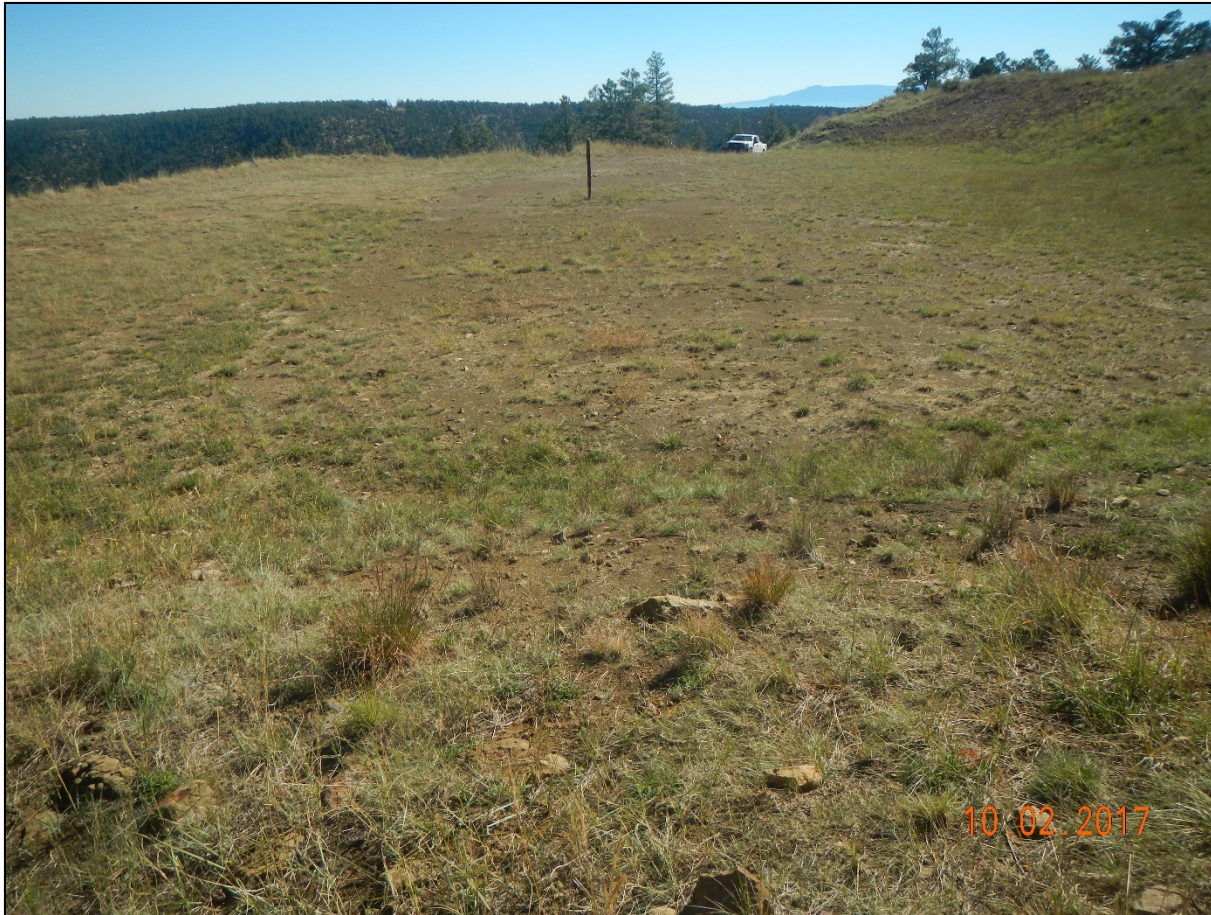
**Photo 23.** West side of the location facing east.

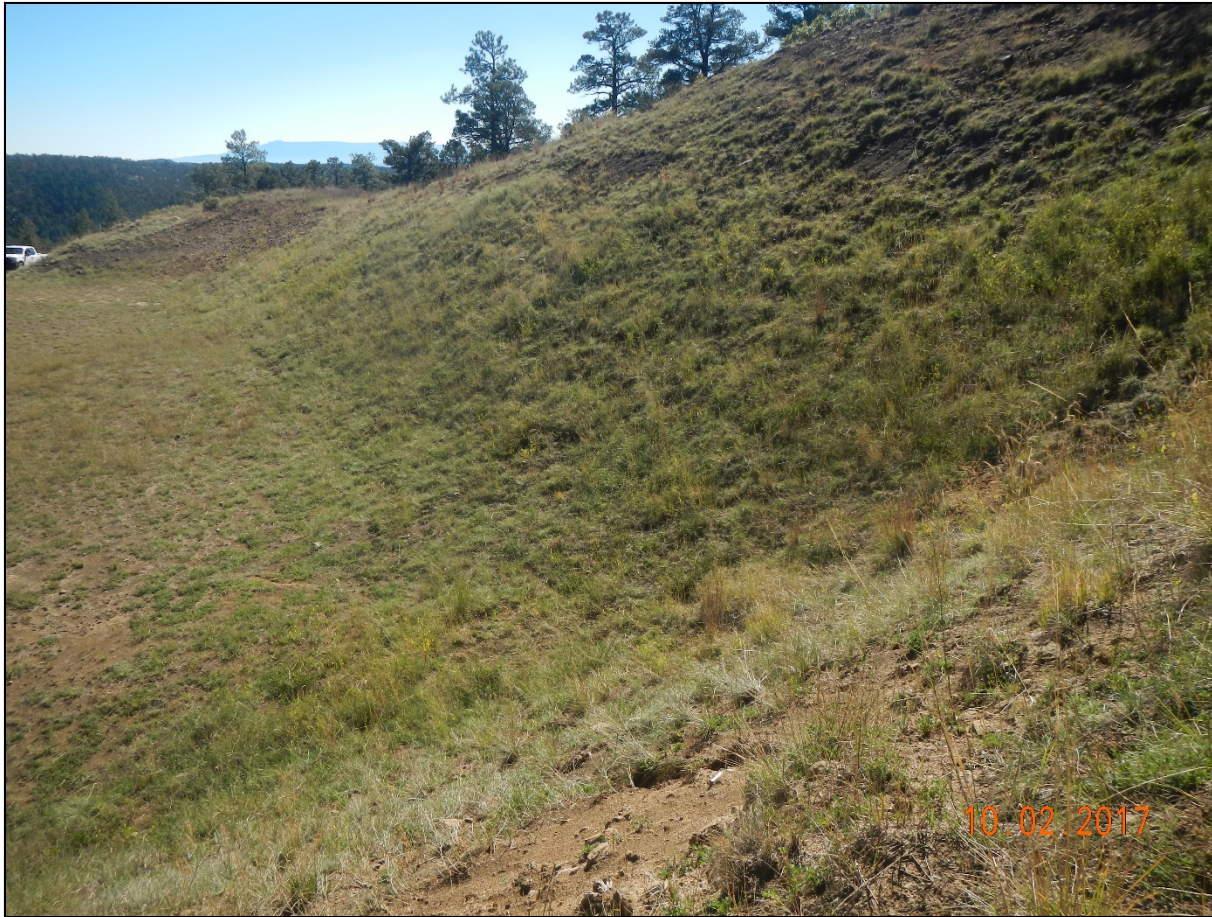
**Photo 24.** Facing east toward the cut slope.

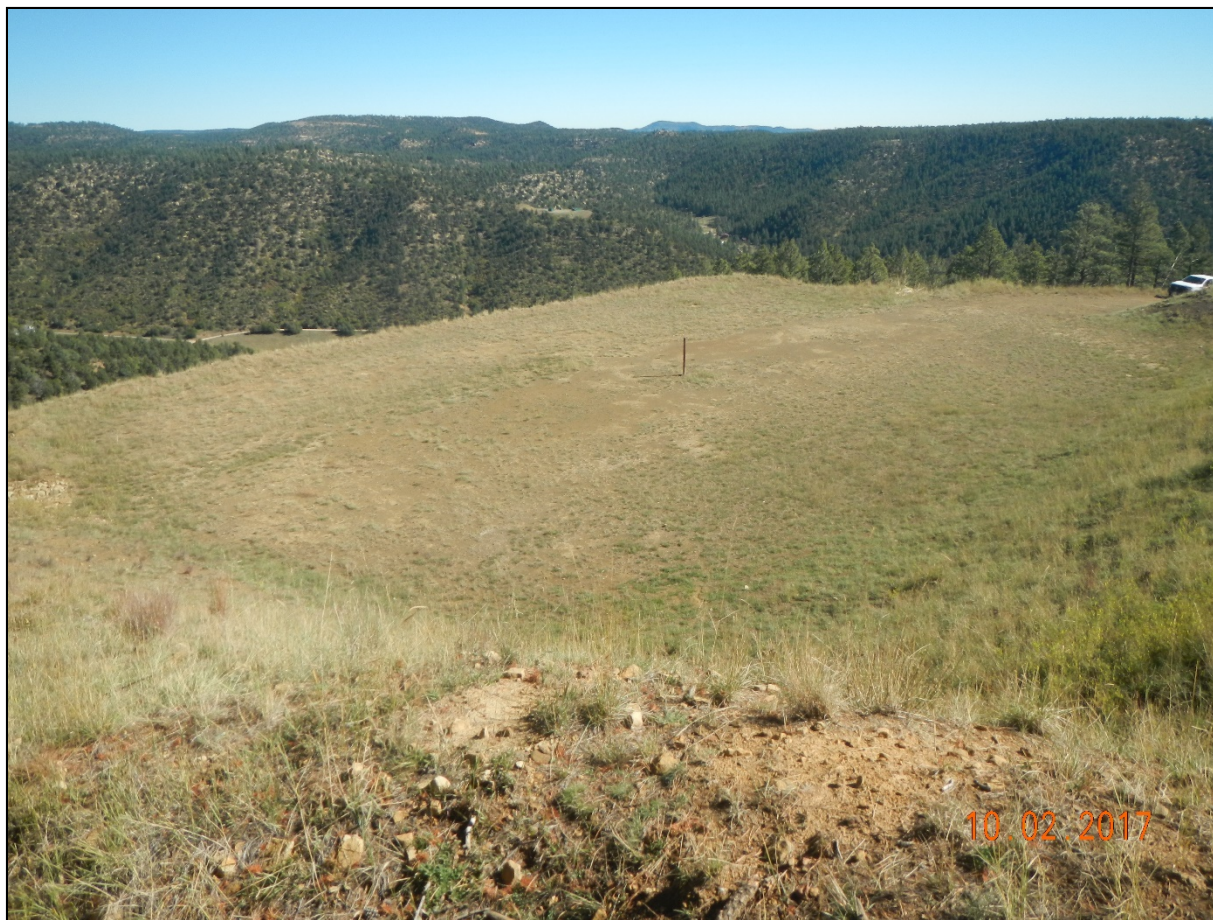
**Photo 25.** Facing northeast overlooking the location.
