Inspection Photos
Location Name: Stroh 24-12
API: 05-123-22367

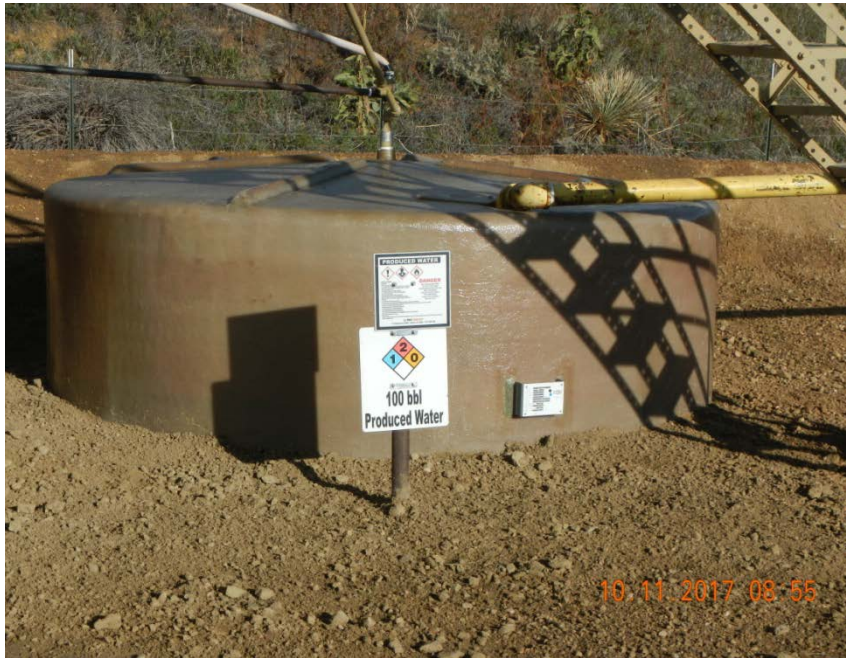
Replaced produced water vault
