Interim Reclamation and Stormwater Inspection

October 6, 2017

Operator: LONGS PEAK RESOURCES LLC- #10611

Location ID: 438066

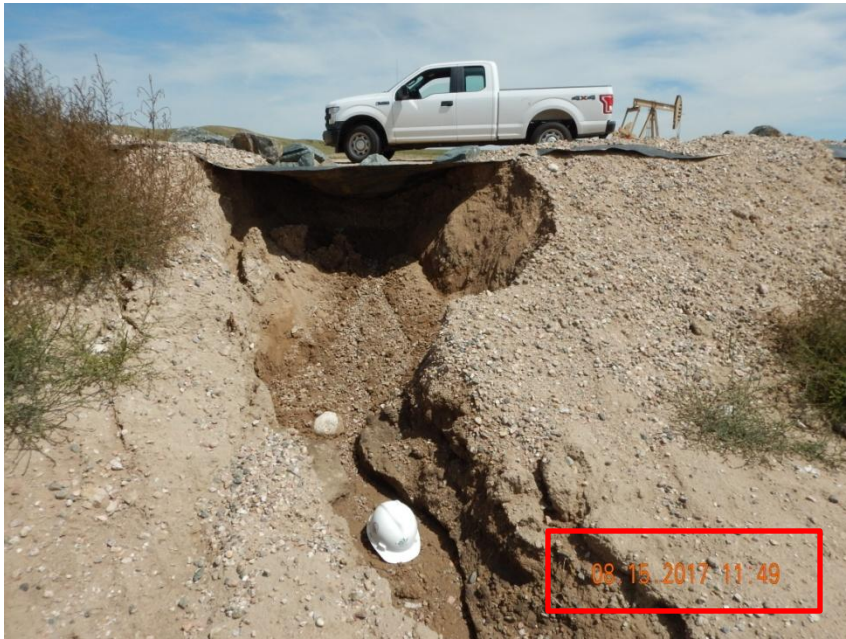
Photo 1. Photo taken on August 15, 2017 from the southwestern location, facing North. Gully erosion observed along the fill slope.

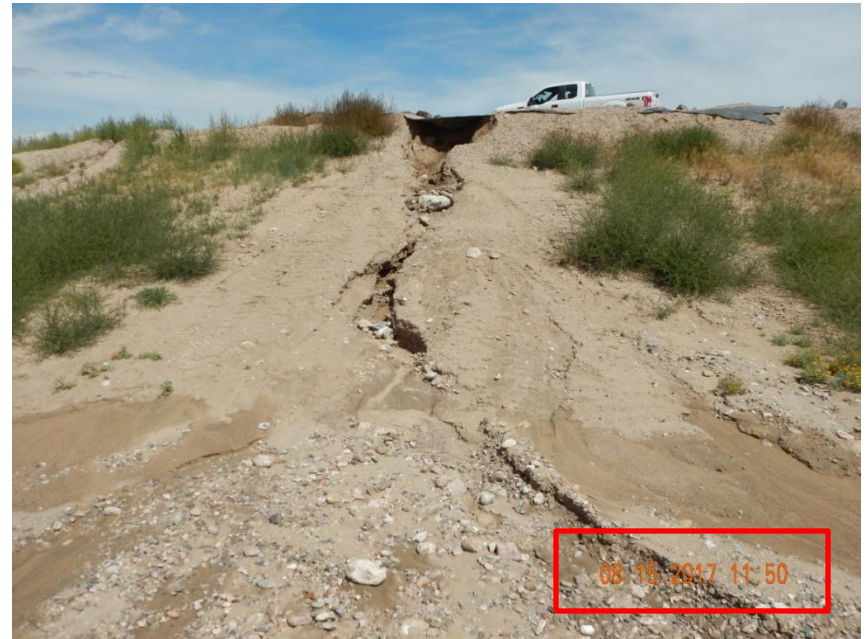
Photo 2. Photo taken on August 15, 2017 from the southwestern location, facing North. Gully erosion observed along the fill slope. Photo illustrates sediment deposition accumulation.

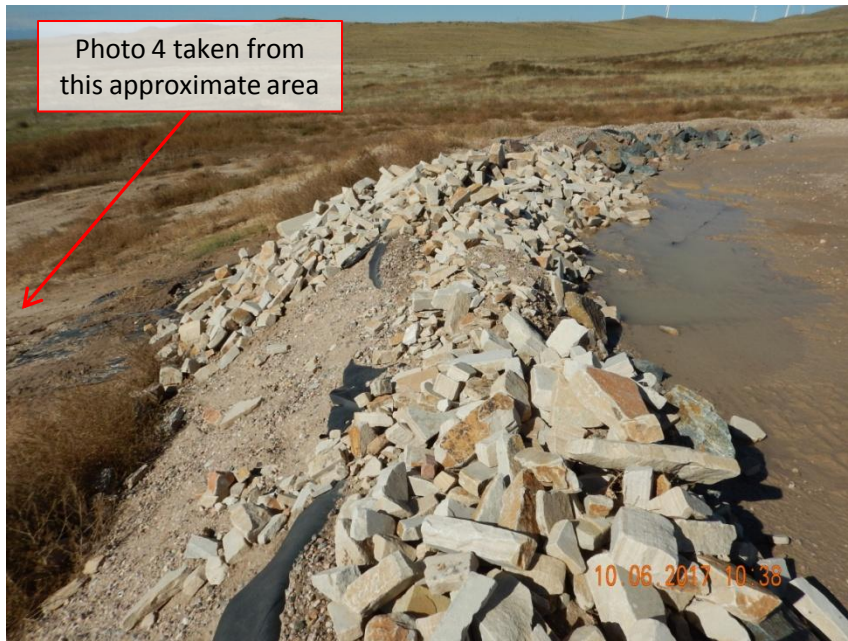
Photo 3. Photo taken from the southwestern location, facing West. Operator has haphazardly installed rock material that appears to be used as a berm BMP but appears to be functioning like a check dam- see Photo 4.

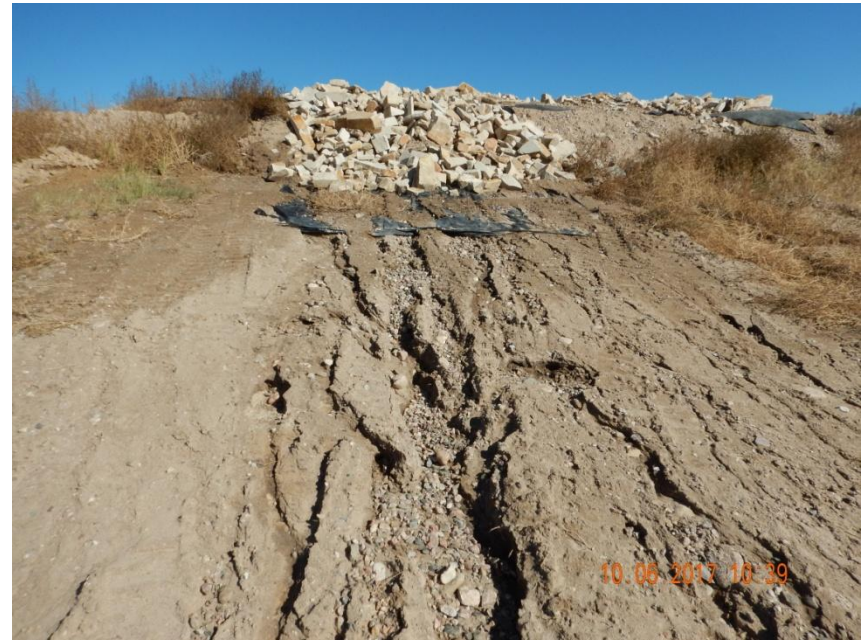
Photo 4. Photo taken from the southwestern location, facing North. Rill erosion forming into gully erosion observed down slope of the installed rock material.

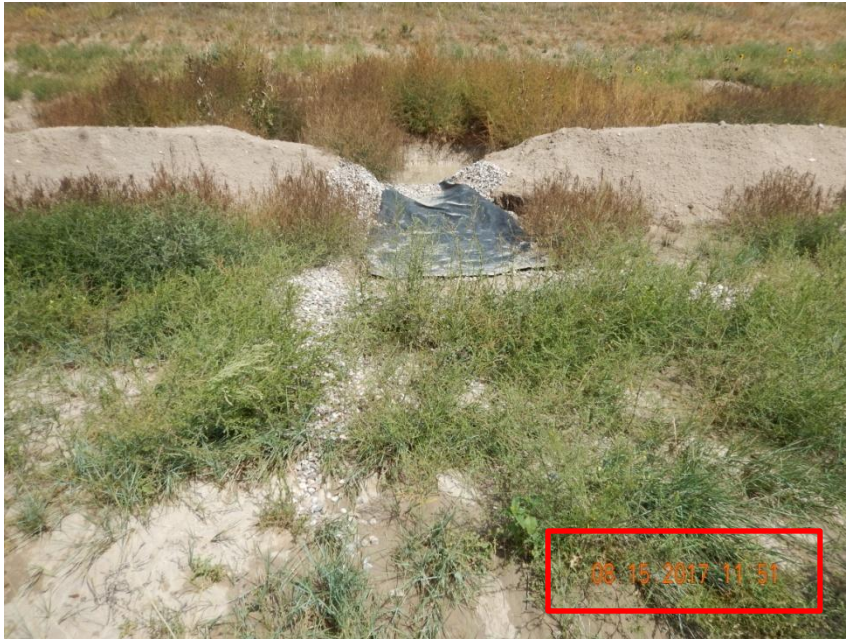
Photo 5. Photo taken on August 15, 2017 from the southwest sediment trap outlet area, facing North. Sediment trap does not appear to have a sufficient stabilized outlet. Rock material does not appear to be the appropriate size and the plastic-like material only appears to allow stormwater flows to accelerate out of the sediment trap. A point of sediment discharge was observed south of the outlet area.

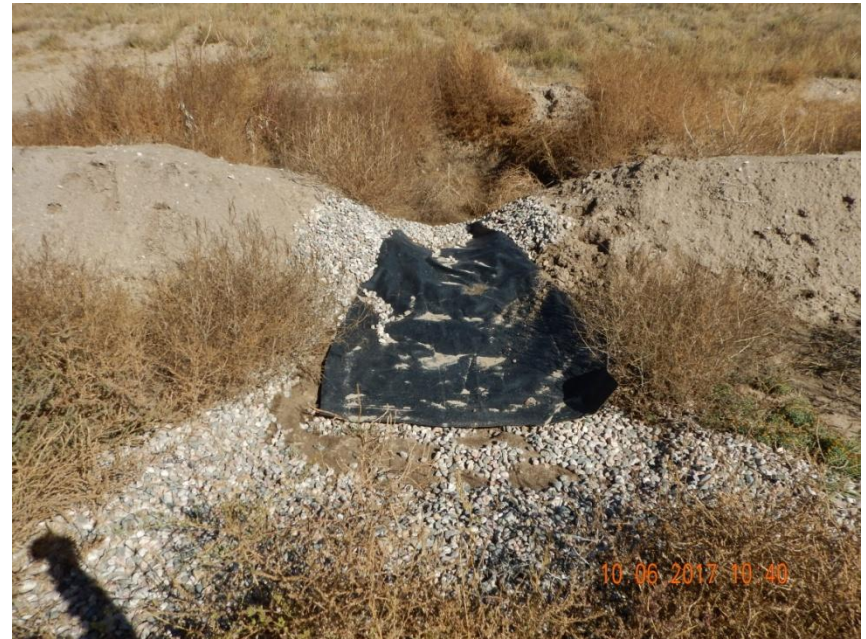
Photo 6. Photo taken on October 6, 2017 from the southwest sediment trap outlet area, facing North. Does not appear the Operator has made improvements to the sediment trap. Also, does not appear the Operator has performed any work to manage and control the Russian thistle that was observed in the August 15, 2017 inspection.

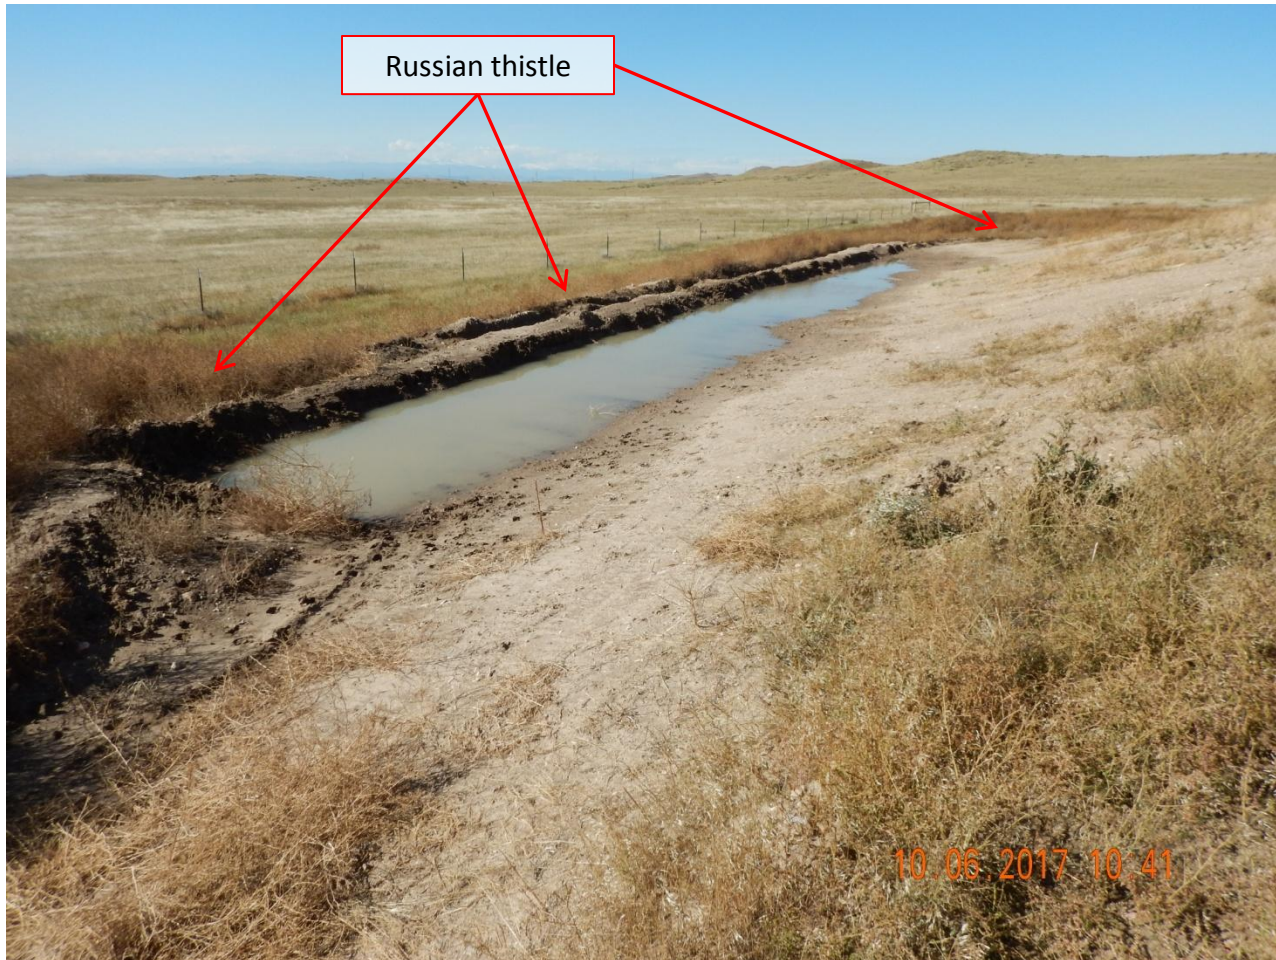
Photo 7. Photo taken from the southwestern location, facing West. Appears the Operator has created a retention area that would be used in conjunction with the southwestern sediment trap. Russian thistle observed along the perimeter of the location. This is considered weed debris which the Operator needs to control and manage.

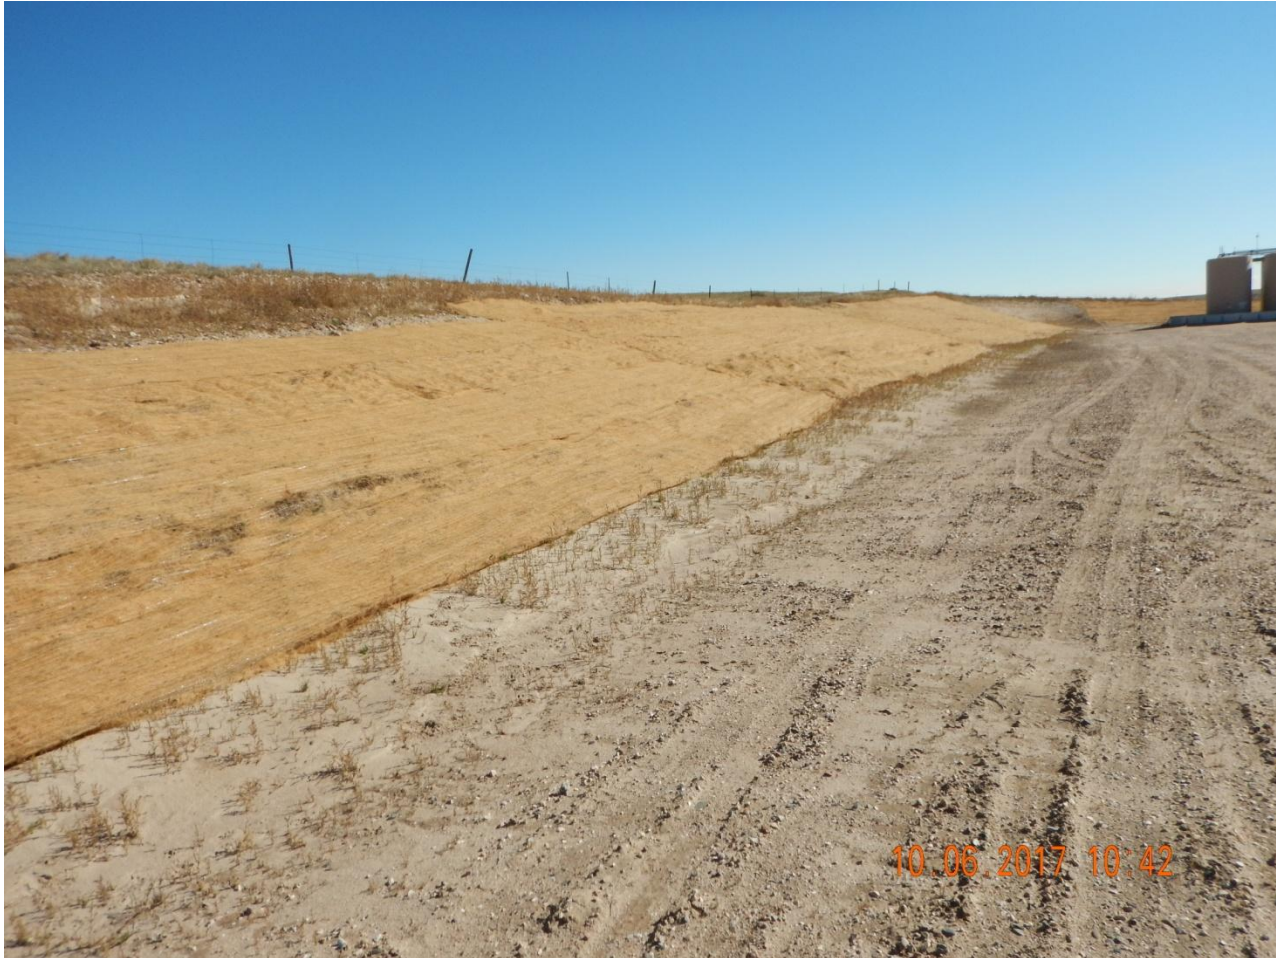
Photo 8. Photo taken from the northwestern cut slope area, facing East. Appears the Operator has installed erosion blankets along the entire cut slope; however, the Operator has not properly installed the BMP- see Photos 9-12.

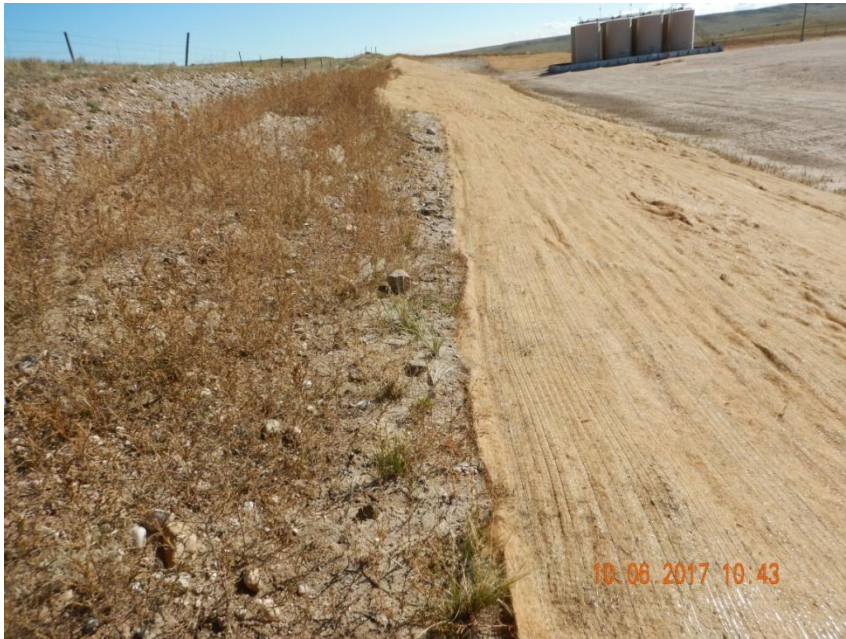
Photo 9. Photo taken from the northwestern cut slope area, facing East. Operator has not properly installed the erosion blanket using good engineering practices. Operator has not properly trenched and anchored BMP. Operator has not installed the BMP with good contact with the ground to avoid tenting.

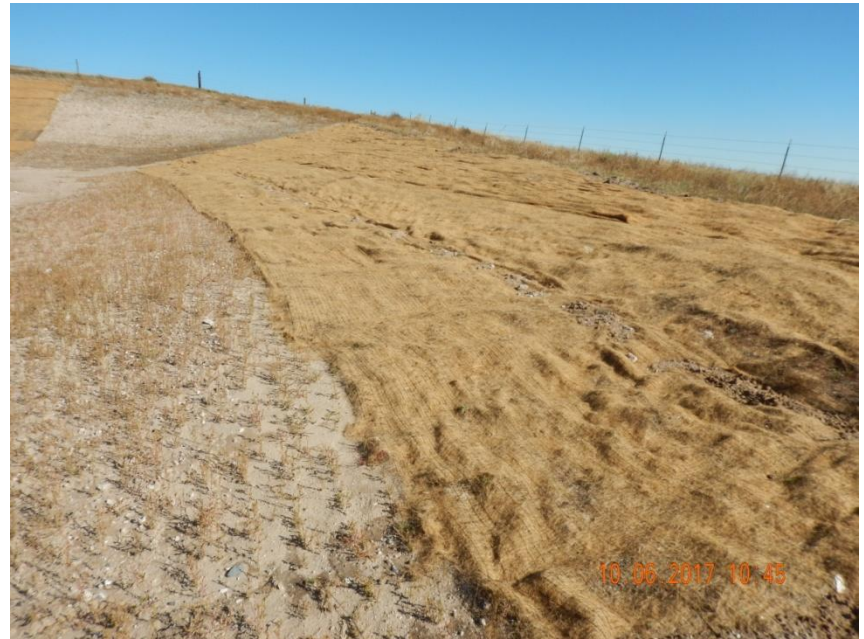
Photo 10. Photo taken from the northeastern cut slope area, facing North. See comments under Photo 9.

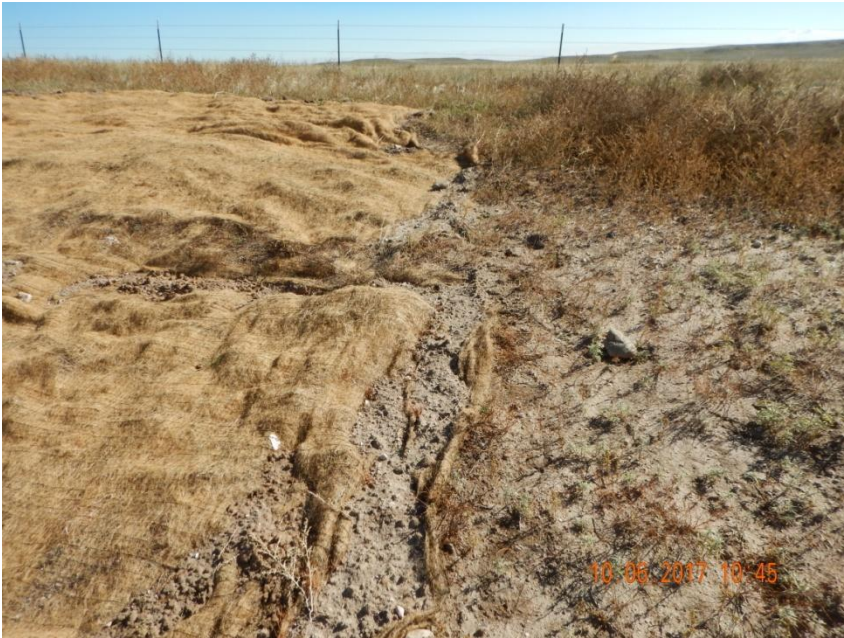
Photo 11. Photo taken from the previous photo location, facing East. See comments under Photo 9.

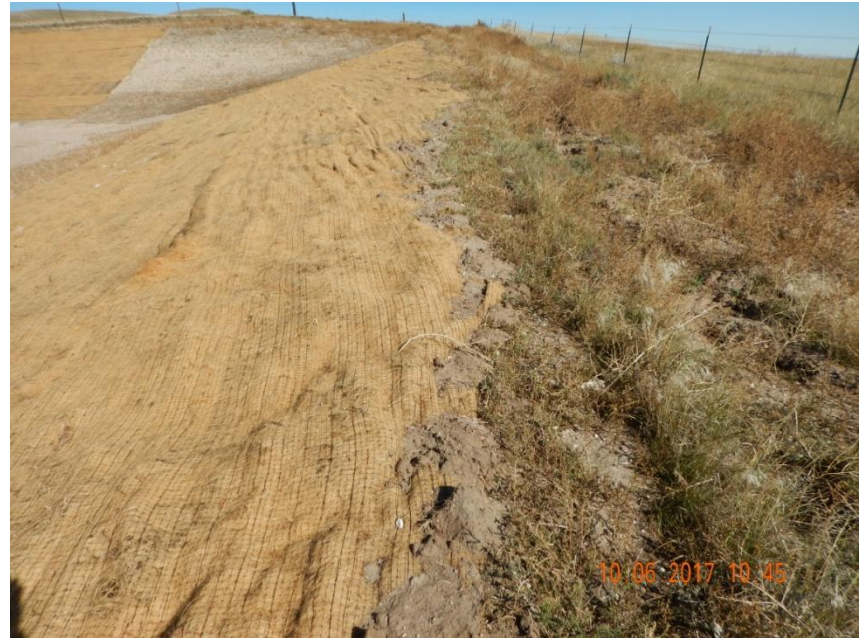
Photo 12. Photo taken from the top of the northeastern cut slope area, facing North. See comments under Photo 9.

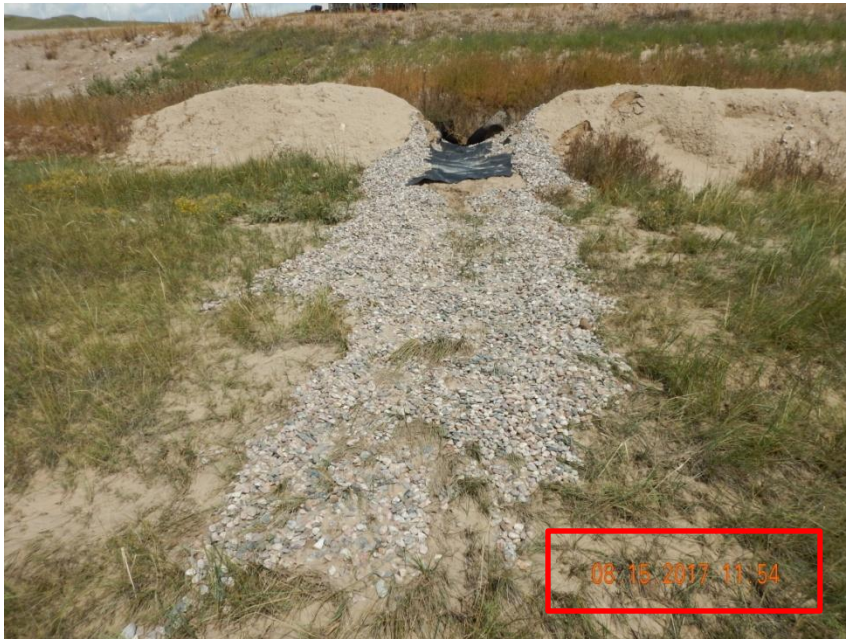
Photo 13. Photo taken on August 15, 2017 from the southeast sediment trap outlet area, facing North. Sediment trap does not appear to have a sufficient stabilized outlet. Rock material does not appear to be the appropriate size and the plastic-like material only appears to allow stormwater flows to accelerate out of the sediment trap.

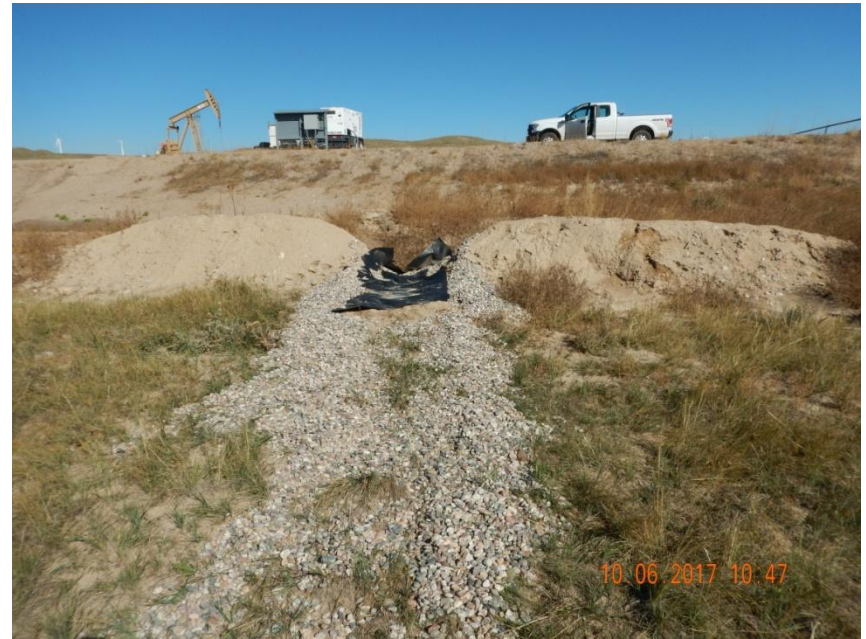
Photo 14. Photo taken from the southeast sediment trap outlet area, facing North. See comments under Photo 6.

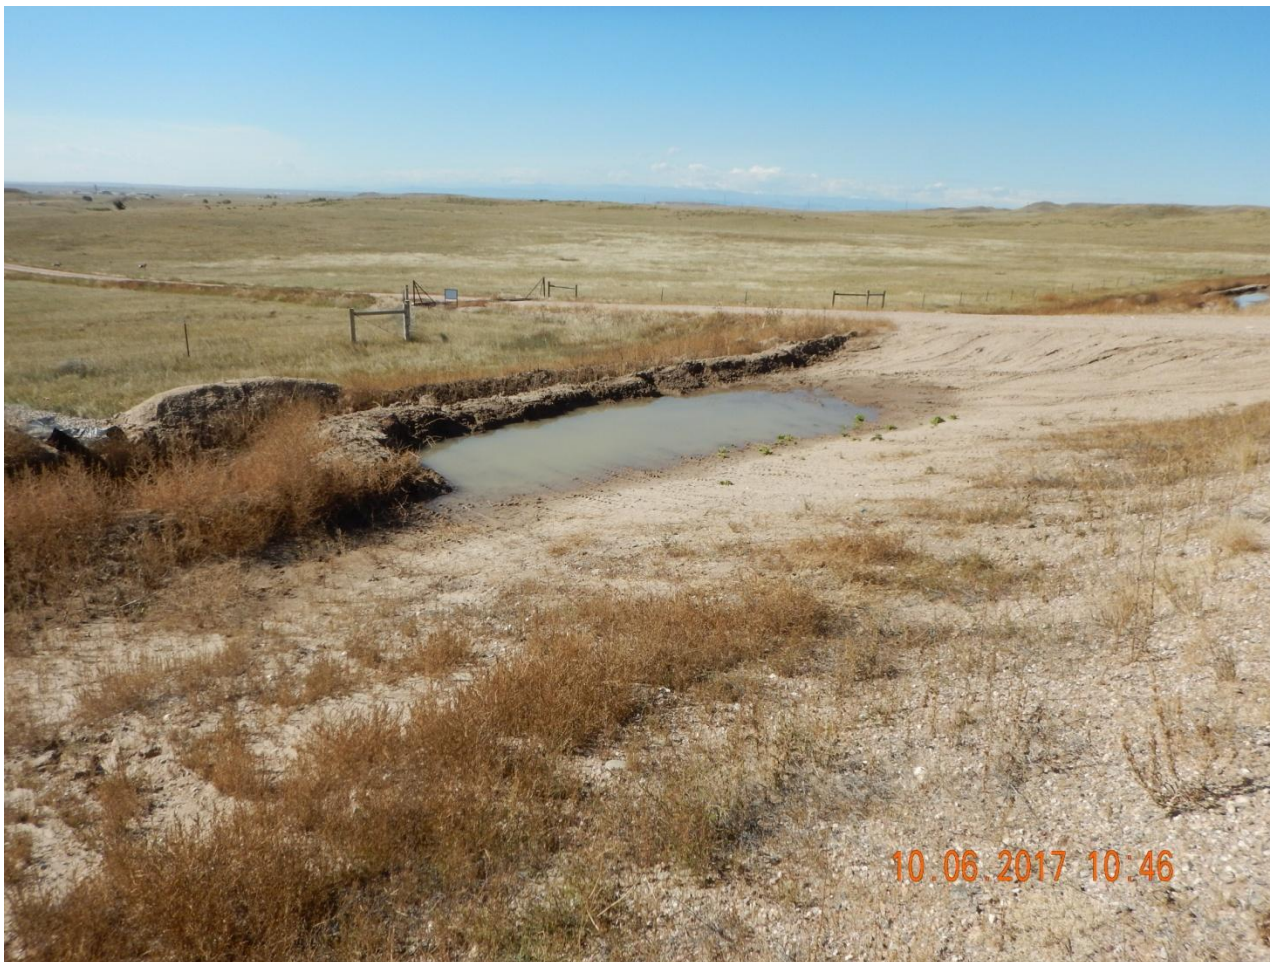
Photo 15. Photo taken from the southeastern location, facing West. See comments under Photo 7.
