Inspection Photos

10/06/2017

Operator: CONTINENTAL OIL COMPANY -
100207

Inspection Doc. Number: 682502699
Washington County, CO

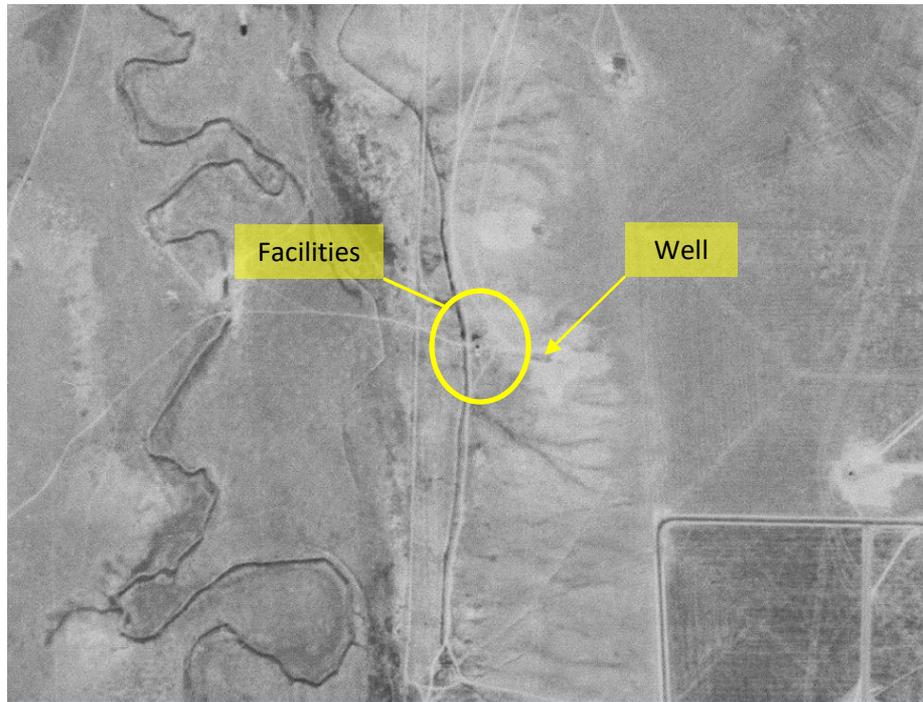
Photo 1: 1953 Aerial imagery. Records indicate well was SPUD 1952 and PA'd in 1965. Image shows location of wells and facilities. Records list Continental oil Co as the operator. COGCC financial assurance records show Conoco Phillips as the surviving company and responsible for any outstanding liability.

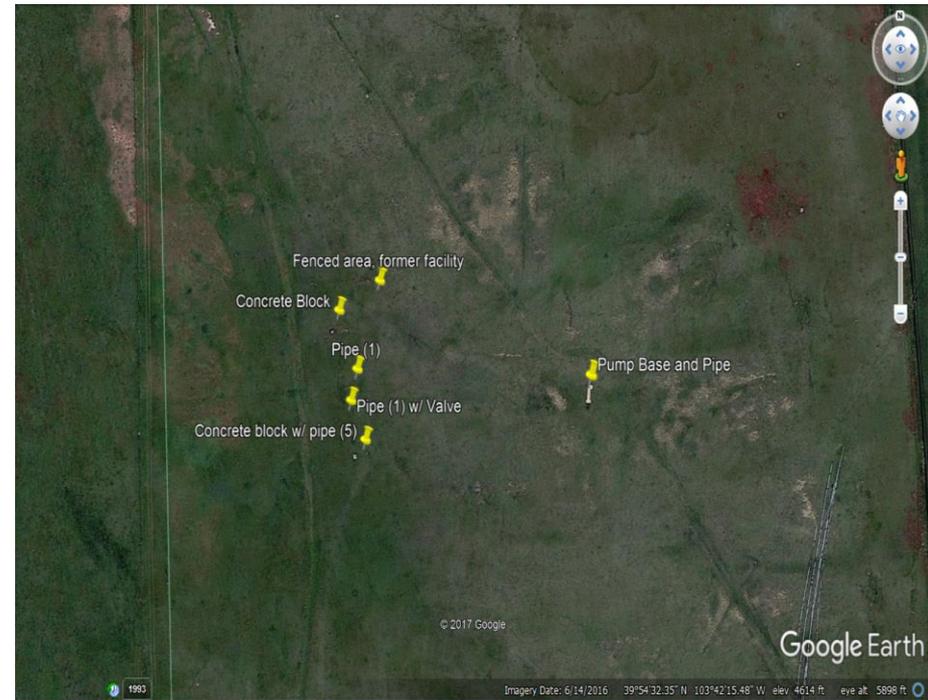
Photo 2: Current available (2016) aerial imagery. Photo shows locations of various pipe and risers, concrete block and the concrete pump base w/ pipe are located.

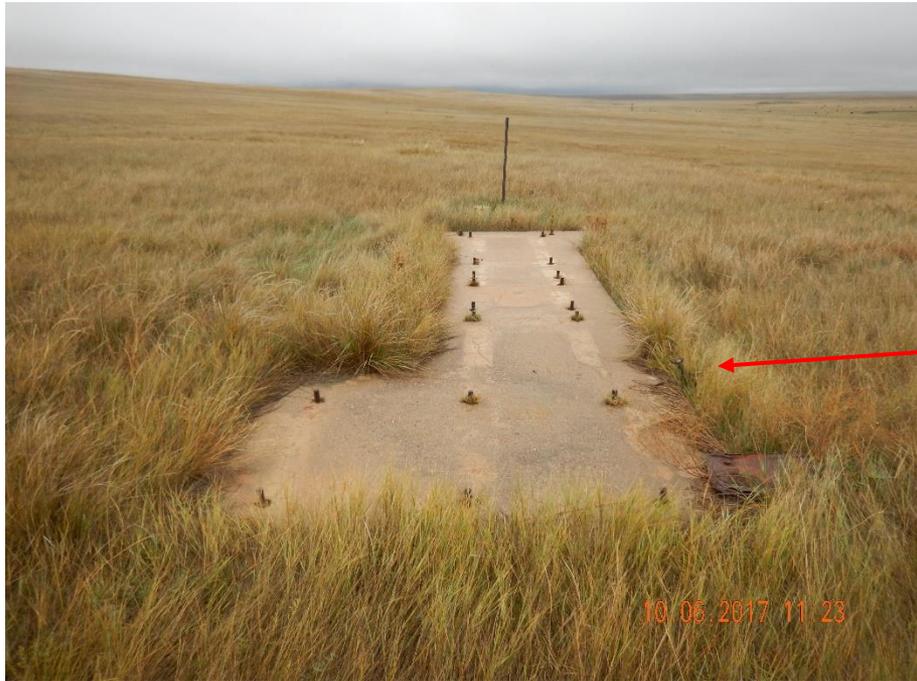
Photo 3: Photo taken from the north side of the well, facing south. Photo shows concrete pump base and pipe remaining on the location. This needs to be removed. Located ~ 39°54'31.87"N, 103°42'13.13"W

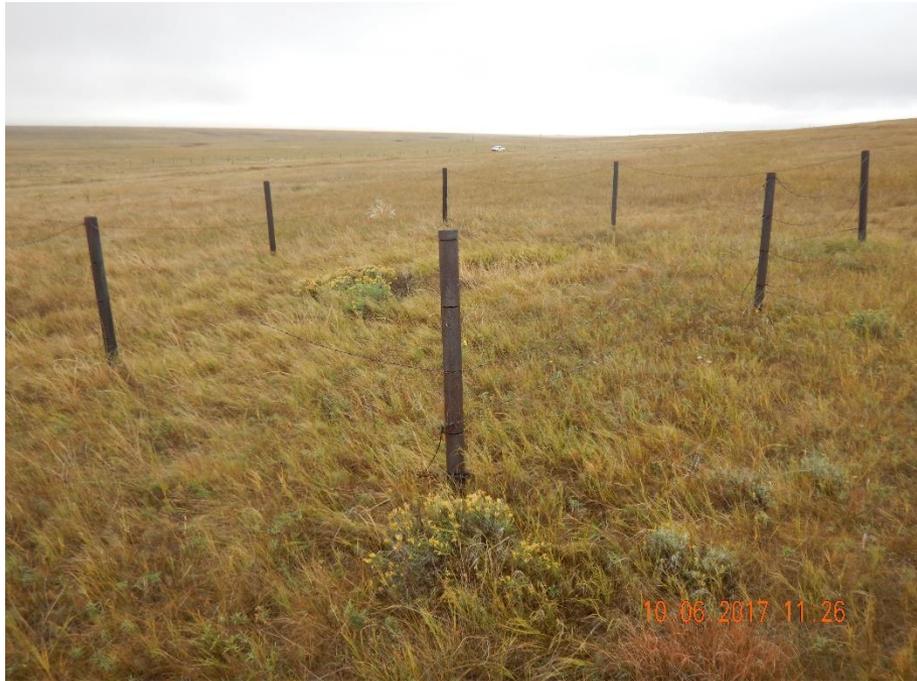
Photo 5: Photo taken ~ 39°54'33.16"N, 103°42'17.46"W, facing northwest. Photo shows old fenced area around what appears to have been a former facility.

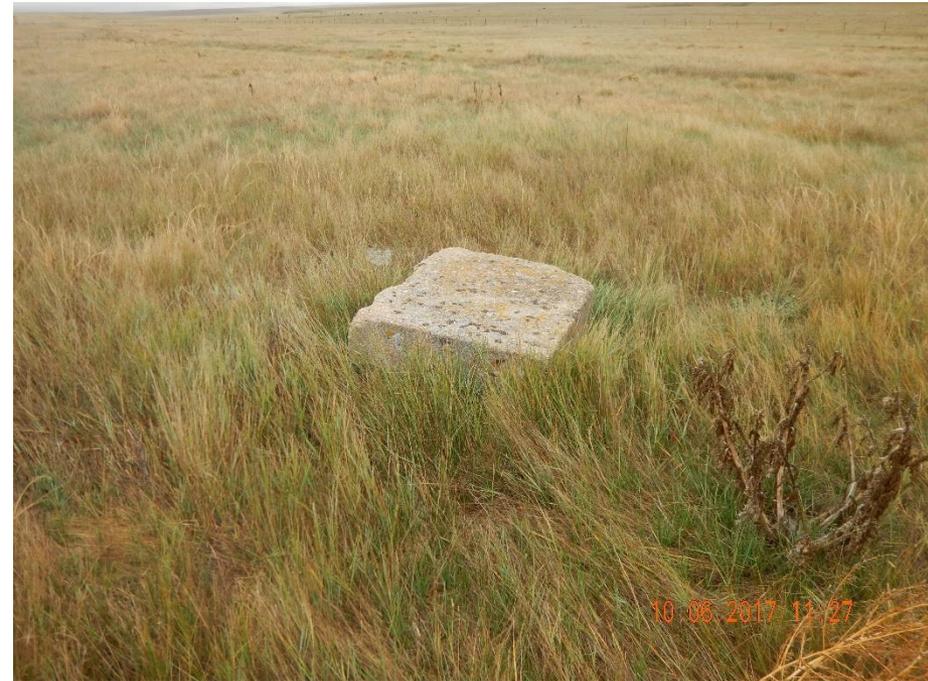
Photo 6: Photo taken ~ 39°54'32.80"N, 103°42'18.32"W. Photo shows concrete block remaining at the facilities location.

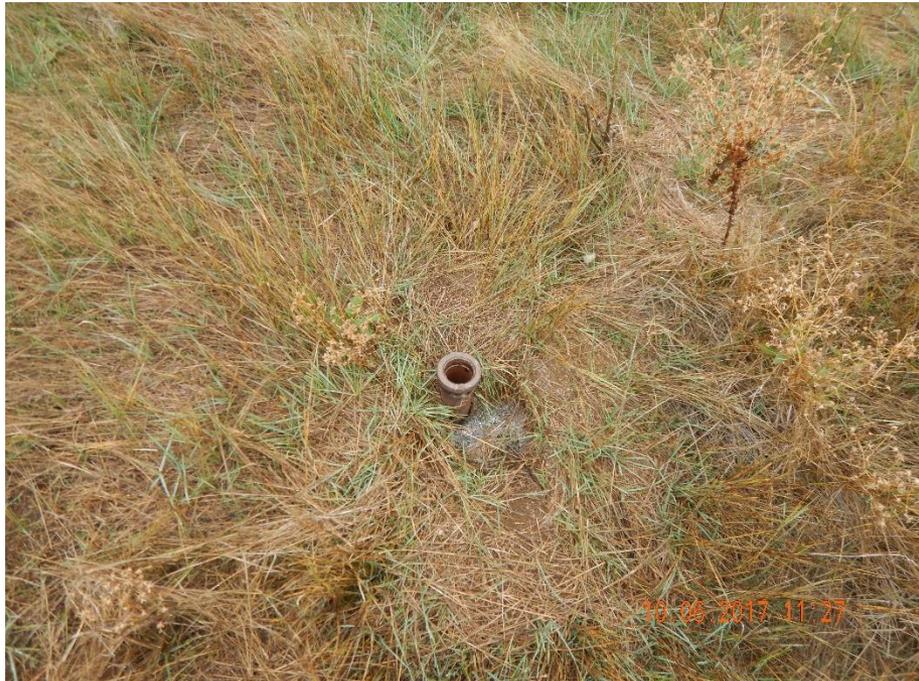
Photo 7: Photo taken ~ 39°54'32.04"N, 103°42'17.96"W. Photo shows pipe riser remaining at former facility location.

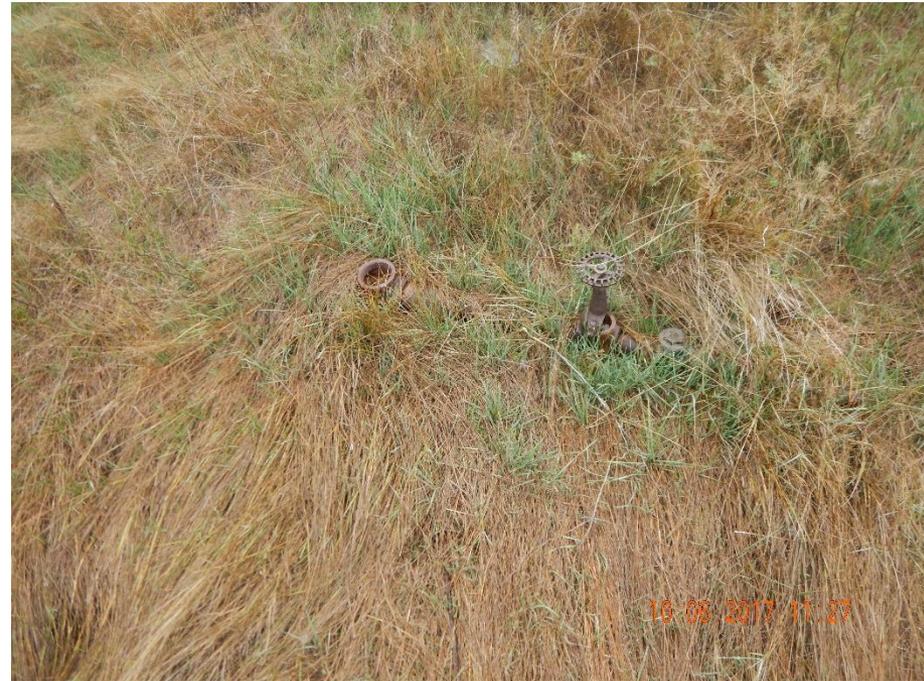
Photo 8: Photo taken ~ 39°54'31.64"N, 103°42'18.11"W. Photo shows pipe riser w/ valve remaining at the former facility location.

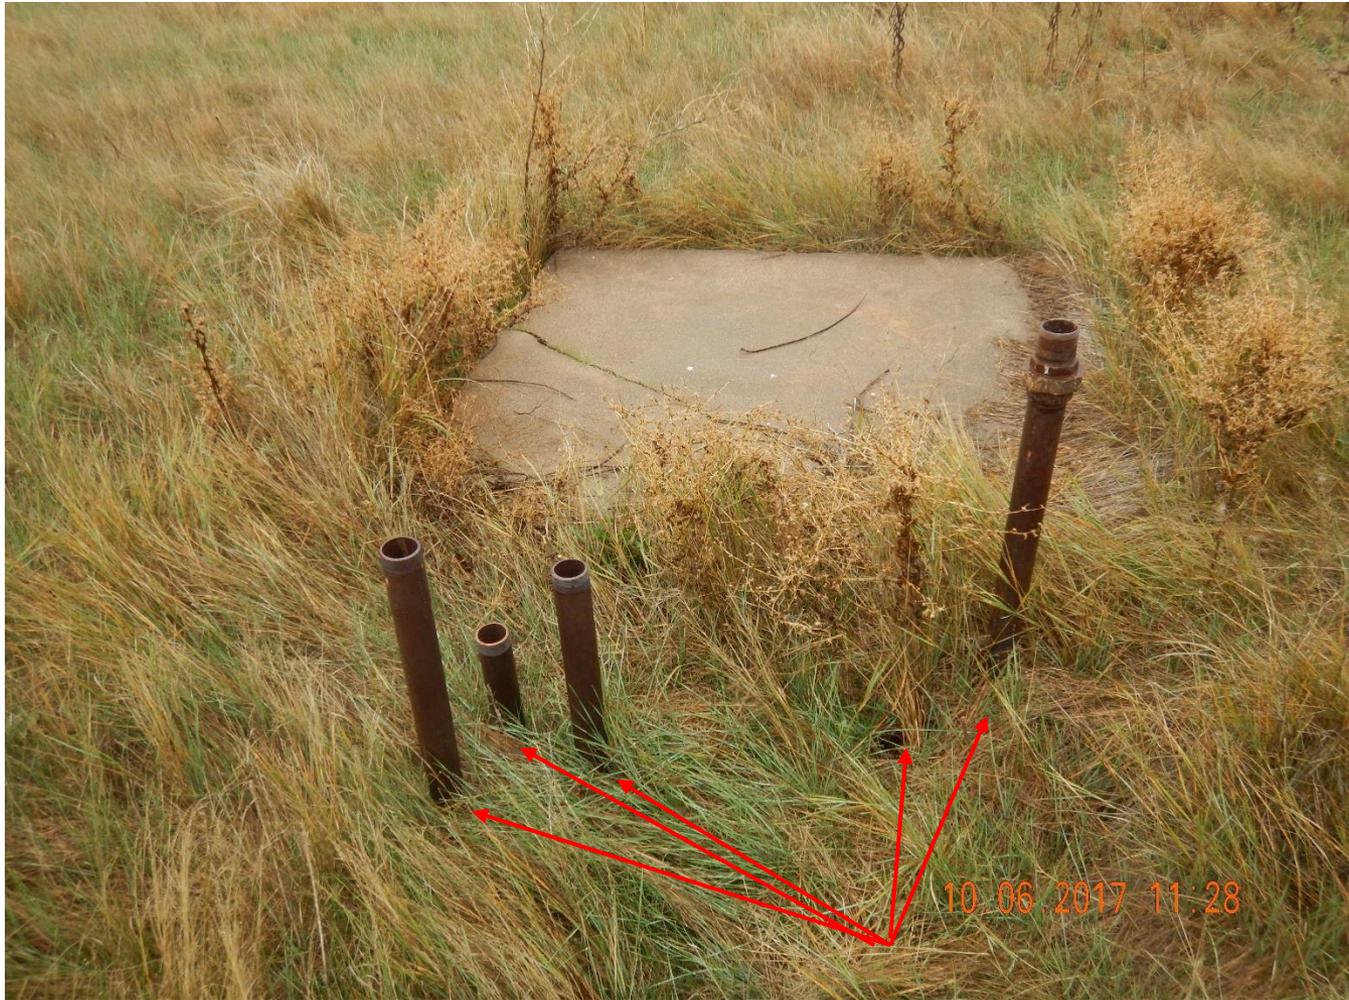
Photo 9: Photo taken ~ 39°54'31.14"N, 103°42'17.82"W. Photo shows concrete block and 5 pipe risers remaining at the former facility location.
