Inspection Photos

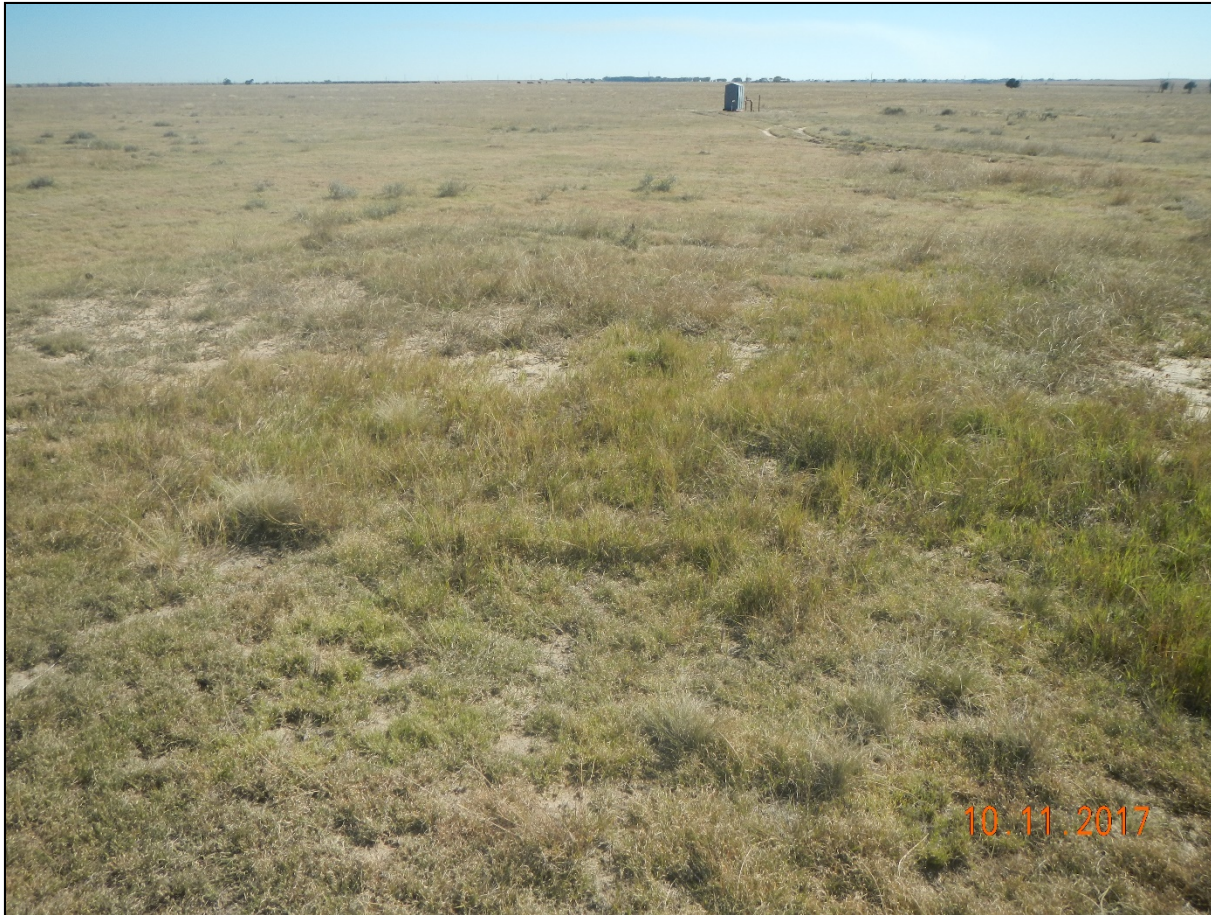
Photo 1. Facing south at the location where pipe riser was removed.

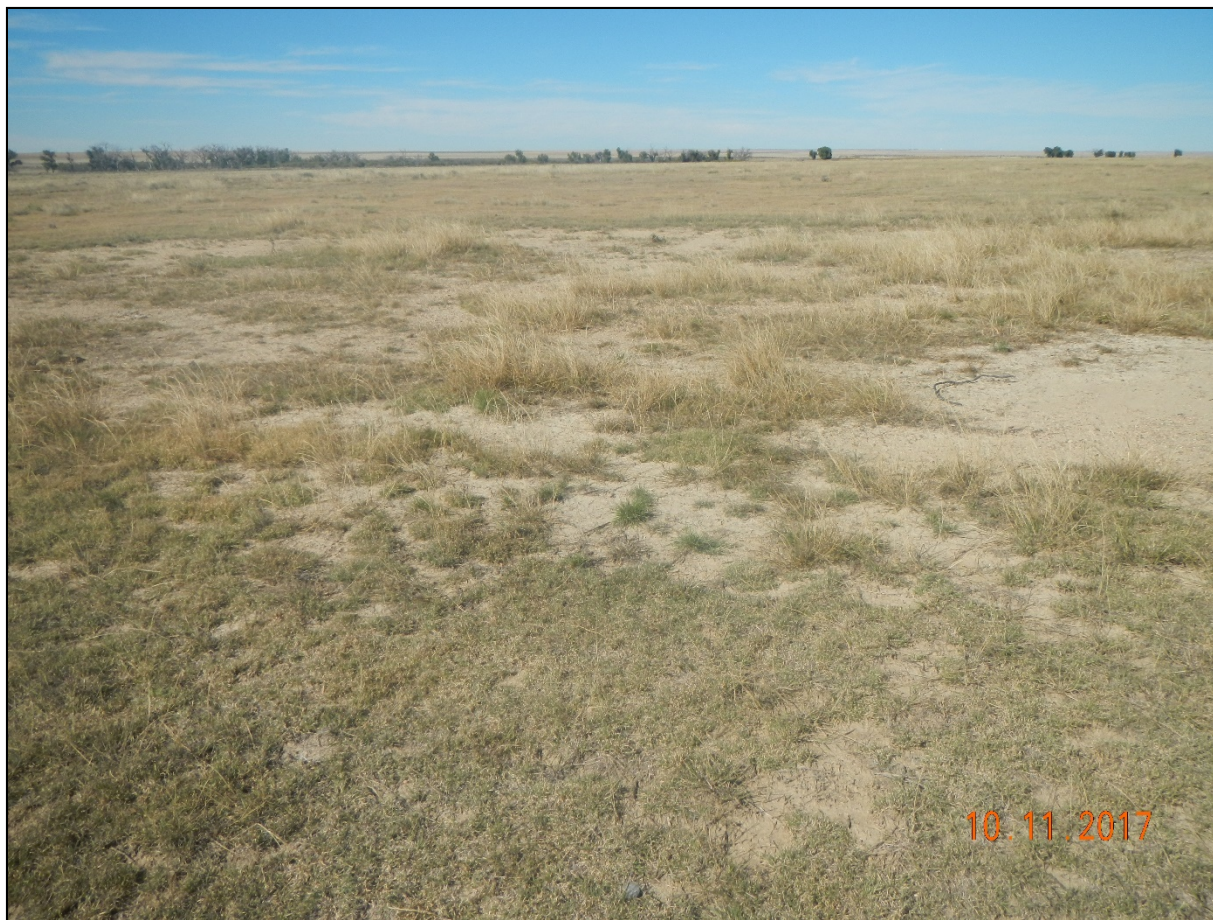
Photo 2. South side of the location facing north.

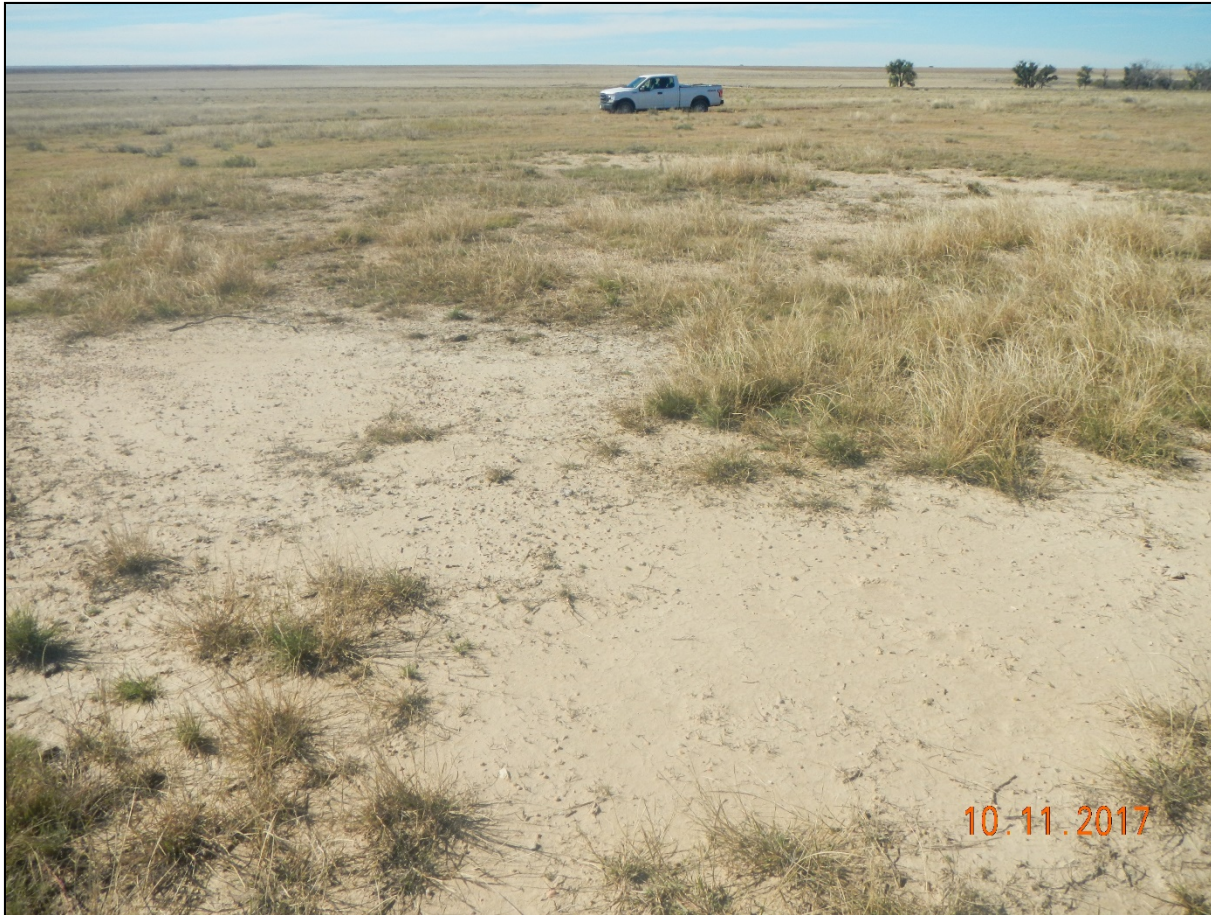
Photo 3. Facing west at the location. The are bare areas that have not adequately re-established vegetation.

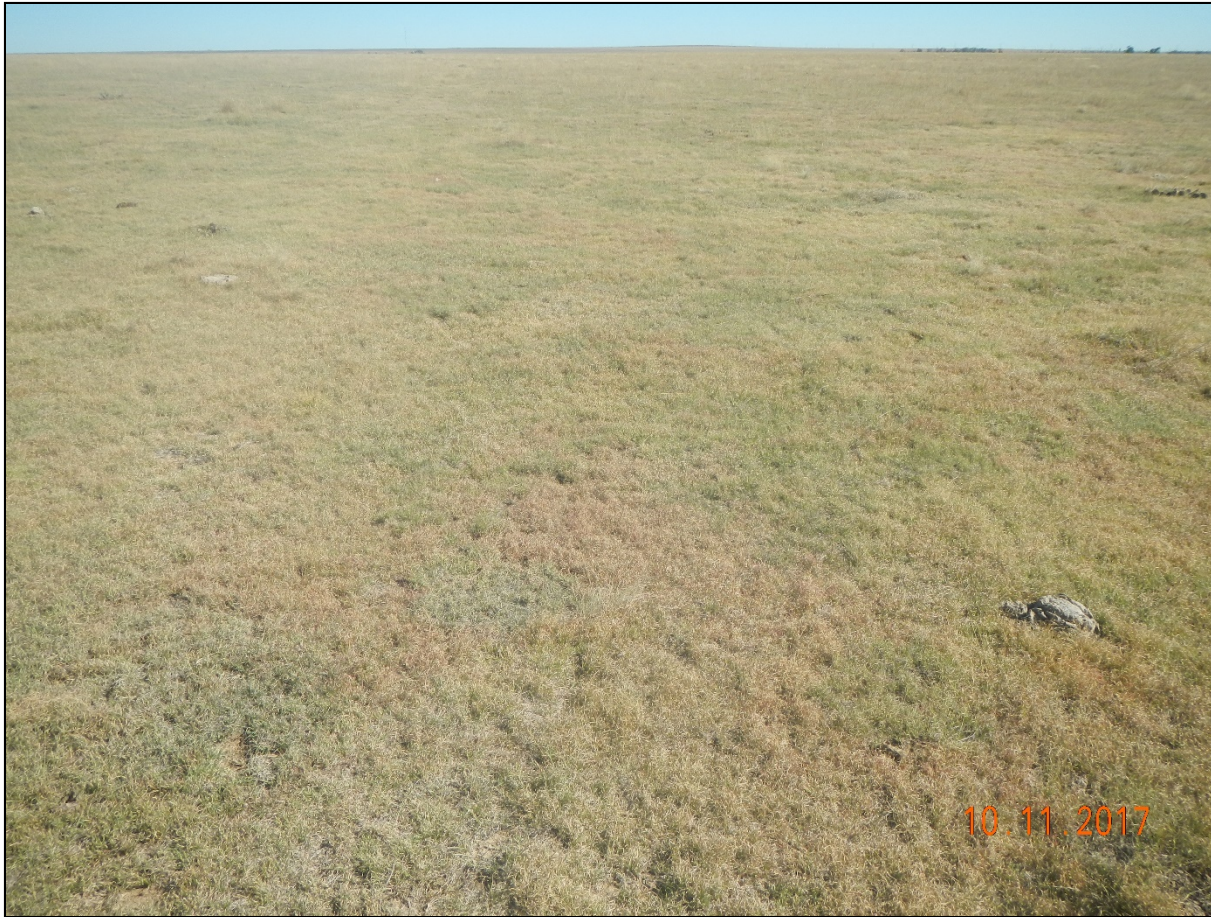
Photo 4. Facing east toward the surrounding undisturbed pasture.
