Inspection Photos

Operator: PAPE OILFIELD SERVICE INC - 67165

Location ID: 317172

Inspection Doc. Number: 682502705

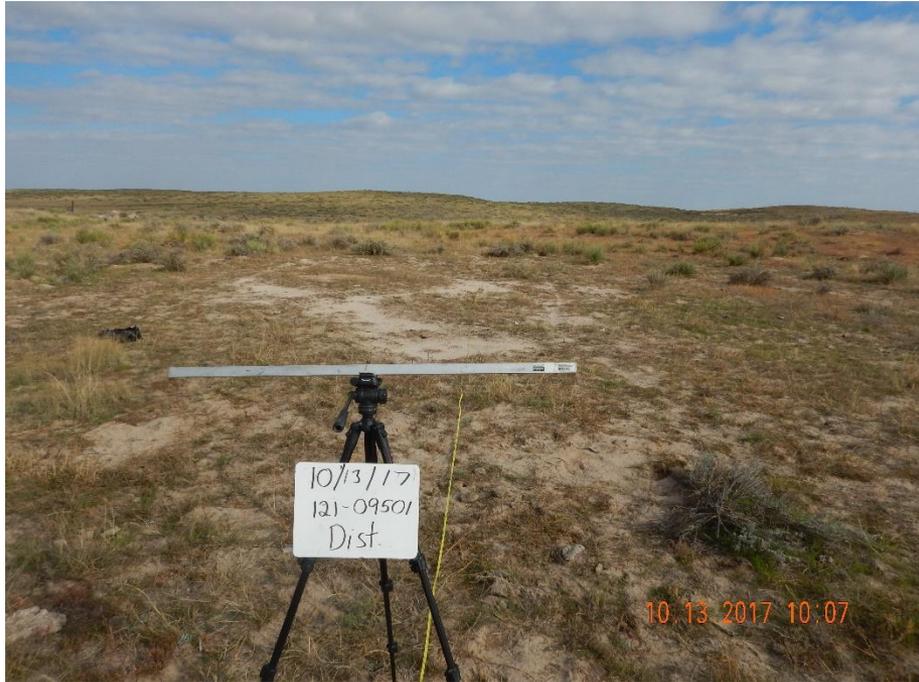
Photo 1: Photo taken from the south end of the location, facing north. Photo shows the starting point of the disturbance transect.

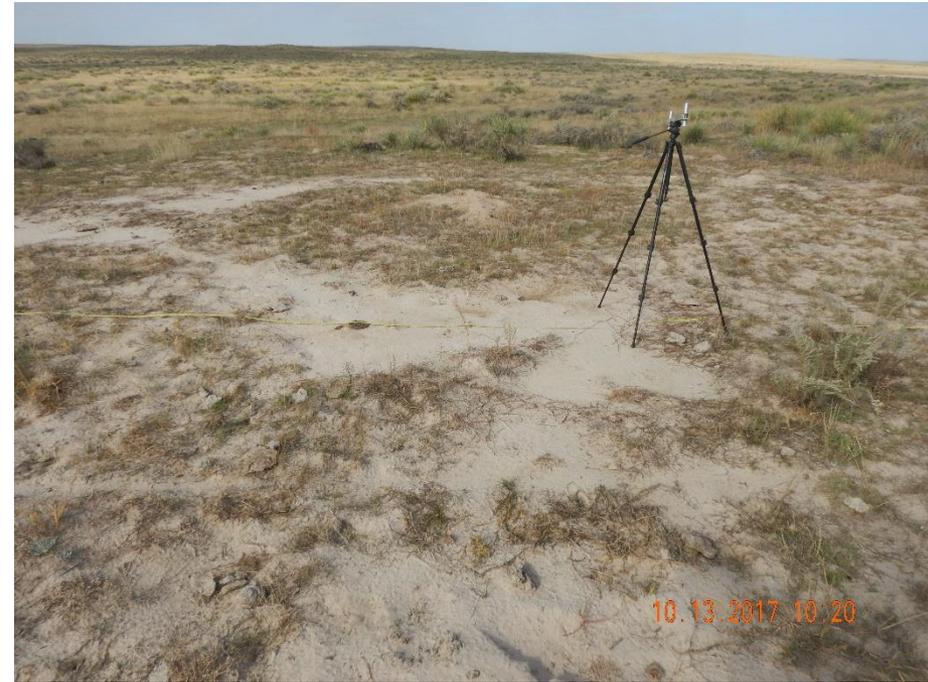
Photo 2: Photo of the 50th point of the disturbance transect, facing west. Photo shows vegetation over the reclamation area.

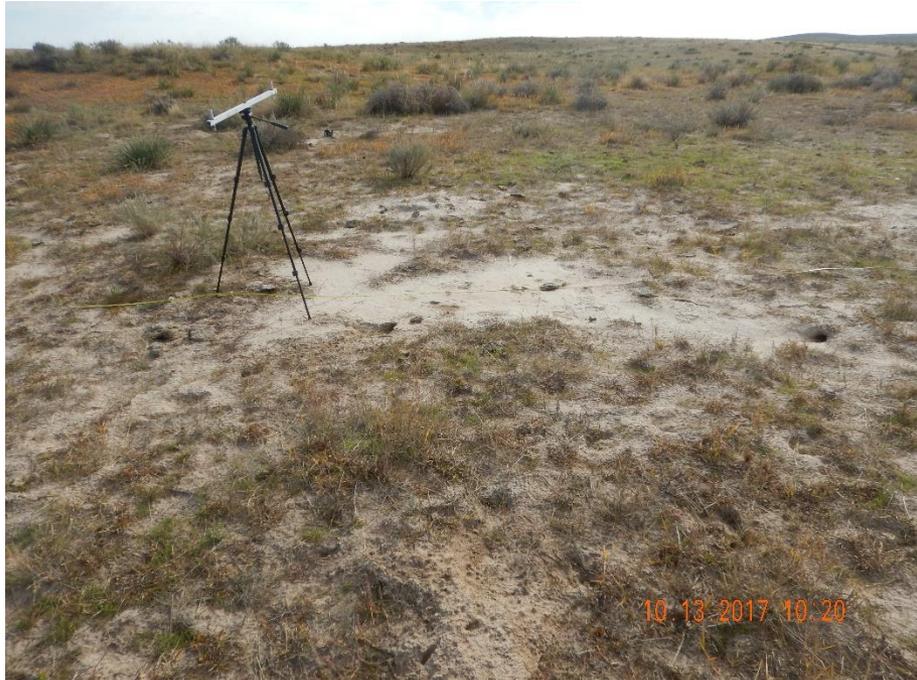
Photo 3: Photo of the 50th point of the disturbance transect, facing east. Photo shows vegetation over the reclamation area.

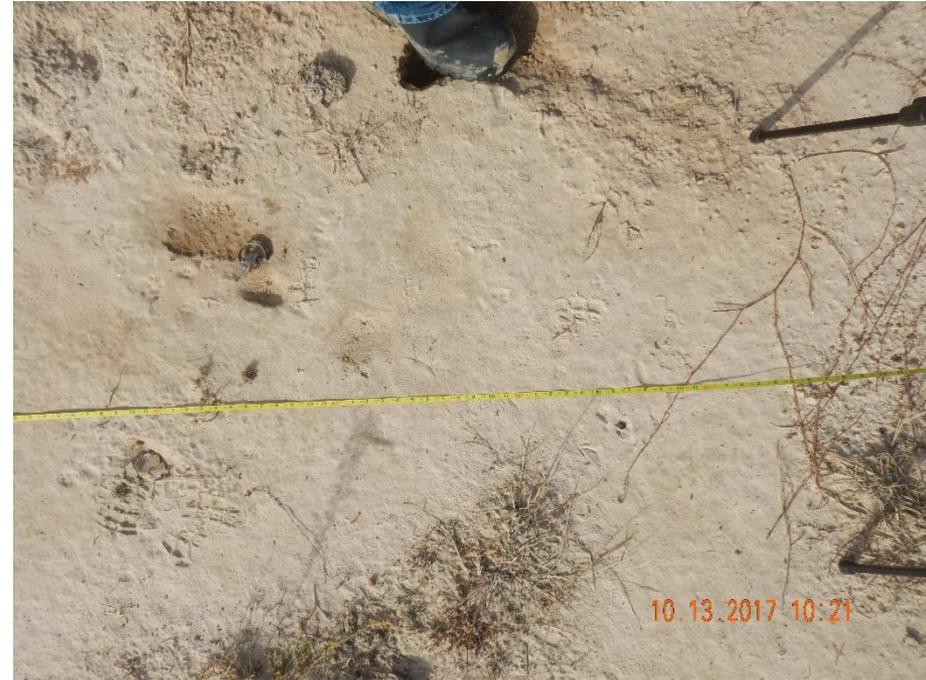
Photo 4: Photo of the 50th point of the disturbance transect. Photo shows vegetation over the reclamation area.

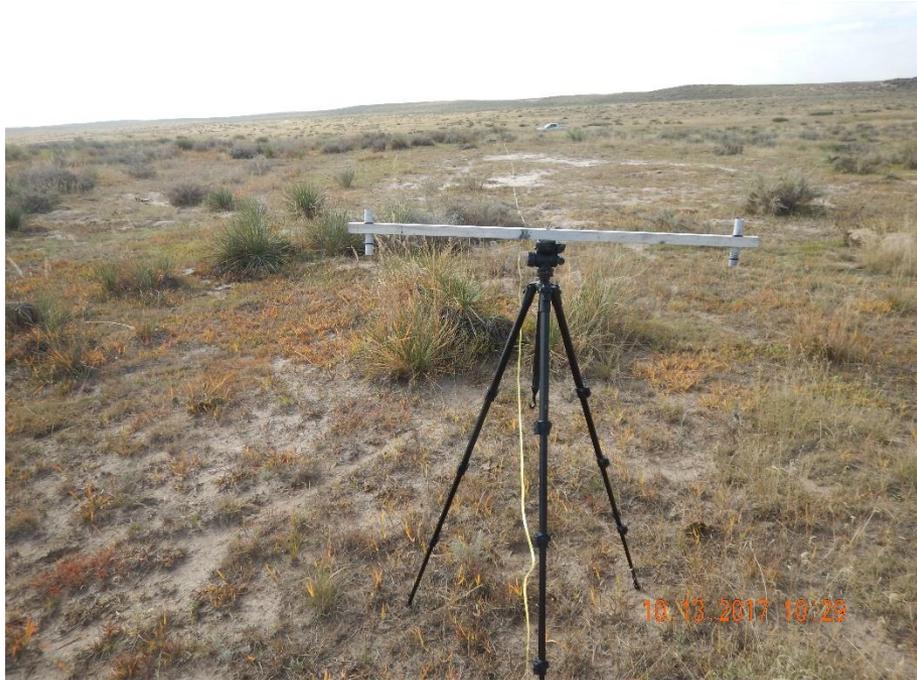
Photo 5: Photo taken from the north end of the location, facing south. Photo shows the end point of the disturbance transect.

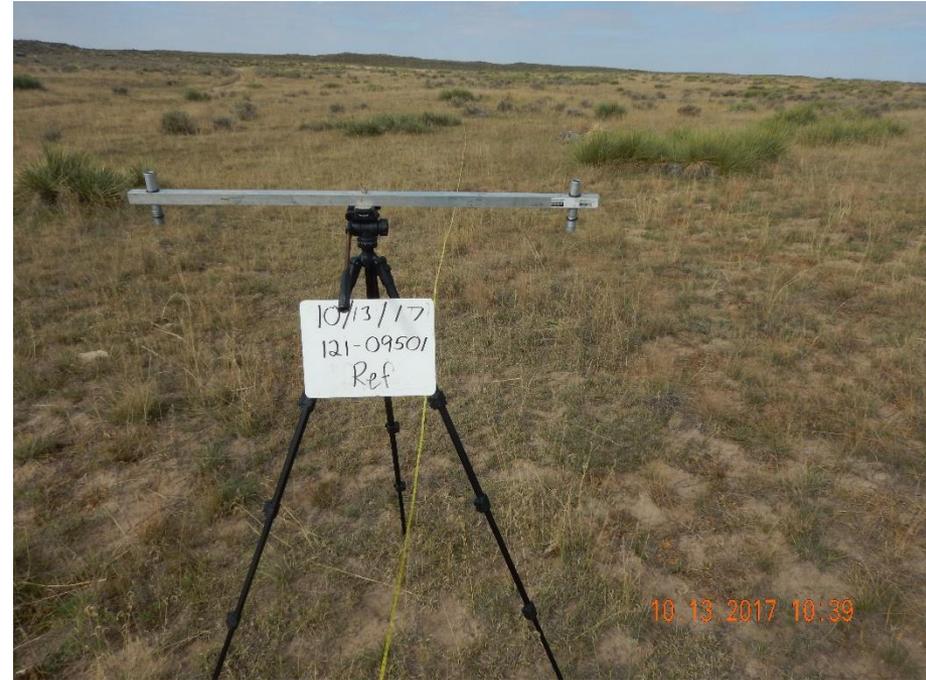
Photo 6: Photo taken from the adjacent reference area, facing west. Photo shows the starting point of the reference transect.

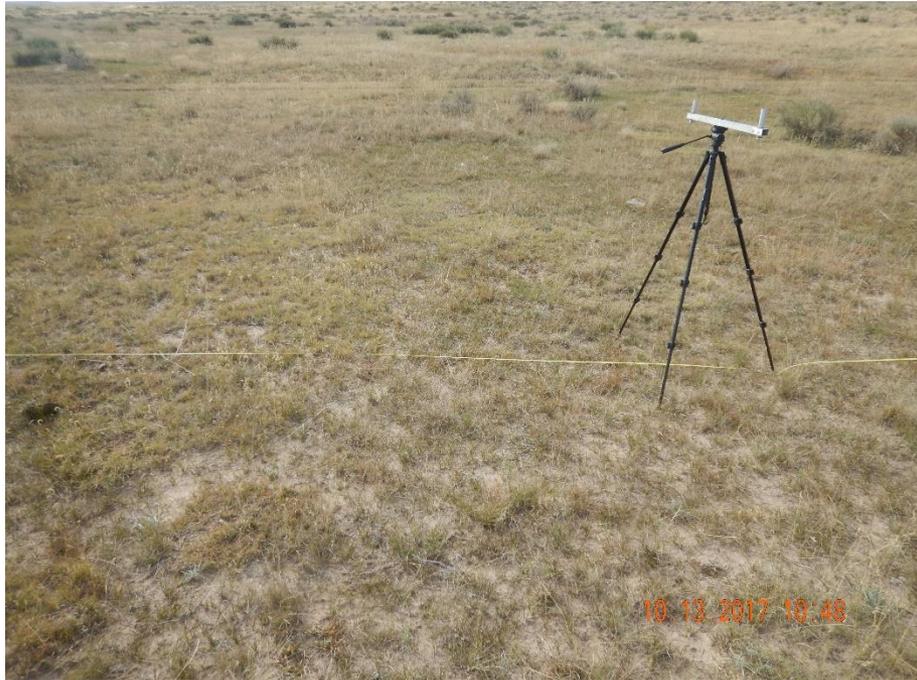
Photo 7: Photo of the 50th point of the reference transect, facing south. Photo shows vegetation over the reference area.

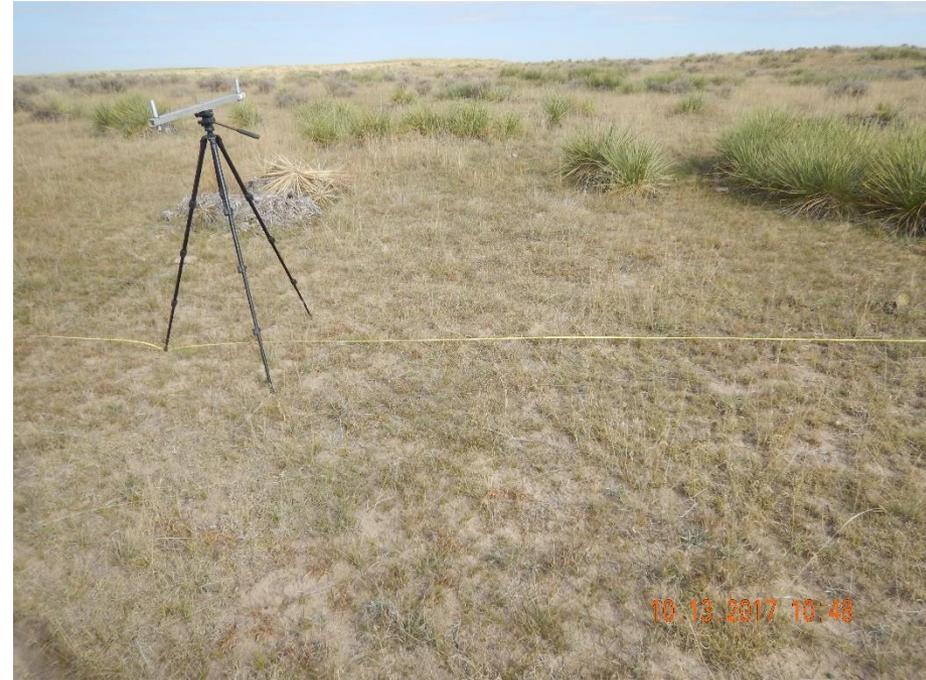
Photo 8: Photo of the 50th point of the reference transect, facing north. Photo shows vegetation over the reference area.

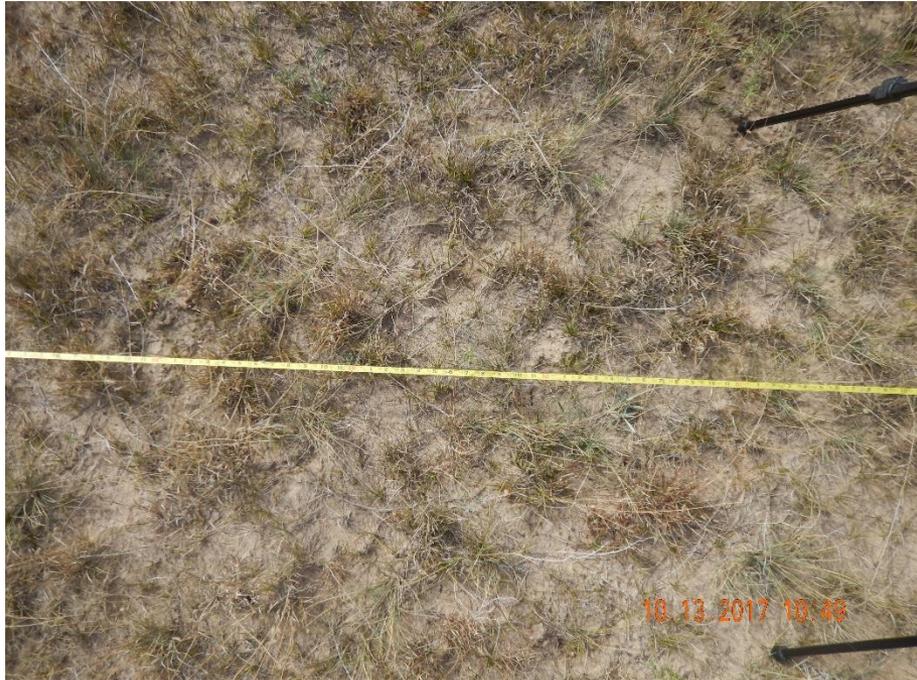
Photo 9: Photo of the 50th point of the reference transect. Photo shows vegetation over the reference area.

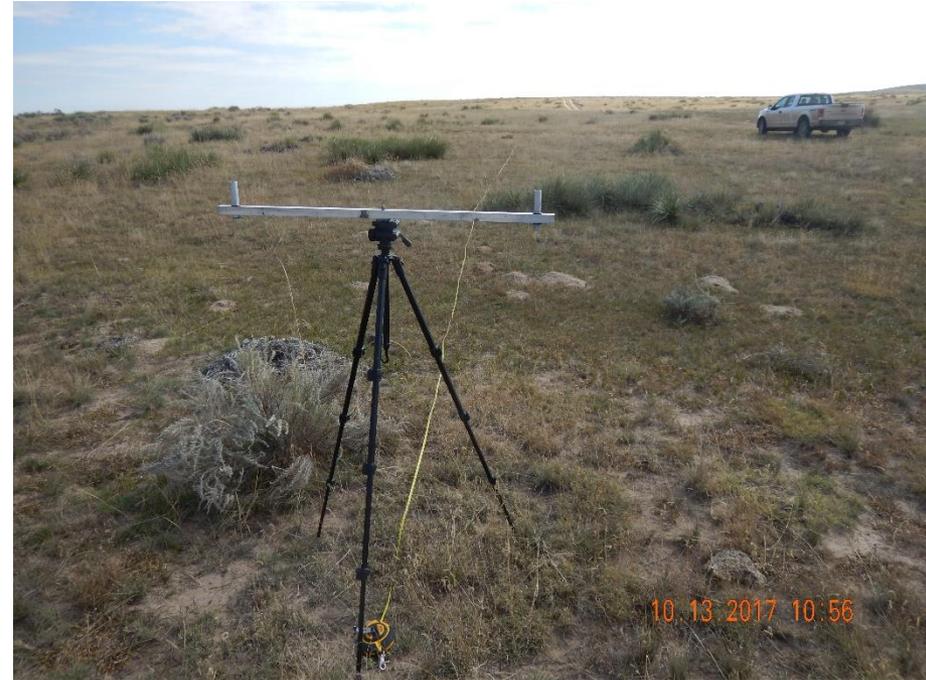
Photo 10: Photo taken from the adjacent reference area, facing west. Photo shows the end point of the reference transect.

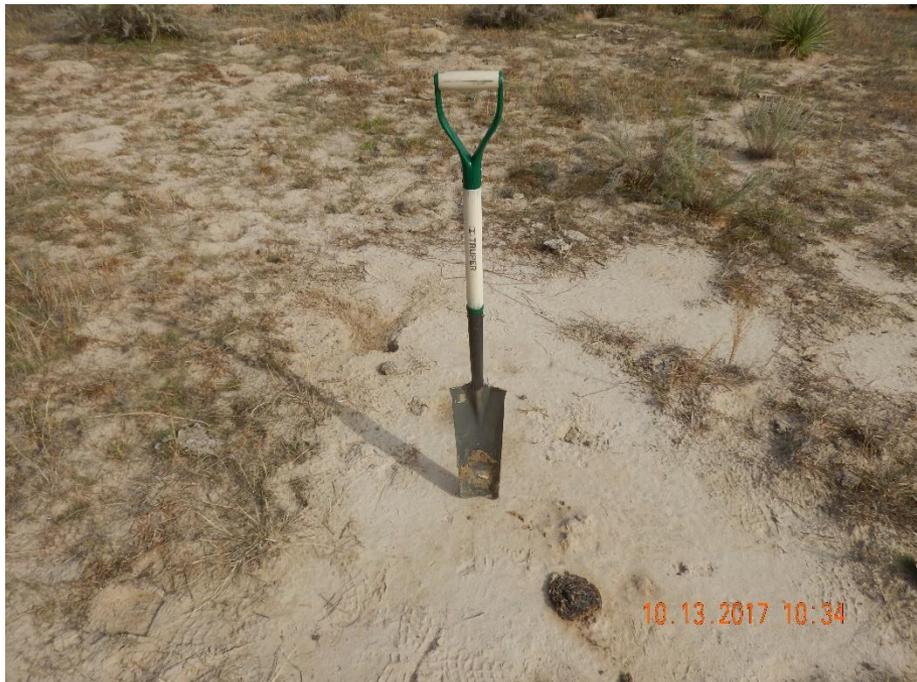
Photo 11: Photo taken from the location. Inspector had tested the site for compaction concerns. Photo shows inspector was only able to penetrate the first couple of inches of topsoil with relative ease.

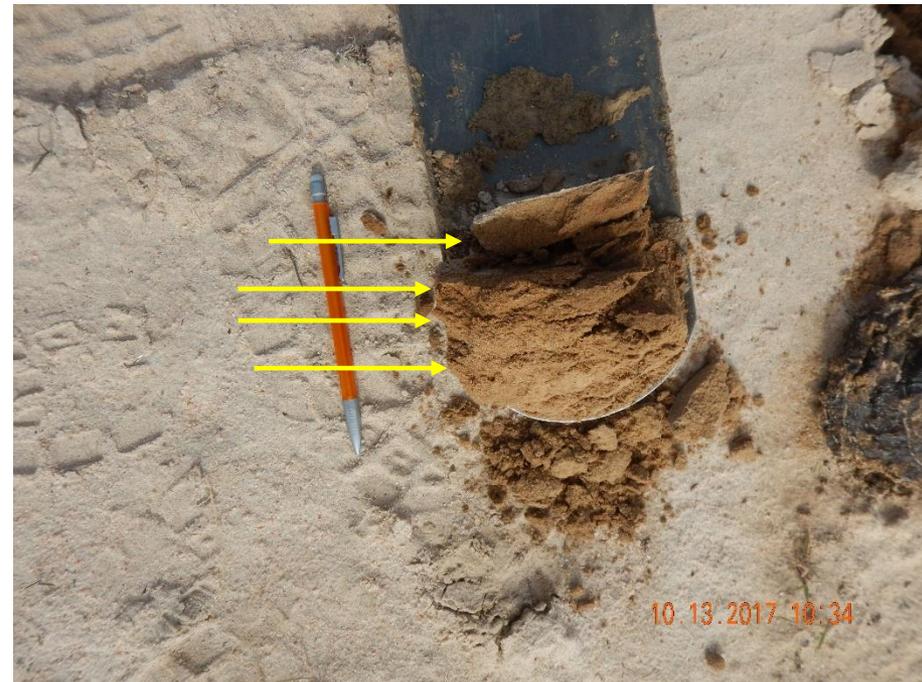
Photo 12: Inspector tested the site for soil compaction, photo shows horizontal plate formations in the top inches of soil. This is an indication of soil compaction.

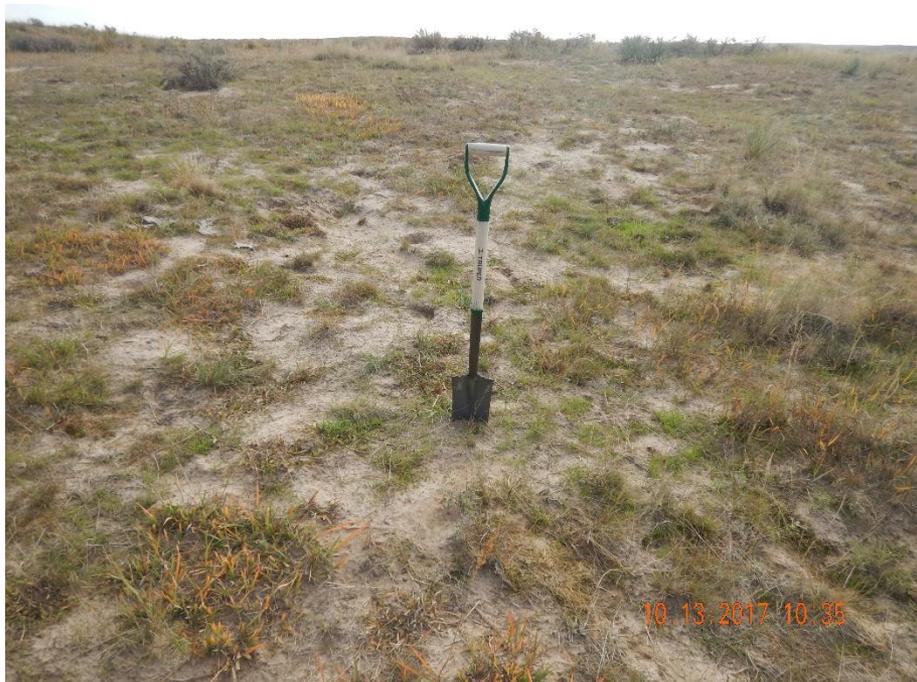
Photo 13: Photo taken from the reference area. Inspector had tested the soil in the reference area for comparison. Photo shows inspector was able to easily penetrate the topsoil.

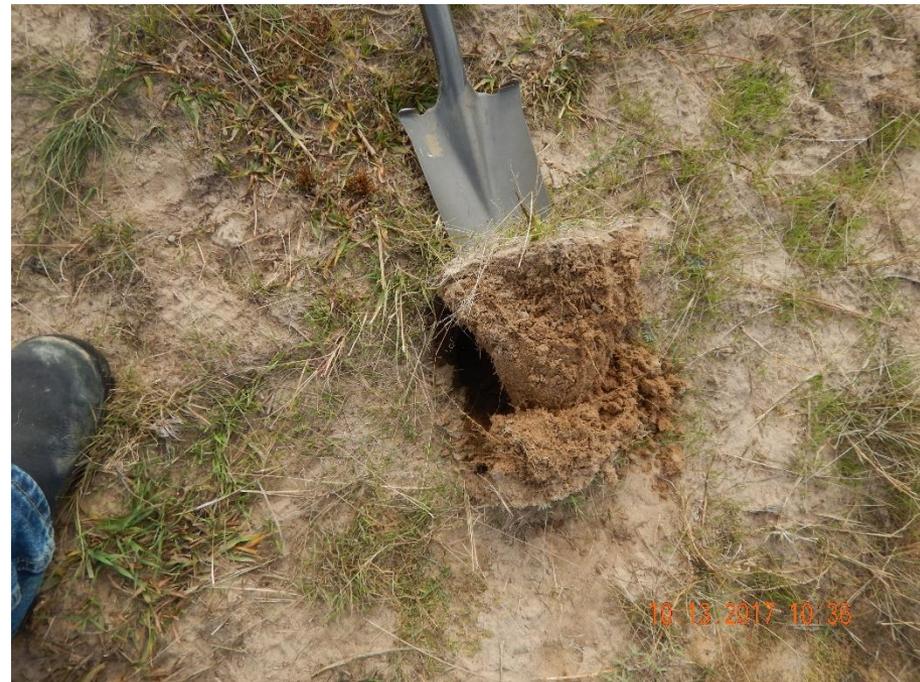
Photo 14: Photo of the reference area topsoil to compare to the disturbance area.
