Construction and Stormwater Inspection

October 12, 2017

Operator: BONANZA CREEK ENERGY OPERATING COMPANY LLC -#8960

Inspection Photos
Location Name: Mustang /44-34 Pad
Location ID: 450213

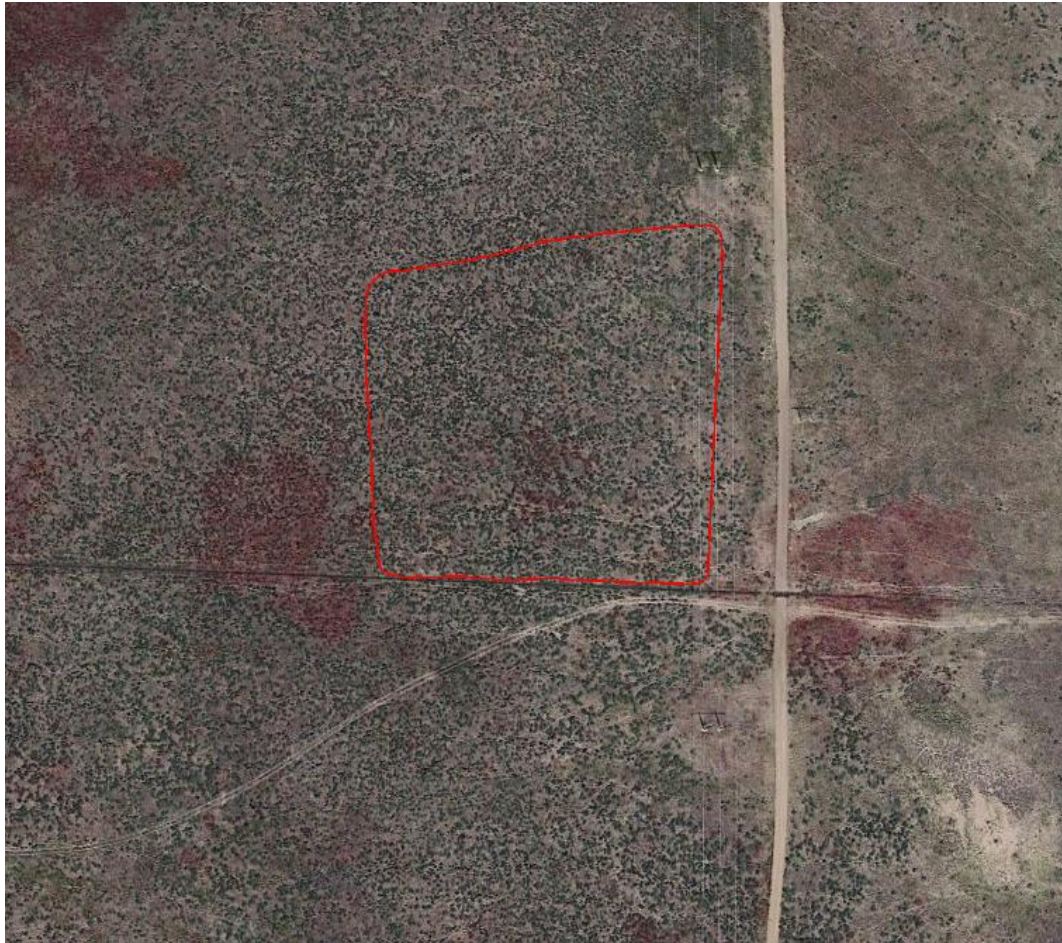
Photo 1. Google Earth aerial imagery taken on June 14, 2016. A disturbance area of 4.75 acres was mapped on 10/12/2017 using a Trimble Juno 3B handheld device (red line). Appears the Operator has overbuilt the location by 1.25 acres (36% overbuilt) per the approved Form 2A .

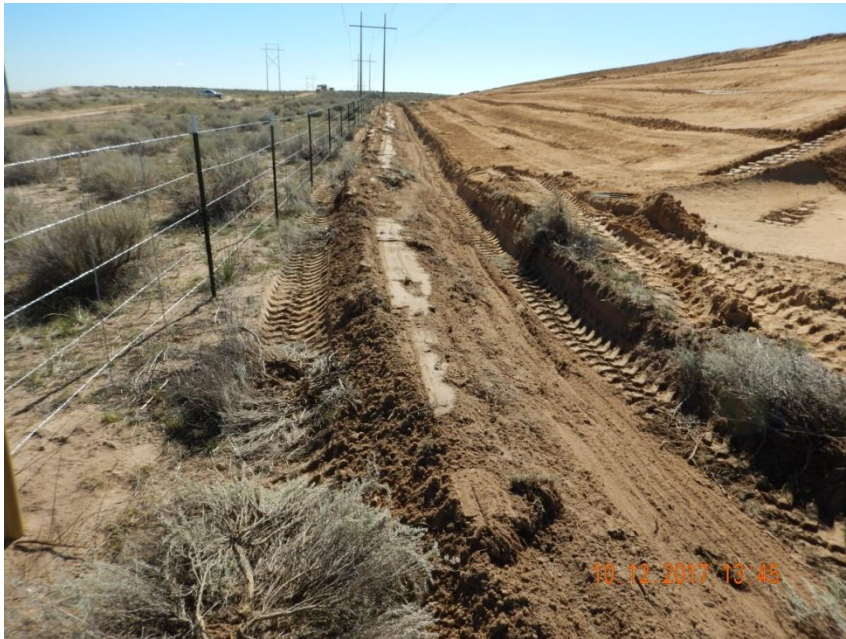
Photo 2. Photo taken from the eastern location, facing South. Operator has installed a ditch and berm around the entire location perimeter. Portions of the berm BMP have not been properly compacted and have been left unconsolidated.

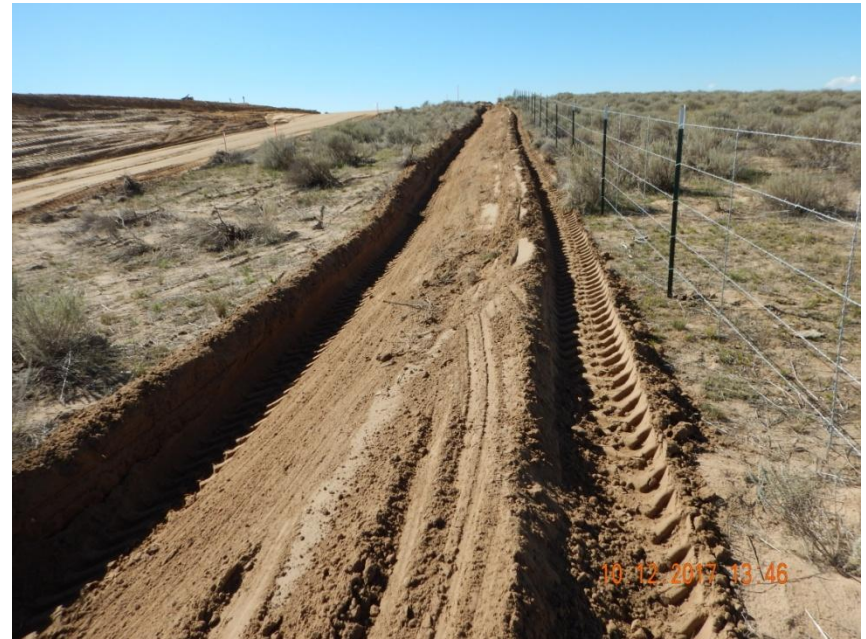
Photo 3. Photo taken from the northeastern location, facing West. See comments under Photo 2.

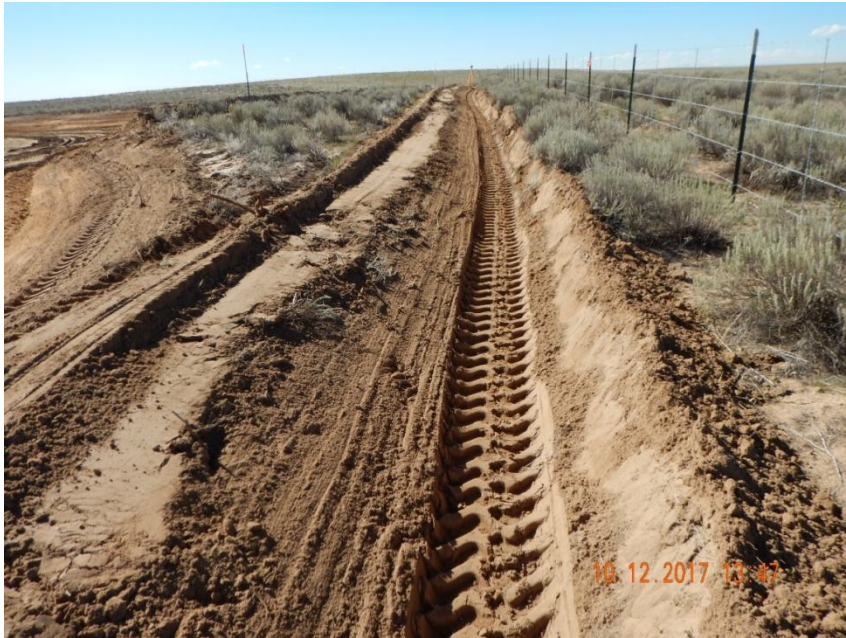
Photo 4. Photo taken from the northwestern location, facing West. See comments under Photo 2.

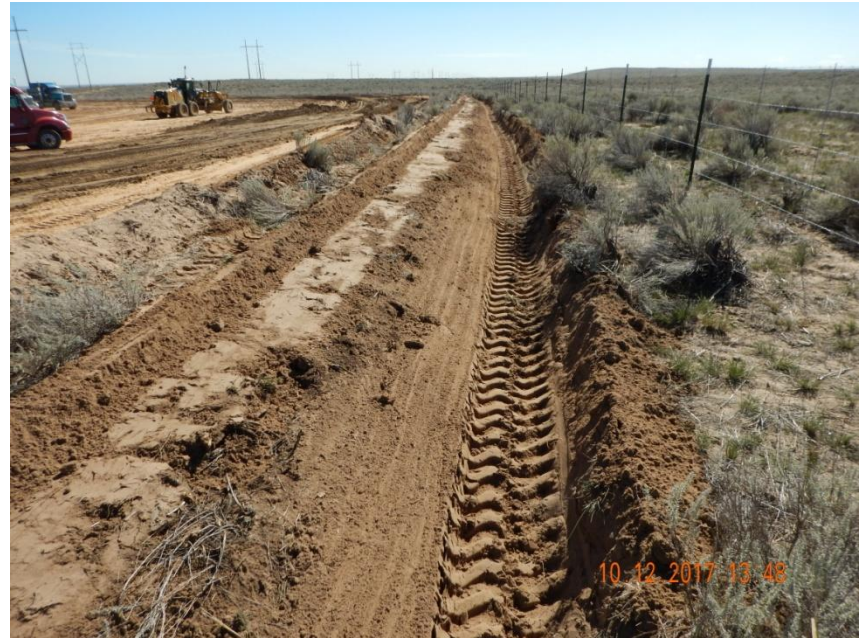
Photo 5. Photo taken from the western location, facing South. See comments under Photo 2.

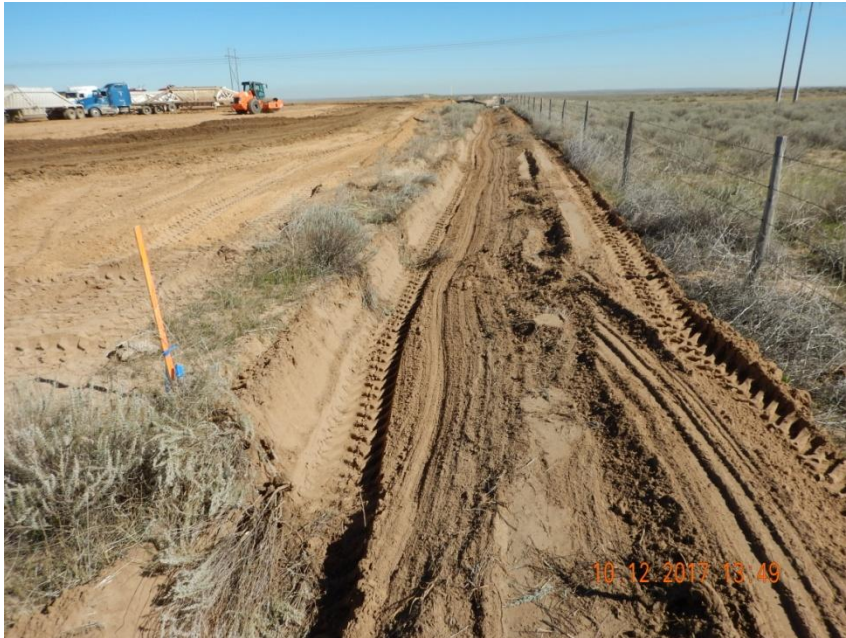
Photo 6. Photo taken from the southern location, facing East. See comments under Photo 2.
