Construction and Stormwater Inspection

October 12, 2017

Operator: BONANZA CREEK ENERGY OPERATING COMPANY LLC -#8960

Location ID: 450201

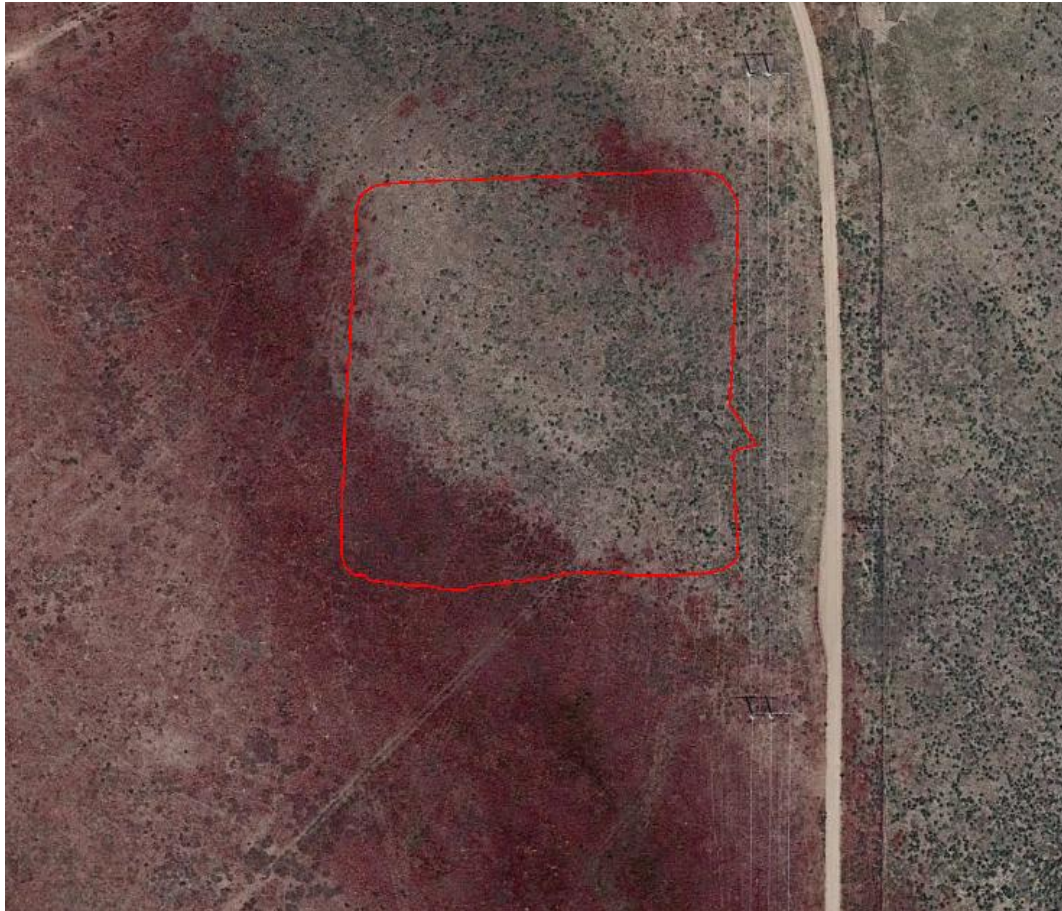
Photo 1. Google Earth aerial imagery taken on June 14, 2016. A disturbance area of 4.64 acres was mapped on 10/12/2017 using a Trimble Juno 3B handheld device (red line). Appears the Operator has overbuilt the location by 0.94 acres (25% overbuilt) per the approved Form 2A .

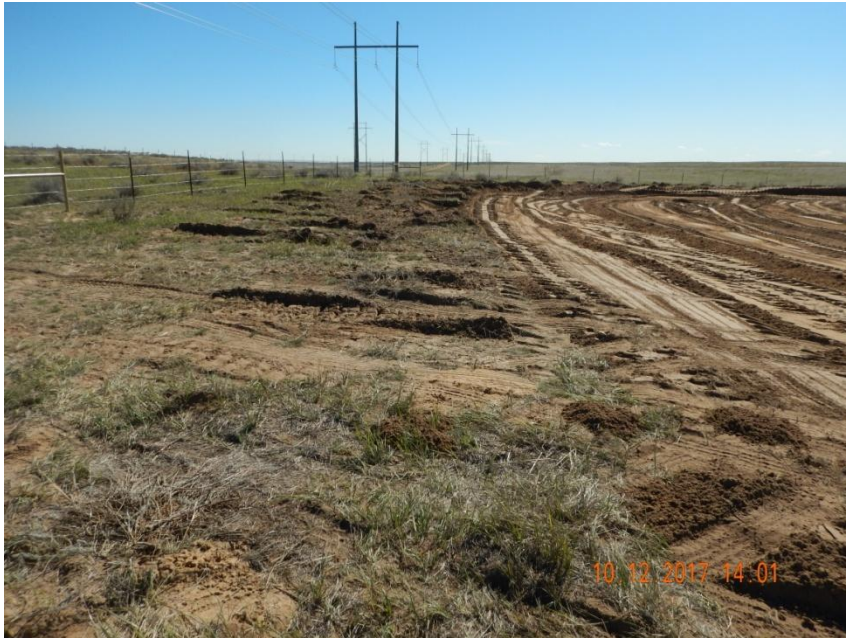
Photo 2. Photo taken from the eastern location, facing South. Operator has failed to install stormwater and erosion control BMPs prior to, or at, the beginning of construction.

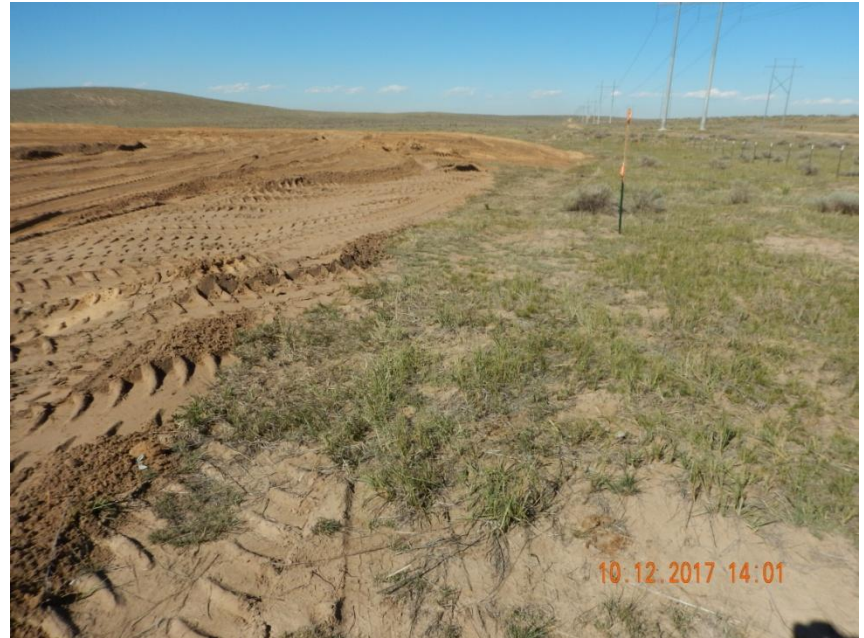
Photo 3. Photo taken from the eastern location, facing North. See comments under Photo 2.

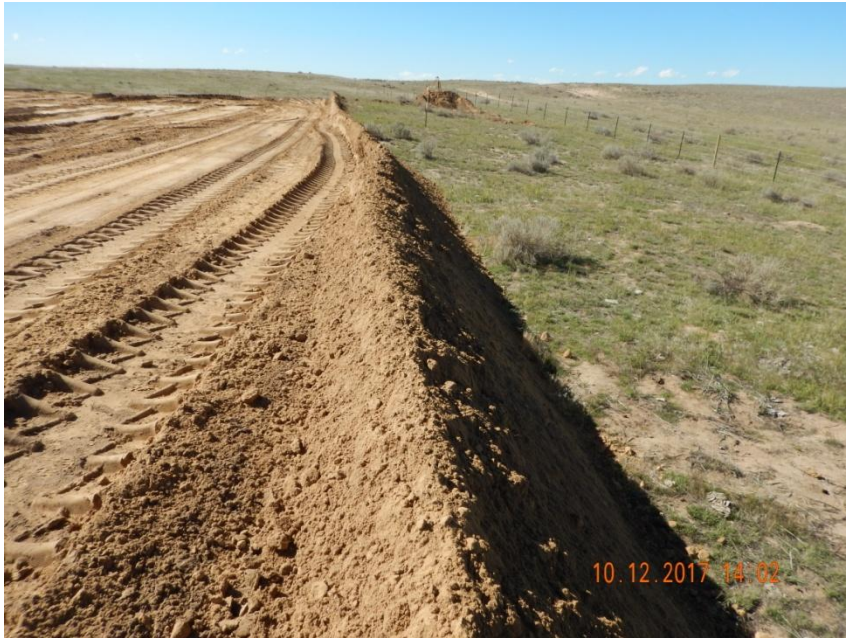
Photo 4. Photo taken from the northern location, facing West. See comments under Photo 2.

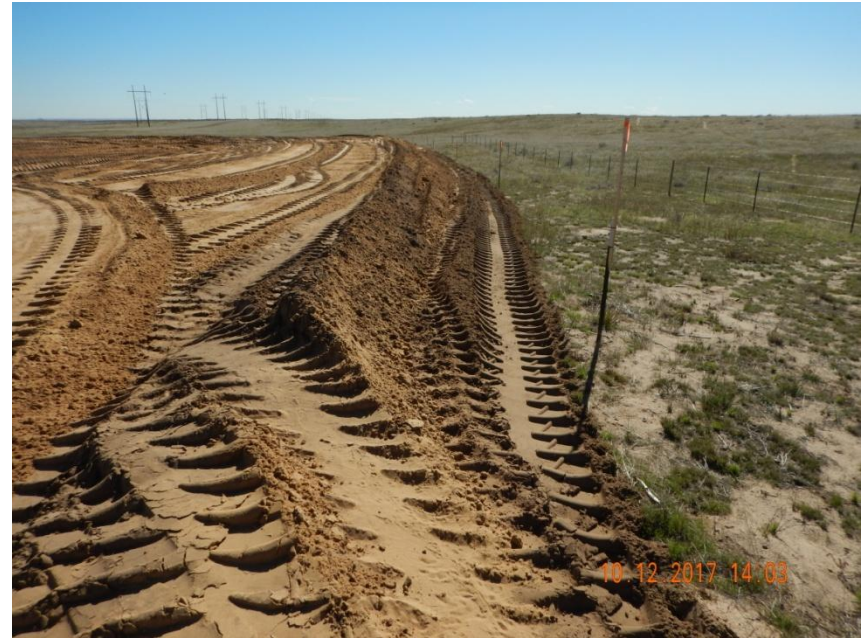
Photo 5. Photo taken from the western location, facing South. See comments under Photo 2.

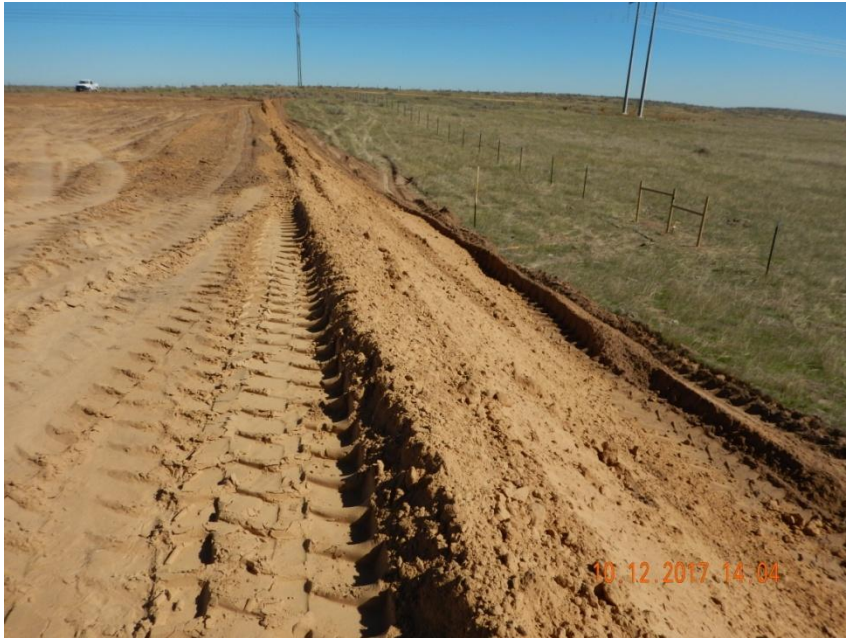
Photo 6. Photo taken from the southern location, facing East. See comments under Photo 2.

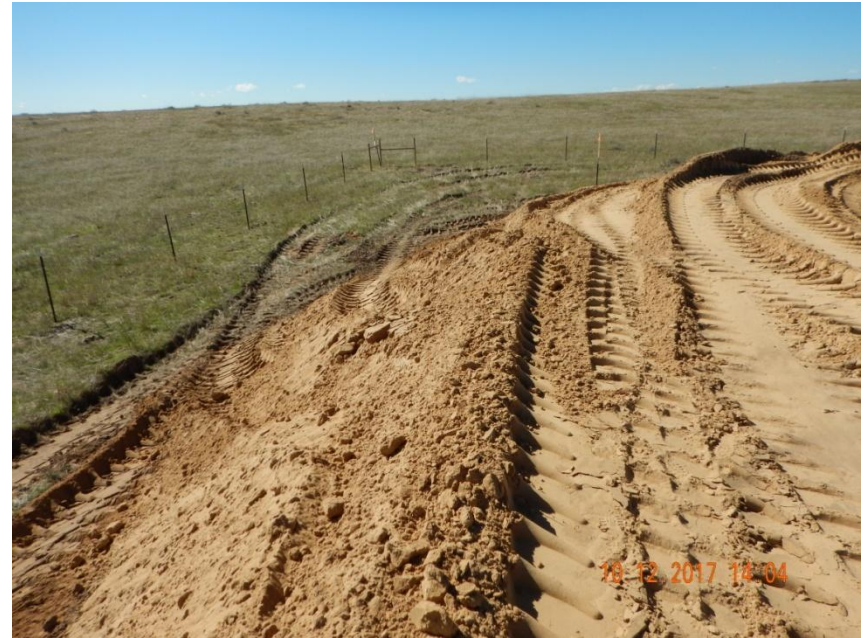
Photo 7. Photo taken from the southeastern location, facing South. See comments under Photo 2.

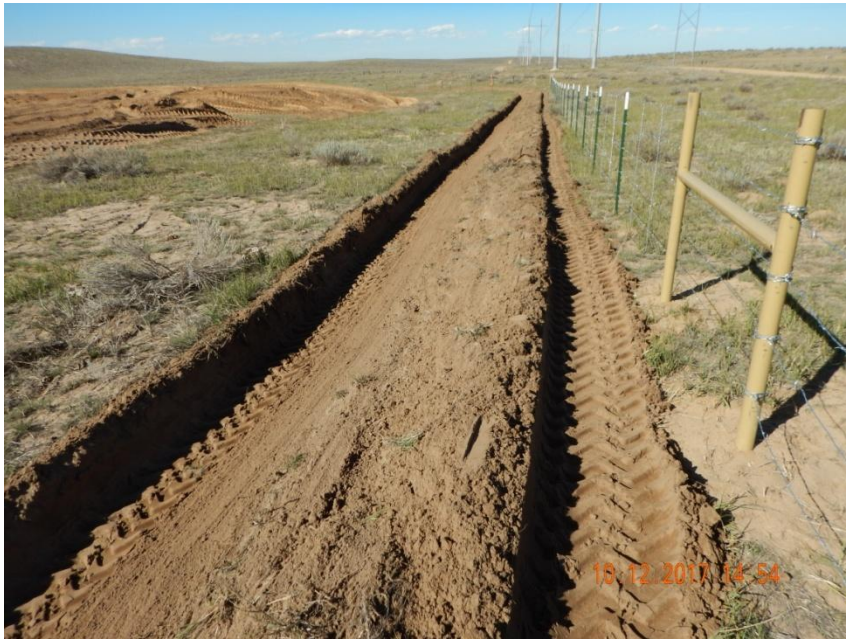
Photo 8. Photo taken from the eastern location, facing South. Operator installed a ditch and berm BMP after COGCC staff communicated to the Operator stormwater management requirements. The berm BMP has not been properly compacted and left unconsolidated.

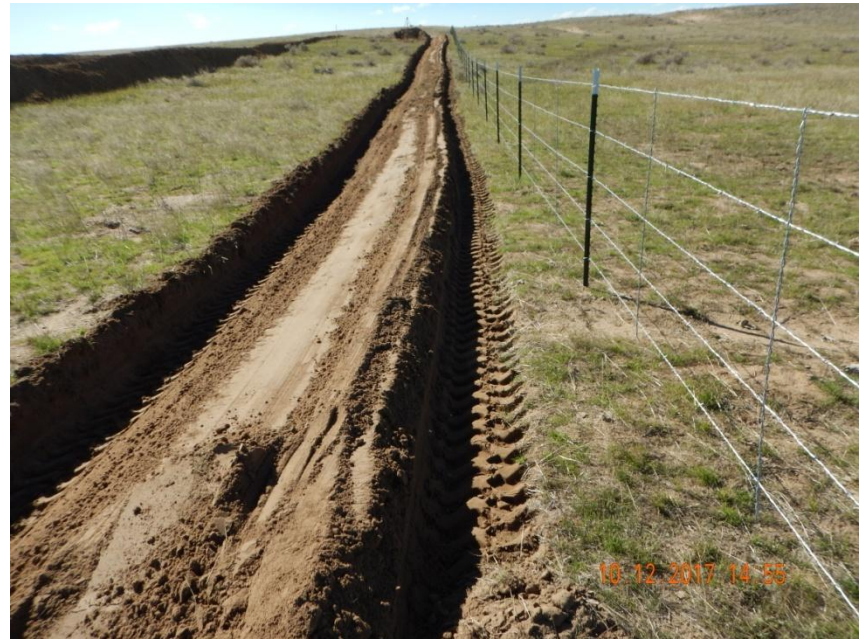
Photo 9. Photo taken from the northern location, facing West. See comments under Photo 8.

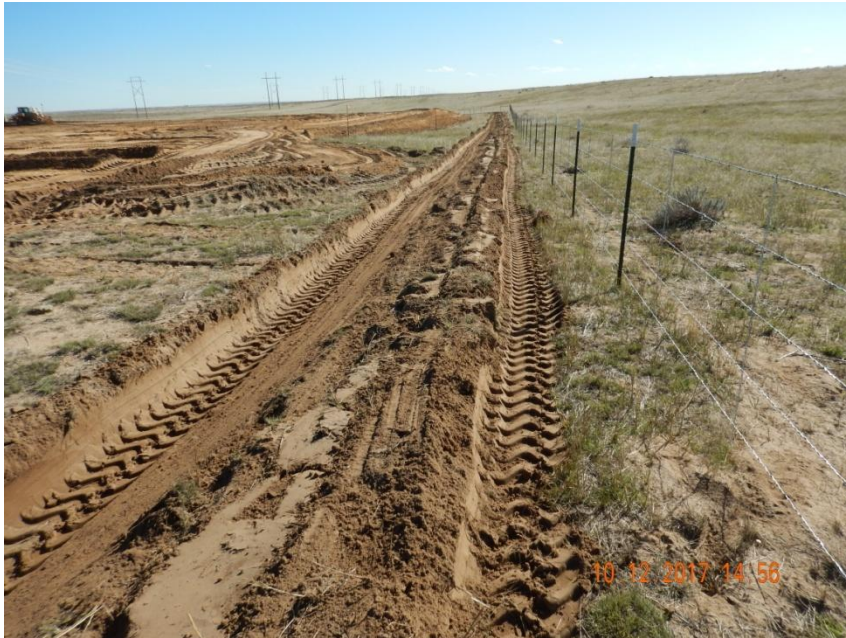
Photo 10. Photo taken from the western location, facing South. See comments under Photo 8.

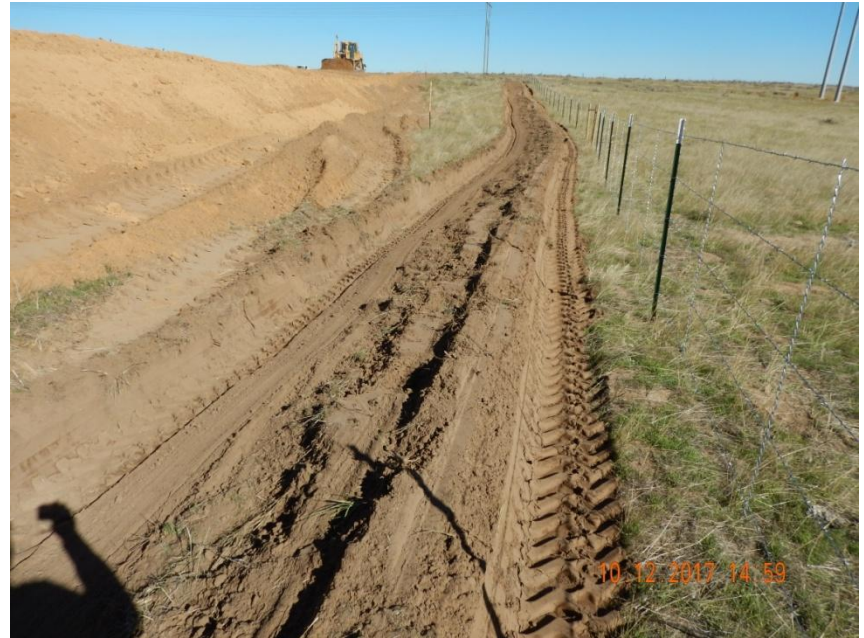
Photo 11. Photo taken from the southern location, facing East. See comments under Photo 8.
