Construction and Stormwater Inspection

Operator: BONANZA CREEK ENERGY OPERATING COMPANY LLC -#8960

Location ID: 451353

Inspection Photos
Location Name: Longhorn /14-11
Location ID: 451353

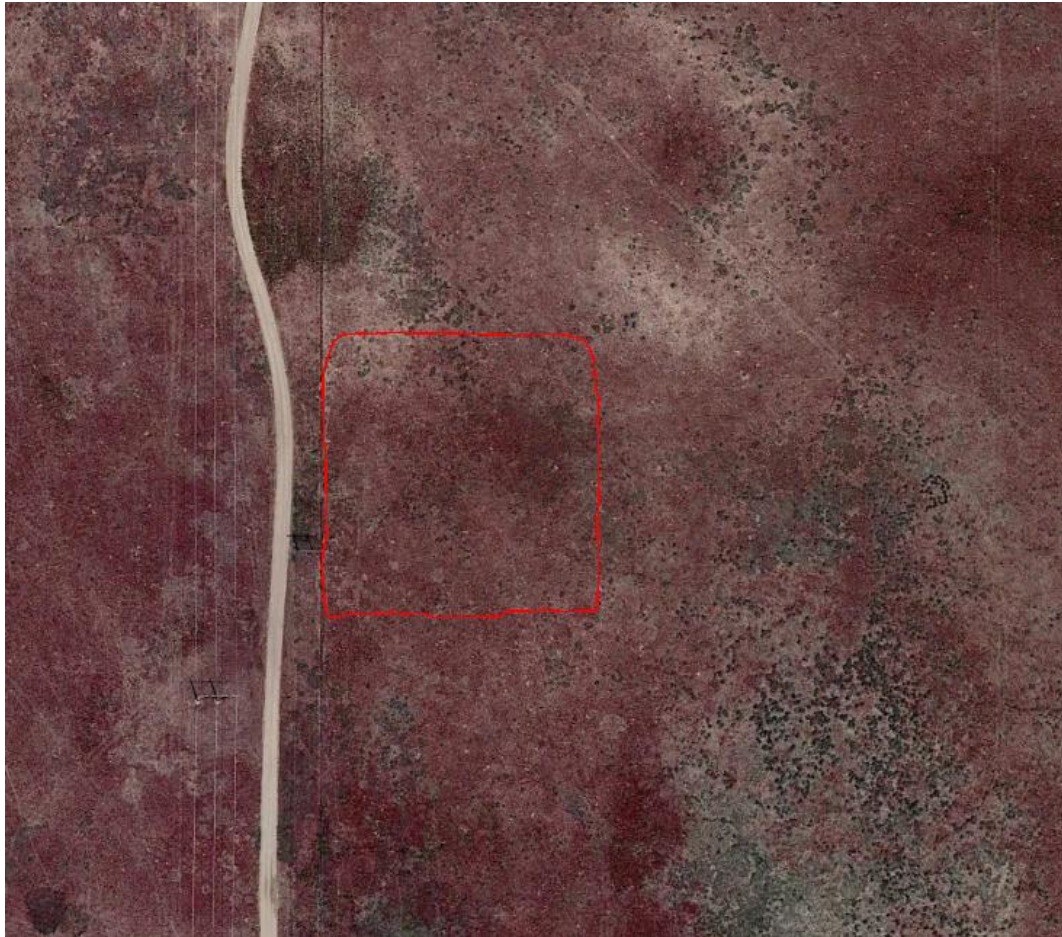
Photo 1. Google Earth aerial imagery taken on June 14, 2016. A disturbance area of 2.20 acres was mapped on 10/12/2017 using a Trimble Juno 3B handheld device (red line).

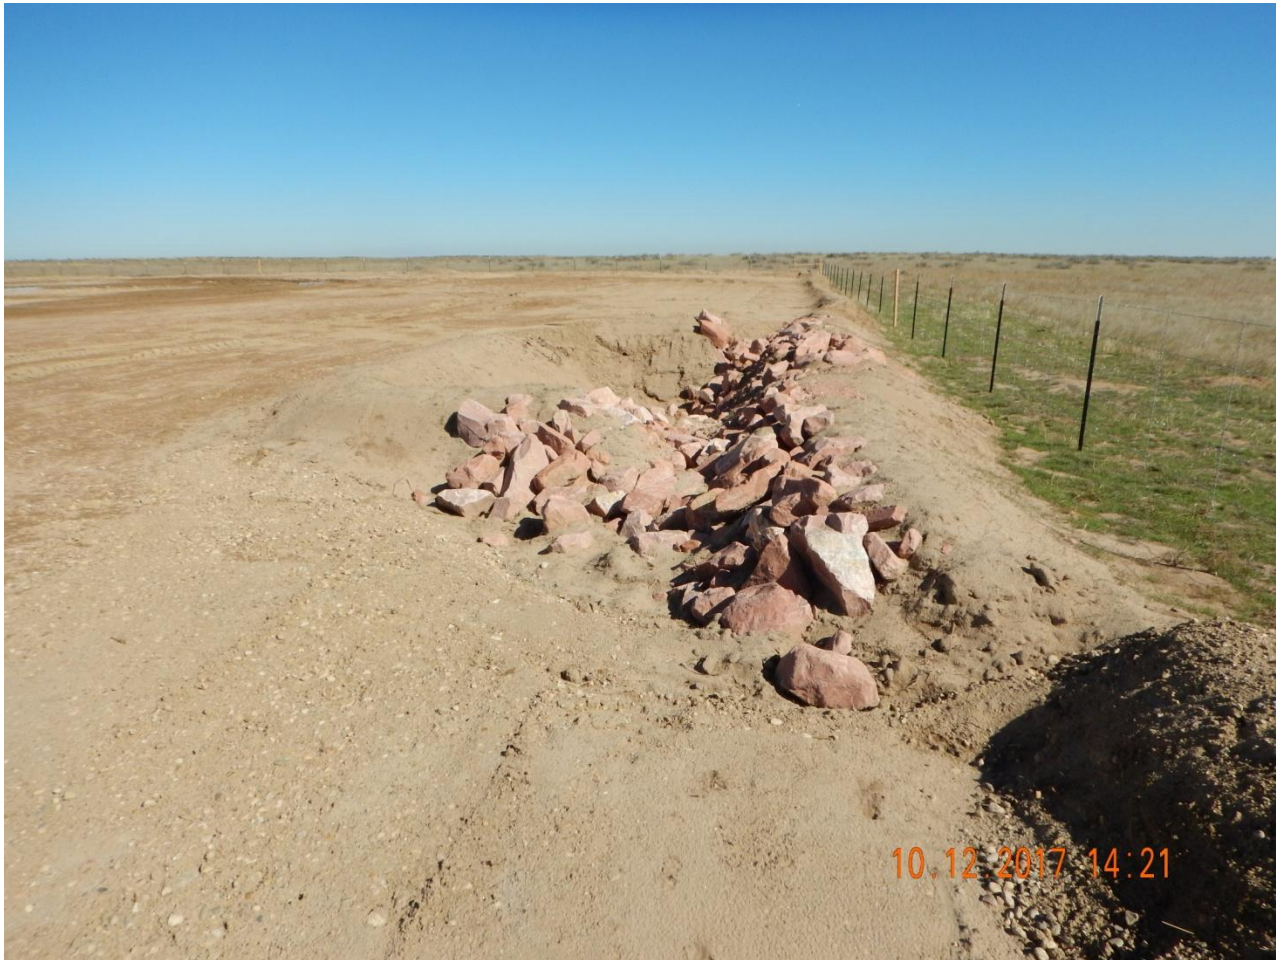
Photo 2. Photo taken from the southern location, facing East. Appears the Operator has installed a sediment trap with both inlet and outlet devices.

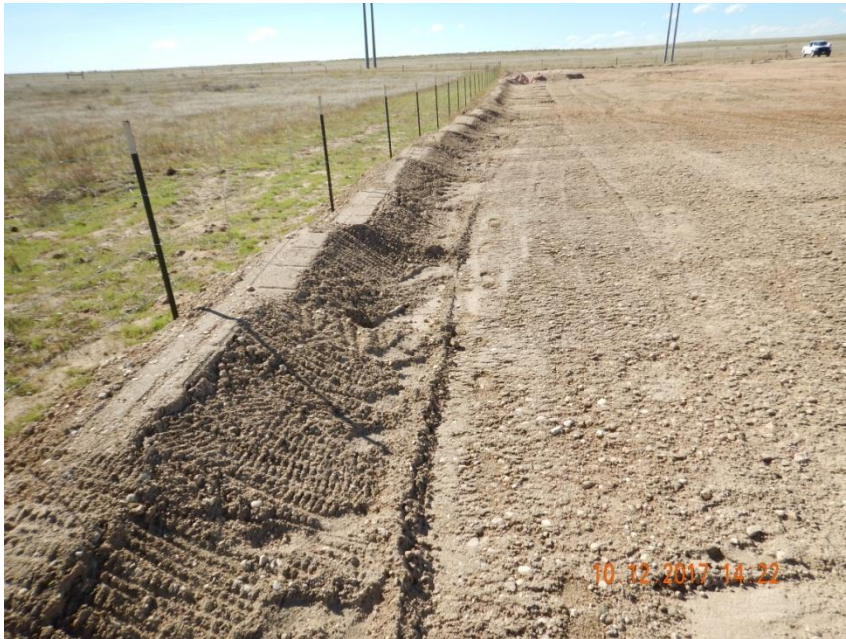
Photo 3. Photo taken from the eastern location, facing South. Appears the Operator has installed a berm BMP. The berm BMP appears sufficiently compacted but shall be monitored to ensure compaction holds up overtime.

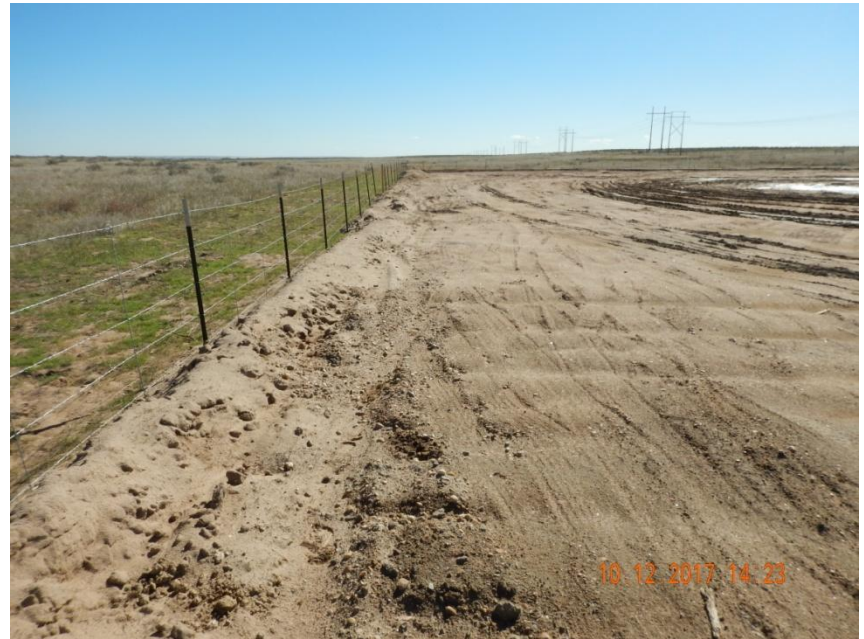
Photo 4. Photo taken from the northern location, facing East. Appears the Operator has installed a berm BMP but has been left unconsolidated.

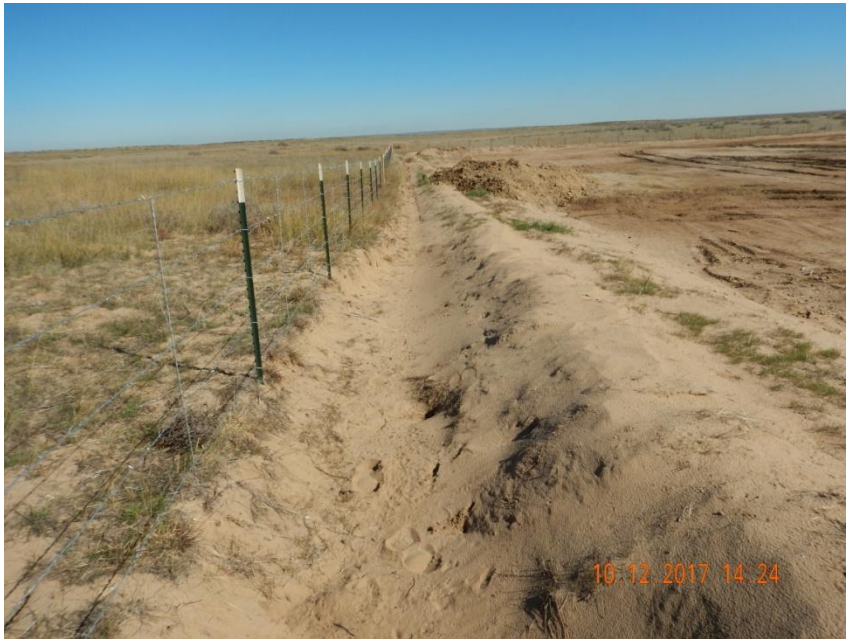
Photo 5. Photo taken from the western location, facing North. Appears the Operator has installed a ditch and berm BMP. Berm BMP appears to be left unconsolidated. Operator shall monitor BMP as this could be susceptible to wind and water erosion overtime.

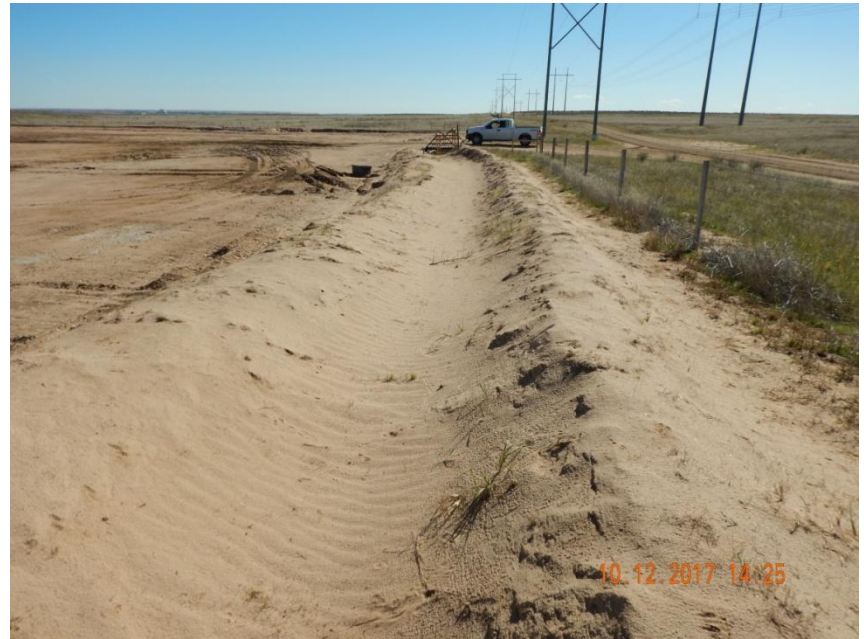
Photo 6. Photo taken from the western location, facing South. See comments under Photo 5.

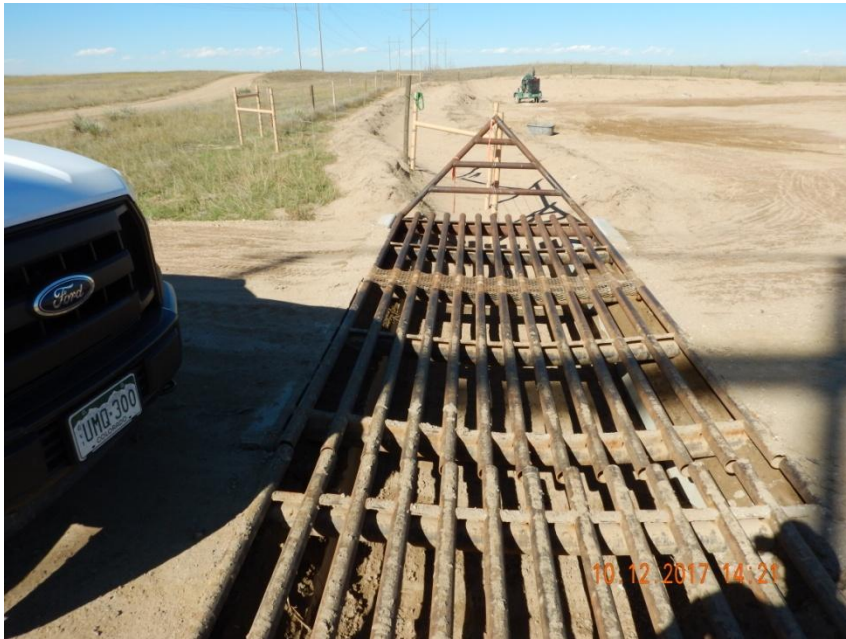
Photo 7. Photo taken from the entrance of location, facing North. Operator has installed a cattle guard tracking device.
