Inspection Photos

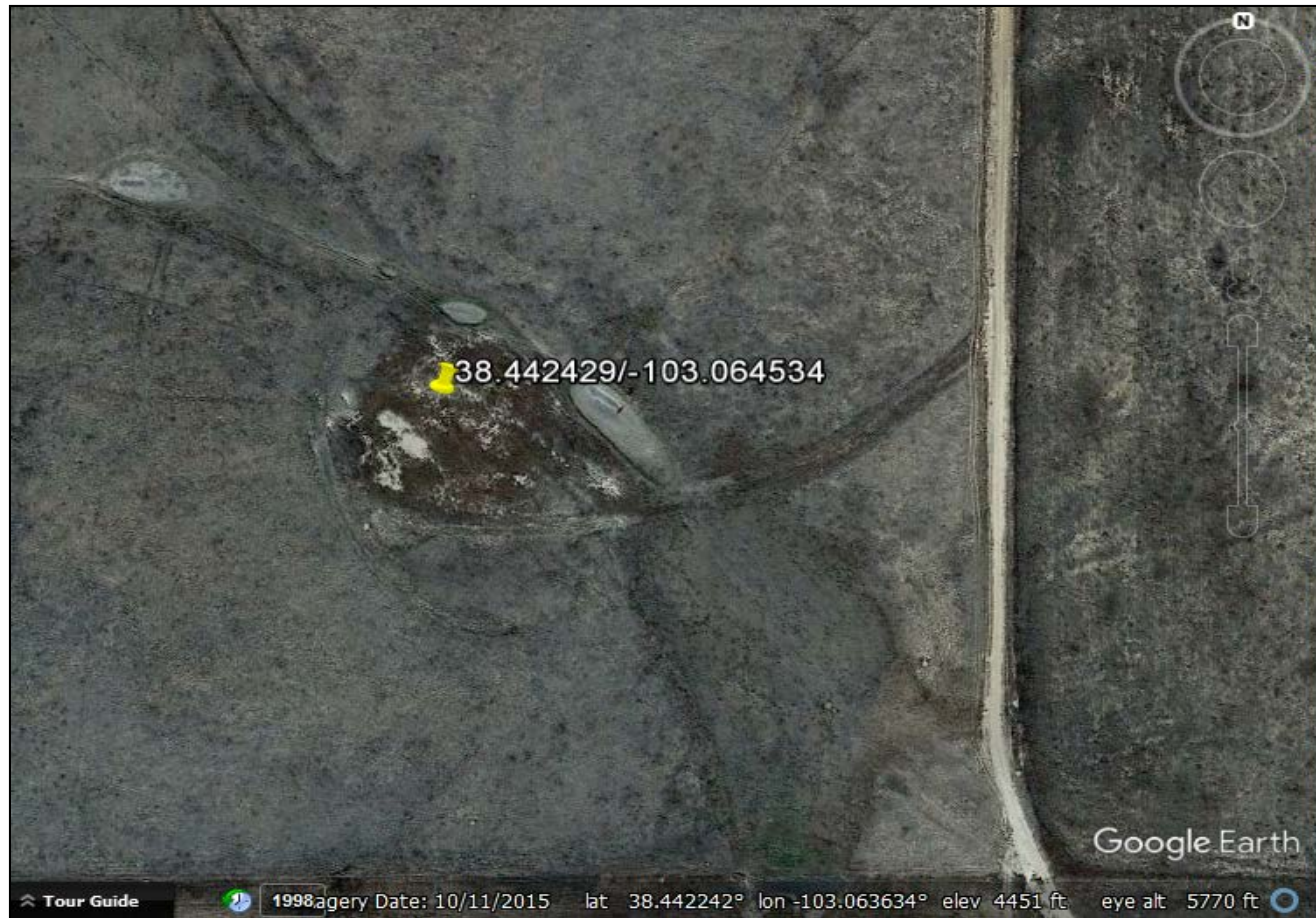
Photo 1. 2015 aerial image shows access road and location disturbance still exists.

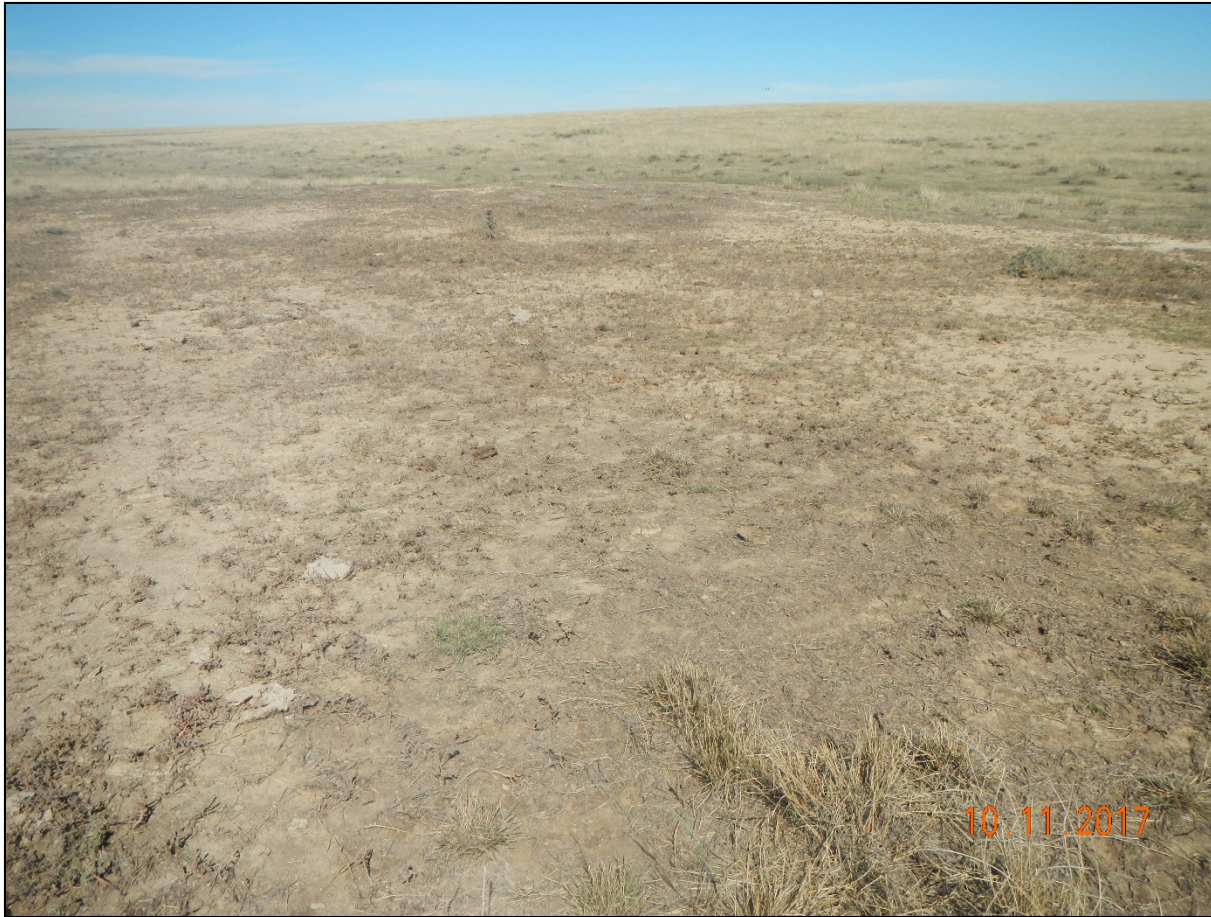
Photo 2. Center of the location facing north. The desirable vegetation has not re-established.

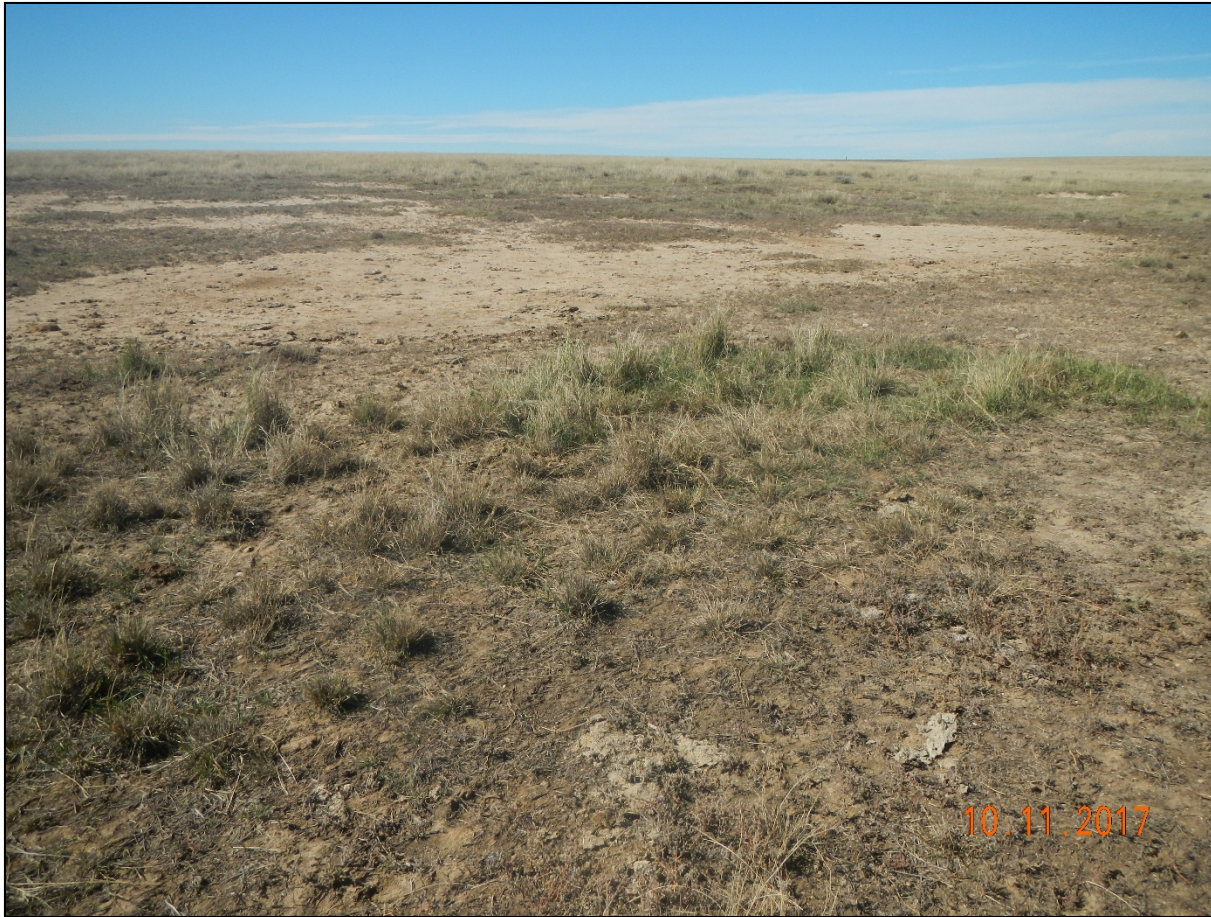
Photo 3. Center of the location facing west.

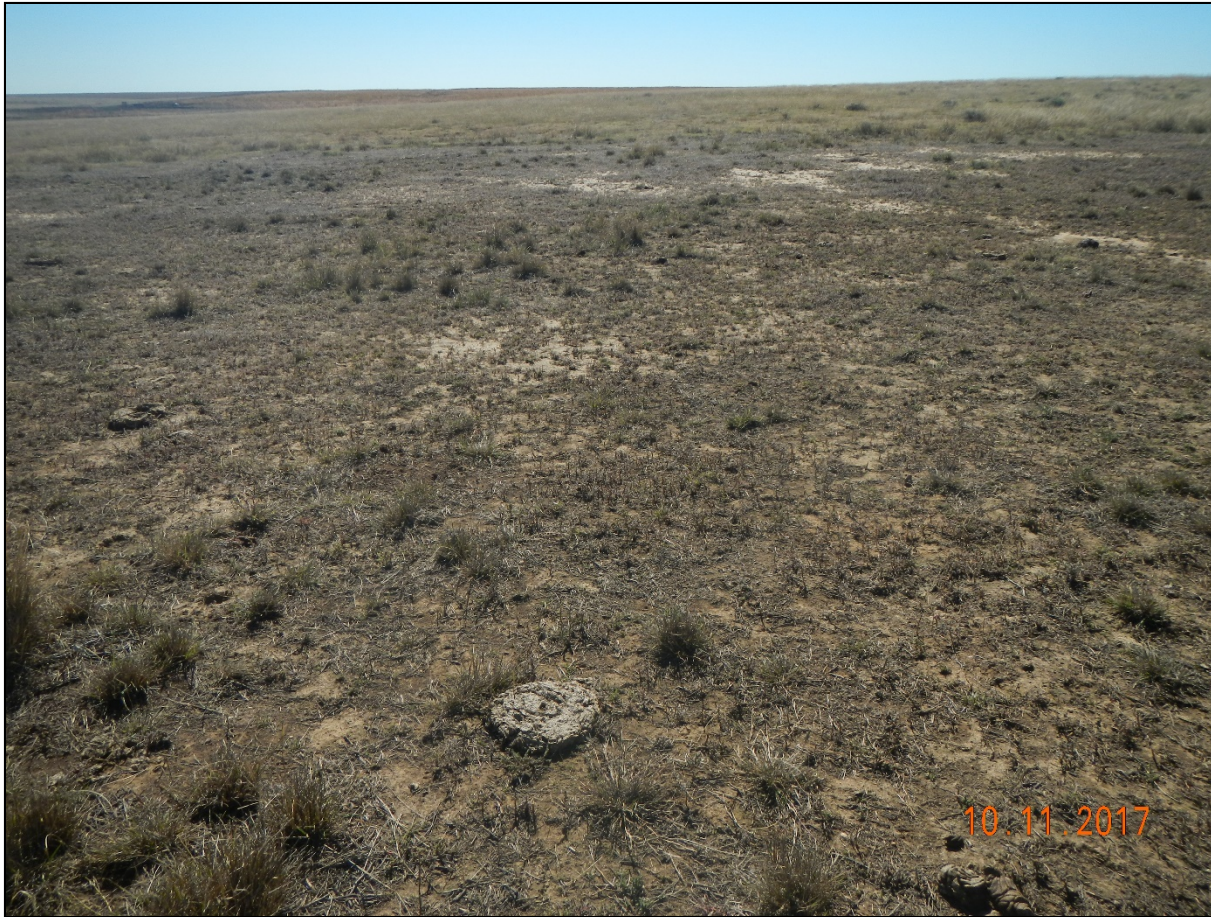
Photo 4. Center of the location facing south.

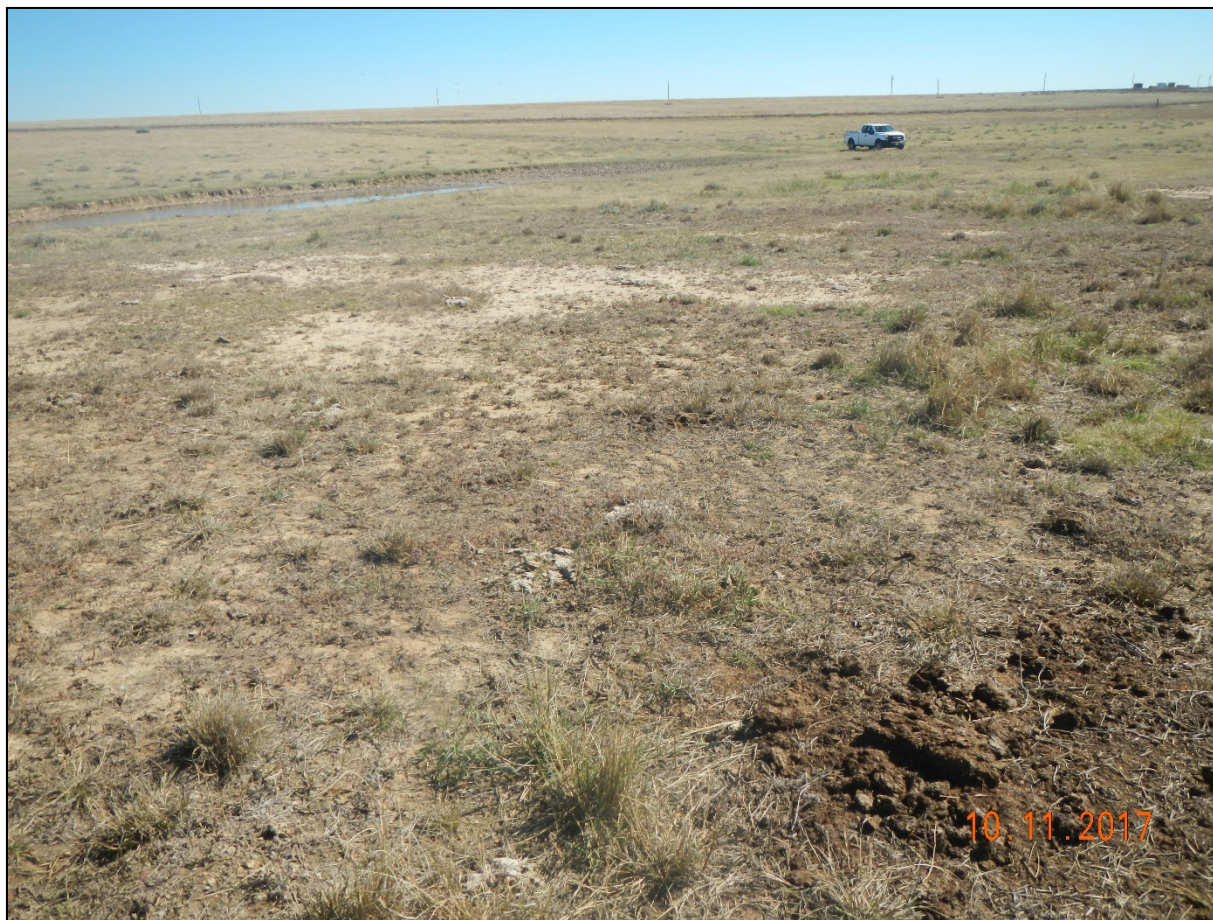
Photo 5. Center of the location facing east.

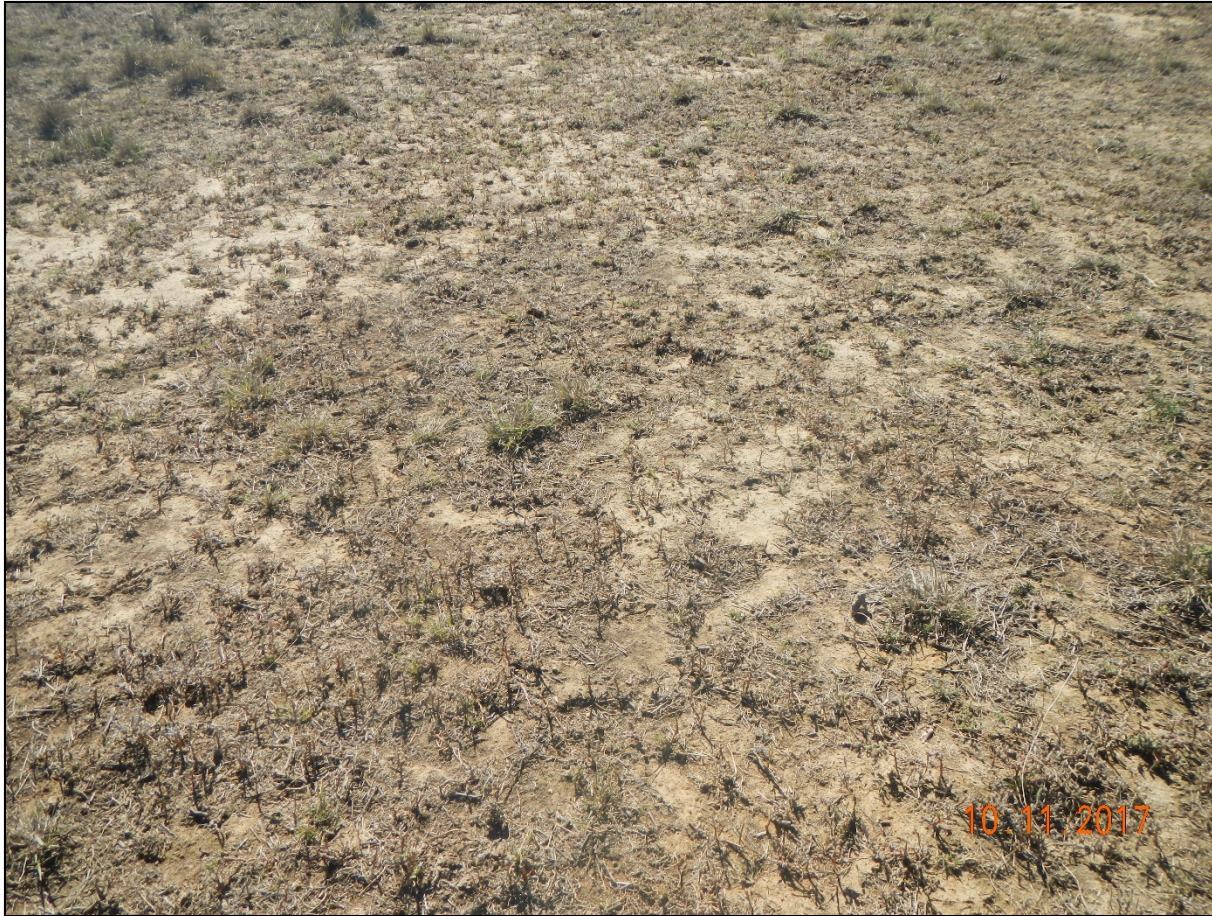
Photo 6. View of groundcover at the location. There is predominately undesirable weeds (*Kochia* sp.) throughout the location.

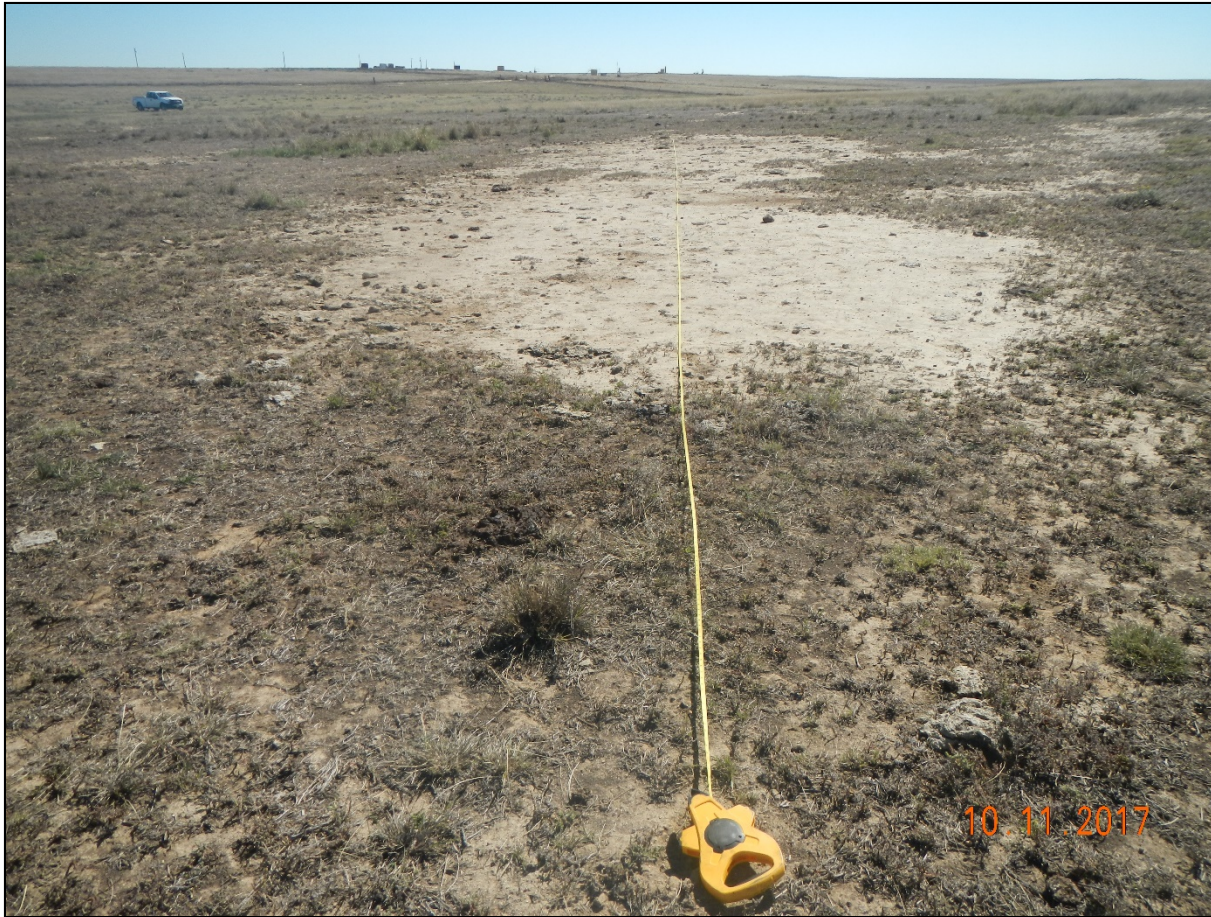
Photo 7. Facing southeast at the location. A 100ft. tape measure shows a portion of the location with no vegetation establishment.

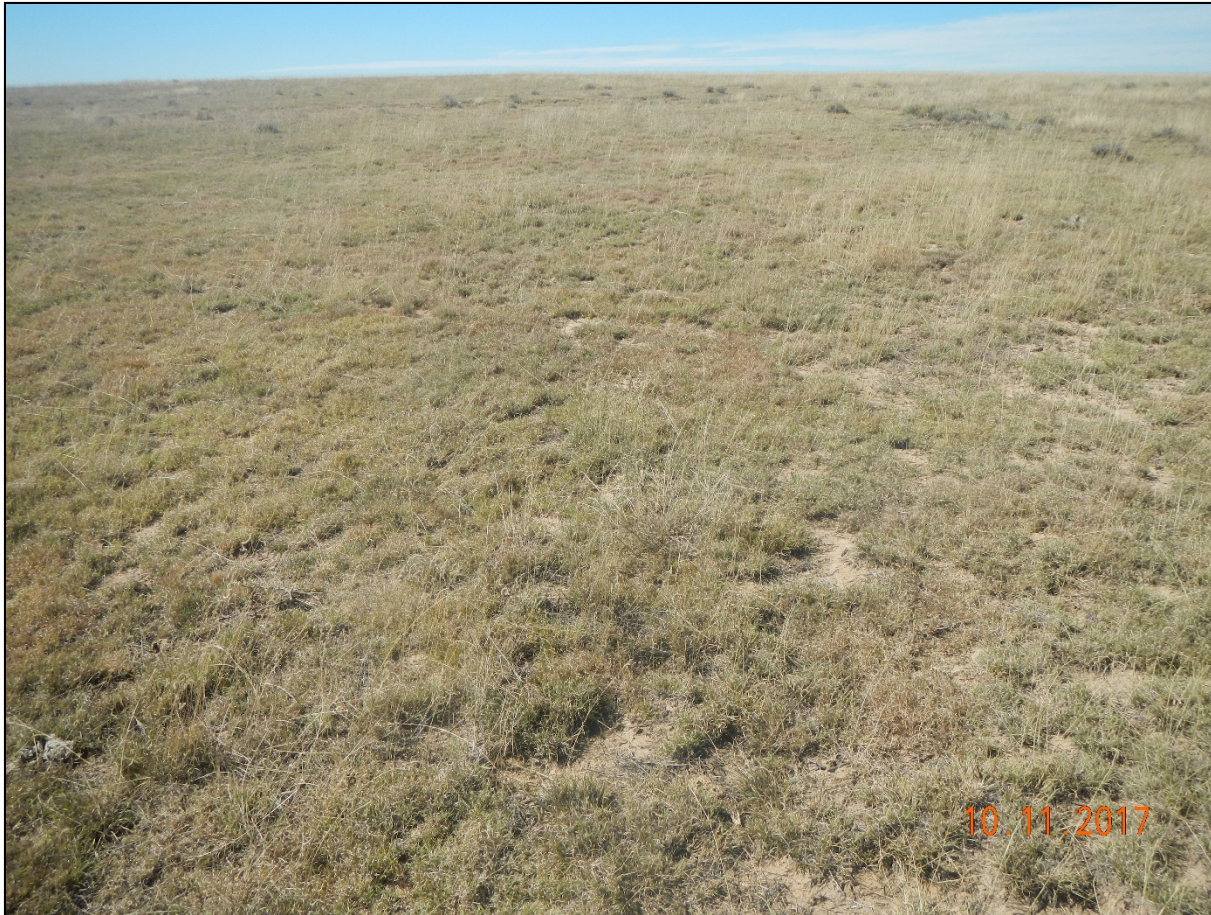
Photo 8. Facing south off the location toward the undisturbed vegetation.
