## Inspection Photos

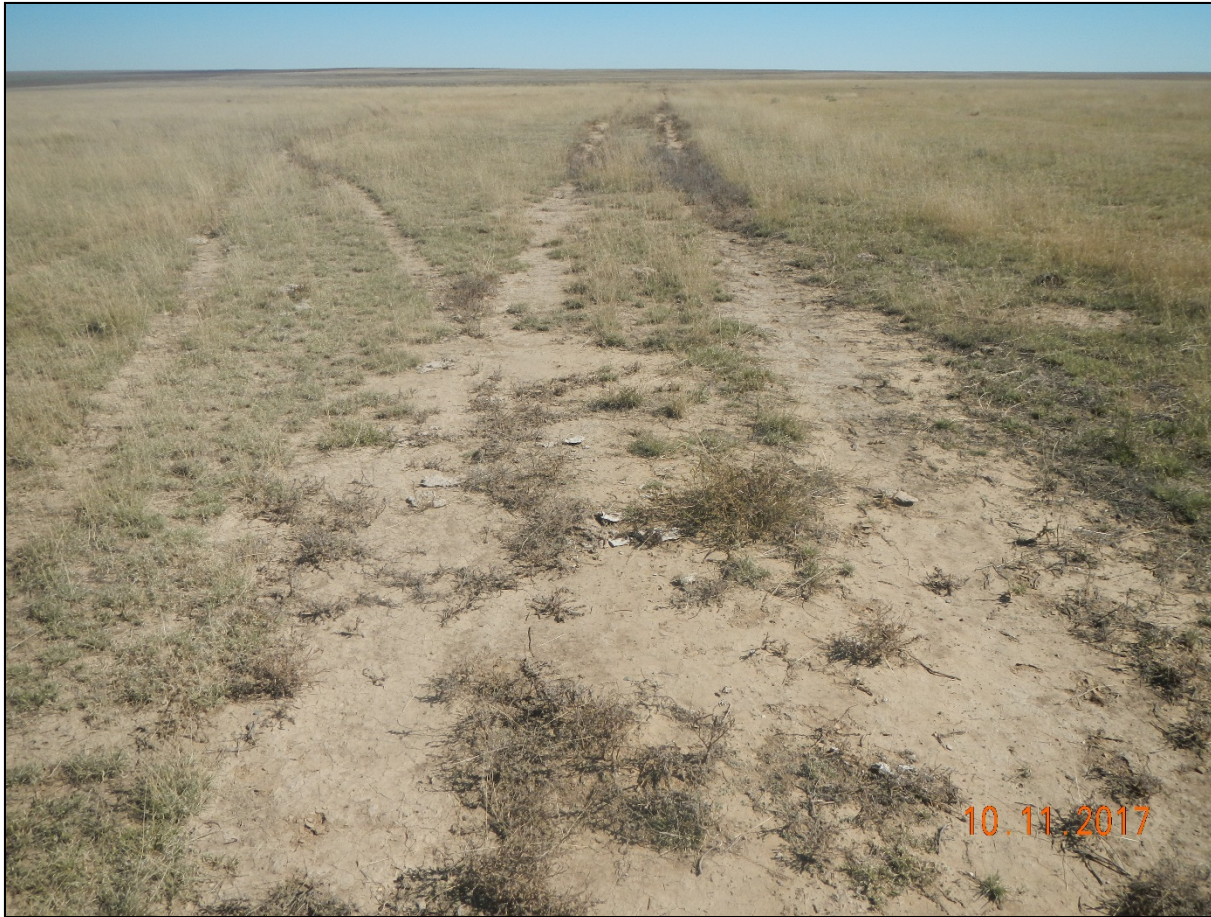
**Photo 1.** Facing east along the former access road which is still noticeable.

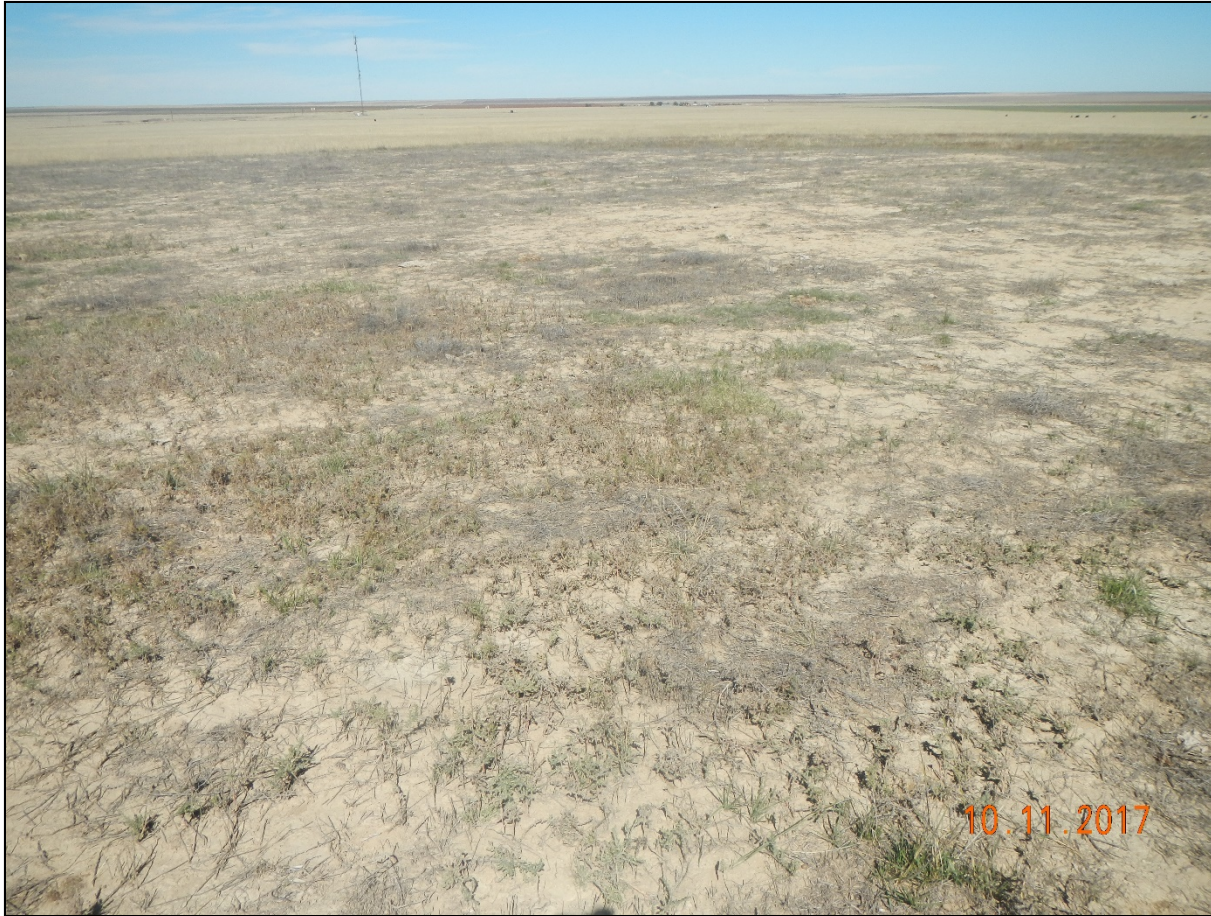
**Photo 2.** Center of the location facing north. The desirable vegetation has not adequately re-established.

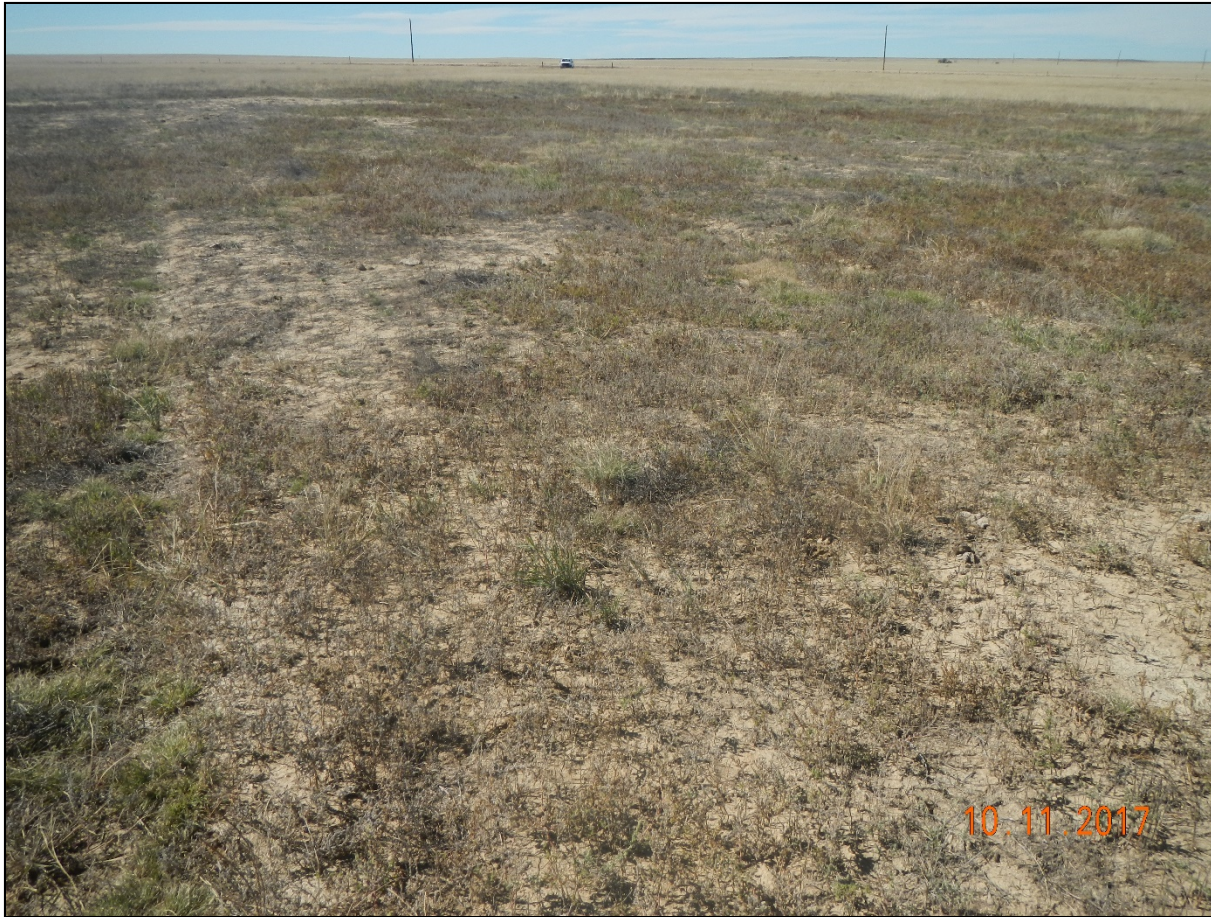
**Photo 3.** Center of the location facing west. The dark-brown vegetation is predominately undesirable vegetation (*Kochia* sp., *R. thistle*).

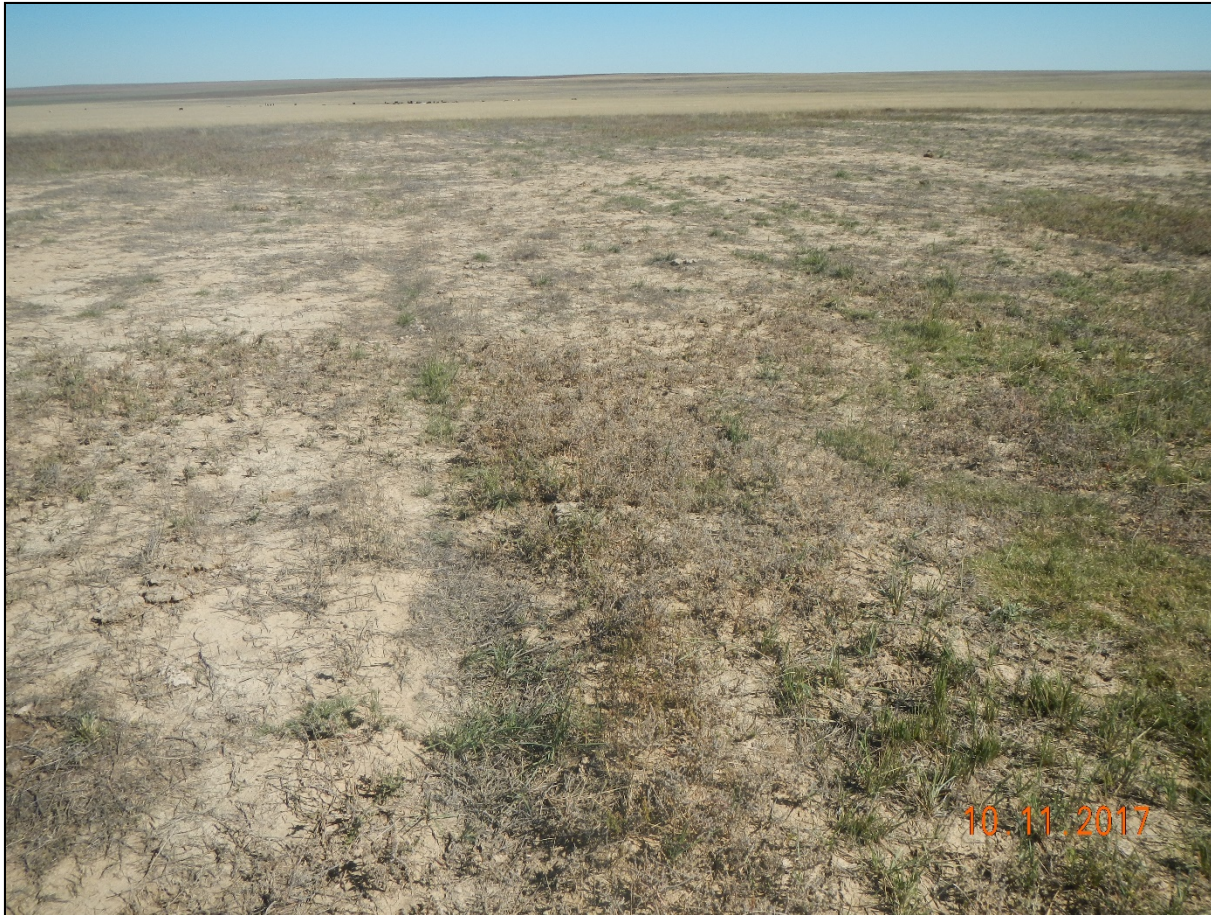
**Photo 5.** Center of the location facing east. The desirable vegetation has not adequately re-established.

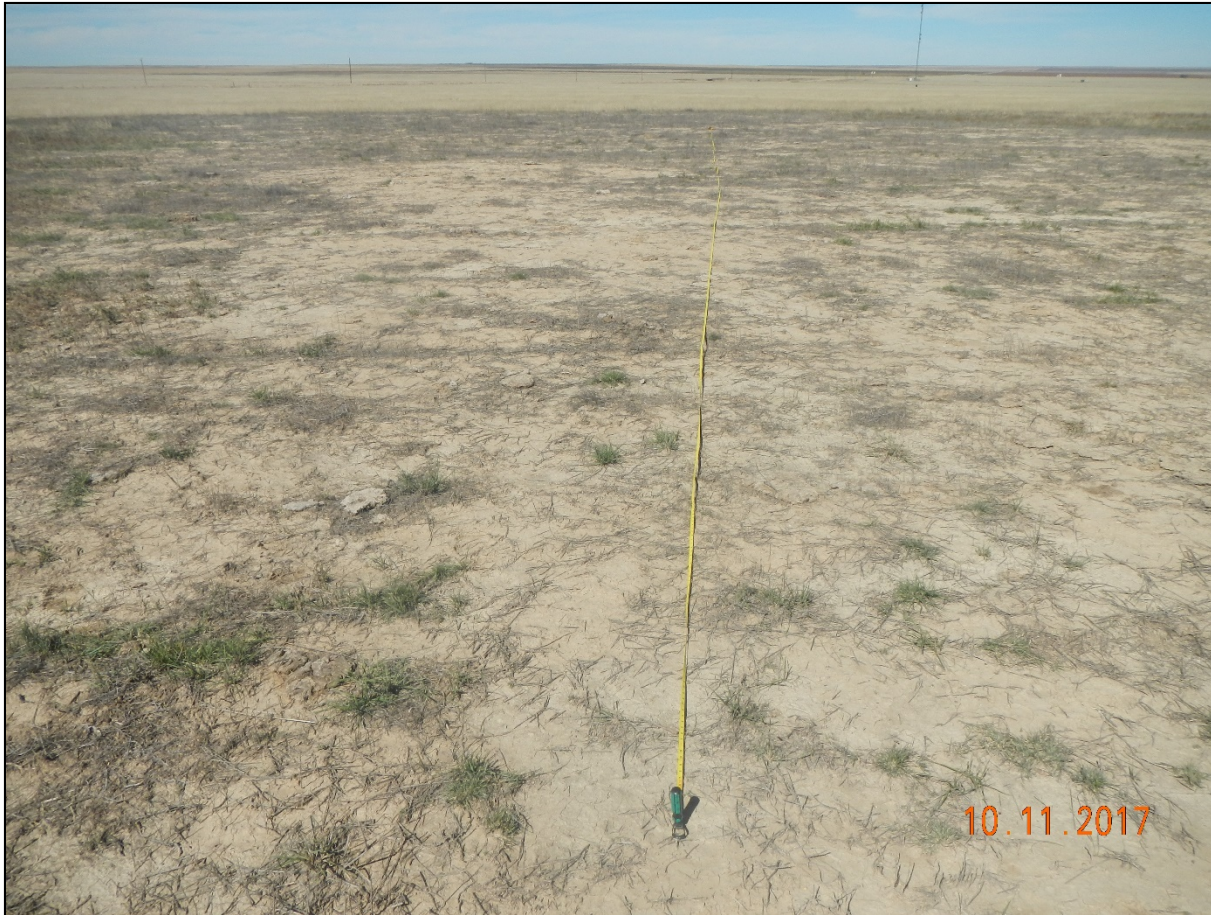
**Photo 6.** Facing north at the location. A 100 ft. tape measure shows a portion of the location which vegetation has not re-established.

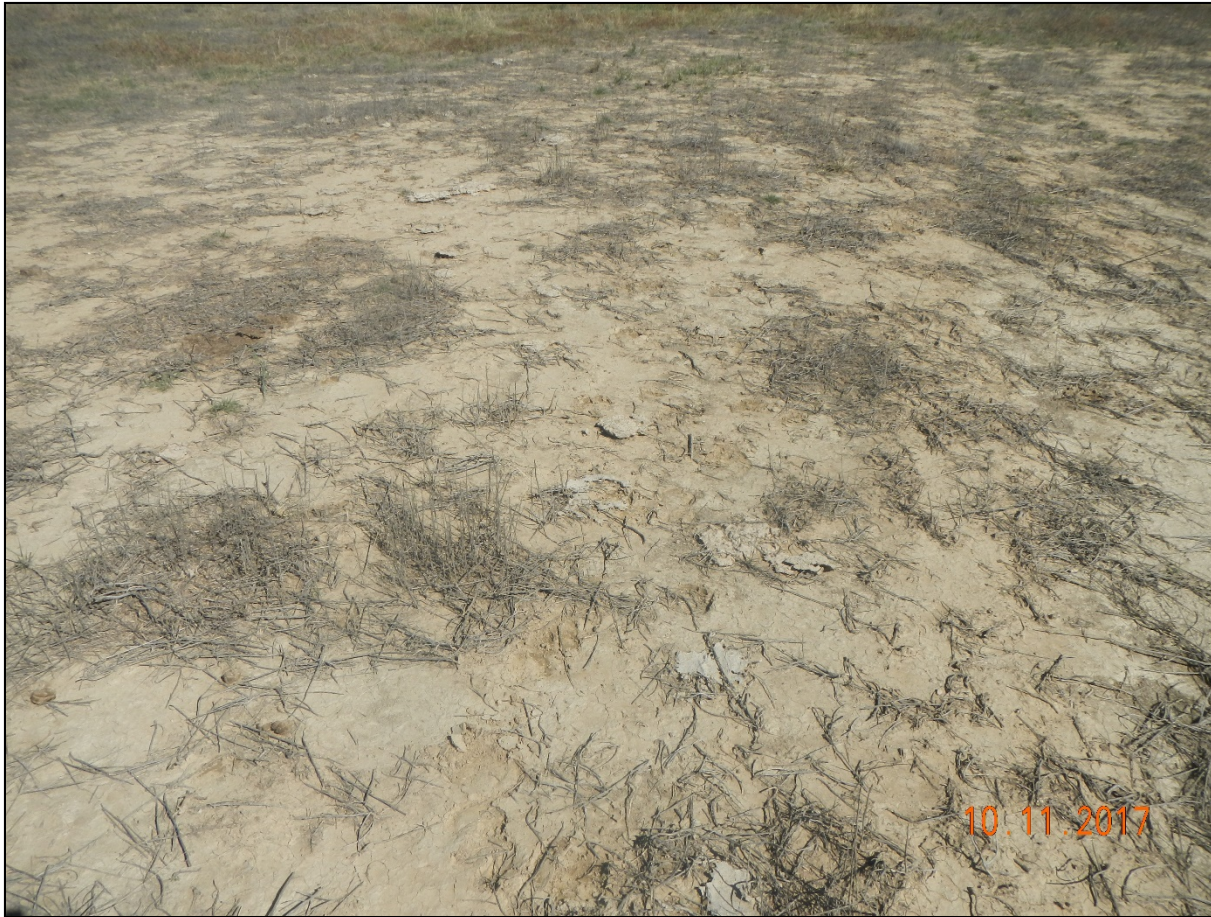
**Photo 7.** View of groundcover at the location. The desirable vegetation has not adequately re-established.
