Reclamation and Stormwater Inspection

October 20, 2017

Operator: BISON EXPLORATION LLC - #10646

Location ID: 451389

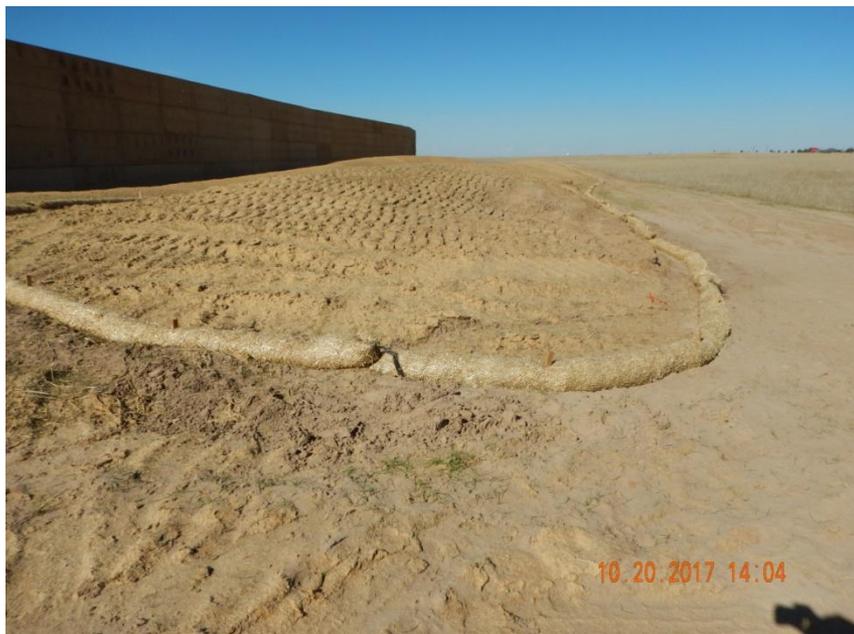
Photo 1. Photo taken from the entrance of location, facing North. 2 Topsoil stockpiles are located along the eastern location. Appears topsoil stockpiles have been hydromulched and tracked with equipment. Straw wattles have been installed around the topsoil piles.

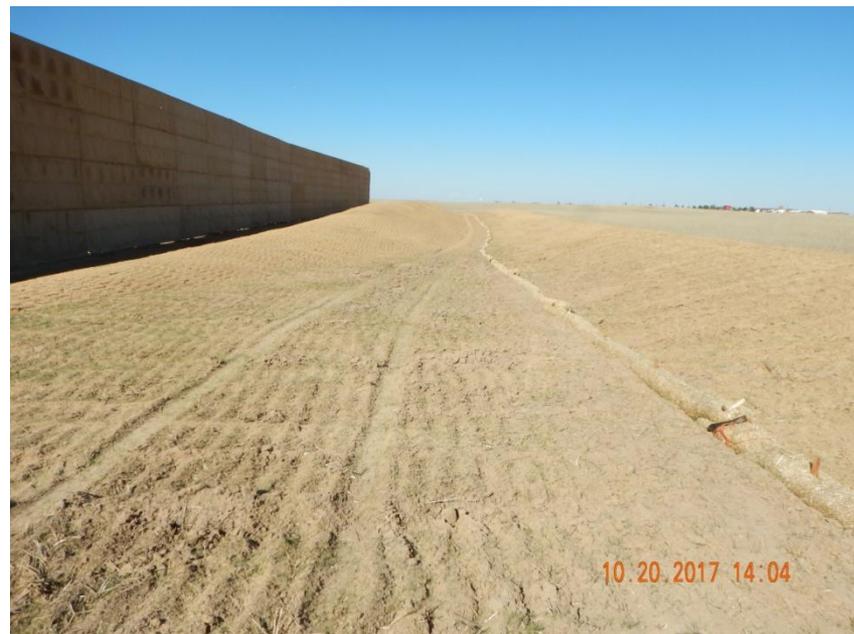
Photo 2. Photo taken from the entrance of location, facing North. See comments under Photo 1.

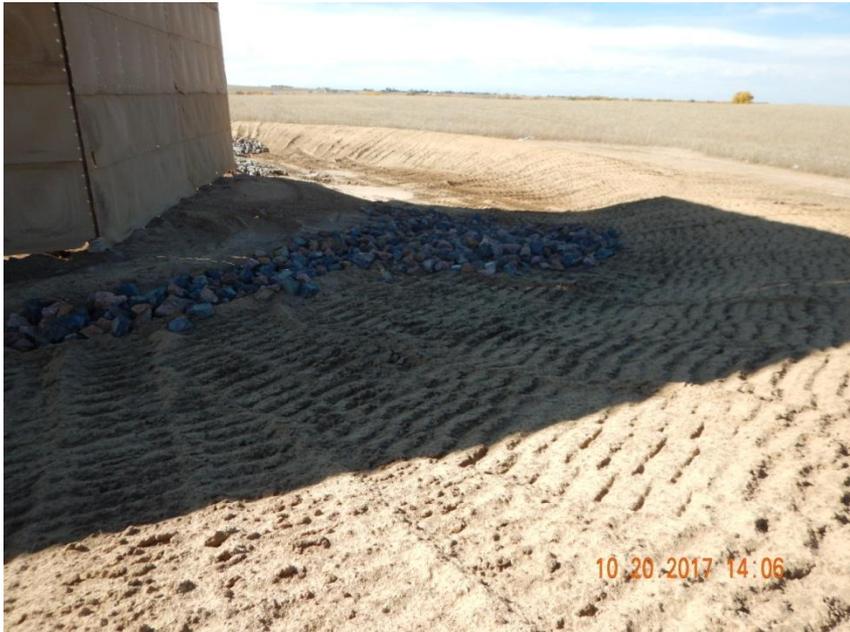
Photo 3. Photo taken from the northeast location, facing West. Retention pond has been installed with inlet protection devices (rip-rap). Perimeter disturbance areas have been temporarily stabilized with hydromulch and tracked with equipment.

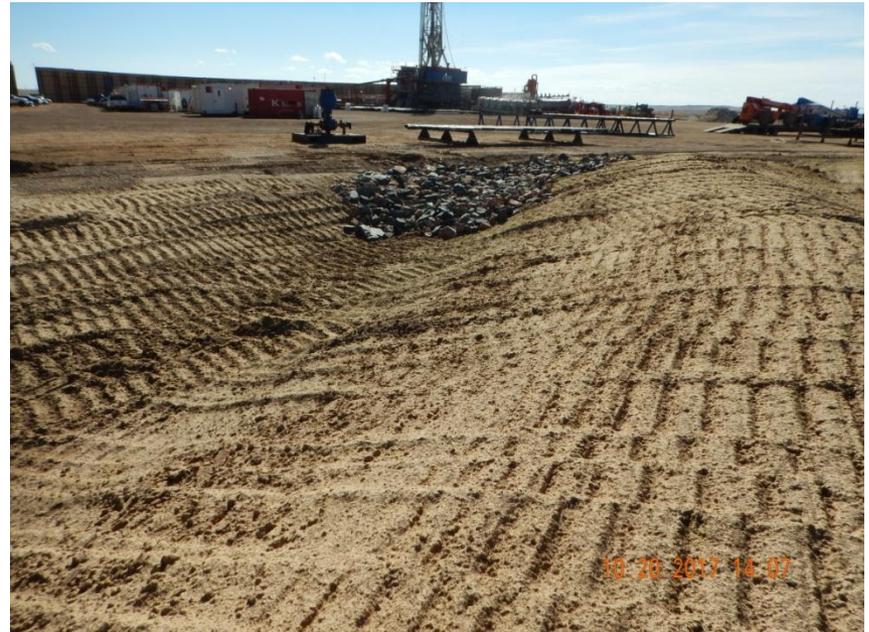
Photo 4. Photo taken from the northeastern location, facing South. See comments under Photo 3.

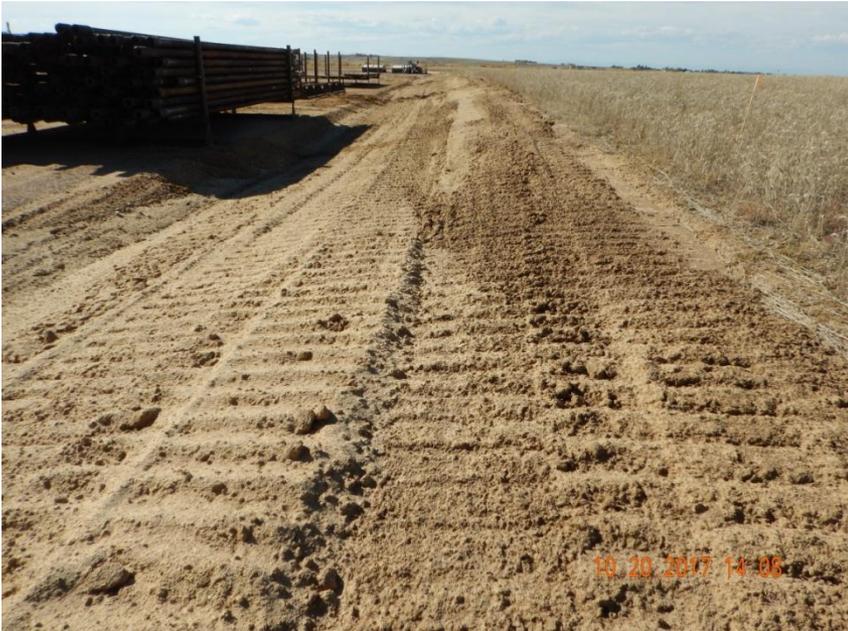
Photo 5. Photo taken from the northern location, facing West. Ditch BMP has been installed that is directed to a retention pond area. Perimeter disturbance areas have been temporarily stabilized with hydromulch and tracked with equipment.

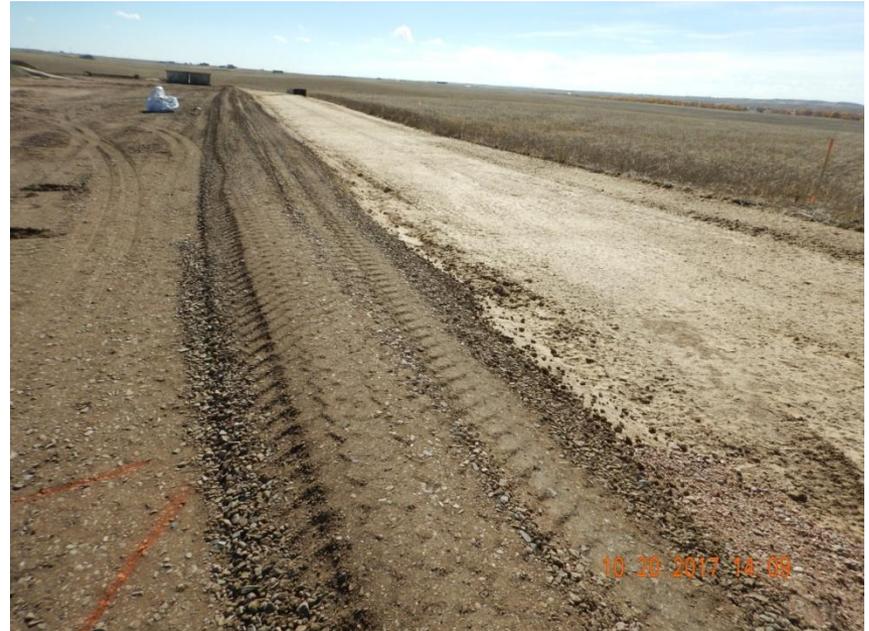
Photo 6. Photo taken from the northwestern location, facing South. Operator has installed a berm BMP using compacted gravel. Western outer perimeter disturbance area has been temporarily stabilized with hydromulch.

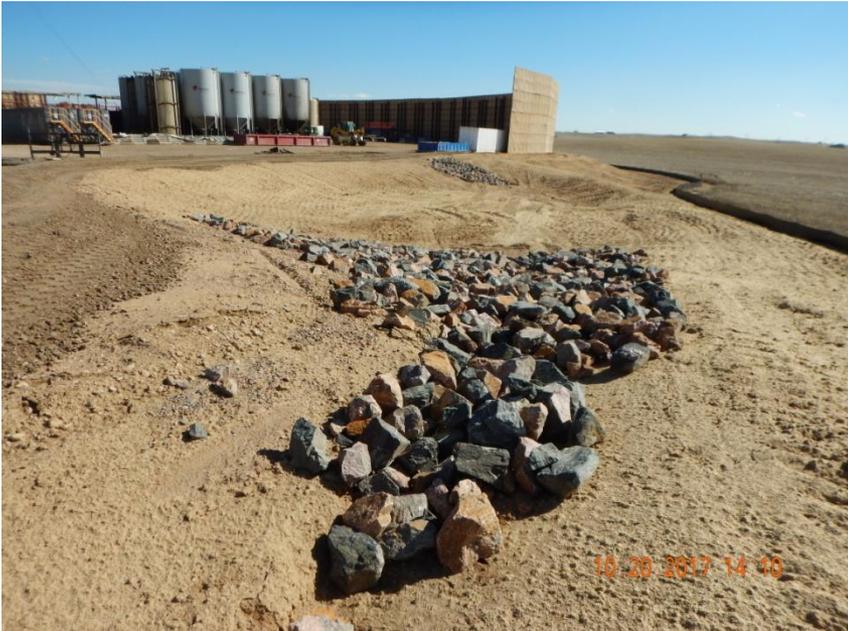
Photo 7. Photo taken from the western location, facing South. Retention pond has been installed with inlet protection devices (rip-rap). Silt fence BMP has been installed along the southwest and southern location perimeter. Disturbance areas have been temporarily stabilized with hydromulch and tracked with equipment.

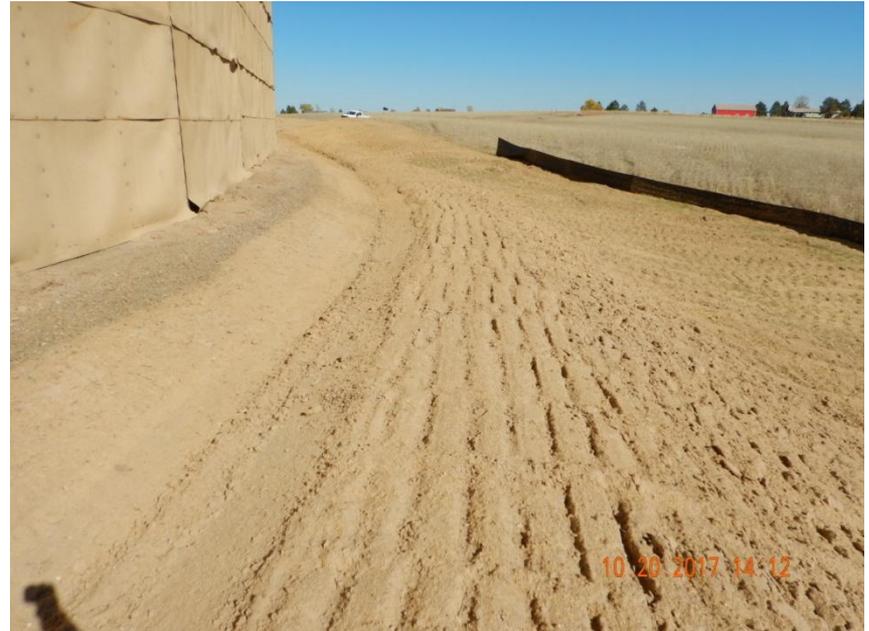
Photo 8. Photo taken from the southern location, facing East. Ditch BMP has been installed that is directed to a retention pond area with silt fence BMP downgradient. Appears fill slope areas have been temporarily stabilized with hydromulch and tracked with equipment.

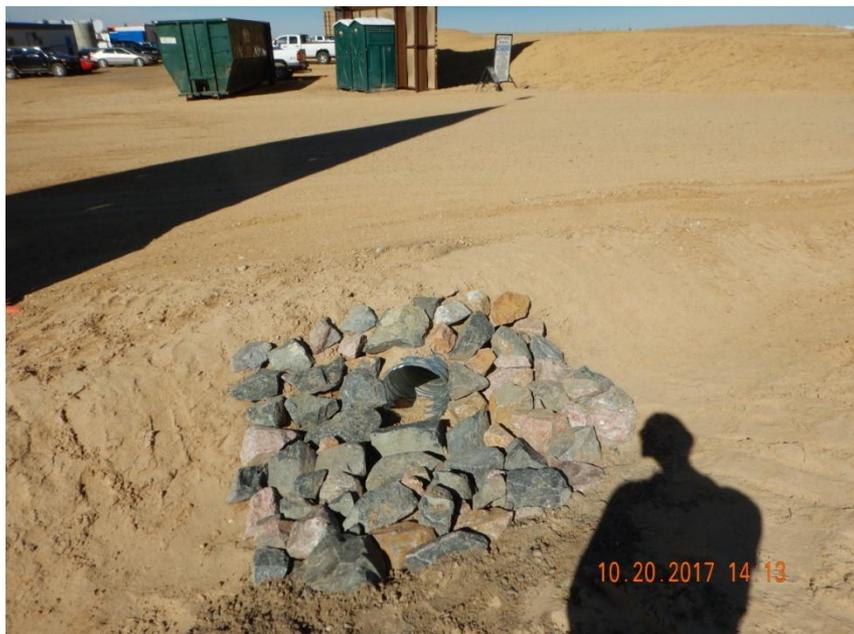
Photo 9. Photo taken from the entrance of the location, facing North. Inlet and outlet devices (rip-rap) have been installed in conjunction with the culvert.

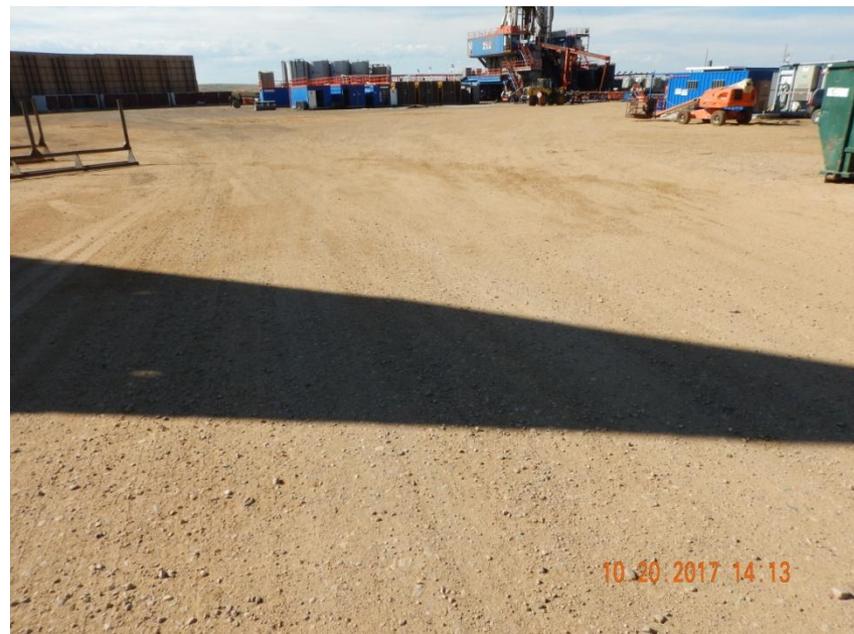
Photo 10. Photo taken from the entrance of location, facing West. Location appears to be stabilized with gravel.
