Construction and Stormwater Inspection

October 12, 2017

Operator: BONANZA CREEK ENERGY OPERATING COMPANY LLC -#8960

Location ID: 452584 (COMPLIANCE POINT #1)

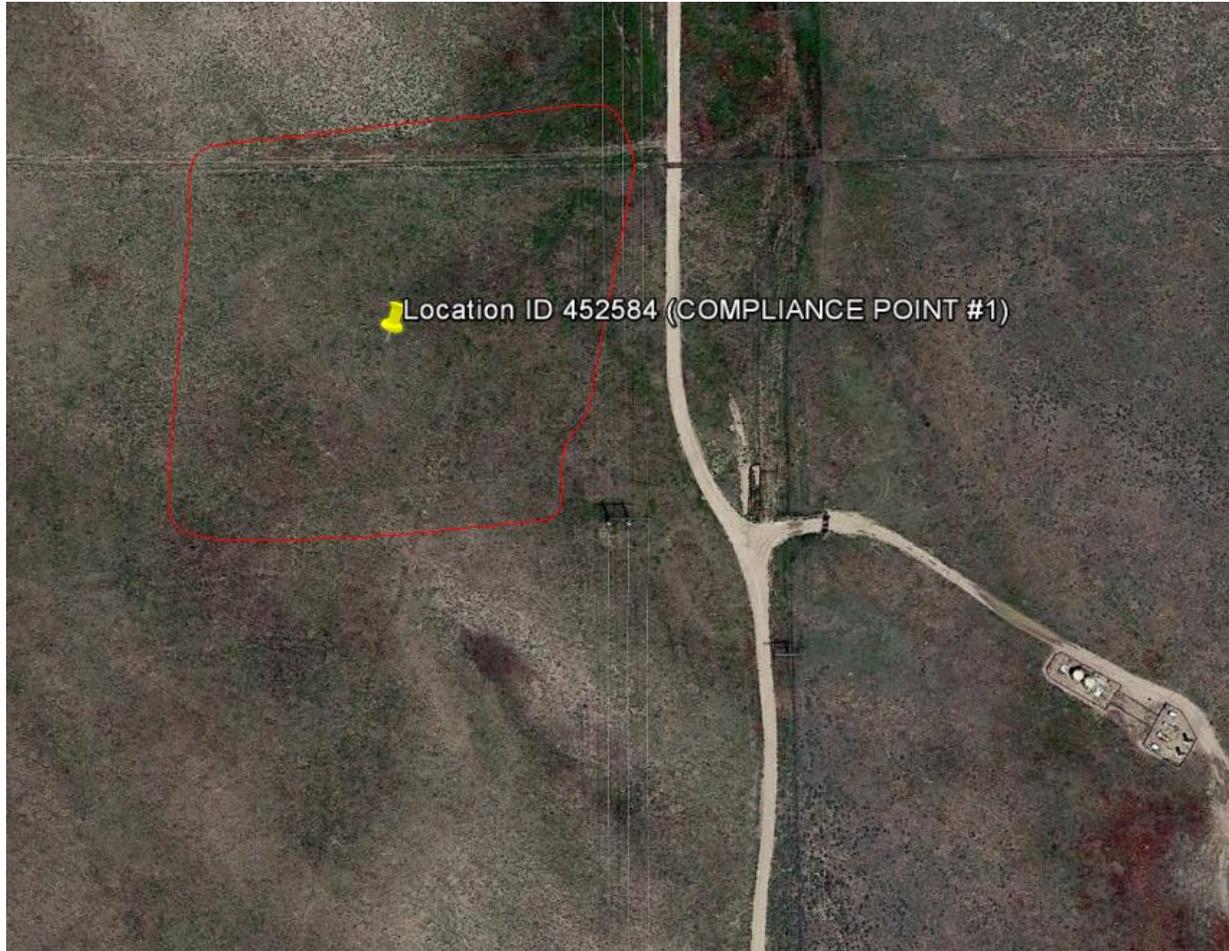
Photo 1. Google Earth aerial imagery taken on June 14, 2016. Operator has constructed a pad in the northeast of Section 22, Township 4N, Range 63W without an approved 2A- see Photo 2. The approximate center of the pad is at the following Latitude/Longitude: 40.304664/-104.416421. A disturbance area of 5.04 acres was mapped on 10/12/2017 using a Trimble Juno 3B handheld device (red line).

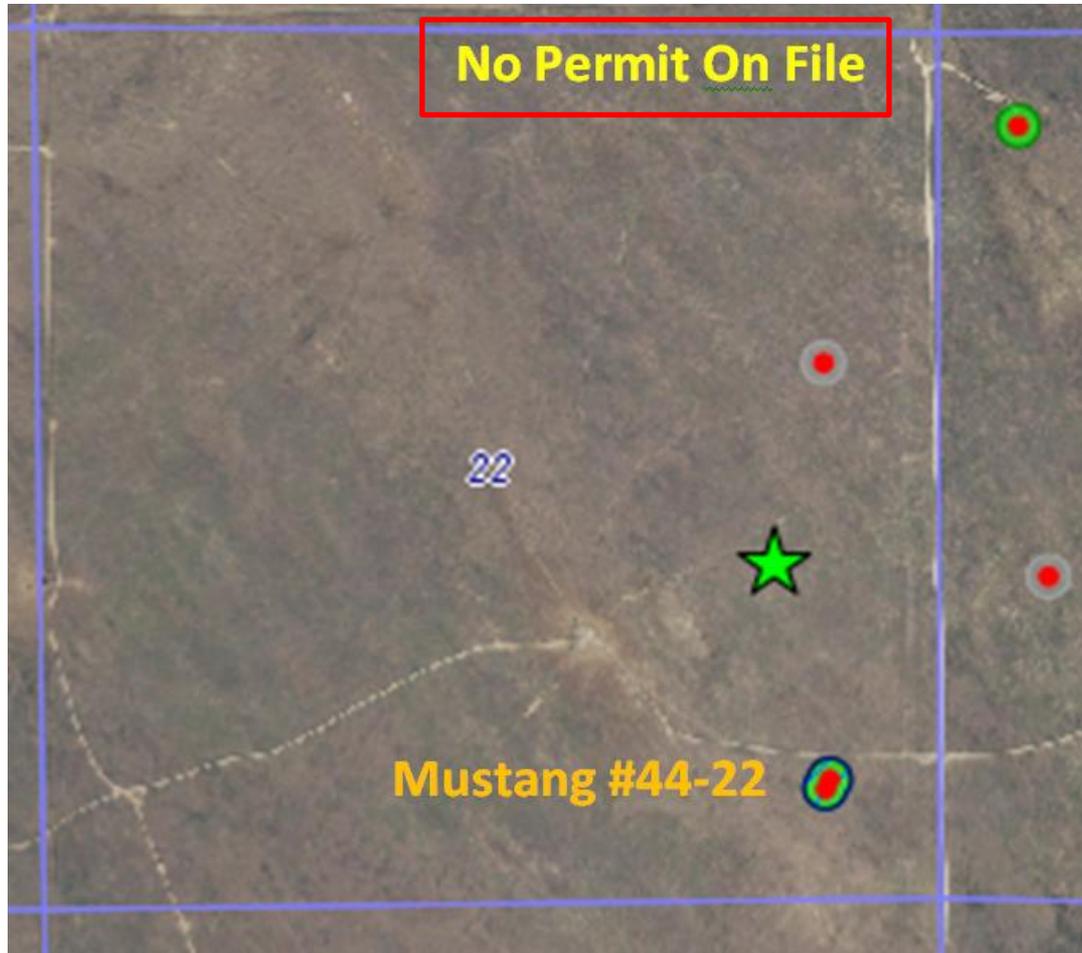
Photo 2. COGCC GISOnline database image illustrates there is no approved 2A in the northeast of Section 22, Township 4N, Range 63W.

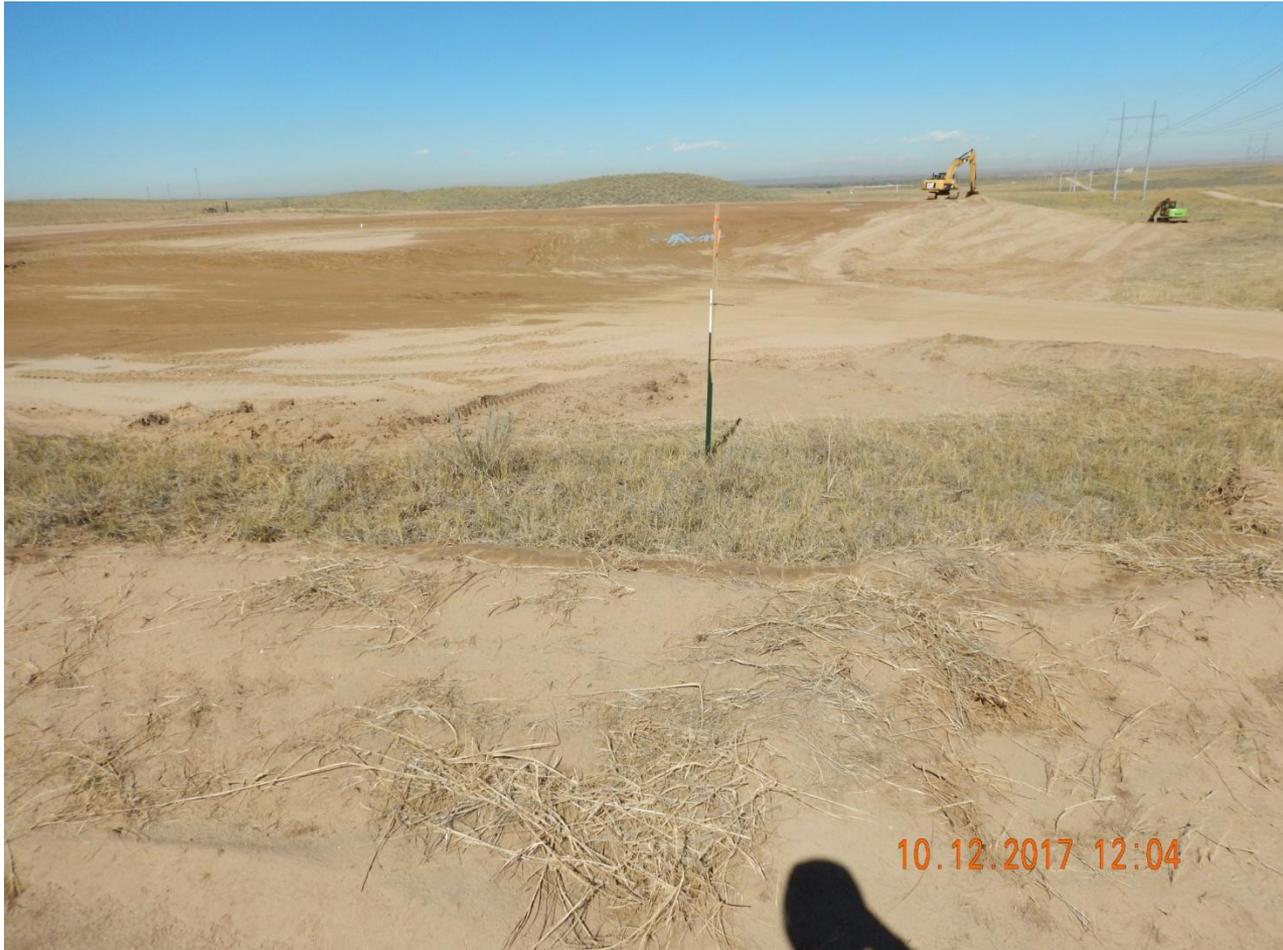
Photo 3. Photo taken from the southeast location, facing North. Photo taken includes most of the location, minus the western and southern location. Photo illustrates that no topsoil stockpile was observed at location, indicating that no topsoil was salvaged during operations.

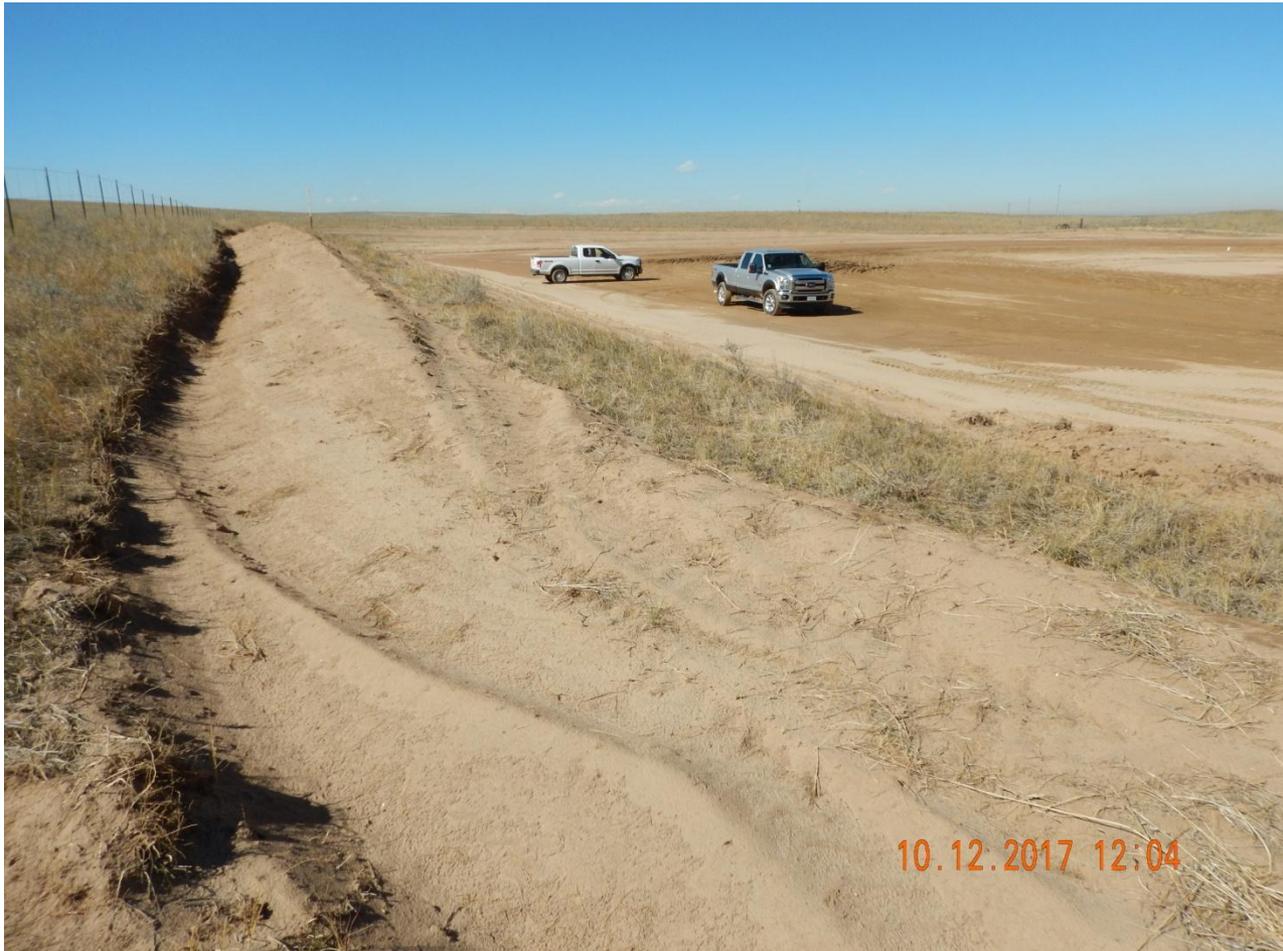
Photo 4. Photo taken from the southeast location, facing North. Photo taken includes the remainder of the western and southern location. See comments under Photo 3.

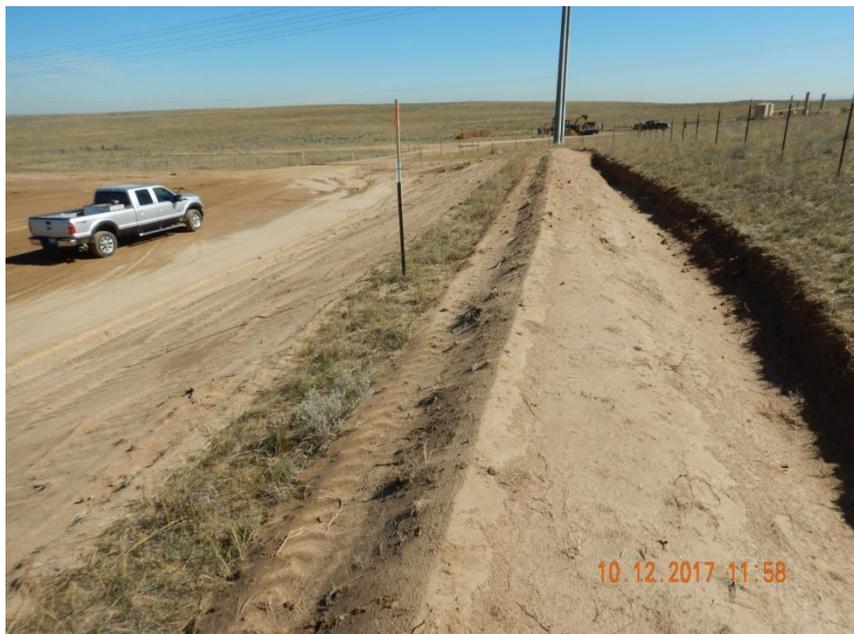
Photo 5. Photo taken from the southern location, facing East. Operator has installed a ditch and berm around the entire location perimeter. The berm BMP has been left unconsolidated which would not be considered in proper functioning condition.

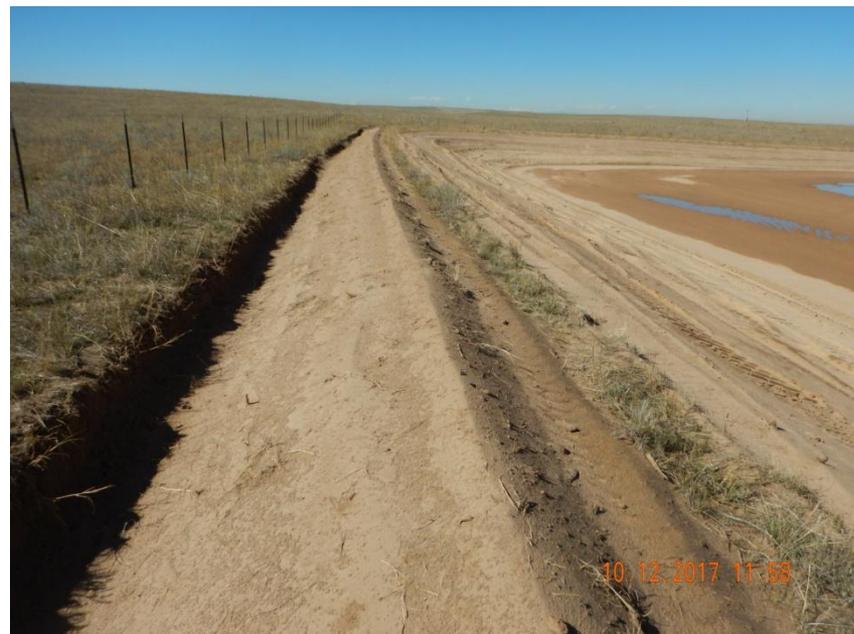
Photo 6. Photo taken from the southern location, facing West. See comments under Photo 3.

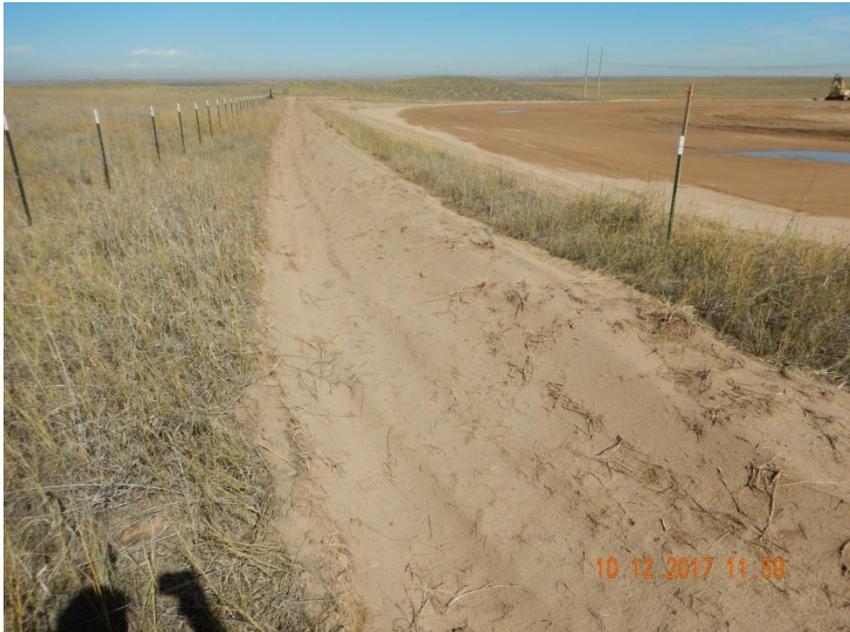
Photo 7. Photo taken from the southwestern location, facing North. See comments under Photo 3.

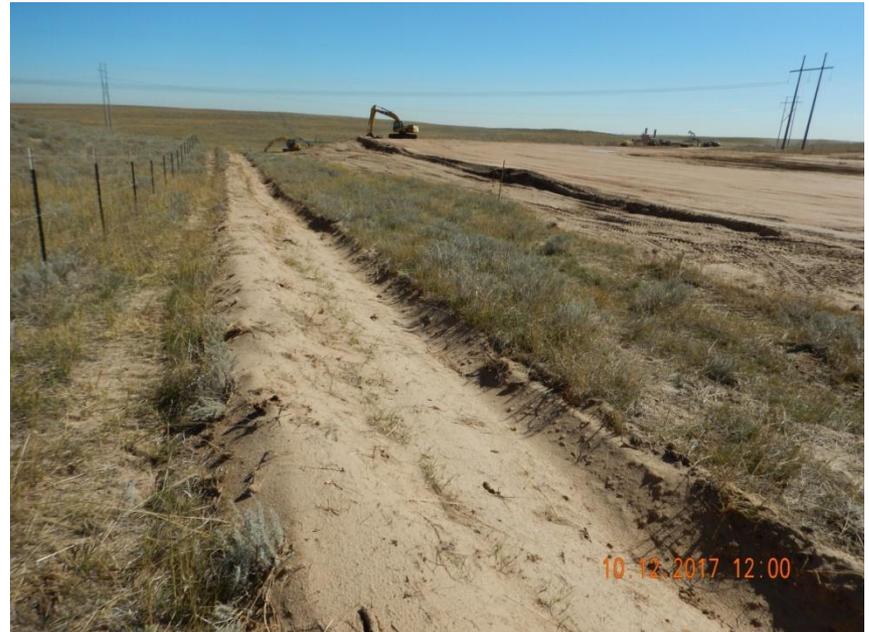
Photo 8. Photo taken from the northeastern location, facing East. See comments under Photo 3.

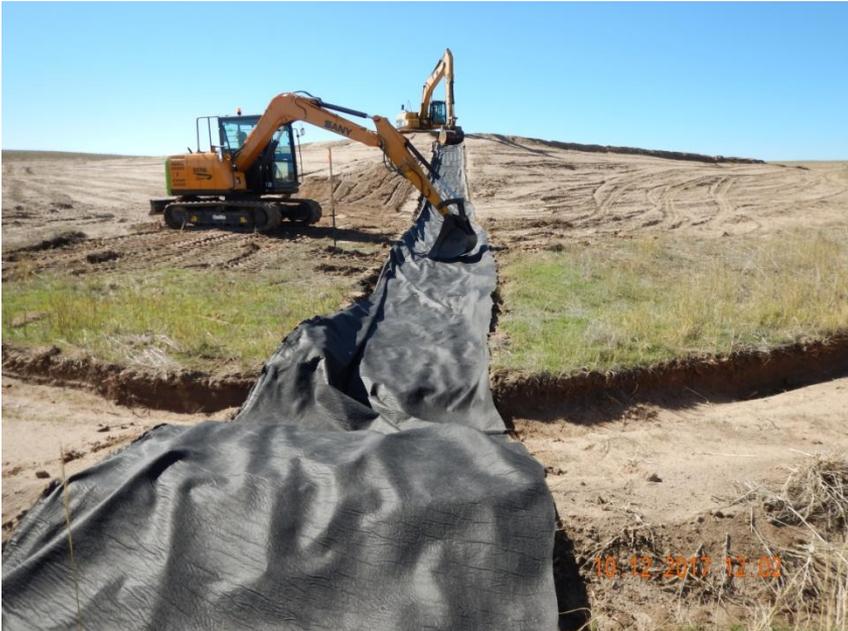
Photo 9. Photo taken from the northeastern location, facing Southwest. Operator in-process of installing an armored ditch.

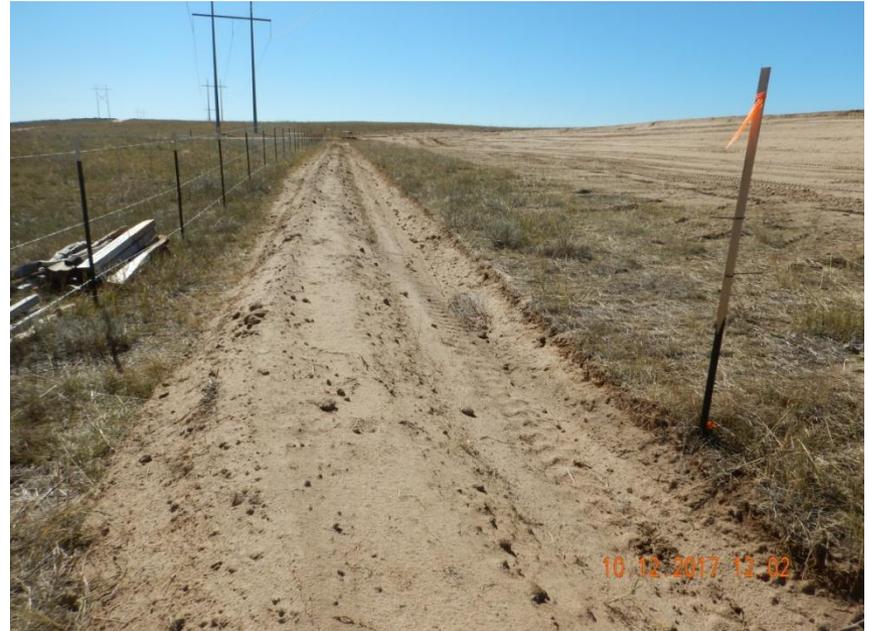
Photo 10. Photo taken from the northeastern location, facing South. See comments under Photo 3.

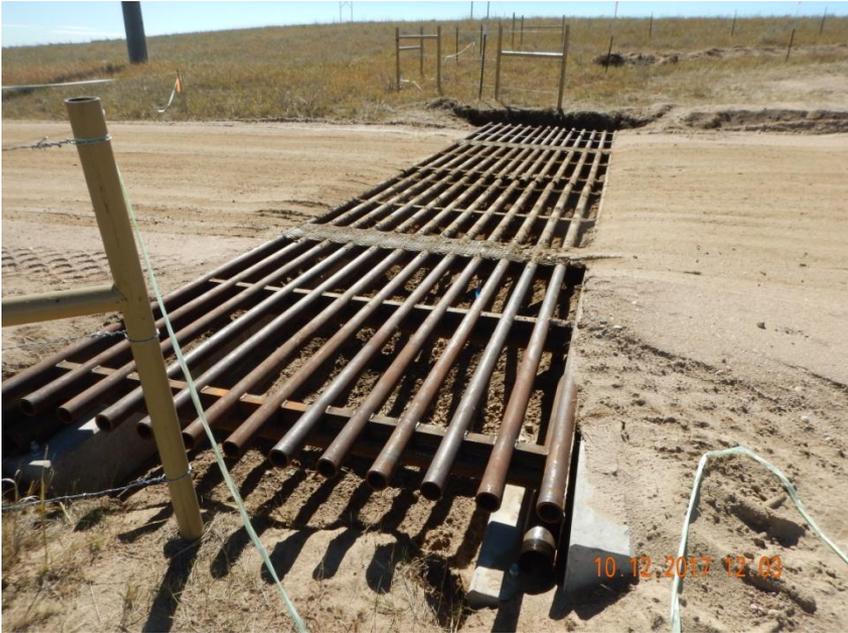
Photo 11. Photo taken from the entrance of the location, facing South. Operator has installed a cattle guard tracking device.
