# Construction and Stormwater Inspection

October 24, 2017

Operator: LONGS PEAK RESOURCES LLC- #10611

Inspection Photos  
Location Name: Oxnard East /0607-8CH  
Location ID: 452516

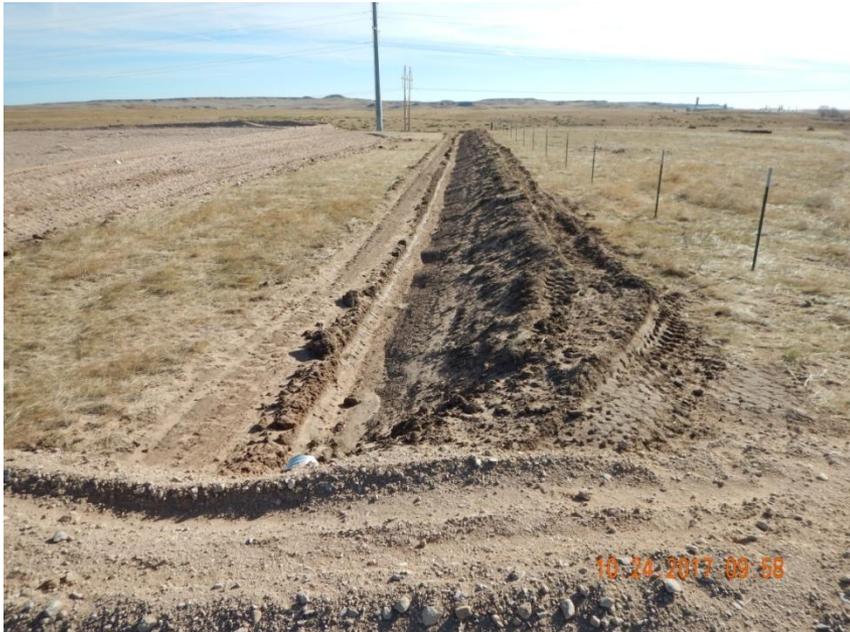
**Photo 1.** Photo taken from the entrance of location, facing East. Ditch and berm BMP installed around the entire perimeter of location. Berm BMP has been left unconsolidated which is not a proper functioning BMP, as unconsolidated material would be susceptible to wind and water erosion.

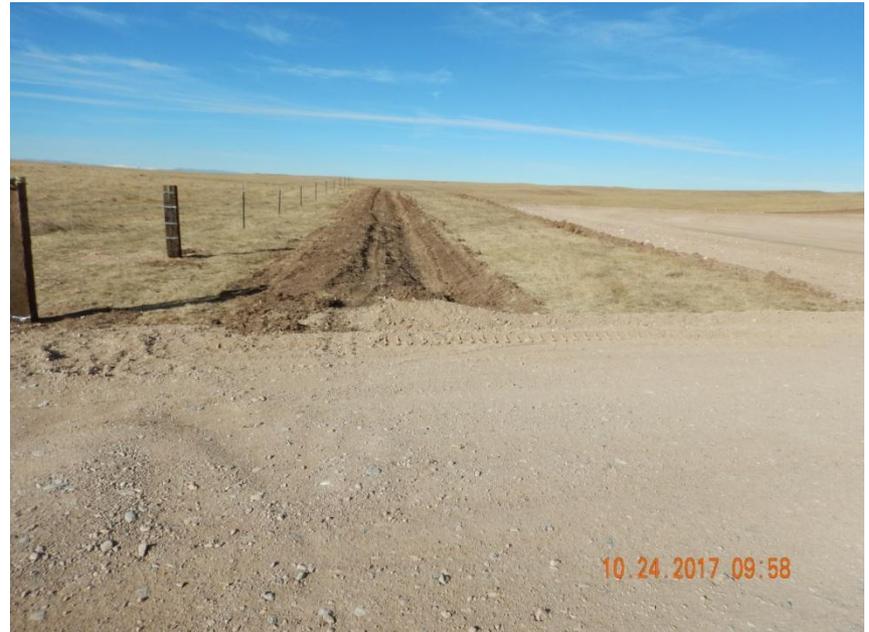
**Photo 2.** Photo taken from the entrance of location, facing West. See comments under Photo 1.

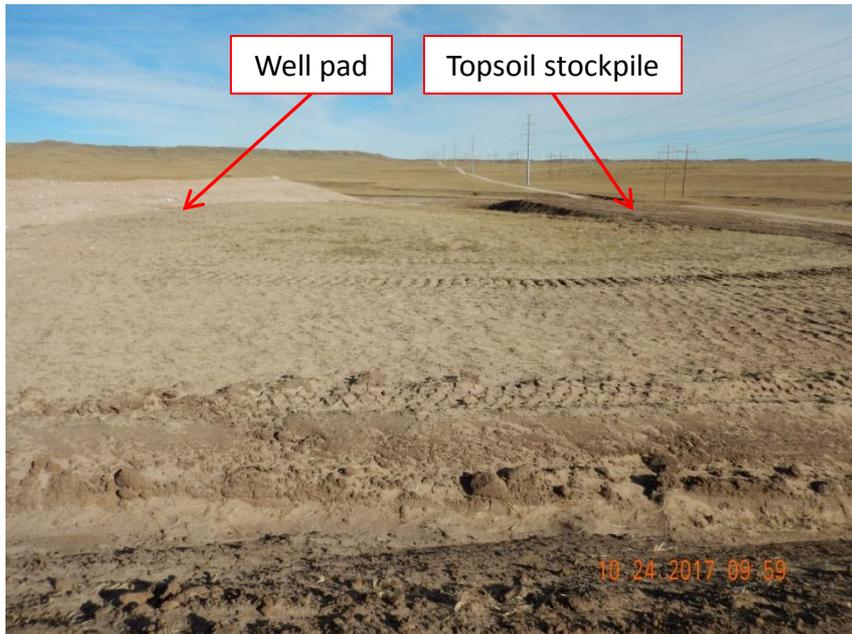
**Photo 3.** Photo taken from the southeastern location, facing North. Appears to be significant amount of space between the well pad and topsoil stockpile. Appears the Operator could have stored the topsoil stockpile closer to the well pad to minimize the total disturbance area.

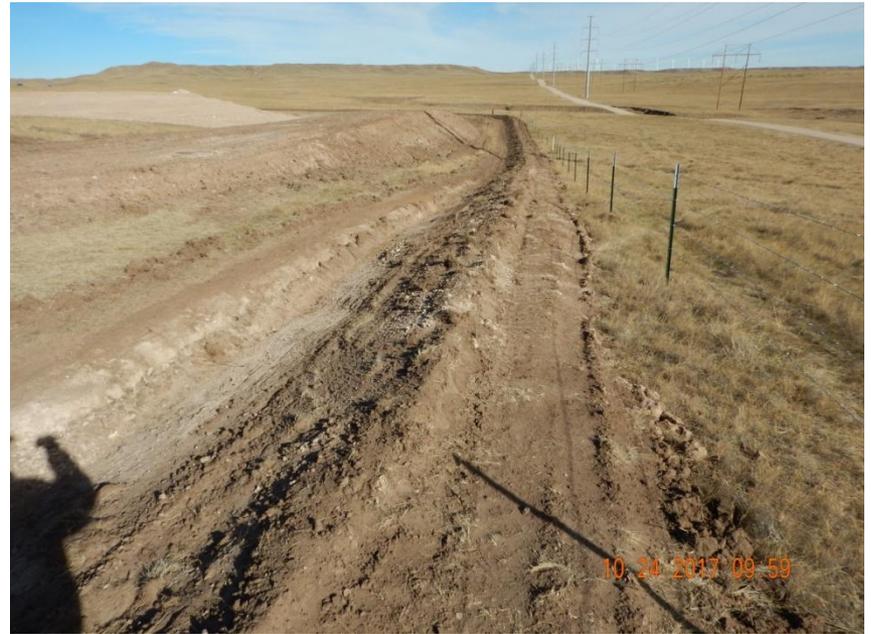
**Photo 4.** Photo taken from the southeast location, facing North. See comments under Photo 1.

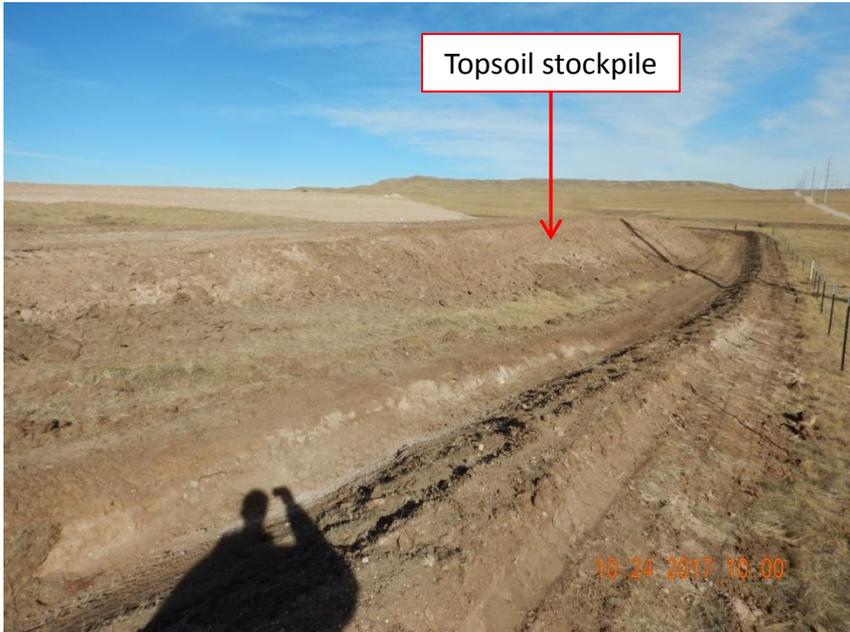
**Photo 5.** Photo taken from the eastern location, facing North. Appears topsoil has been salvaged and stored along the eastern perimeter of the location.

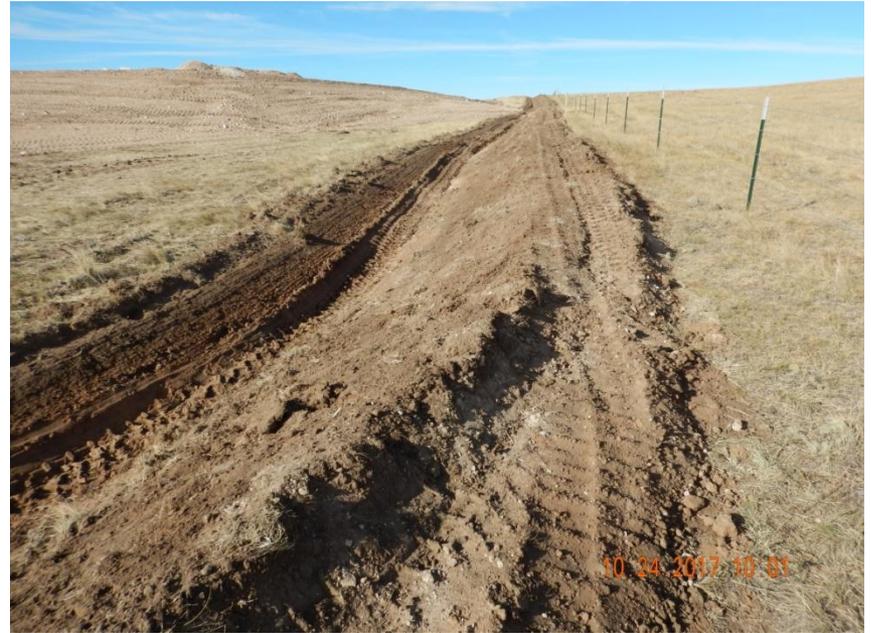
**Photo 6.** Photo taken from the northeast location, facing West. See comments under Photo 1.

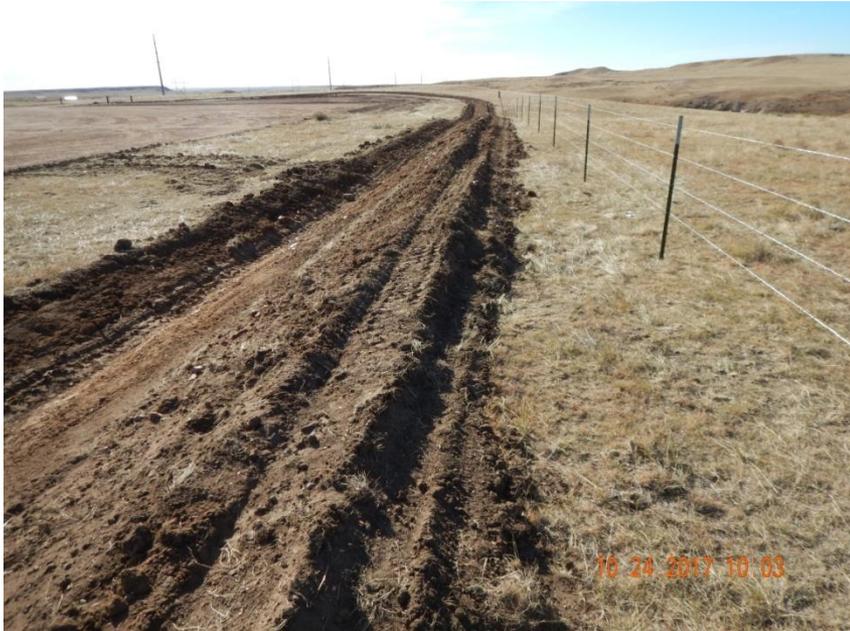
**Photo 7.** Photo taken from the northwest location, facing South. See comments under Photo 1.

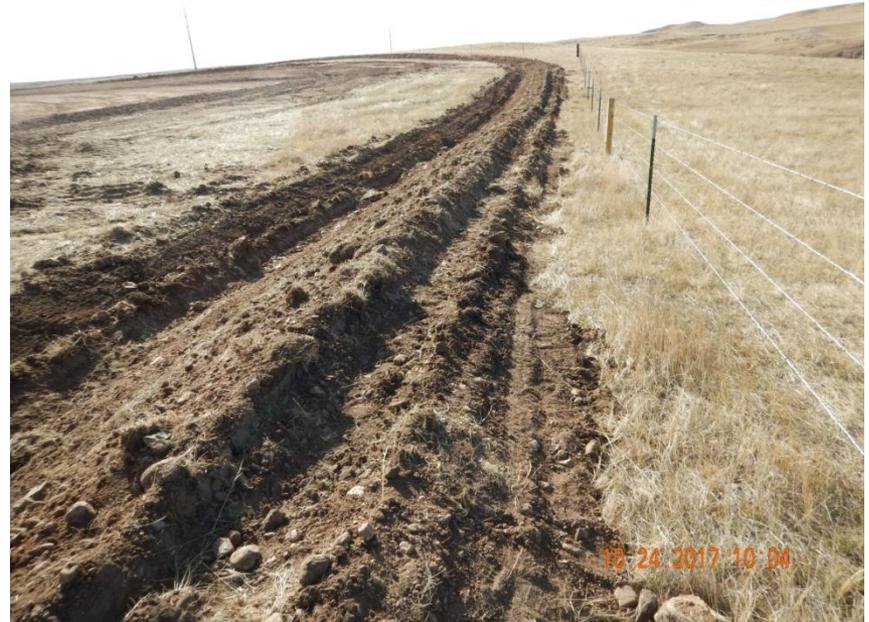
**Photo 8.** Photo taken from the western location, facing South. See comments under Photo 1.
