Inspection Photos
Location Name: State 36-16
API: 05-123-20908
Inspection Date: October 17, 2017

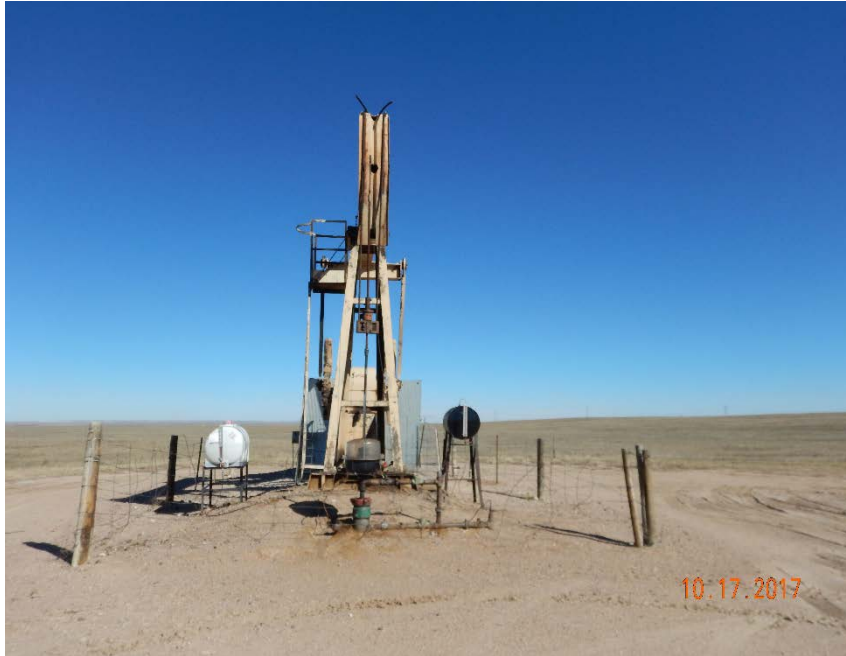
**Photo #1 – View of wellhead and pump jack from the south.
Note chemical storage containers on either side of pump
jack lack secondary containment devices.**

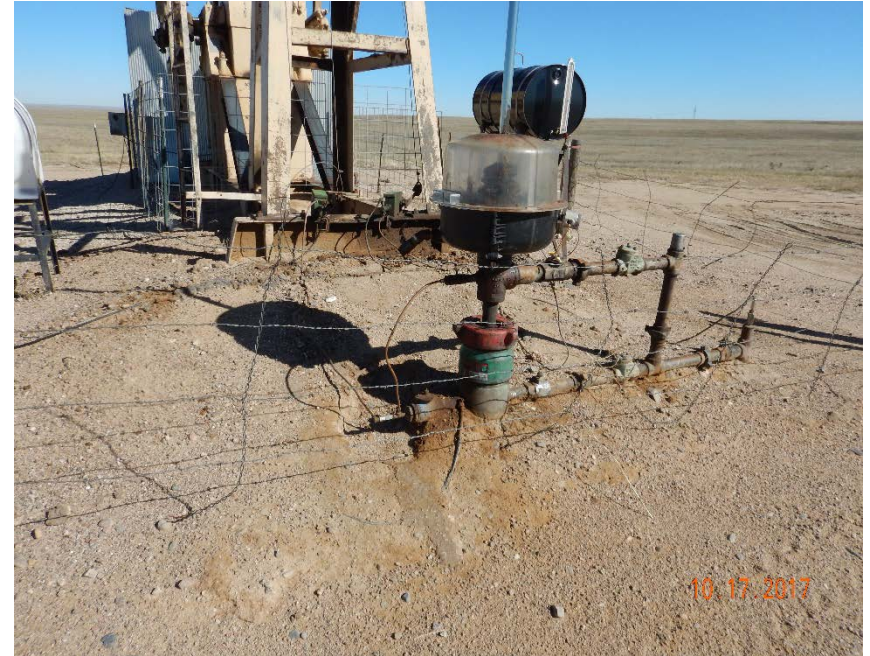
**Photo #2 – Oil-stained soil accumulation at wellhead
(foreground) and SE corner of pump jack (background).**

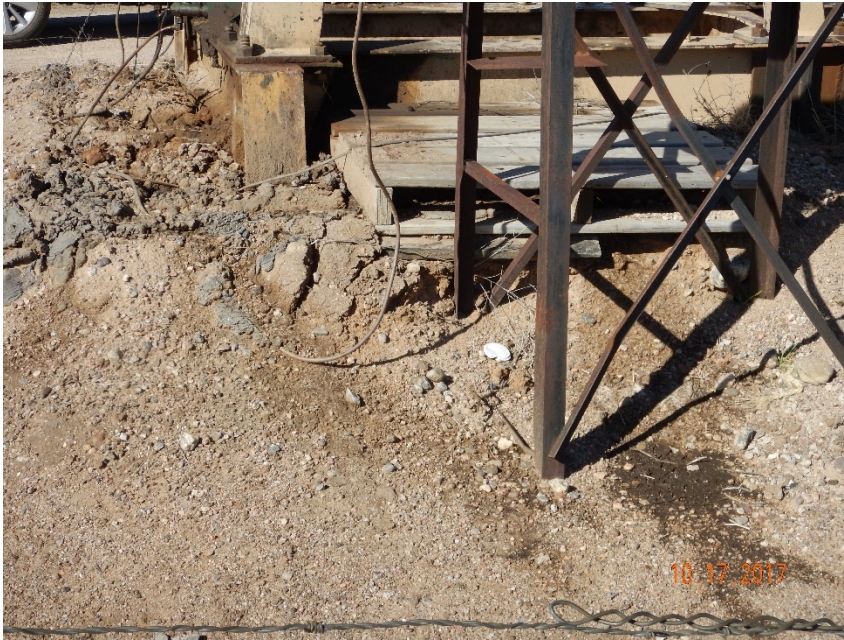
Photo #3 – Localized, oil-stained soil beneath south end of pump jack and beneath day tank at SE corner of pump jack.

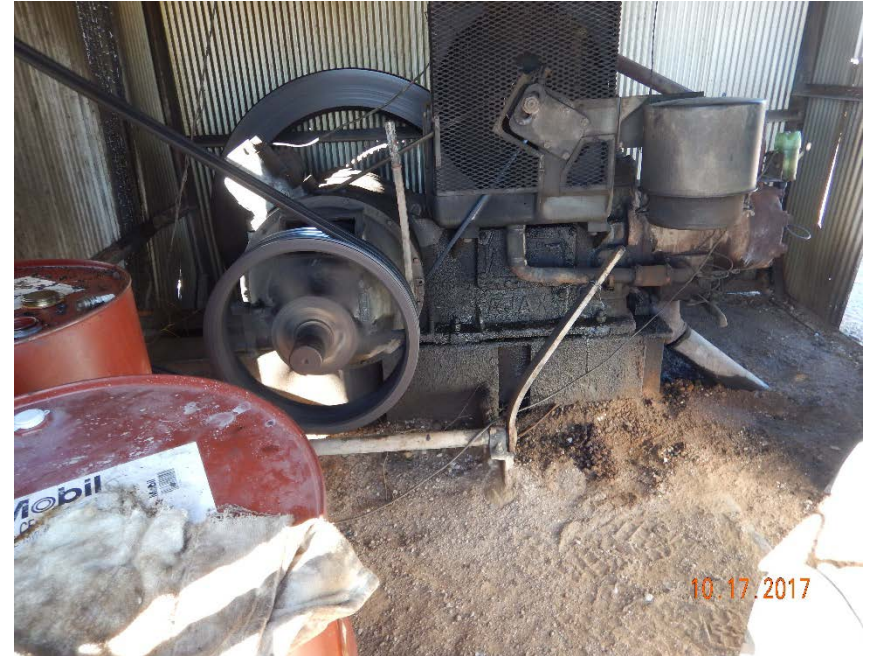
Photo #4 – Localized, oil-stained soil beneath prime mover. Also pictured: chemical storage drums inside of shed.

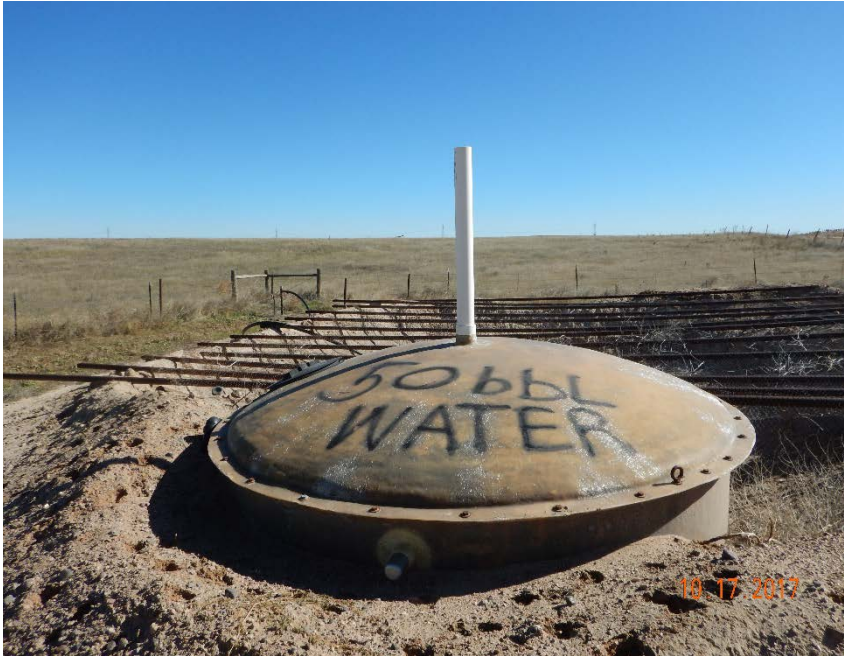
Photo #5 – View of 50 bbl skim tank and produced water pit from west side. Note: skim tank lacks NFPA placard.

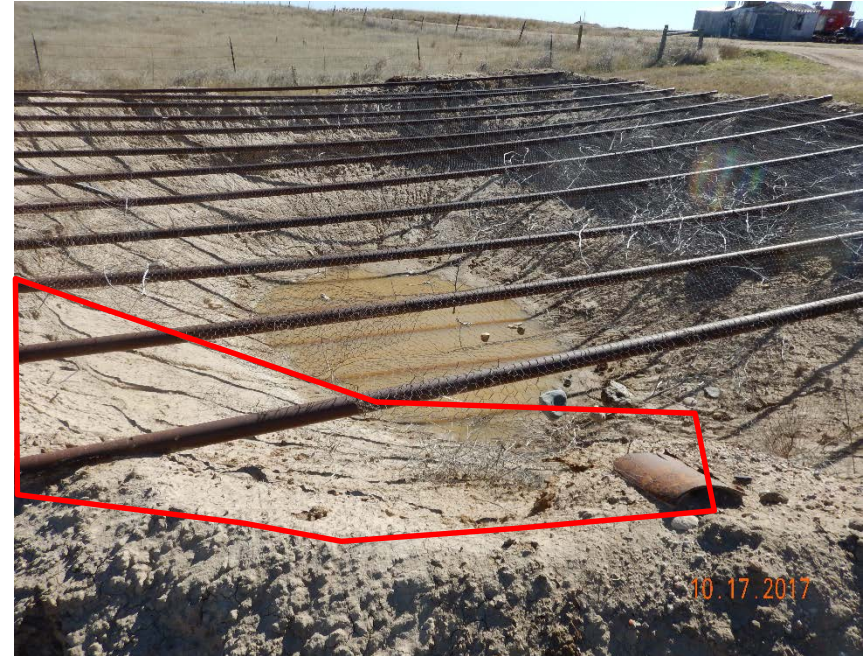
Photo #6 – Gaps in mesh around produced water pit are large enough to allow wildlife access.

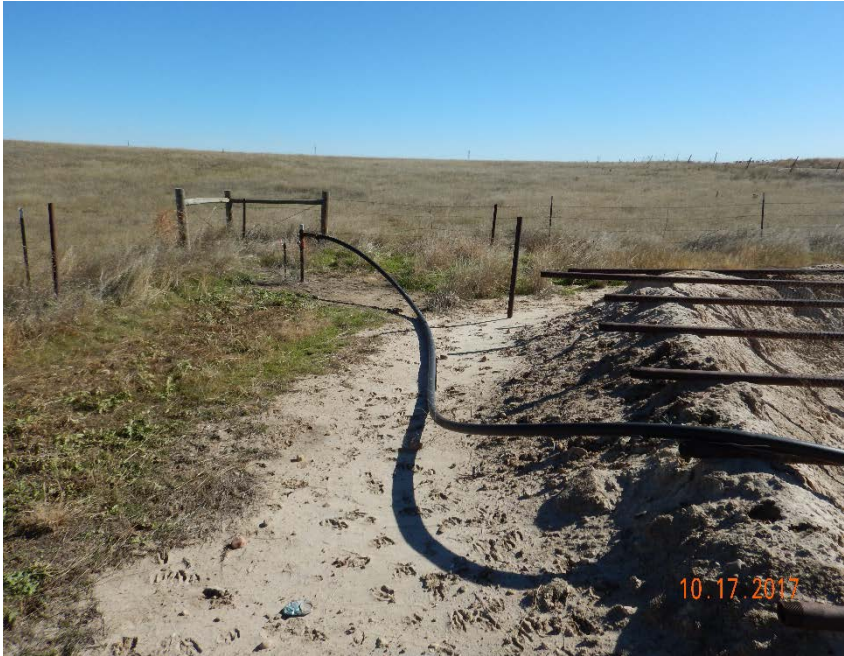
Photo #7 – 2" Flowline riser NE of produced water pit is plumbed to discharge into pit. Note: 1" flowline riser north of 2" and wildlife tracks in sediment north of pit berm.

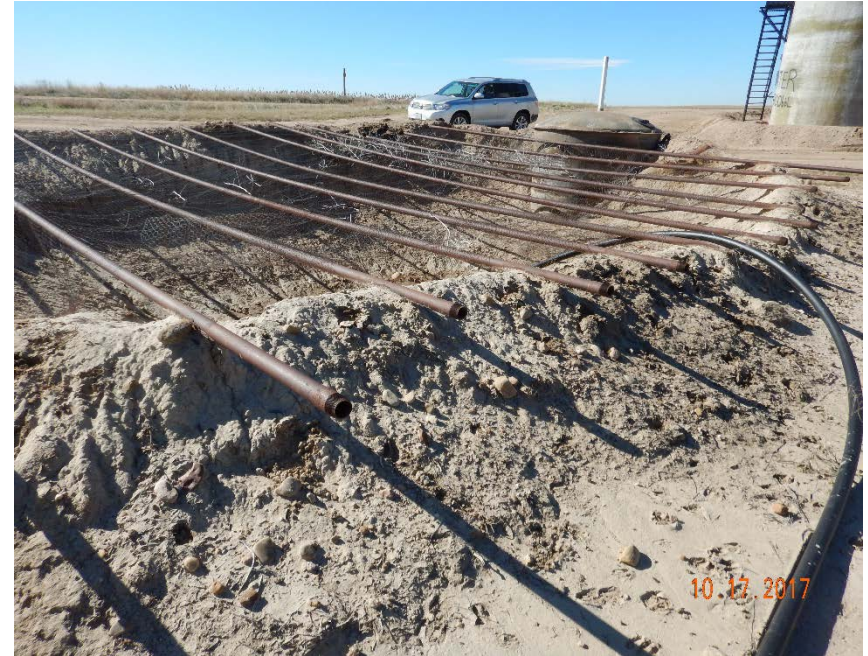
Photo #8 – Pit berm is damaged and eroded on all sides (view from NE corner).

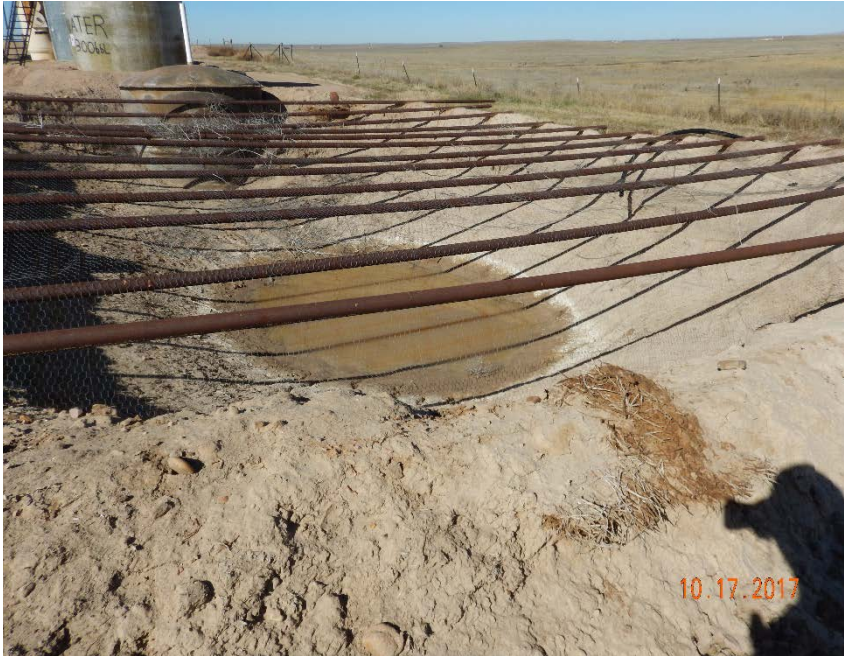
Photo #9 – Localized, oil-stained soil with vegetation incorporated into east pit berm.

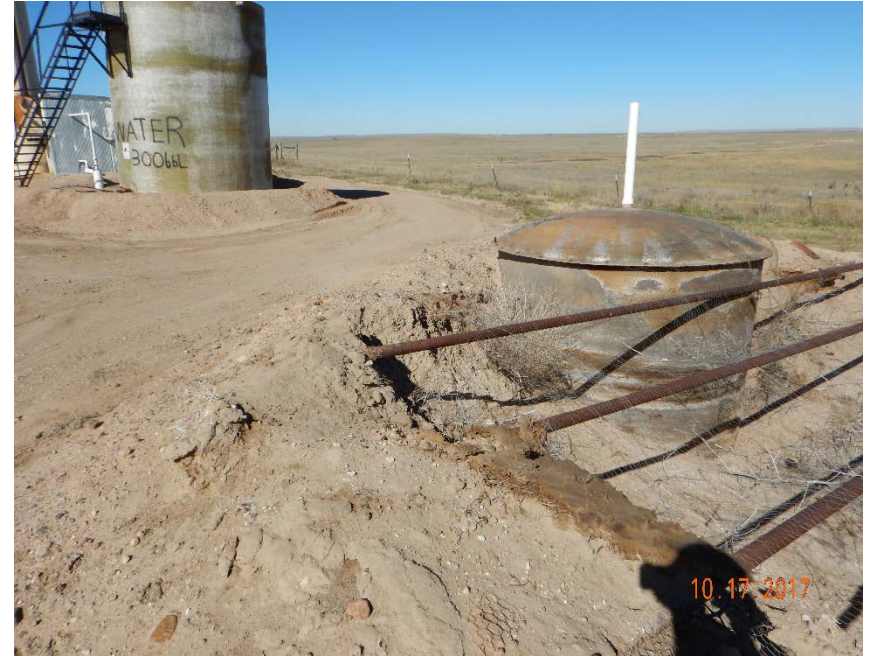
Photo #10 – Oil-stained soil at SW and NW corners of pit berm.

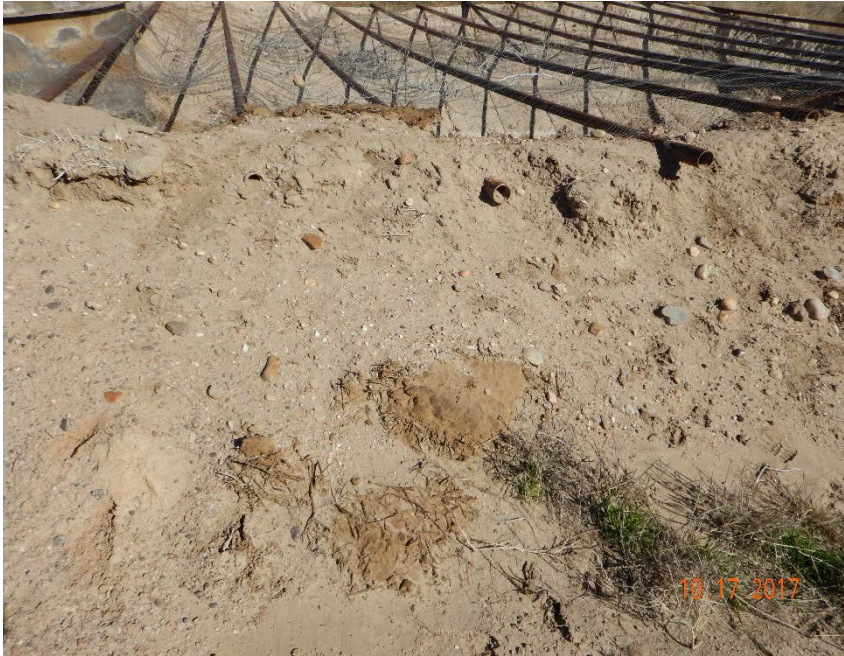
Photo #11 – Oil stained soil outside of pit berm at SW corner.

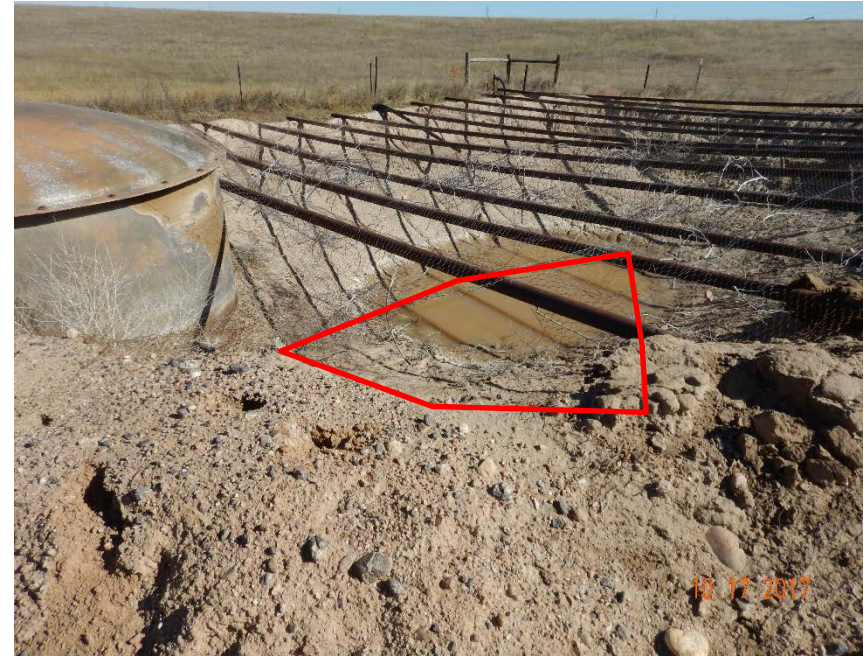
Photo #12 – Additional photo of large gaps in wildlife cover.

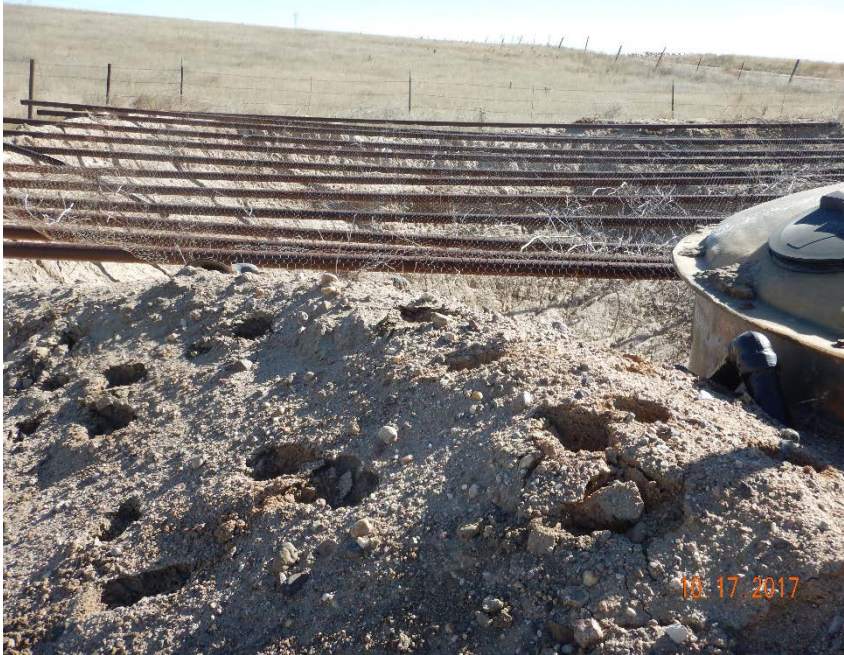
Photo #13 – Damaged pit berm at NW corner.

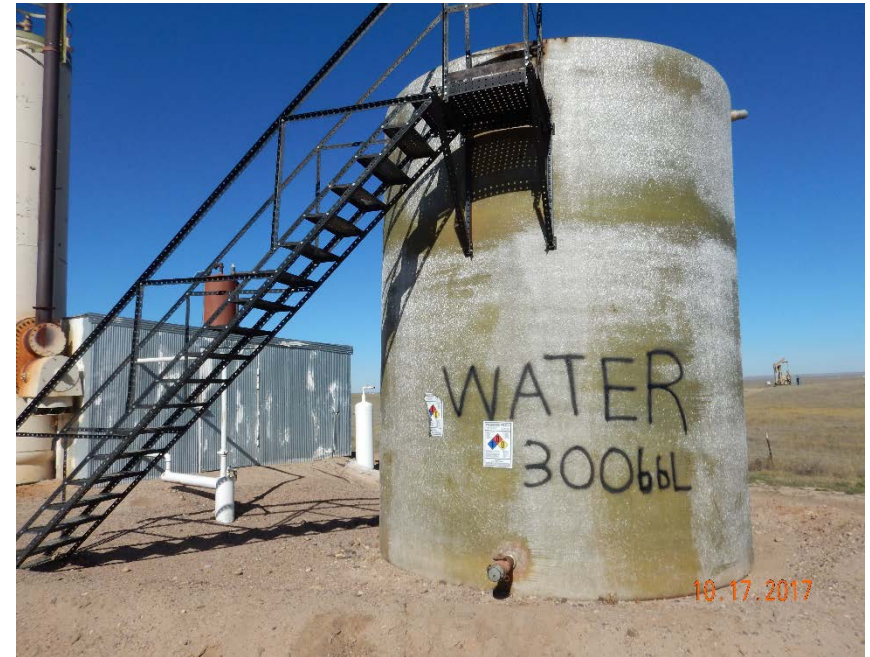
Photo #14 – 300 bbl fiberglass produced water AST shares shallow earthen berm with separator shed.

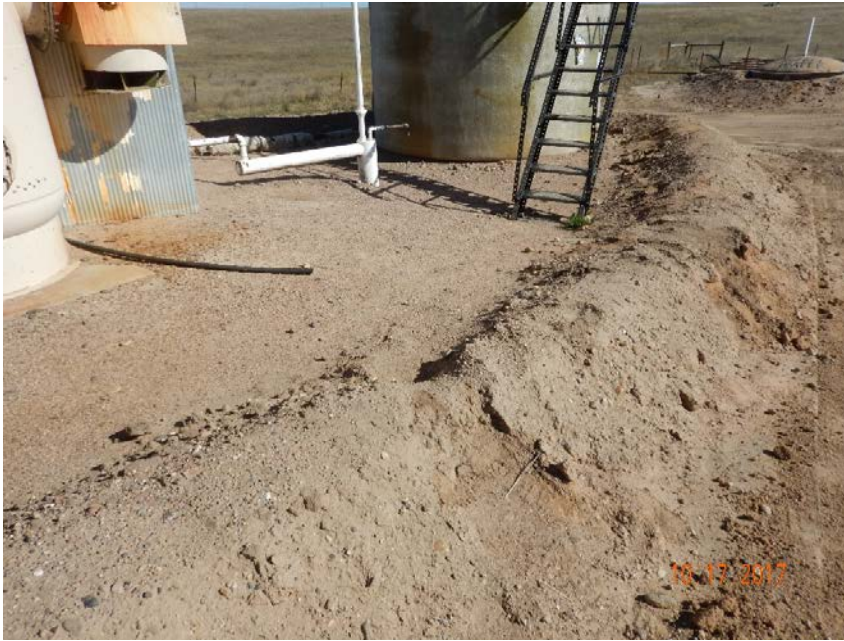
Photo #15 – Earthen berm for produced water tank is shallow, damaged, and eroded. View of SE corner.

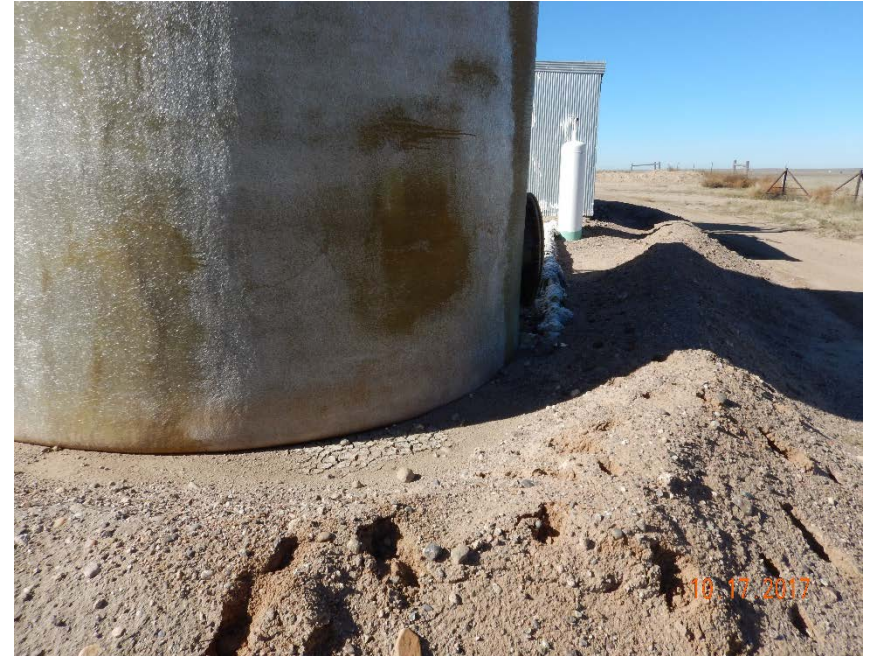
Photo #16 – View of damaged, shallow earthen berm at NE corner of produced water AST. Berm footprint is of insufficient size to satisfy Rule 605.a.(4).

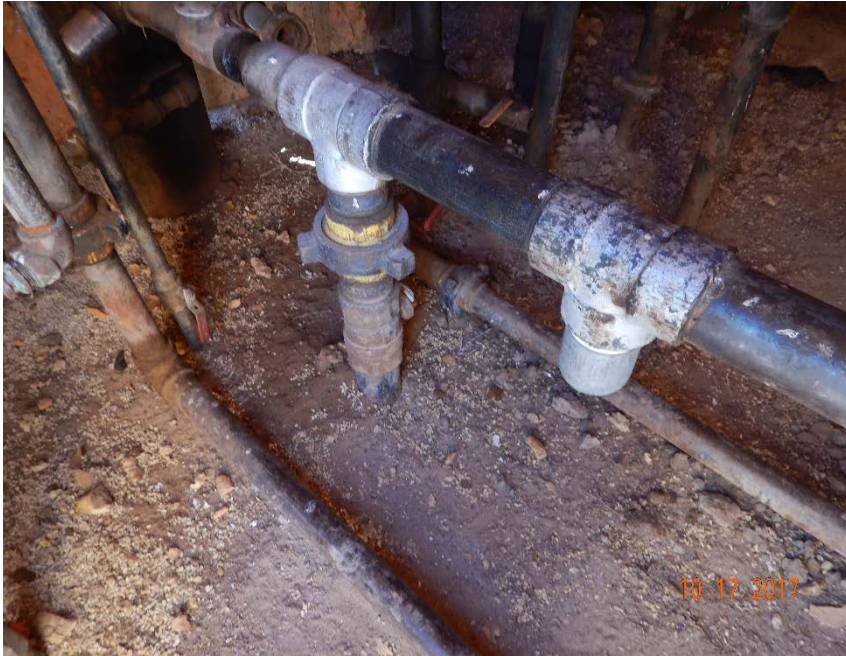
Photo #17 – Historical accumulations of oily waste inside of separator shed.

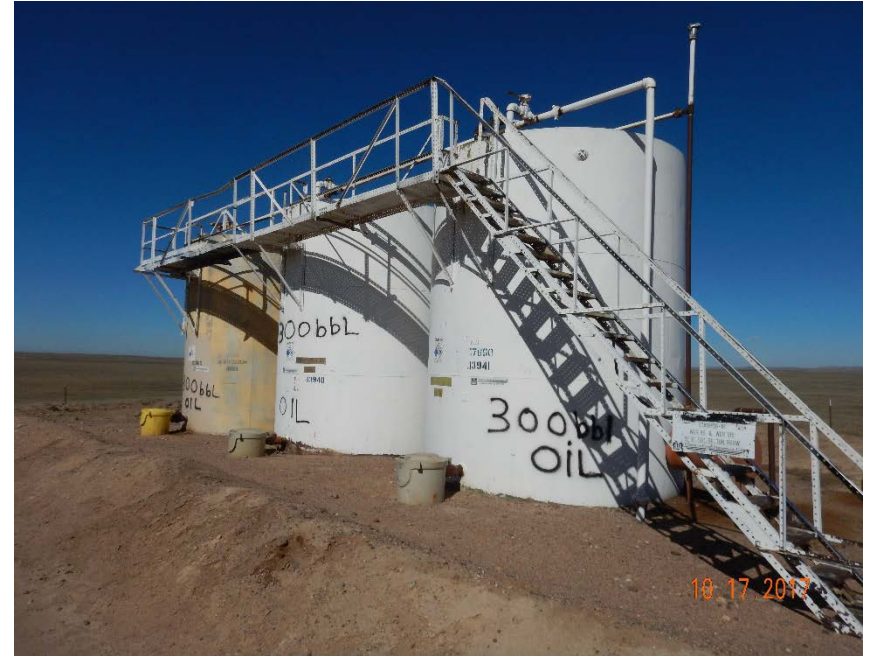
Photo #18 – 300 bbl crude oil ASTs located SW of pump jack. View from SE corner.

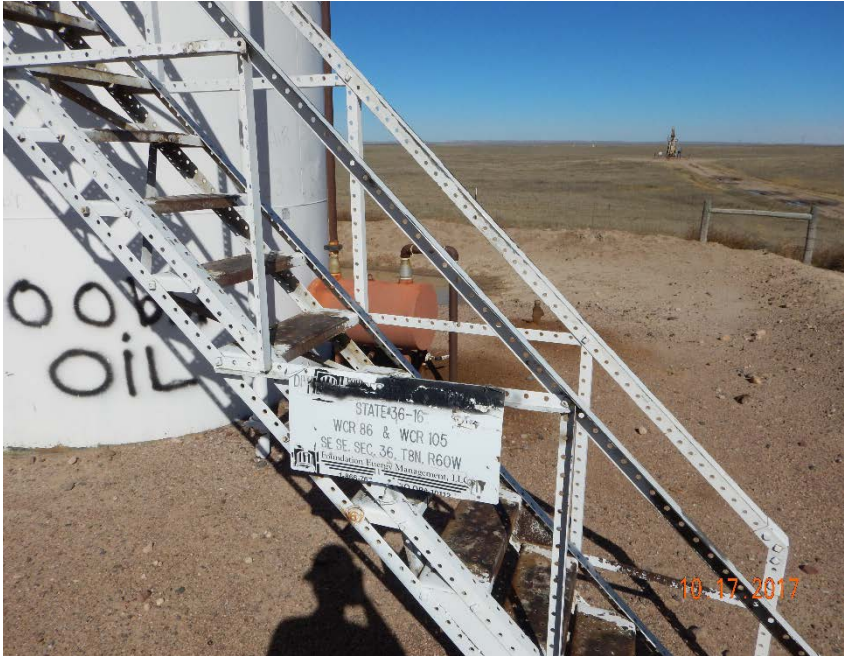
Photo #19 – Battery sign located at SE corner of crude oil tank battery. Operator’s contact information decal is flaking off of sign, rendering emergency contact phone number illegible.

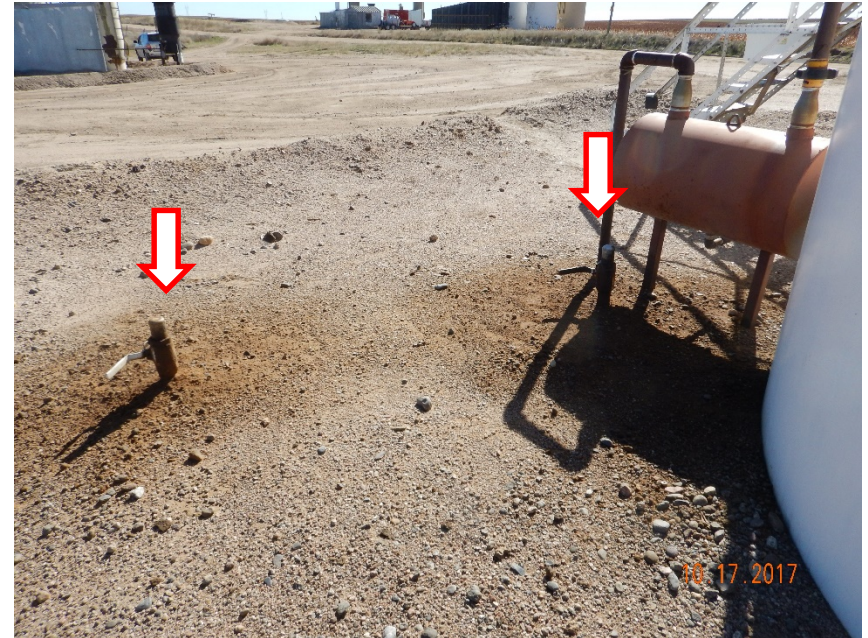
Photo #20 – Oil-stained soil and two bullplugged 2” steel flowline risers east of crude oil ASTs.

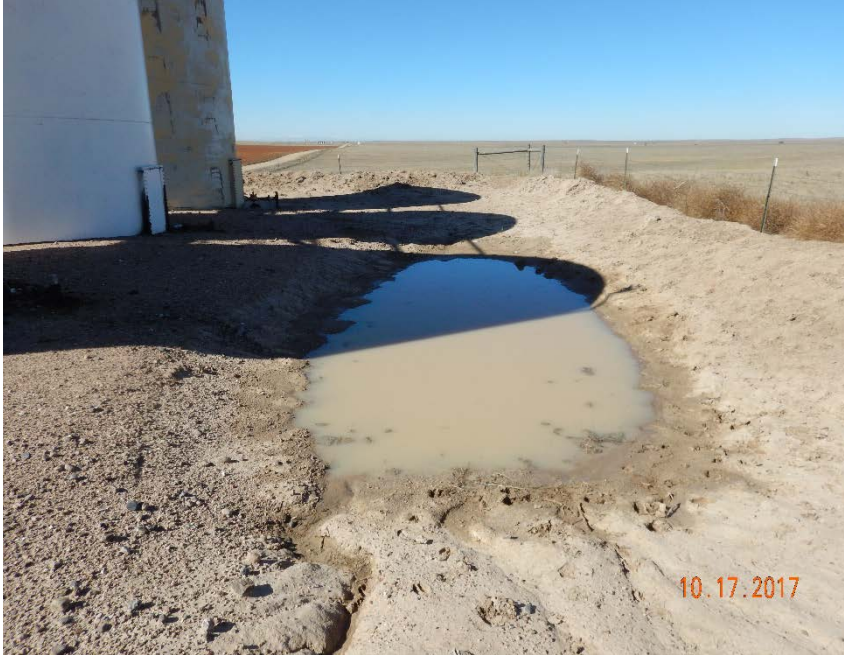
Photo #21 – Water-filled depression north of crude oil ASTs is likely related to unauthorized pit inside of berm area referenced in NOAV #1175574.

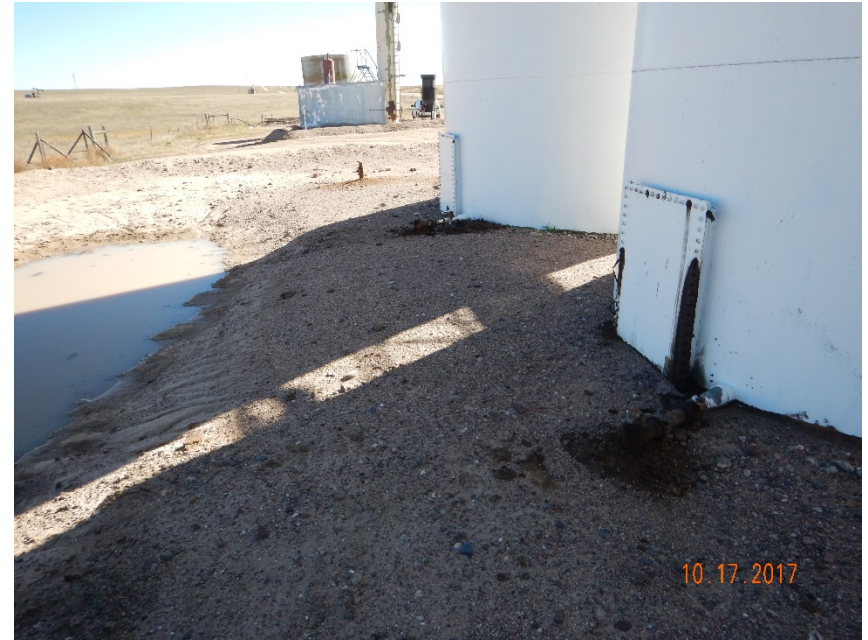
Photo #22 – Historical accumulation of oily waste beneath valves on north side of crude oil ASTs (1).

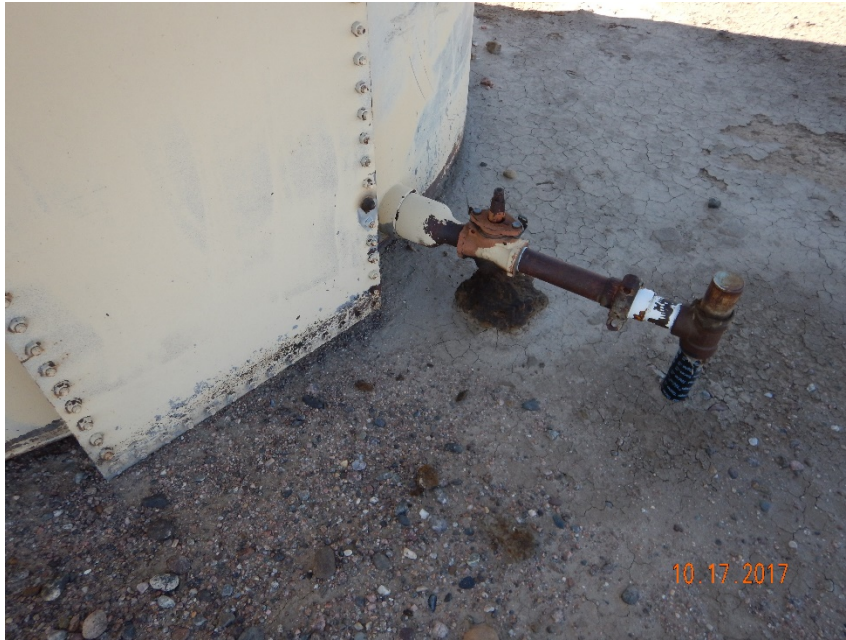
Photo #23 - Historical accumulation of oily waste beneath valves on north side of crude oil ASTs (2).

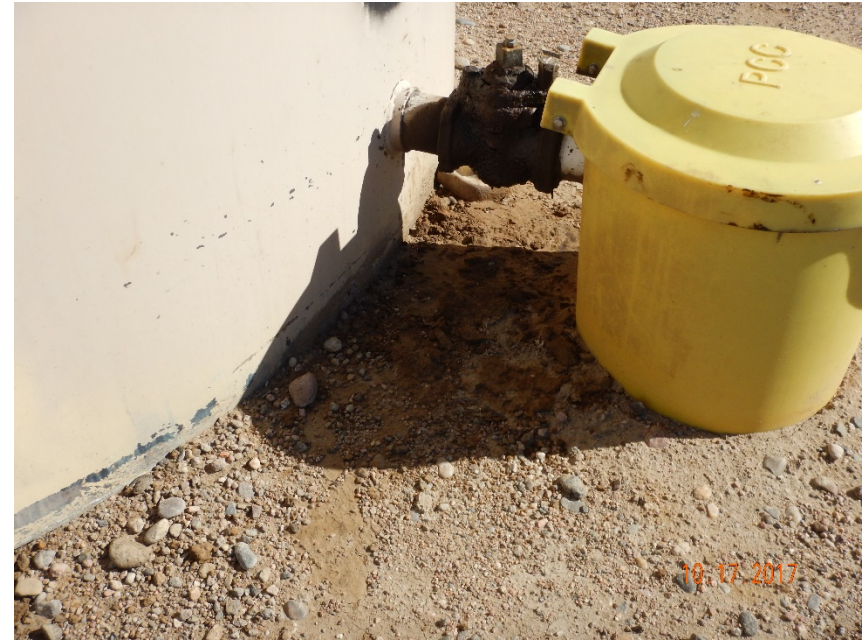
Photo #24 - Historical accumulation of oily waste beneath loadout valve on south side of crude oil AST.

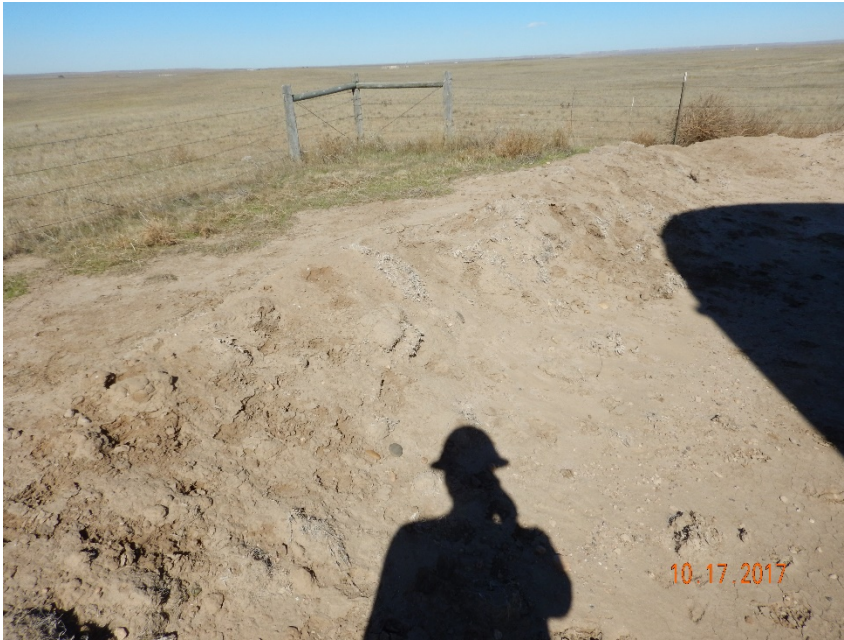
Photo #25 - Damaged and eroded portion of earthen berm NW of crude oil ASTs.

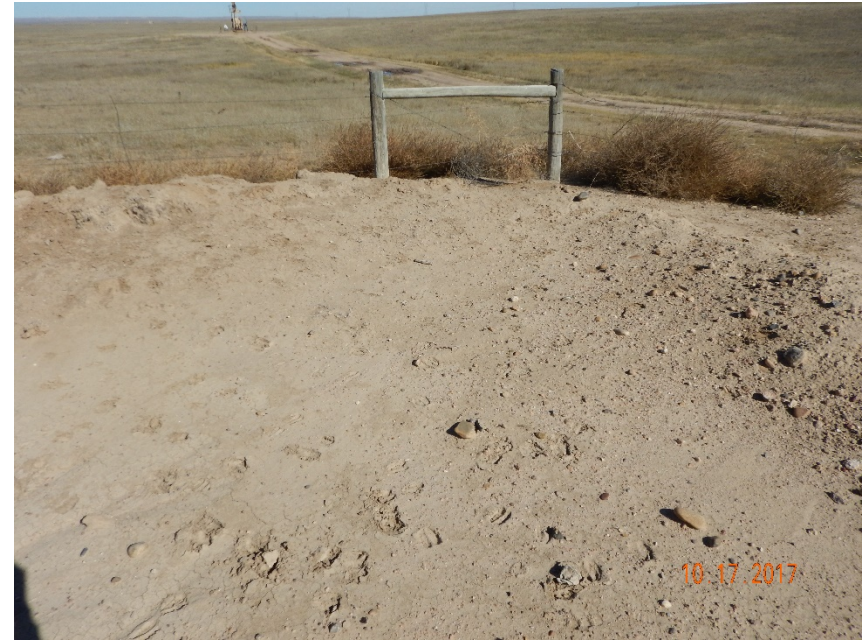
Photo #26 – Shallow, eroded portion of earthen berm NE of crude oil ASTs.
