# Inspection Photos

Operator: CM PRODUCTION LLC - 10352

Location ID: 312244

Inspection Doc. Number: 682502725

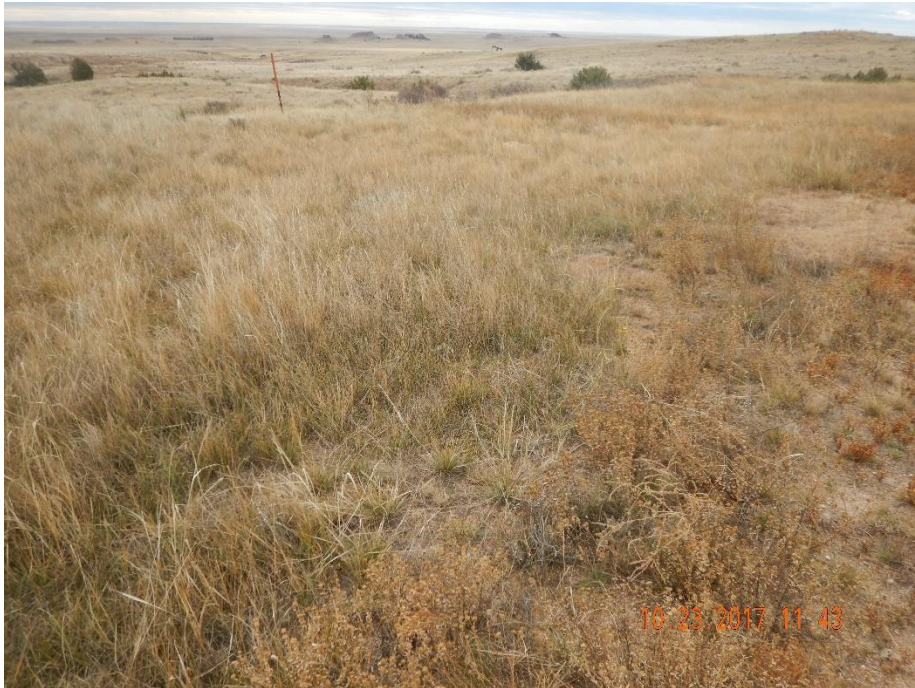
**Photo 1:** Photo taken from the northeast corner of the location, facing south. Photos 1-3 show an overview of the location and interim areas. Interim areas on the southeast end of the location appear to be adequately vegetated.

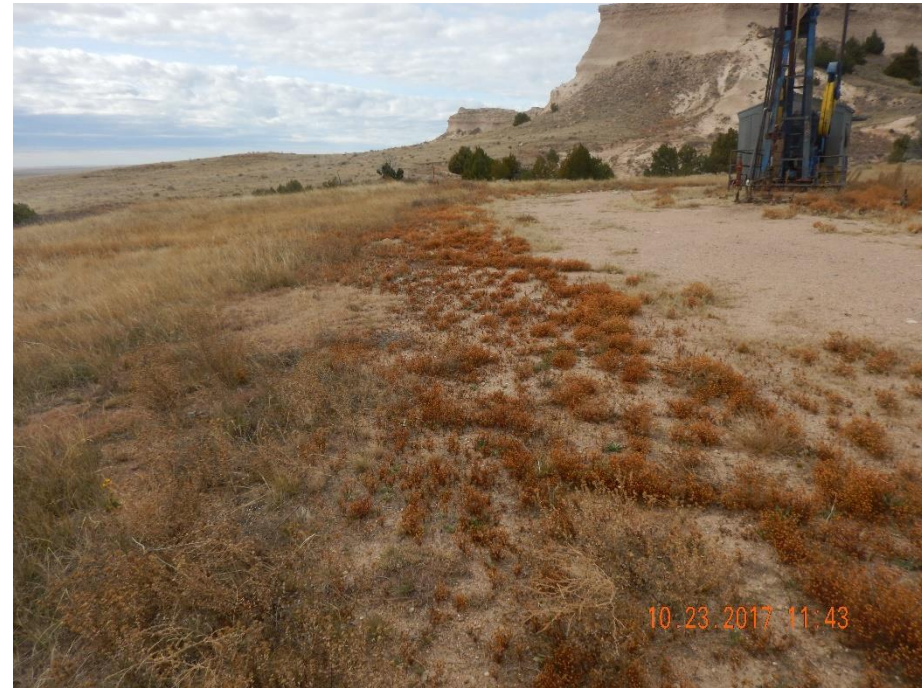
**Photo 2:** Photo taken from the northeast corner of the location, facing southeast. Red colored plants seen in photo appear to be an Aster species, not undesirable weedy plant vegetation.

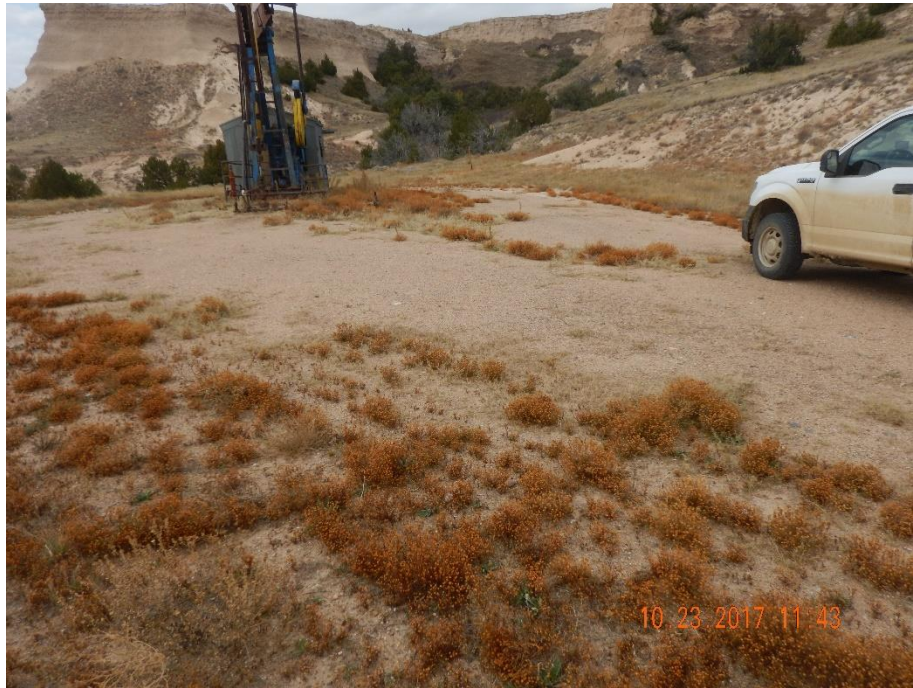
**Photo 3:** Photo taken from the northeast corner of the location, facing southwest

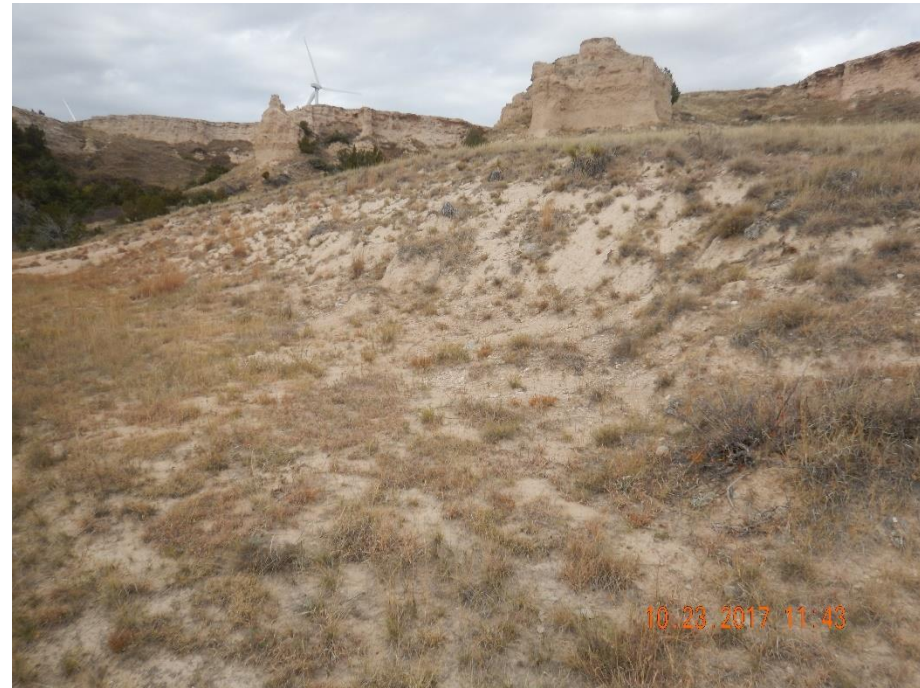
**Photo 4:** Photo taken from the north end of the location, facing northwest. The slopes on the north end show sign of erosion degradation.

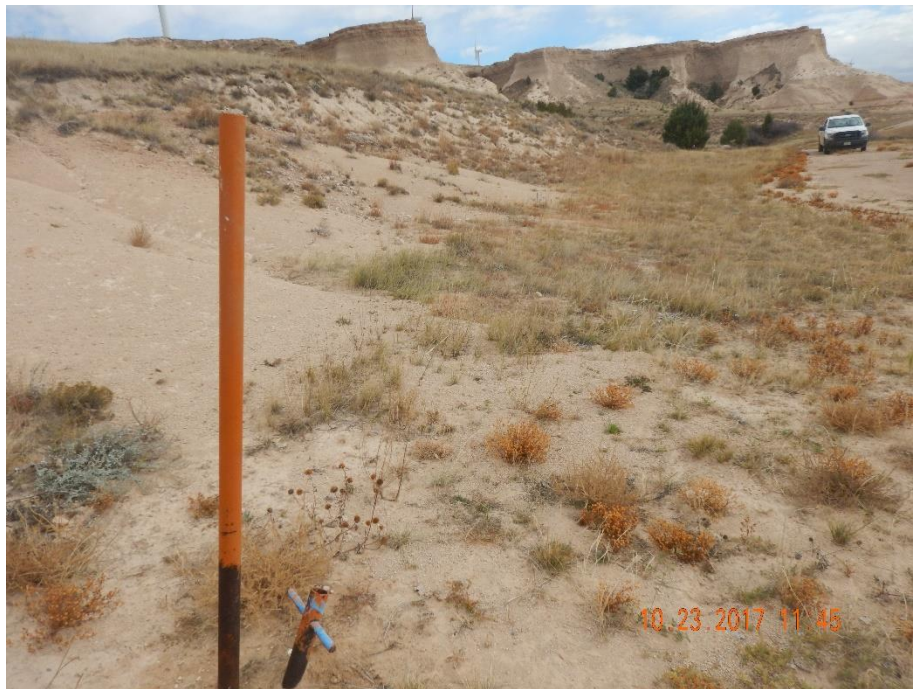
**Photo 5:** Photo taken from the northwest corner of the location, facing east. Photos 5-7 show an overview of the location and interim areas.

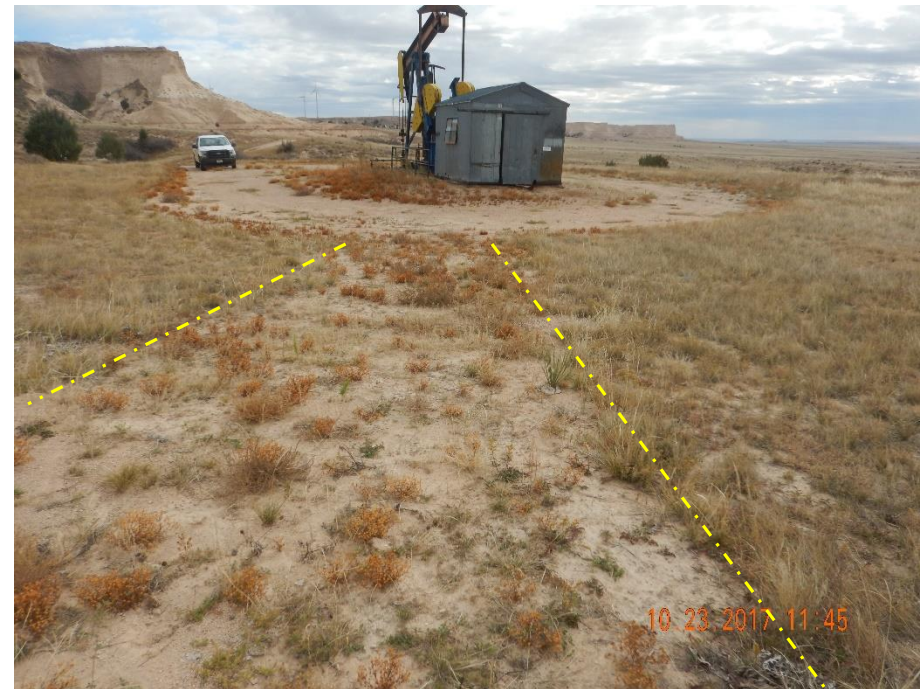
**Photo 6:** Photo taken from the northwest corner of the location, facing east. Note: there appears to be areas leading from the anchors towards the well ~5-6 feet in width where vegetation does not appear to be uniform. This is a common occurrence observed on multiple CM Production locations in the area.

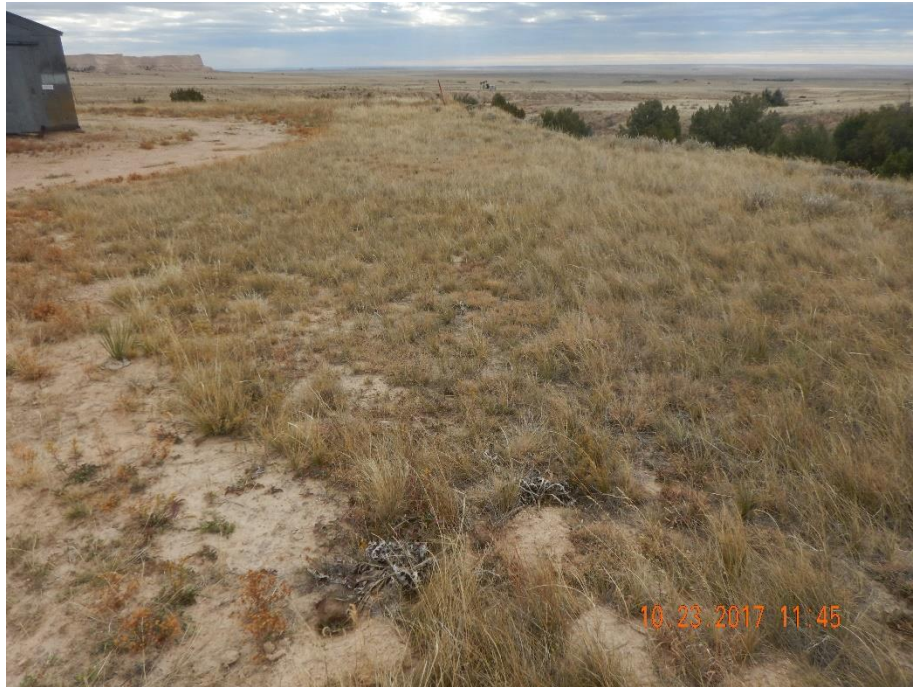
**Photo 7:** Photo taken from the northwest corner of the location, facing southeast. Vegetation on the southwest end of the location appears to have established adequately.

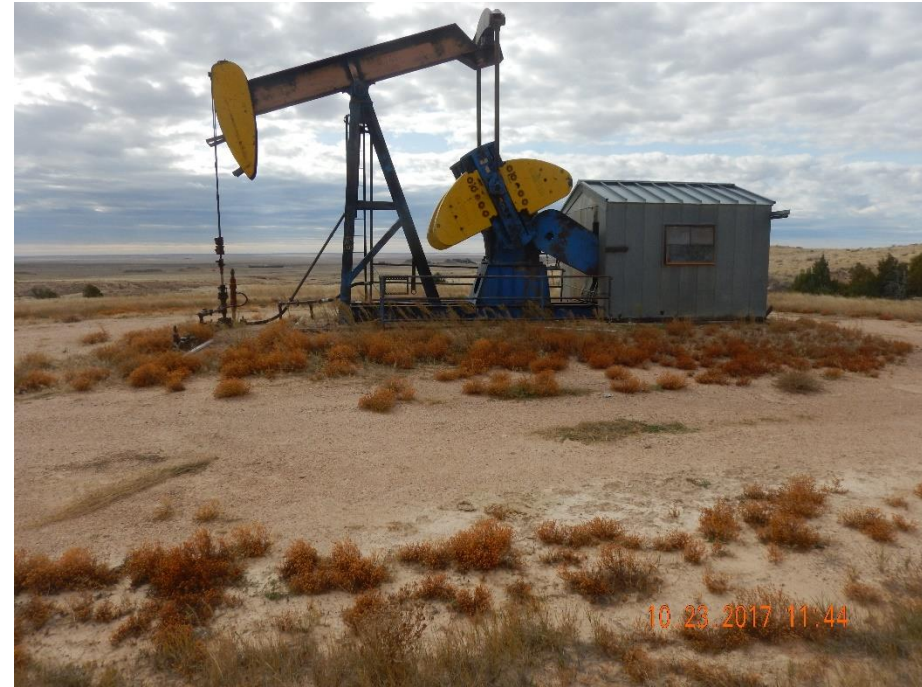
**Photo 8:** Photo taken from the north end of the location, facing south. Photo shows well/pump unit.

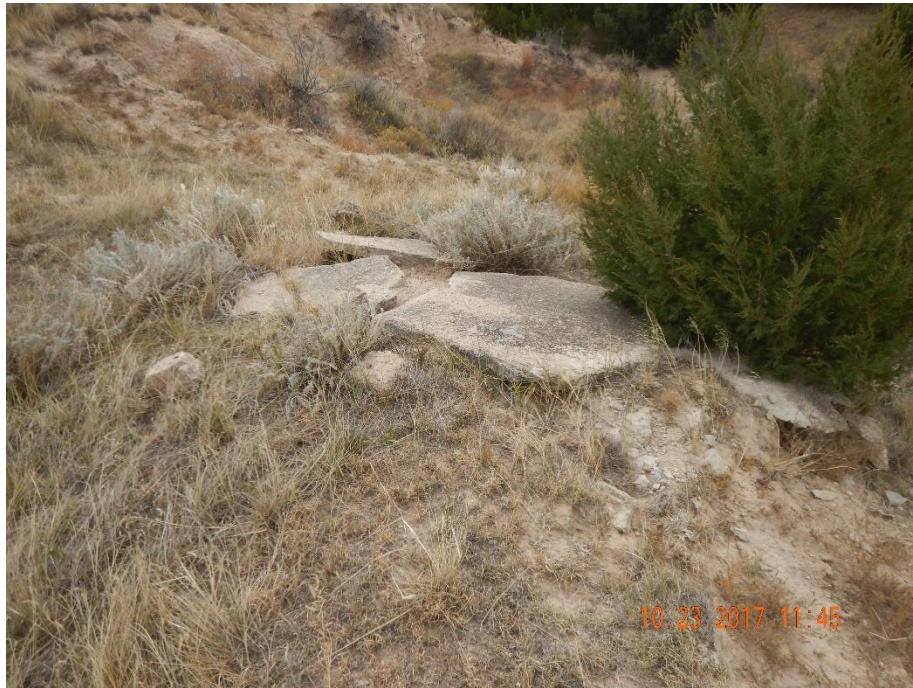
**Photo 9:** Photo taken from the southwest end of the location. Photo shows operator either discarded concrete debris off the location, or had attempted to utilize concrete as rip-rap.

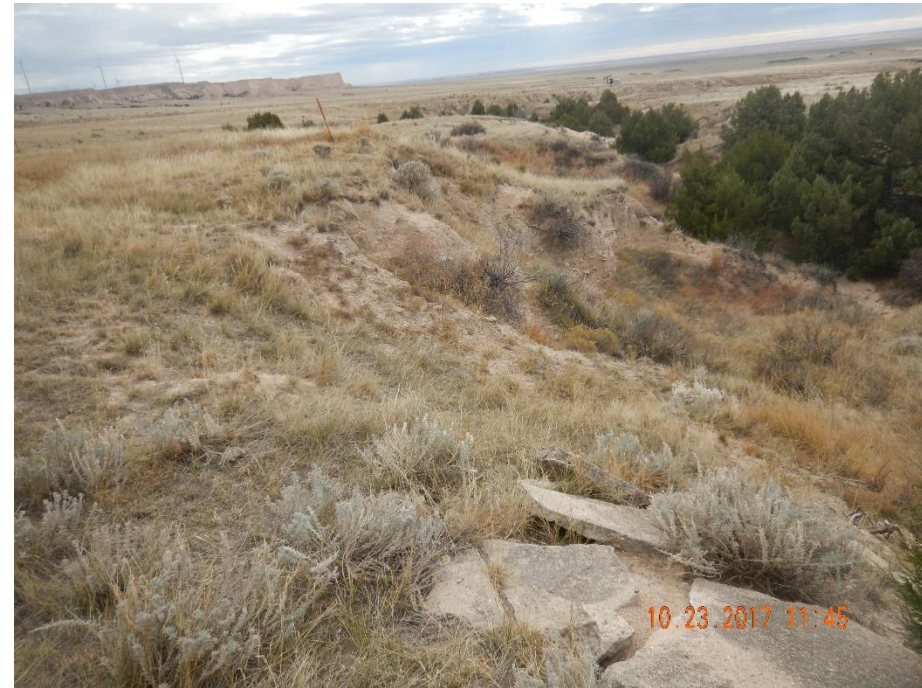
**Photo 10:** Photo taken from the southwest end of the location, facing southeast. Photo shows erosion degradation that has formed, possibly due to stormwater runoff from the location.

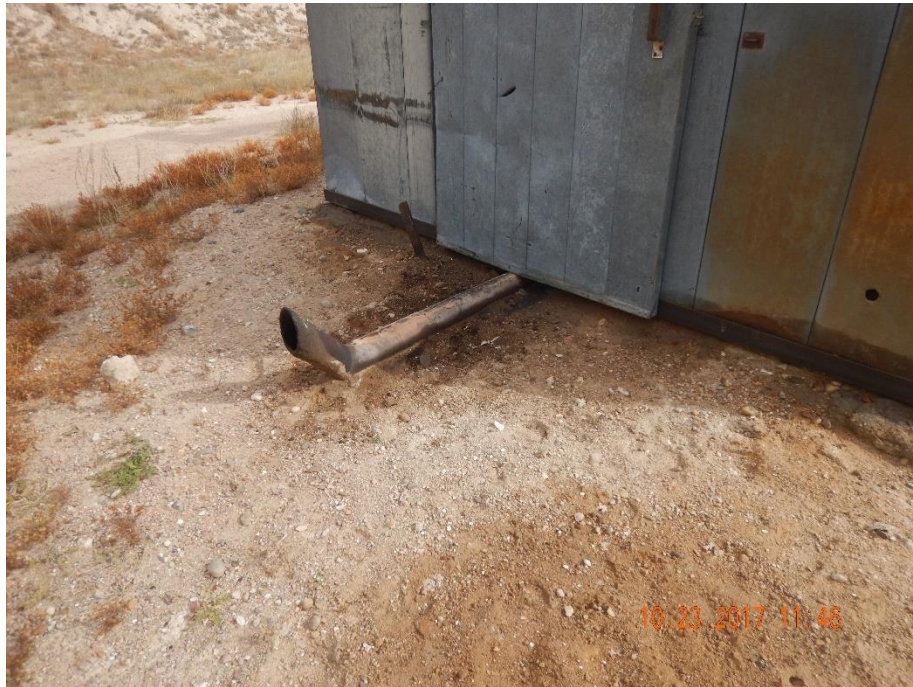
**Photo 11:** Photo taken from the west end of the pump unit. Photo shows dark discolored soil that can be found around the unit, as well as inside.

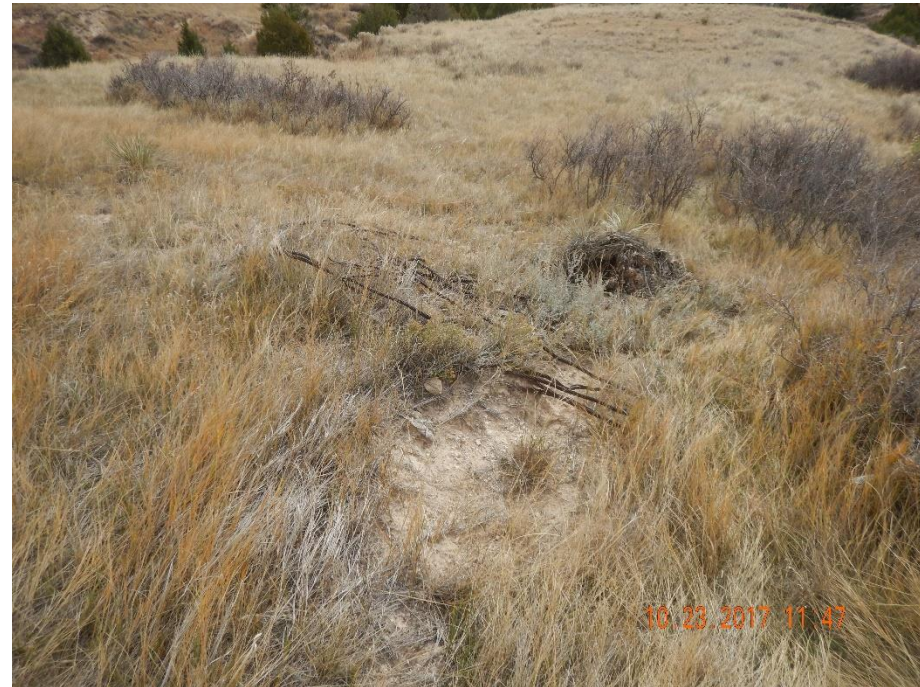
**Photo 12:** Photo taken from the southeast end of the location. Photo shows cable debris observed on the interim area.

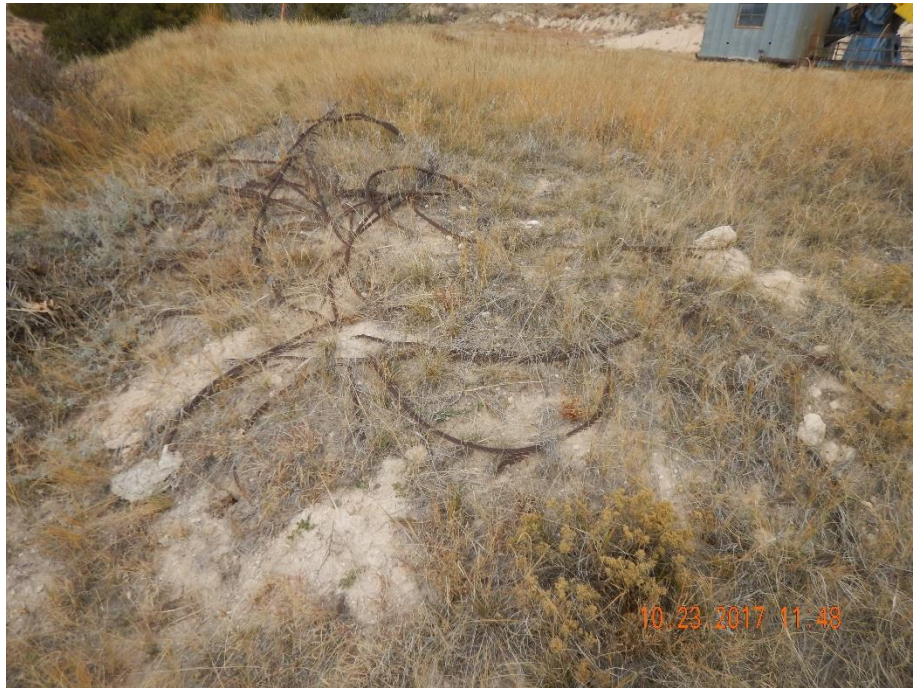
**Photo 13:** Photo taken from the southeast end of the location. Photo shows cable debris observed on the interim area.

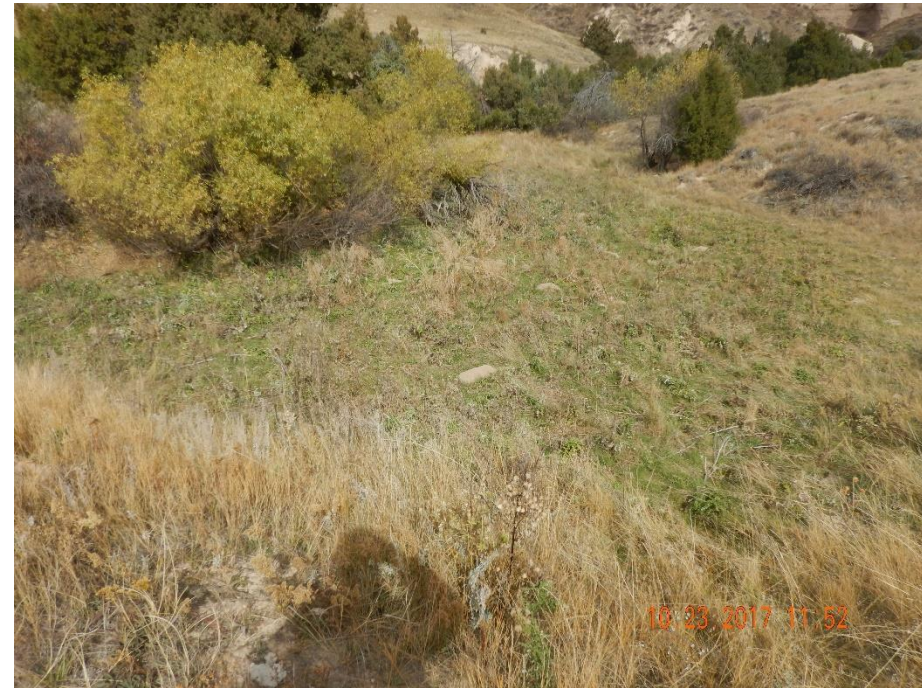
**Photo 14:** Photo taken from a drainage to the immediate east of the well. Photo shows drainage has become inundated with Canada thistle. Though inspector was unable to observe the noxious weed on location, due to the proximity of the weeds, it possible that thistle does exist on site.
