Construction and Stormwater Inspection

October 24, 2017

Operator: GRYNBERG* JACK DBA GRYNBERG PETROLEUM CO - #36200

Location Name: Grynberg Stateline Federal /24-12-65-4 Pad

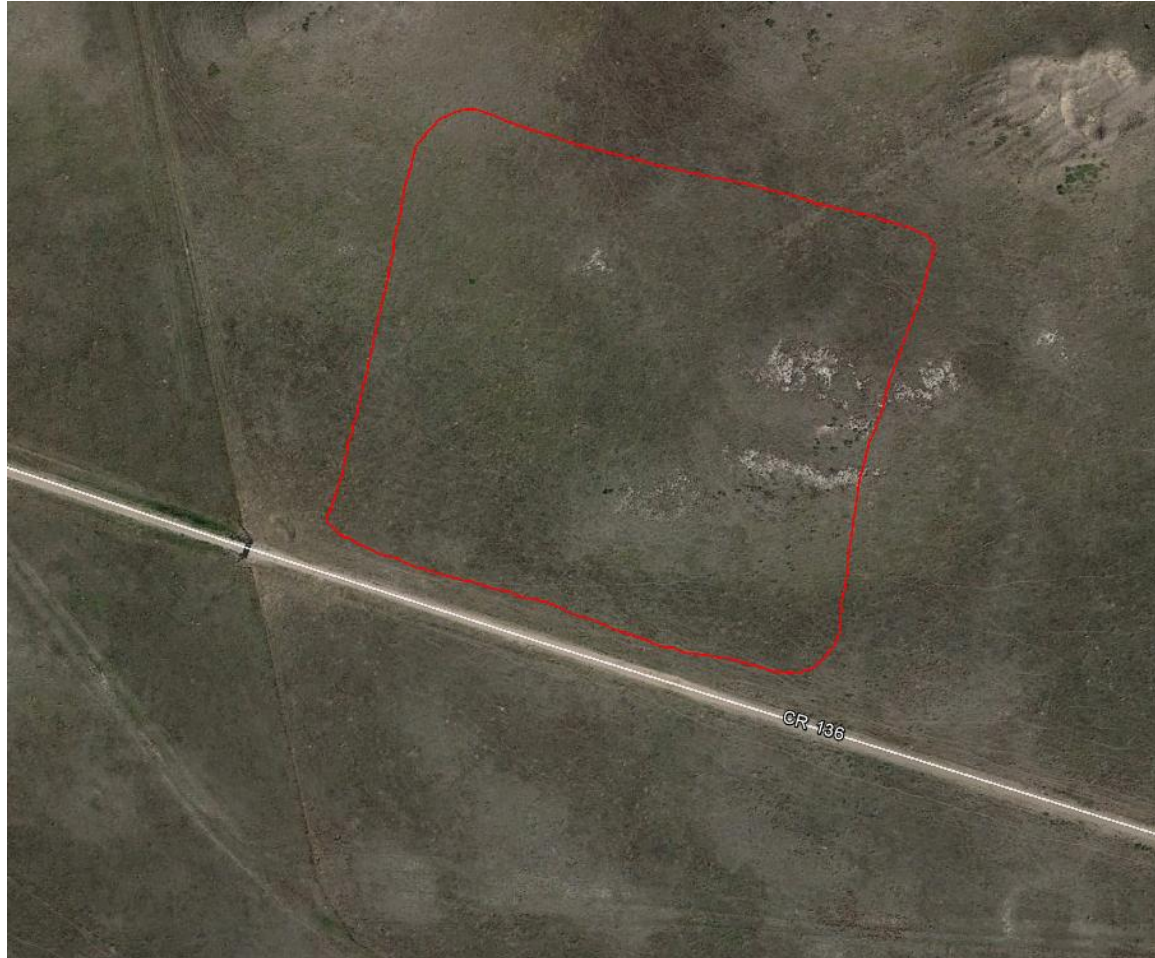
Photo 1. Google Earth aerial imagery taken on September 7, 2016. A disturbance area of 8.95 acres was mapped on 10/24/2017 using a Trimble Juno 3B handheld device (red line). Appears the Operator has overbuilt the location by 1.55 acres (21% overbuilt) per the approved Form 2A .

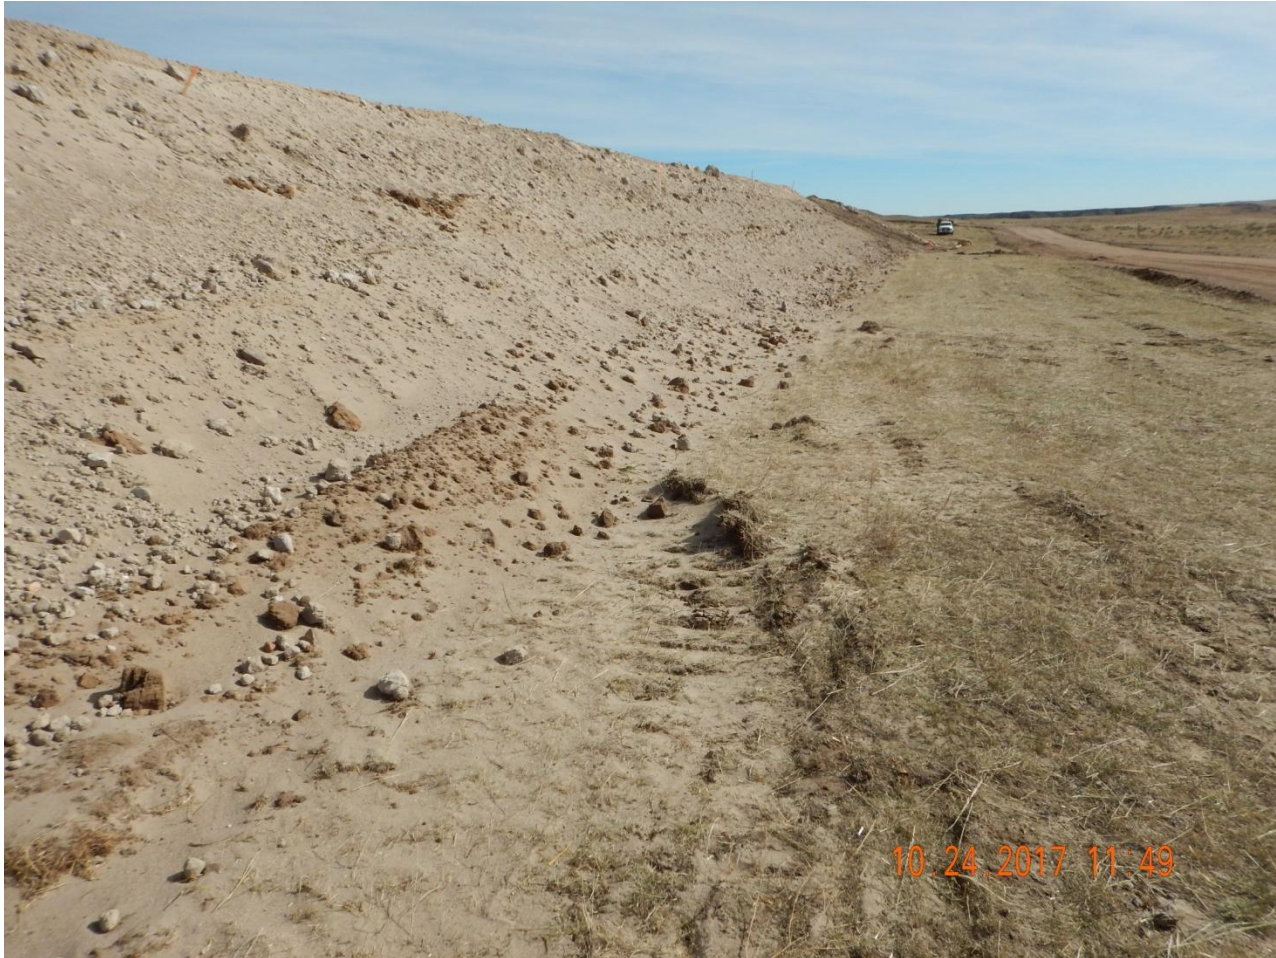
Photo 2. Photo taken from the southwest location, facing East. No stormwater or erosion control BMPs observed. Per Form 42 (Notice of construction), construction activities commenced on October 12, 2017. Operator has failed to install stormwater and erosion control BMPs prior to, or at, the start of construction.

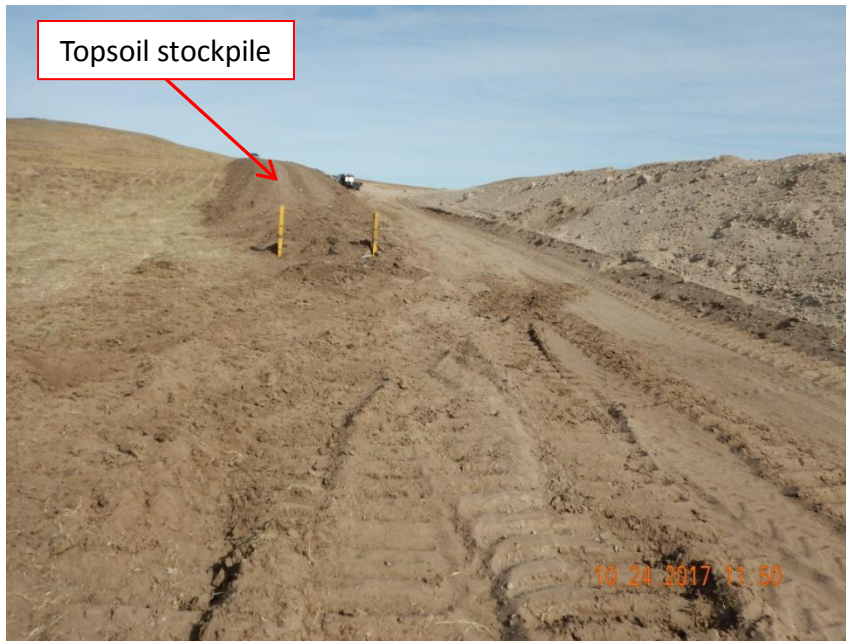
Photo 3. Photo taken from the southwest location, facing North. See comments under Photo 2.

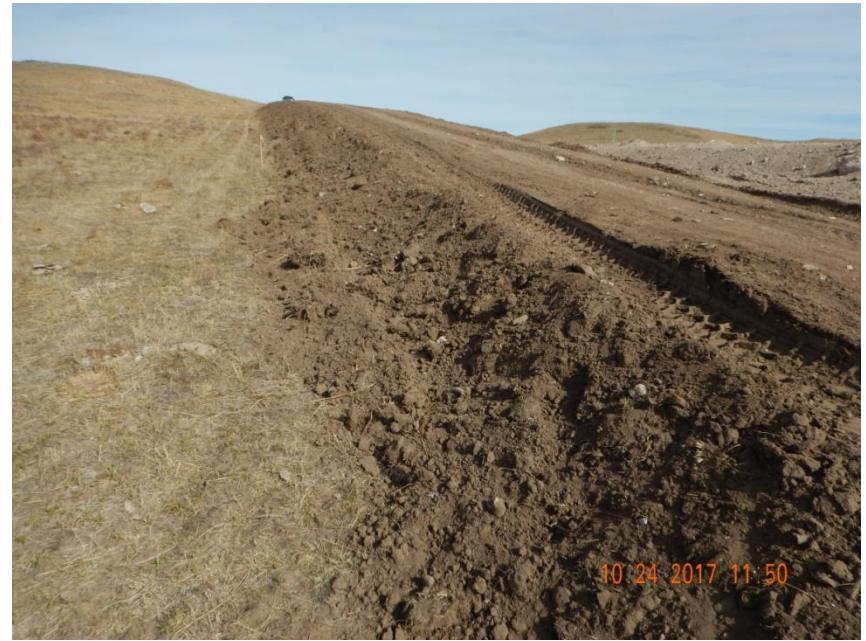
Photo 4. Photo taken from the western location, facing North. Appears topsoil has been salvaged and stored along the western perimeter of the location. No observed stormwater and erosion control BMPs around the topsoil stockpile.

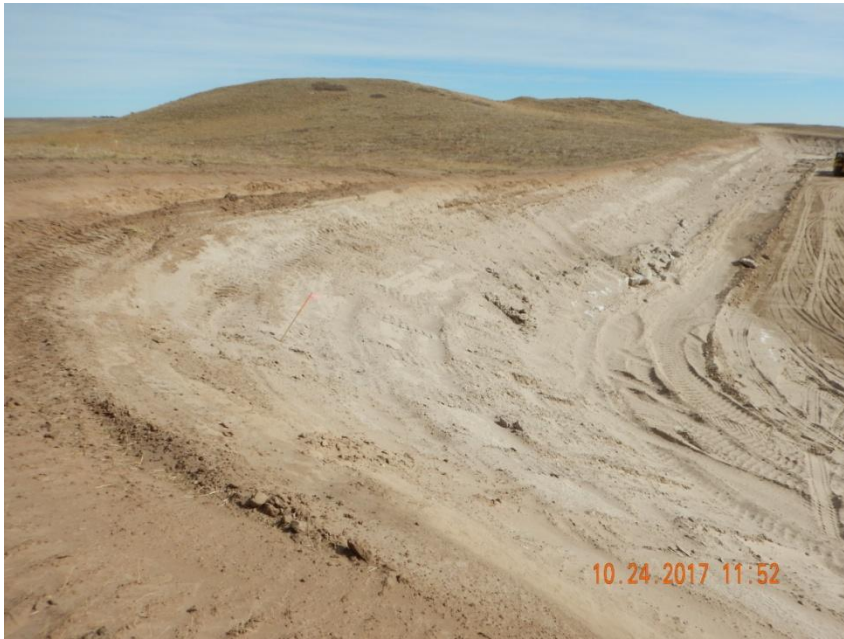
Photo 5. Photo taken from the northwest location, facing East. Operator shall control both run-off and run-on onto location. Operator shall stabilize all cut slopes to minimize site degradation.

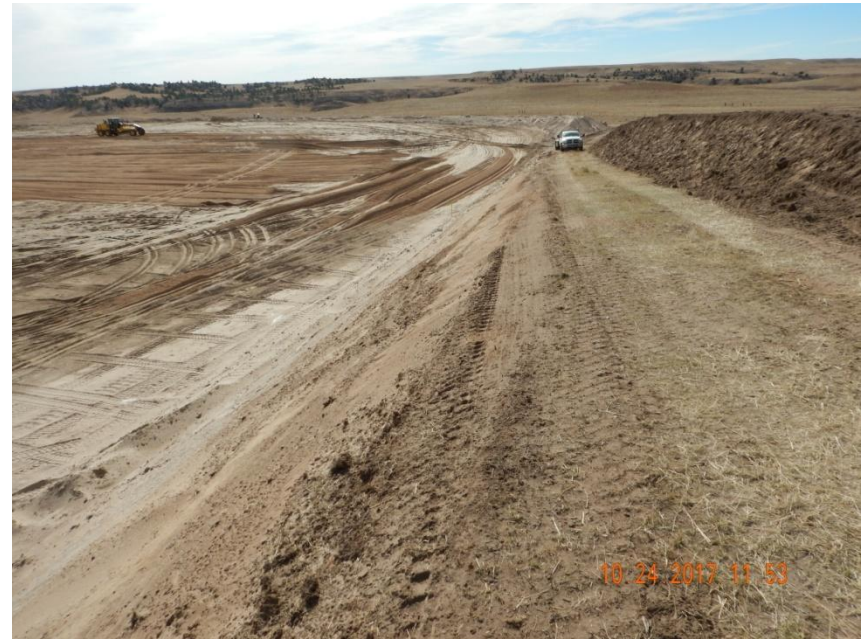
Photo 6. Photo taken from the northwest location, facing South. See comments under Photo 5.

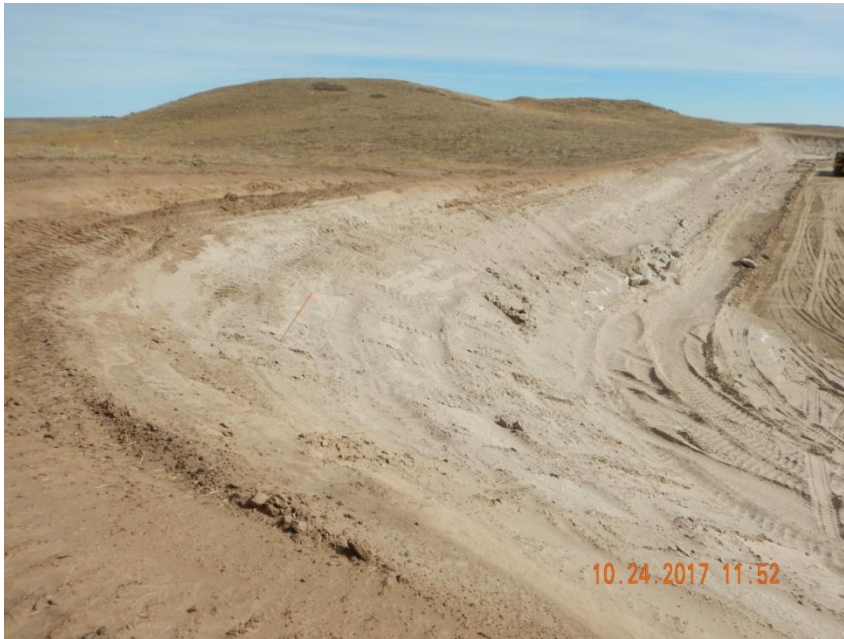
Photo 5. Photo taken from the northwest location, facing East. Operator shall control both run-off and run-on onto location. Operator shall stabilize all cut slopes to minimize site degradation.

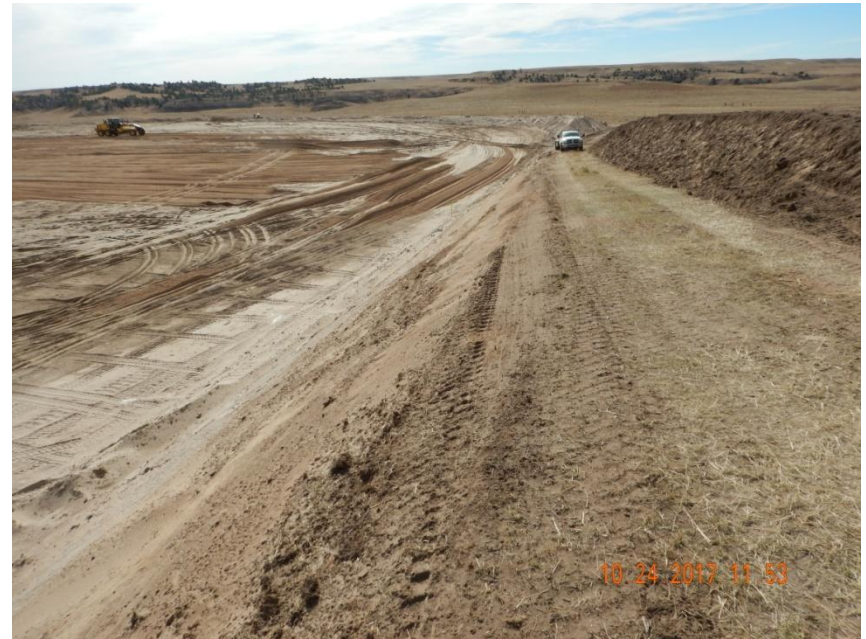
Photo 6. Photo taken from the northwest location, facing South. See comments under Photo 5.

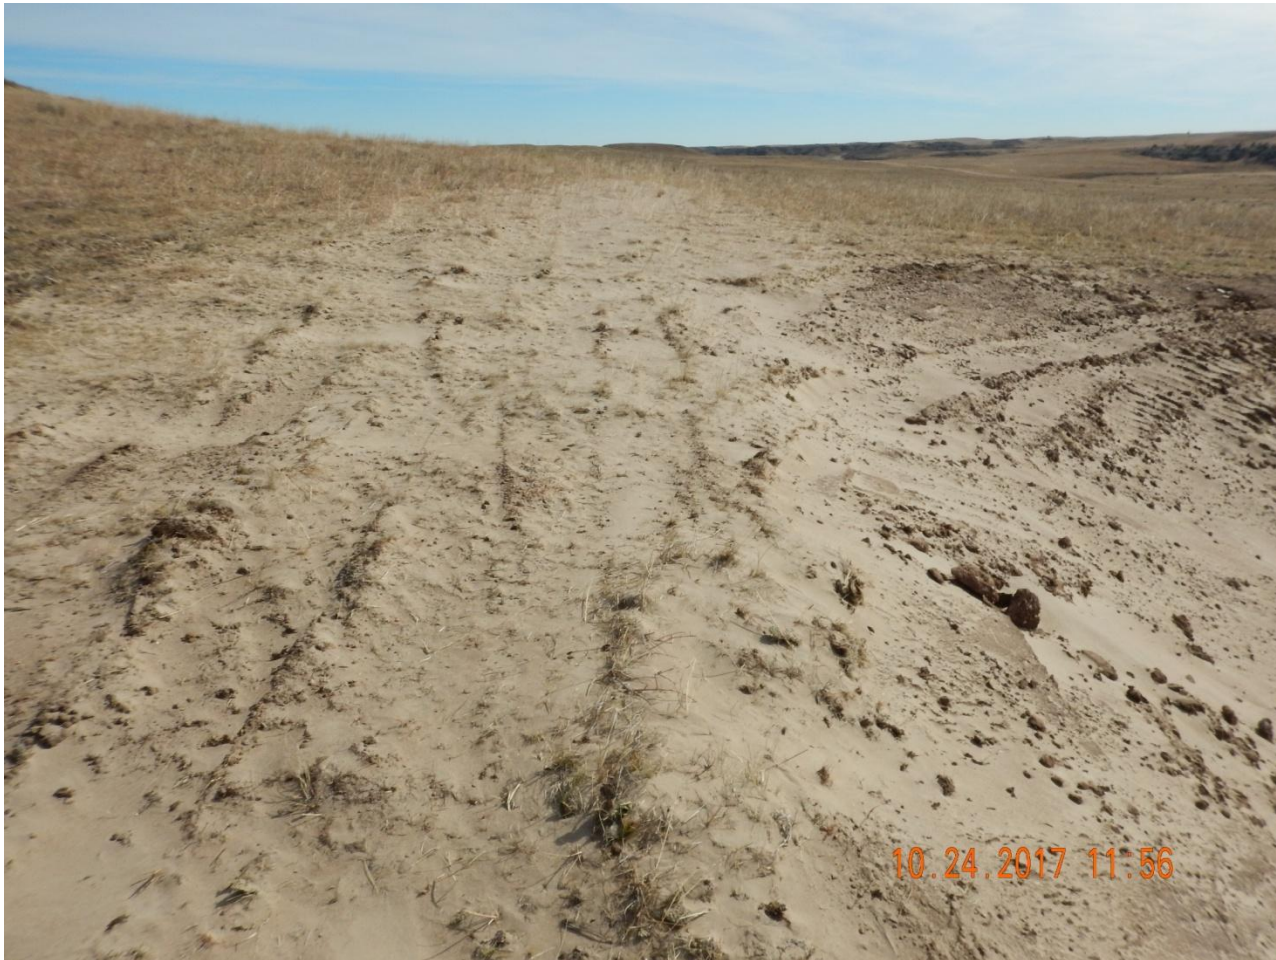
Photo 8. Photo taken from the northeast location, facing East. No observed stormwater and erosion control BMPs. Sediment discharge off location from wind erosion is evident along the northeast, east and southeast areas of the location.

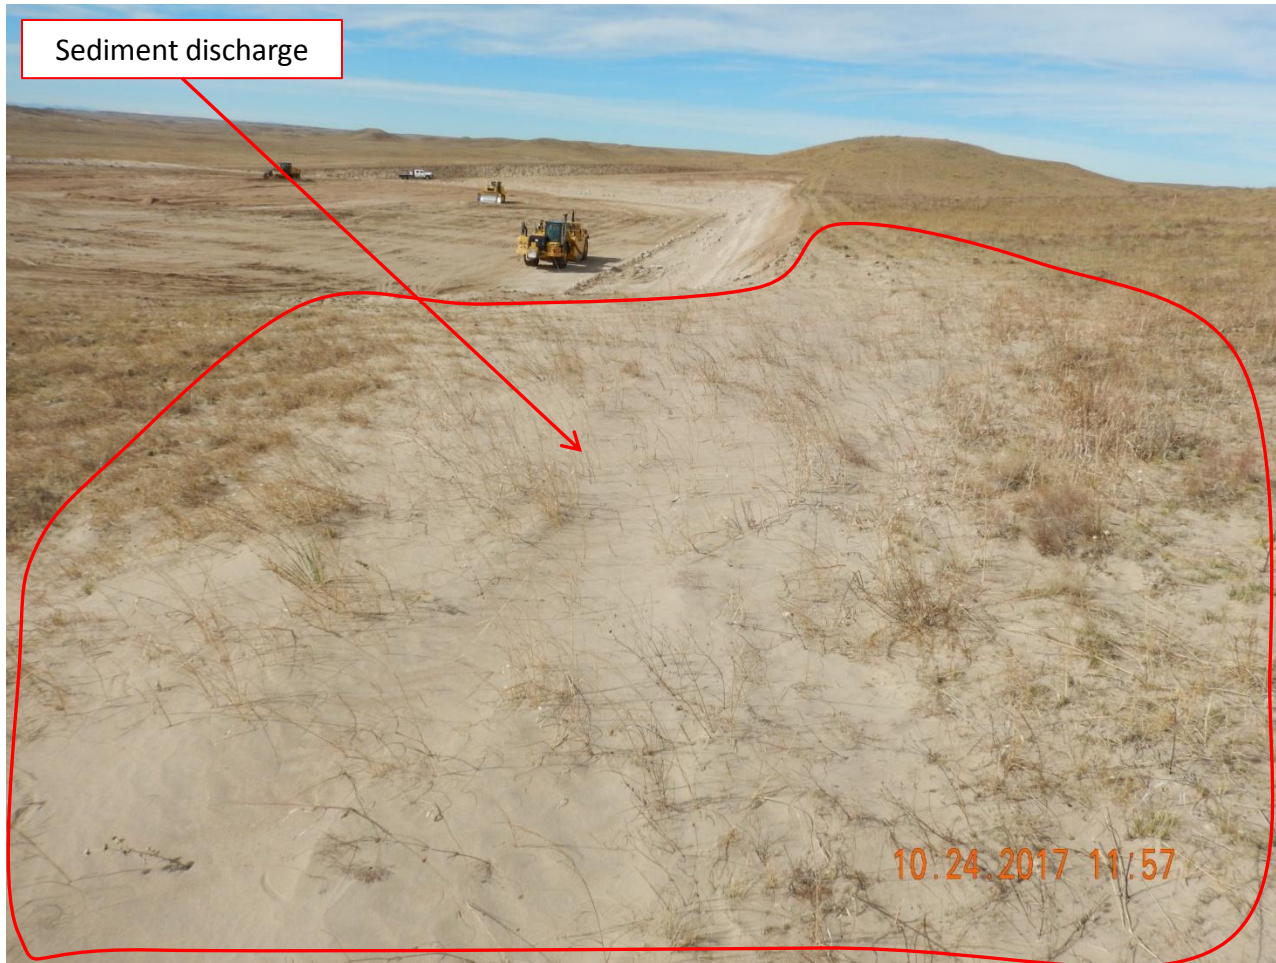
Photo 9. Photo taken approximately 40 feet from the northeast location corner, facing West. See comments under Photo 8.

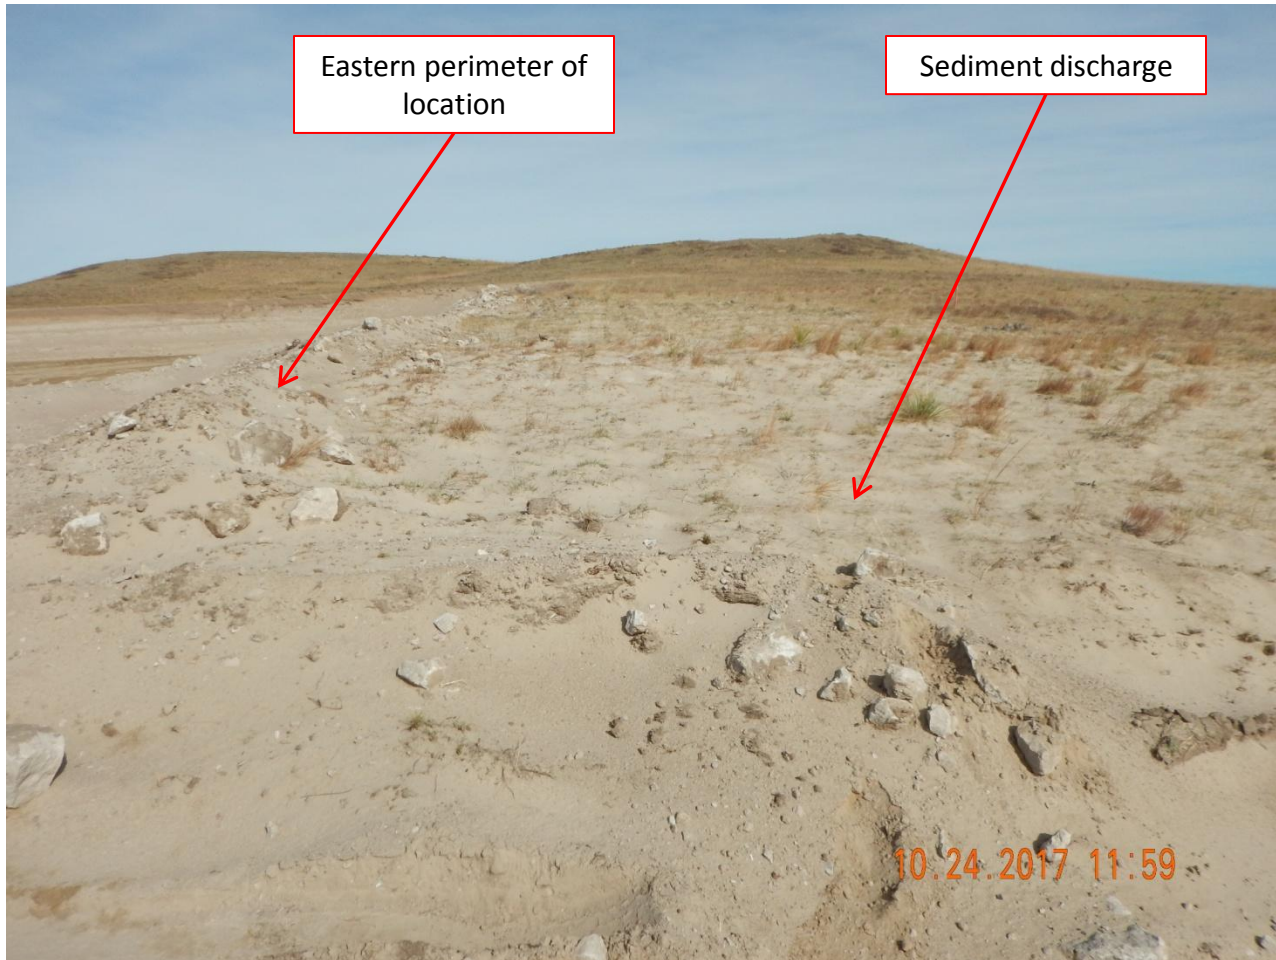
Photo 10. Photo taken from the eastern location from the cut slope, facing North. See comments under Photo 8.

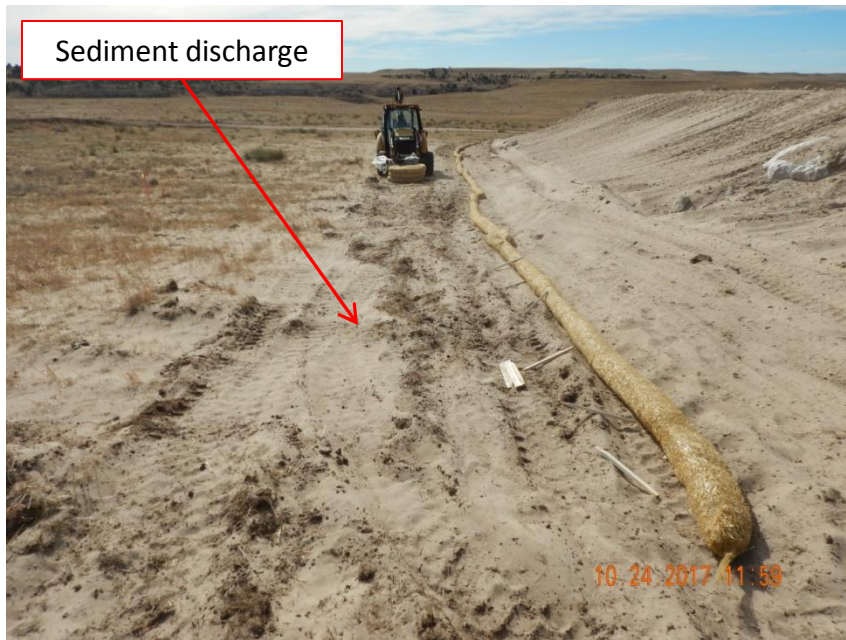
Photo 11. Photo taken from the eastern location on the fill slope, facing South. Operator starting to install straw wattle BMPs. Sediment discharge off location from wind erosion evident. Straw wattle BMPs are only temporary BMPs and should be used in conjunction with other BMPs.

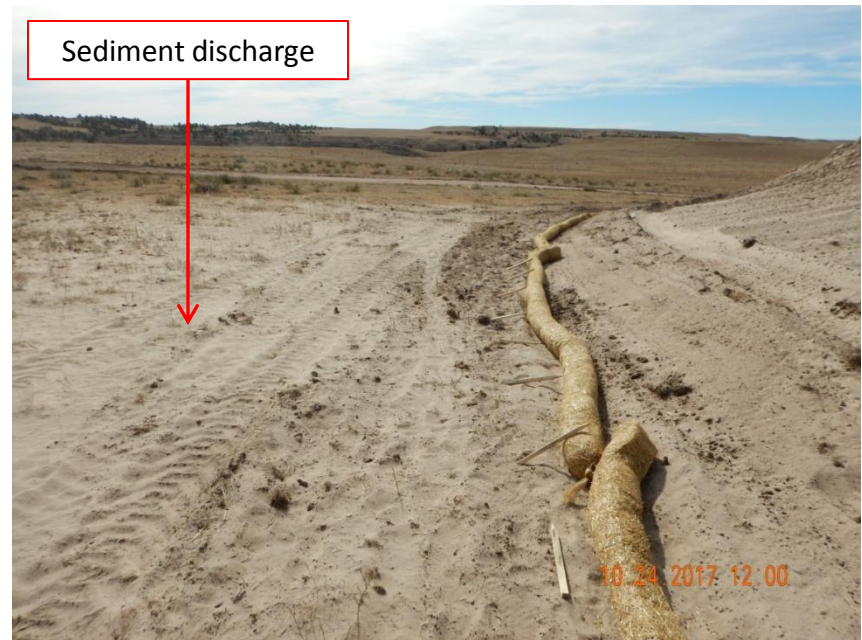
Photo 12. Photo taken from the southeast location, facing South. See comments under Photo 11.
