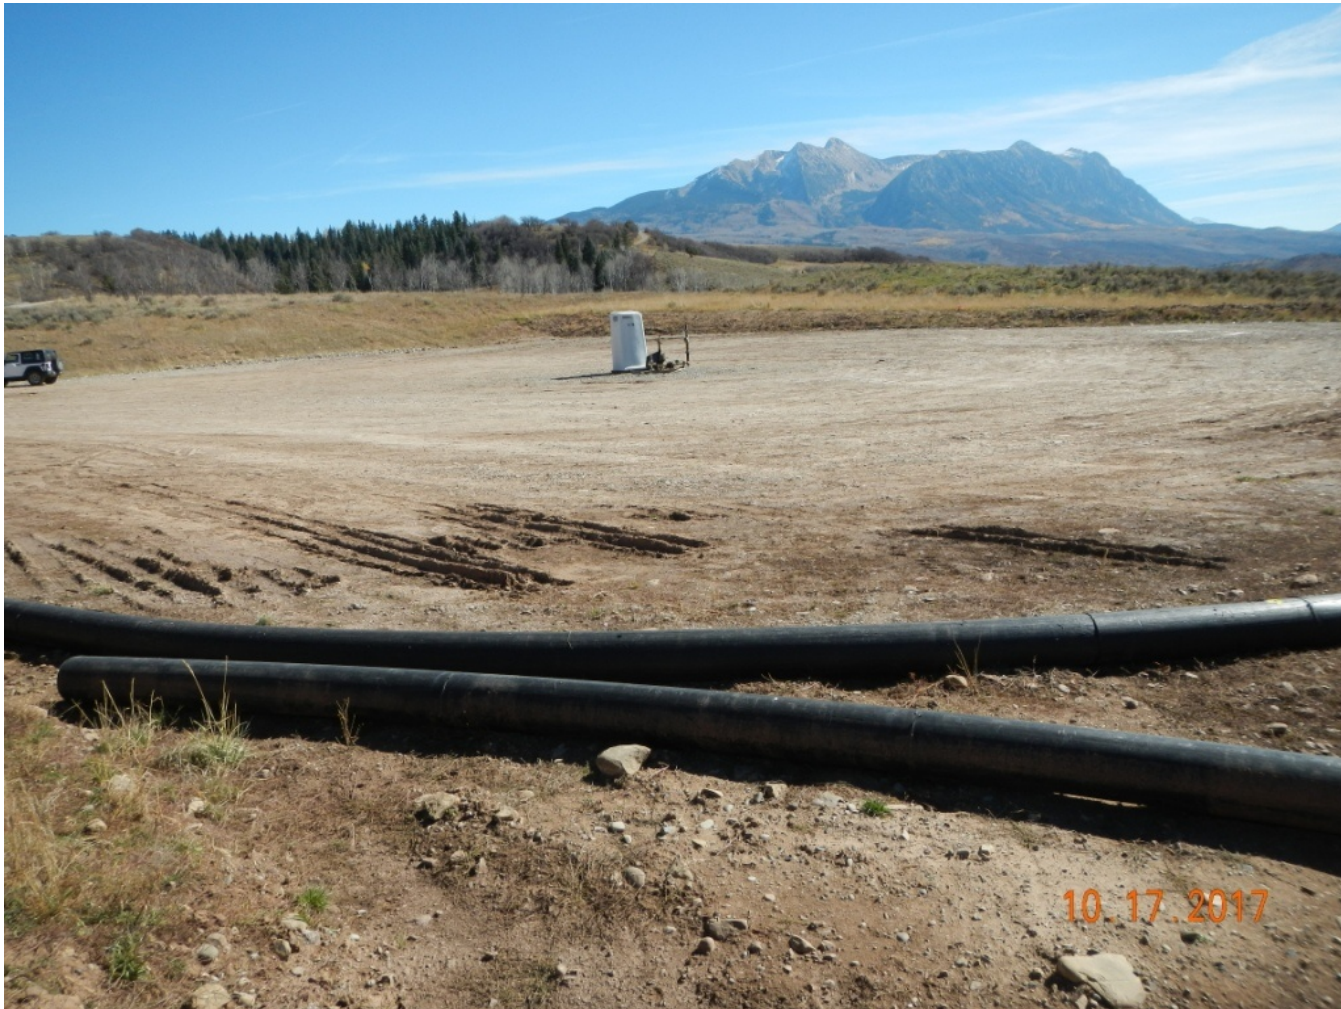
Photo 1. View of the project area from the northwestern corner of the working area facing center.

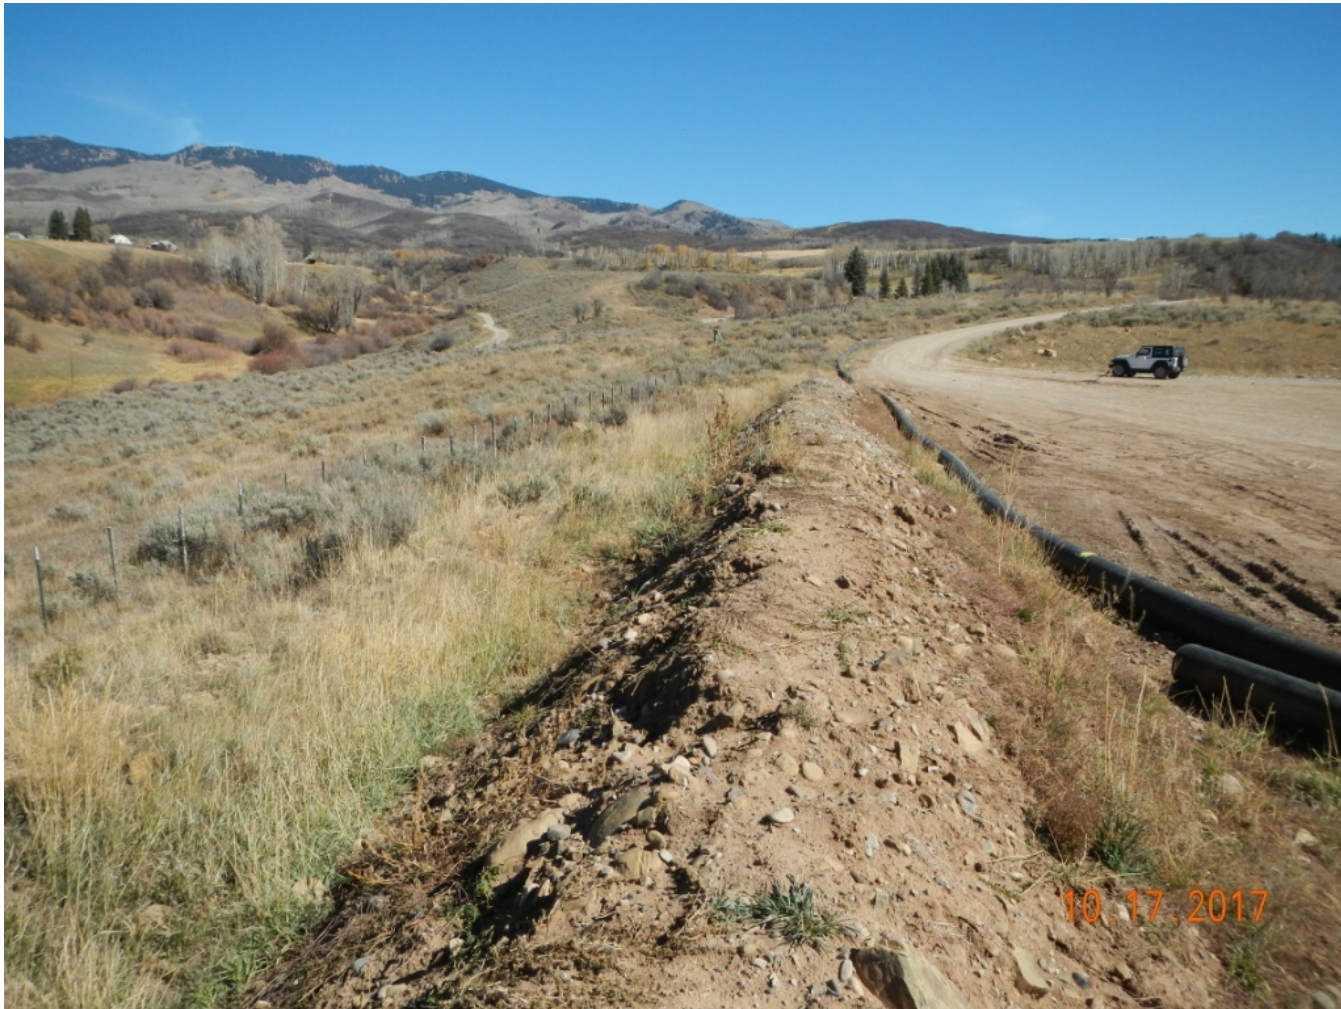
Photo 2. View of the northern portion of the project area from the northwestern corner of the working area facing eastward.

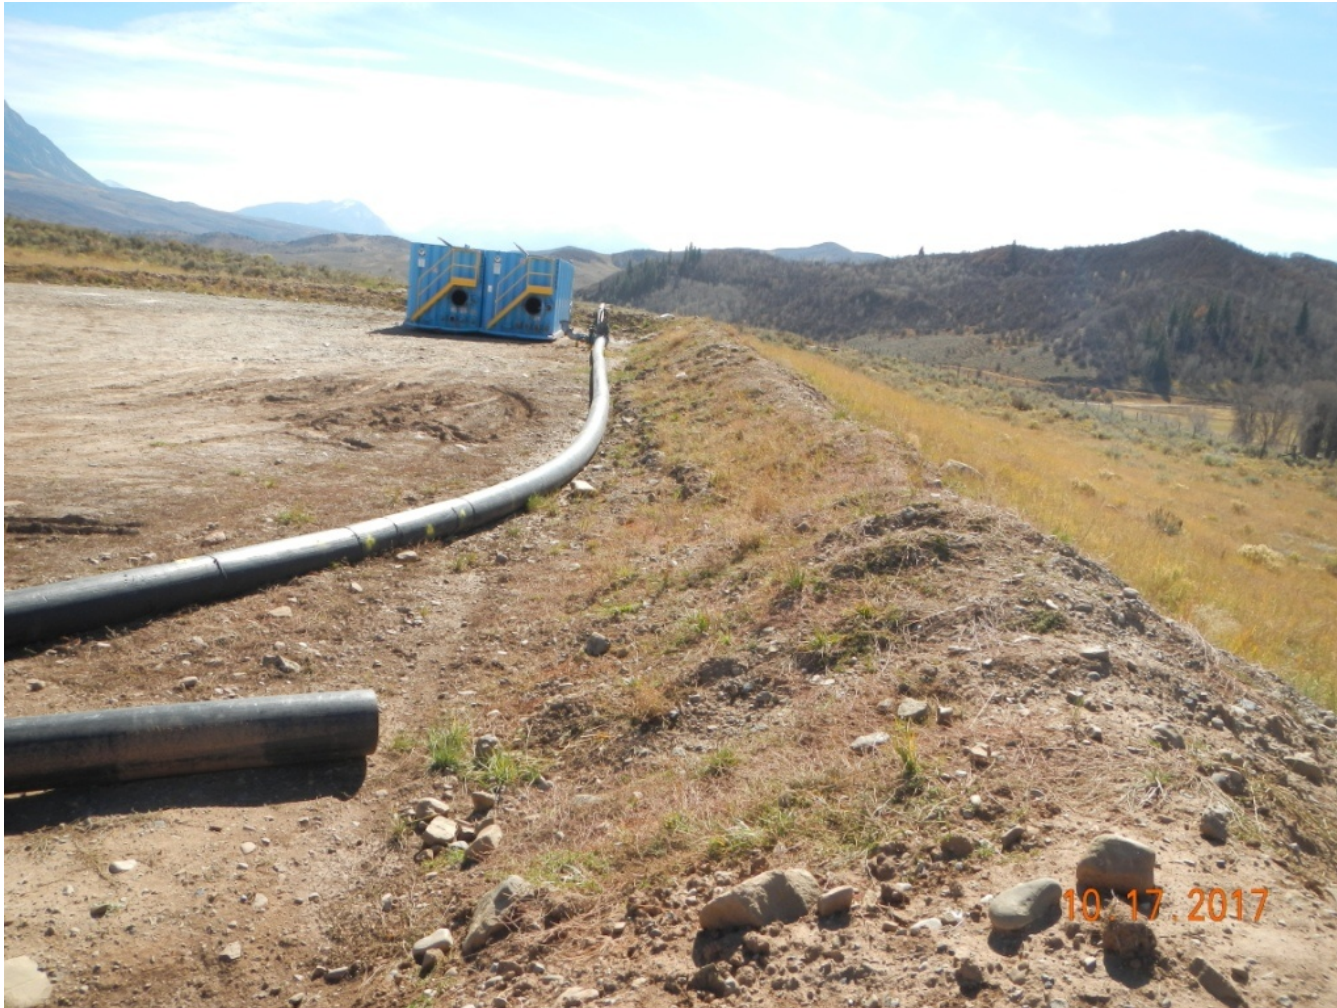
Photo 3. View of the western portion of the project area from the northwestern corner of the working area facing southward. Revegetation is progressing within the outer disturbance areas and comprised of species such as western wheatgrass (*Pascopyrum smithii*). Blue frac tanks in the southwestern portion of the working area do not appear to be in use and need to be removed.

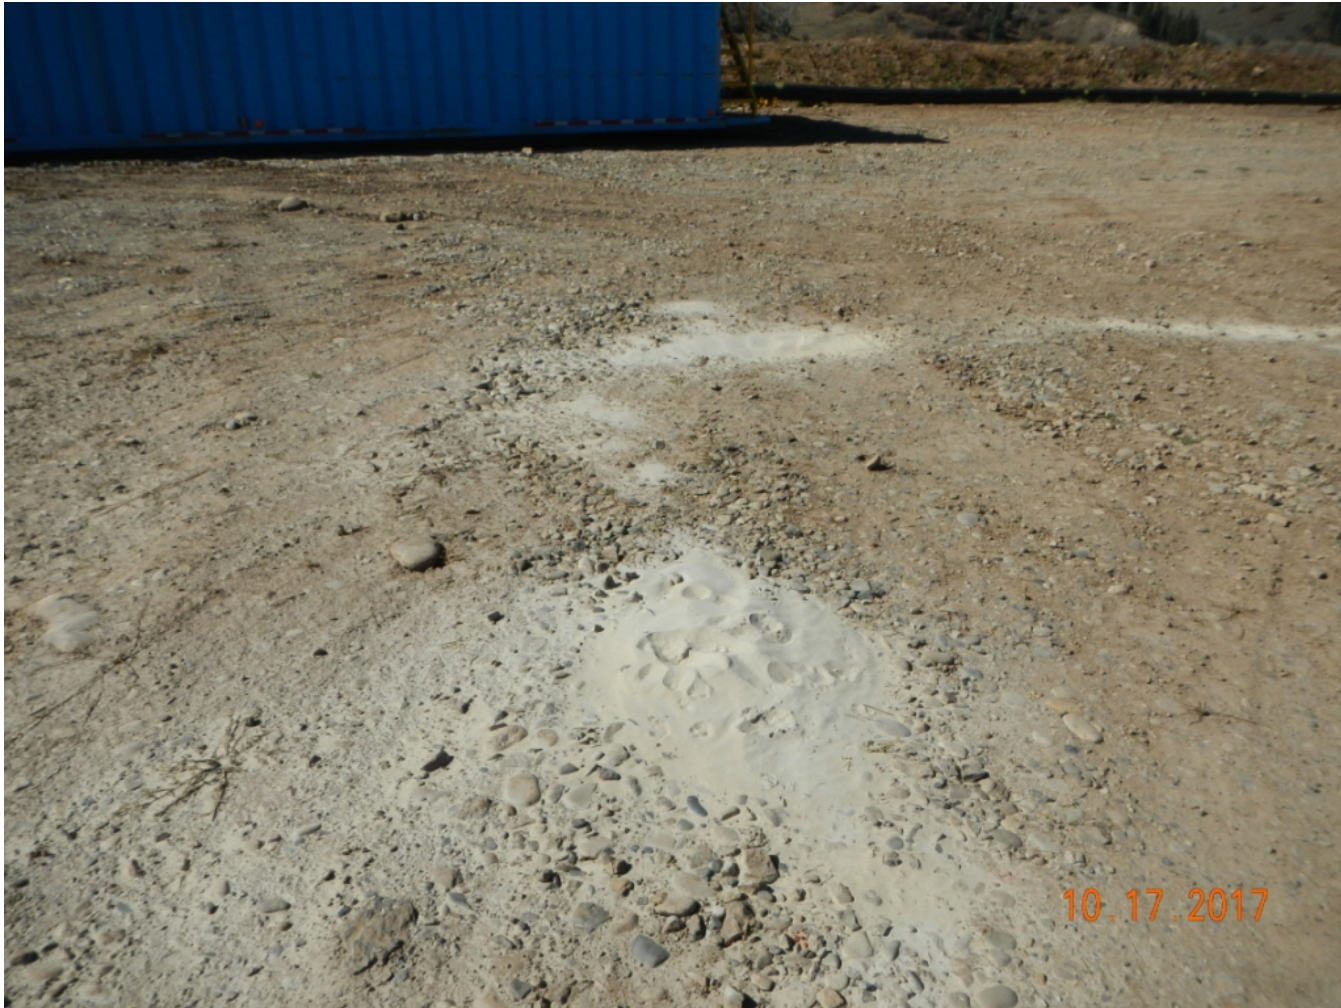
Photo 4. View of what appears to be frac sand in the southern portion of the working area.

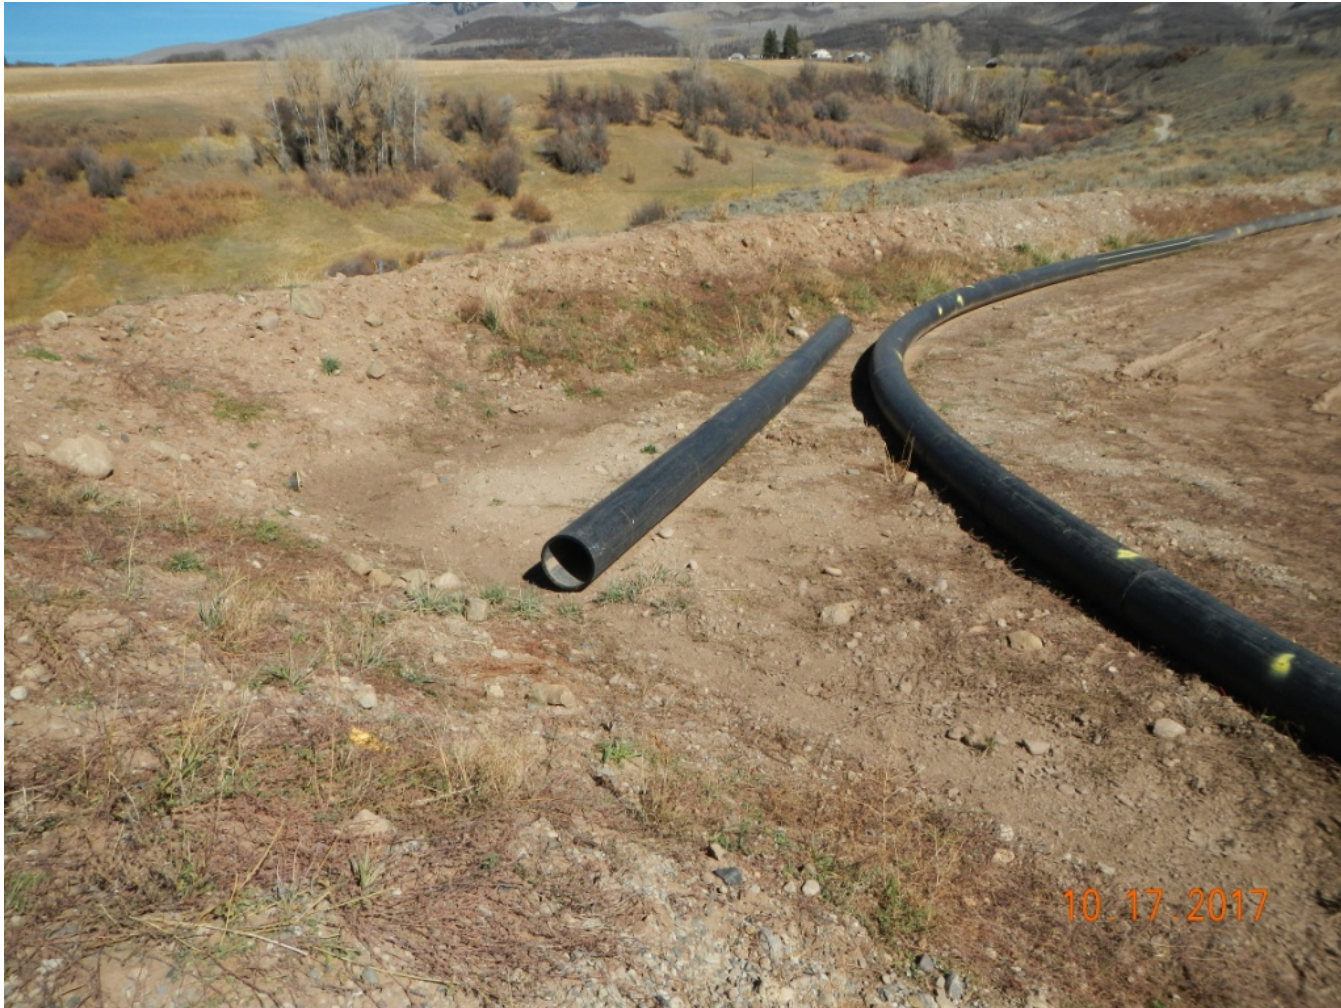
Photo 5. View of pipe segment in the northwestern portion of the project area.

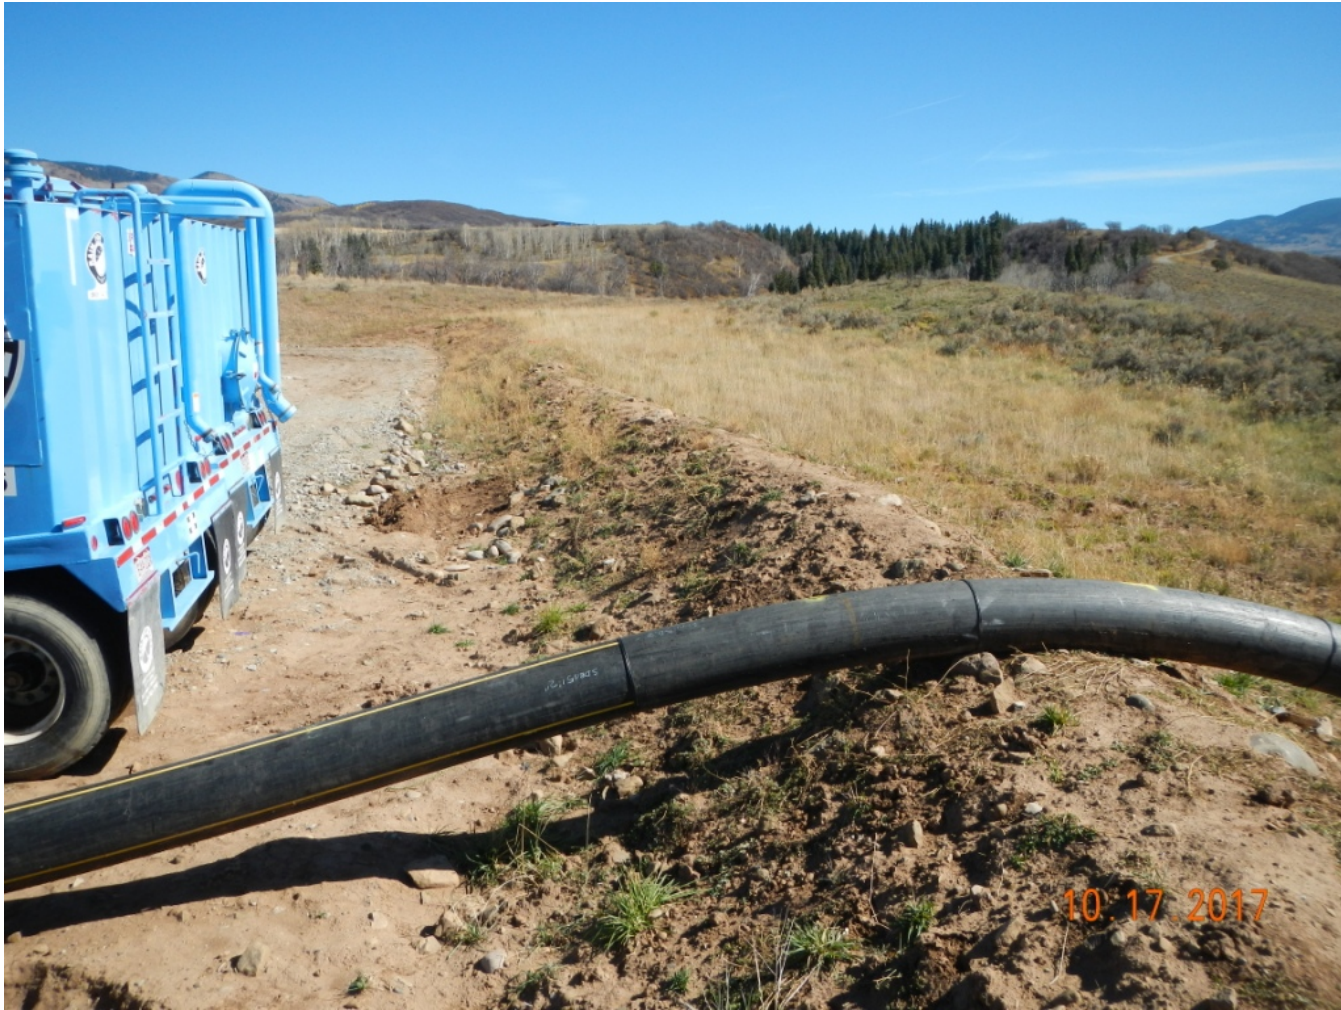
Photo 6. View of the southern edge of the project area from the southwestern corner of the working area facing eastward. Berms have recently been installed and seeded.
